**SAMPLING AND ANALYSIS REPORT**  
**FACILITY 832**  
**BASE REALIGNMENT AND CLOSURE**  
**ZONE D, FLIGHTLINE INDUSTRIAL AREA**

**NAVAL AIR STATION CECIL FIELD**  
**JACKSONVILLE, FLORIDA**

**August 1998**

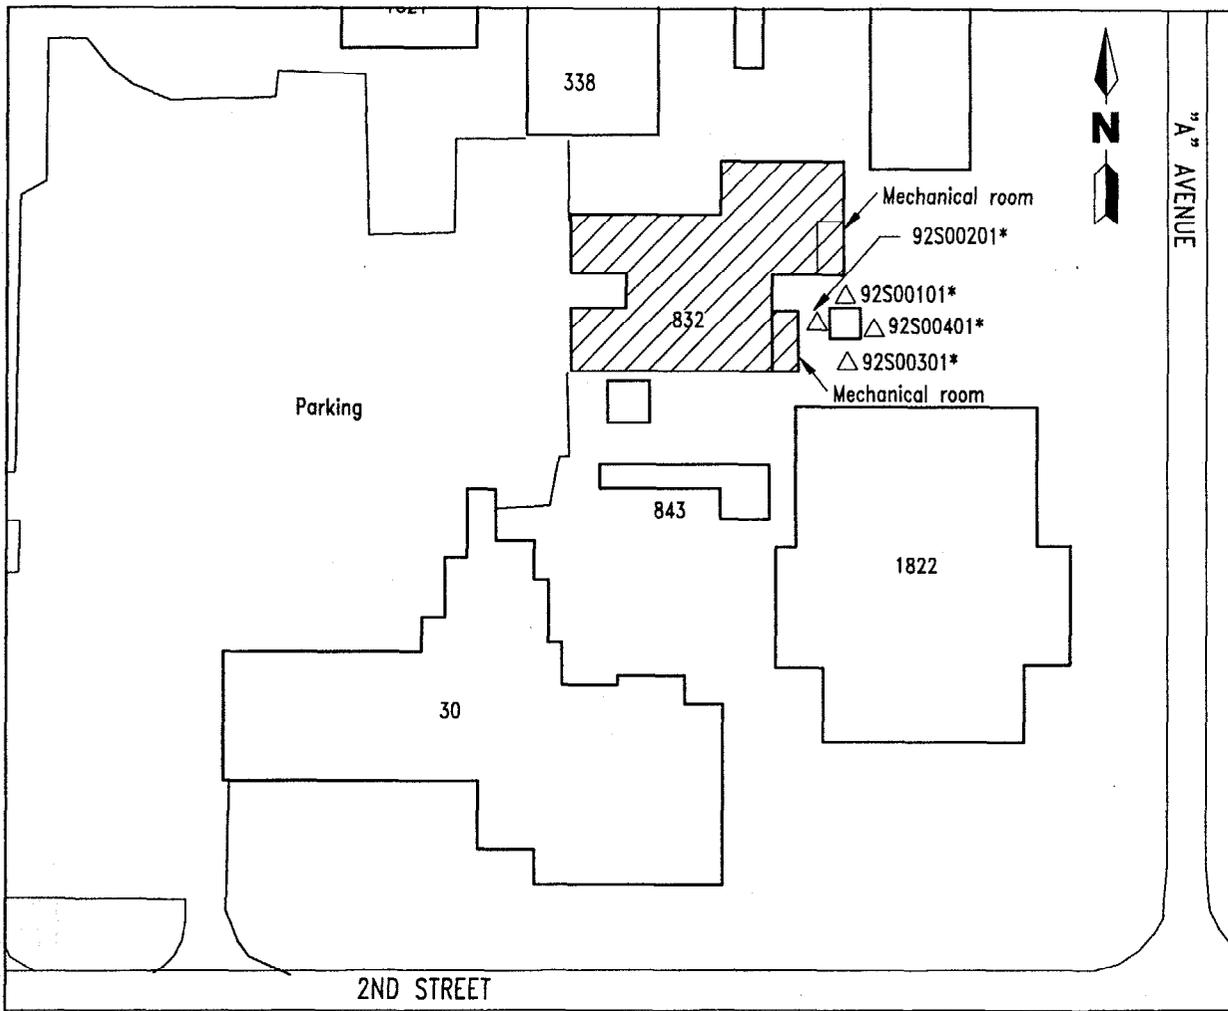
**FIGURE 1**  
**FACILITY 832**  
**FLIGHT SIMULATOR TRAINING BUILDING**  
**SAMPLE LOCATION PLAN**

This Phase II investigation included the collection and analysis of four surface soil samples from the area surrounding the transformer. The samples were collected from 0 to 1 foot below land surface. Field activities were undertaken in general conformance with the Project Operations Plan (ABB-ES, 1994b). The soil samples were analyzed on site using immunoassay methods (D TECH PCB soil test Kit; Item #TK-1002-1) capable of detecting PCBs at concentrations of 0.5 ppm or greater. A site plan indicating the location of the surface soil samples is presented on Figure 1. Sample results are discussed in Section 3.0.

The results of the analyses for PCBs in each of the four surface soil samples were negative; therefore, no preliminary risk evaluation is required.

Based on the information obtained for this assessment, PCBs are not present in the surface soil surrounding the transformer on the east side of Facility 832 and, therefore, there is no associated hazard to human health or the environment. ACM was identified in the building, and should be managed in a manner which prevents human exposure. Based on the age of the Facility, it is likely to have been painted with a lead-based coating. Department of Defense policy does not require evaluation of lead-based paint in non-residential facilities. No other environmental concerns have been identified for this facility.

No remedial action or further evaluation is recommended for Facility 832. Appropriate site operation and management procedures should be undertaken in order to ensure that current and future site activities do not result in release of hazardous substances to the environment. A full disclosure of all environmental conditions and land-use restrictions should be incorporated into any documentation prepared in support of a sale or lease of real property including Facility 832.
