SAMPLING AND ANALYSIS REPORT FOR FACILITY 82 BASE REALIGNMENT AND  
CLOSURE ZONE D INDUSTRIAL AND FLIGHT LINE AREA REVISION 1 NAS CECIL FIELD  
FL  
6/1/1999  
HARDING LAWSON ASSOCIATES

**SAMPLING AND ANALYSIS REPORT**  
**FACILITY 82**  
**BASE REALIGNMENT AND CLOSURE**  
**ZONE D, INDUSTRIAL AND FLIGHT LINE AREA**

**NAVAL AIR STATION CECIL FIELD**  
**JACKSONVILLE, FLORIDA**

**June 1999**

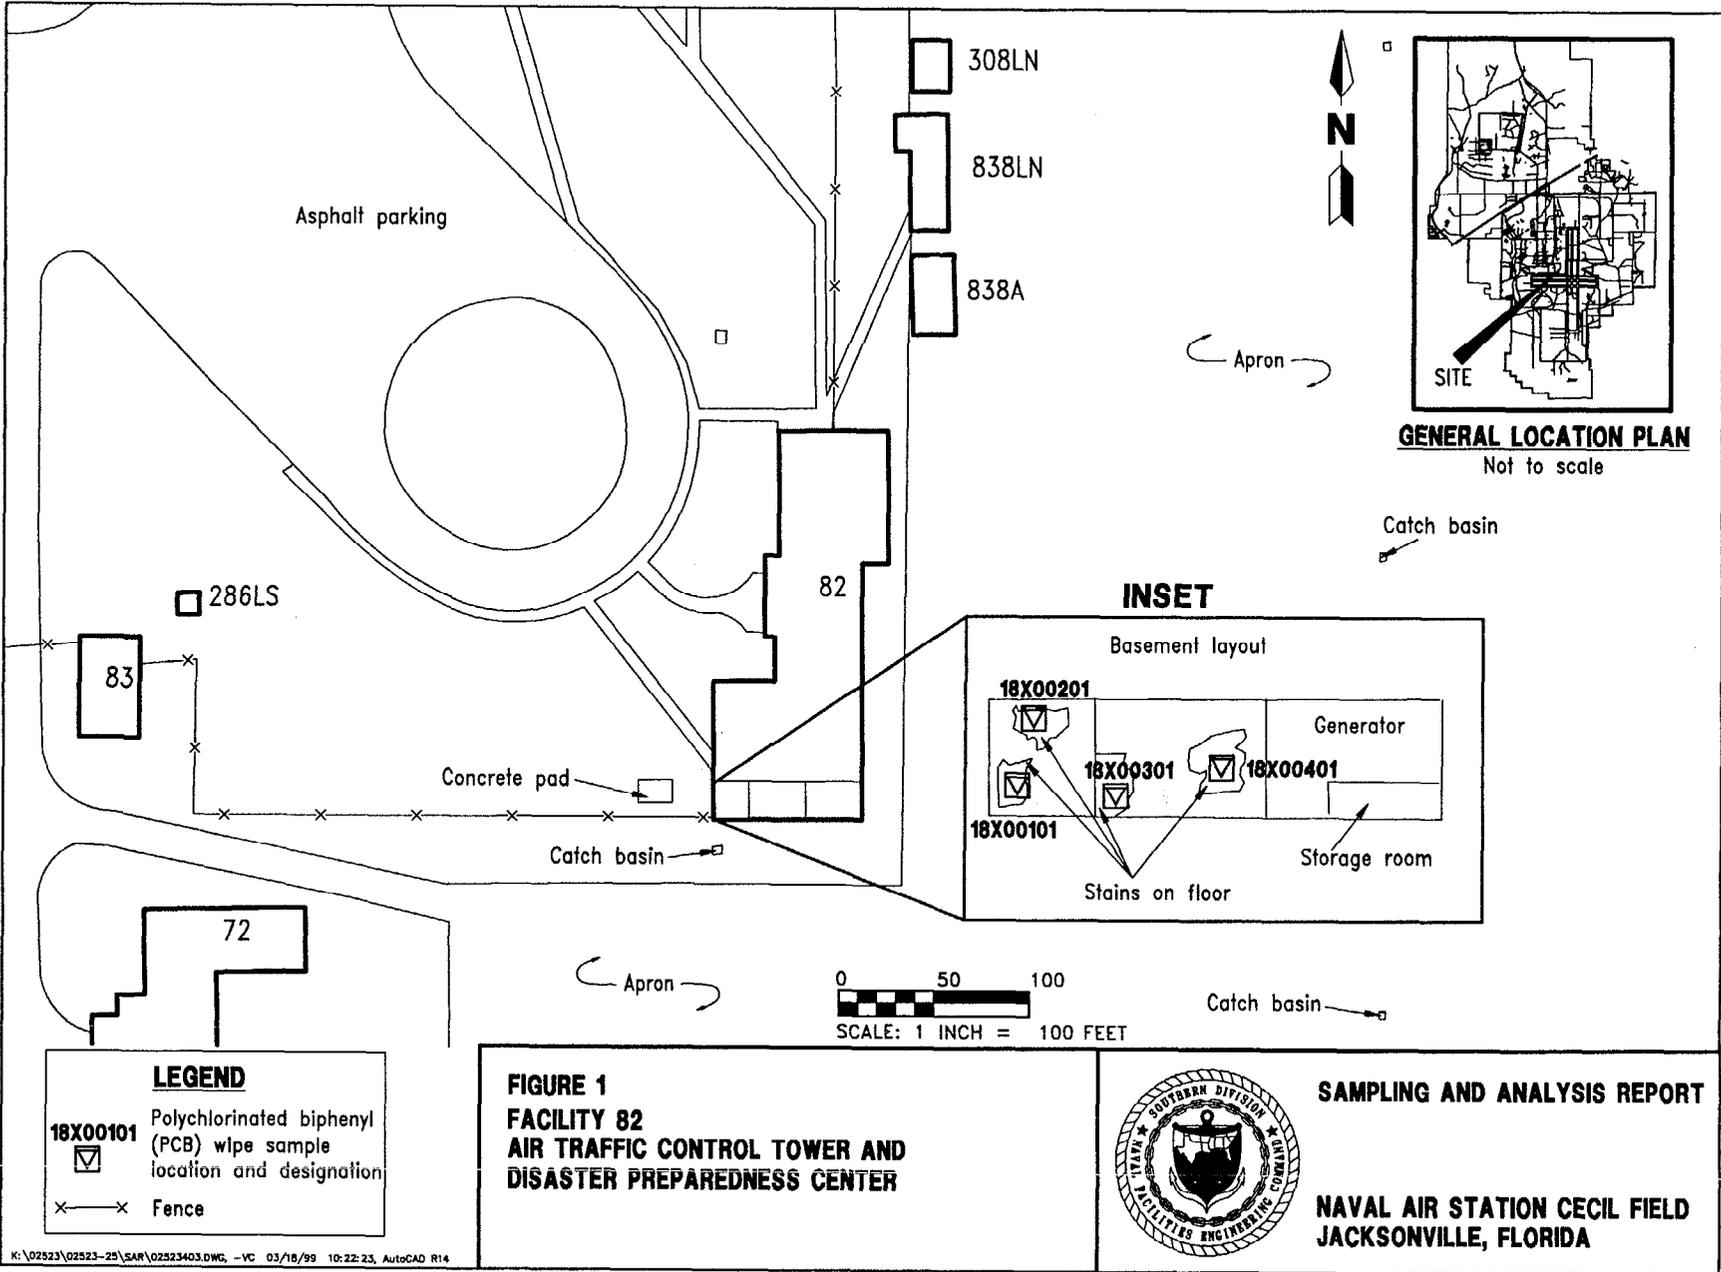
| <u>Figure</u> | <u>Title</u> | <u>Page No.</u> |
|---|--|---|
| 1 | Air Traffic Control Tower and Disaster Preparedness Center . . . . . | 2 |

Four surface wipe samples were collected from stained concrete surfaces inside Facility 82. The samples were analyzed for the full Contract Laboratory Program suite of target compound list PCBs. A site plan with sample locations is presented on Figure 1. Field activities were undertaken in general conformance with the Project Operations Plan (ABB-ES, 1994b).

The surface wipe samples collected from the stained concrete surfaces in Facility 82 contained up to 410 micrograms of Aroclor-1260. No other PCB compounds were detected. A residential human health exposure scenario is not applicable to a stained concrete surface. Therefore, no preliminary risk evaluation was conducted for this site. Analytical results are presented in Appendix A

PCBs have been detected on stained concrete surfaces in the electrical equipment room at the south end of Facility 82, and petroleum contaminated groundwater has been detected in association with a former UST on the north side of Facility 82. Additional assessment of the petroleum contamination is recommended. The stained concrete appears to be from an incidental release of dielectric fluid. Prior to lease or transfer, the stained concrete surfaces should be decontaminated to a non-detect level or removed, during closure procedures for Facility 82. ACM should be managed under an operations and maintenance plan, and should not be damaged or disturbed. The facility is located within an active IR Site, but is not within an area of groundwater contamination. Therefore, the color classification for Facility 82 should be changed to 2/Blue (Yellow) to indicate that a petroleum release has been documented and additional assessment is required.
