STORM SEWER INVESTIGATION LETTER REPORT FOR OPERABLE UNIT 7 (OU 7) SITE
16 NAS CECIL FIELD FL
12/9/1998
TETRA TECH NUS INC

**STORM SEWER INVESTIGATION
LETTER REPORT
OPERABLE UNIT 7, SITE 16
NAVAL AIR STATION CECIL FIELD**

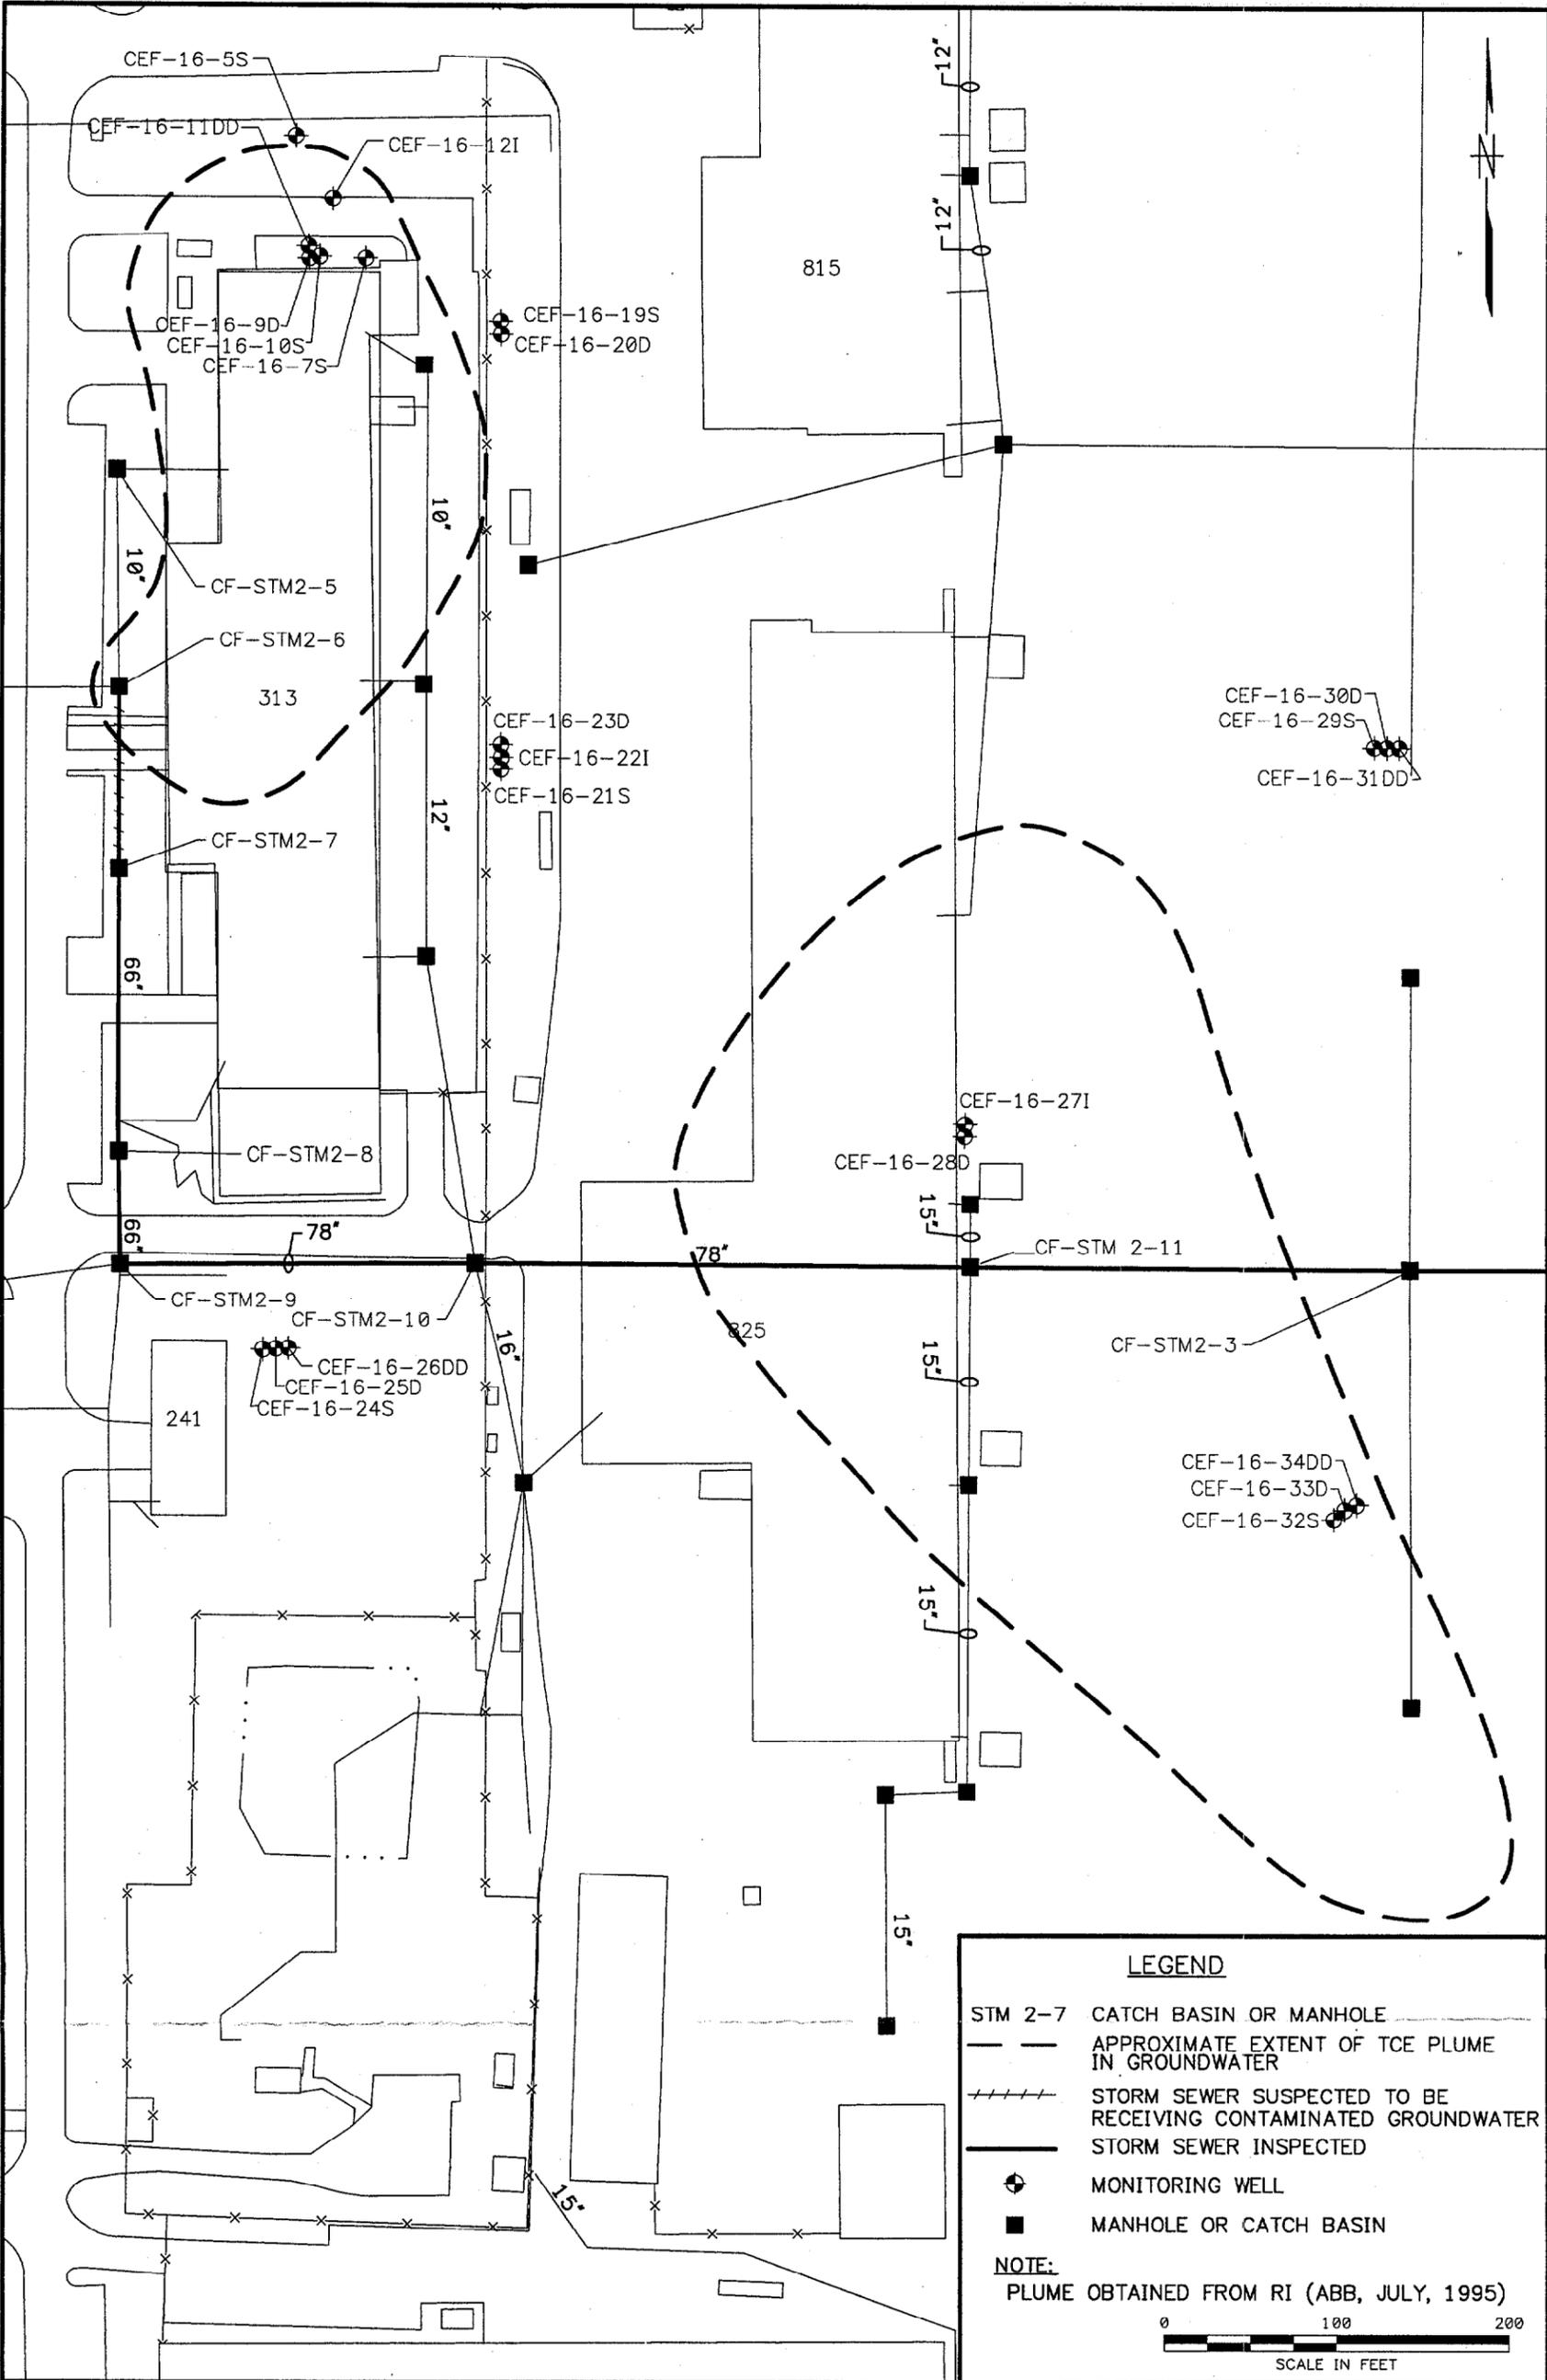
CONTRACT NO. 7792	
APPROVED BY	DATE
APPROVED BY	DATE
DRAWING NO.	FIGURE 1-1
REV.	0

A site plan that illustrates the storm sewer system and TCE contaminant plume near Site 16 is provided on Figure 1-1. The storm sewer system was visually inspected from manhole CF-STM2-6 near Building 313 to manhole CF-STM2-3 east of Building 825. All sewer lines inspected were constructed of corrugated metal pipe. The entire investigation was videotaped. A summary of the storm sewer inspection is provided below. For organizational purposes, the summary has been divided into sections corresponding to the order of inspection.
