DRAFT RESOURCE CONSERVATION AND RECOVERY ACT FACILITY INVESTIGATION
REPORT VOLUME 8 OF 12 APPENDICES A AND B ZONE L CNC CHARLESTON SC
12/18/1998
ENSAFE INC.

**DRAFT ZONE L
RCRA FACILITY INVESTIGATION REPORT
CHARLESTON NAVAL COMPLEX**

**VOLUME 8 OF 12
APPENDICES A TO B**

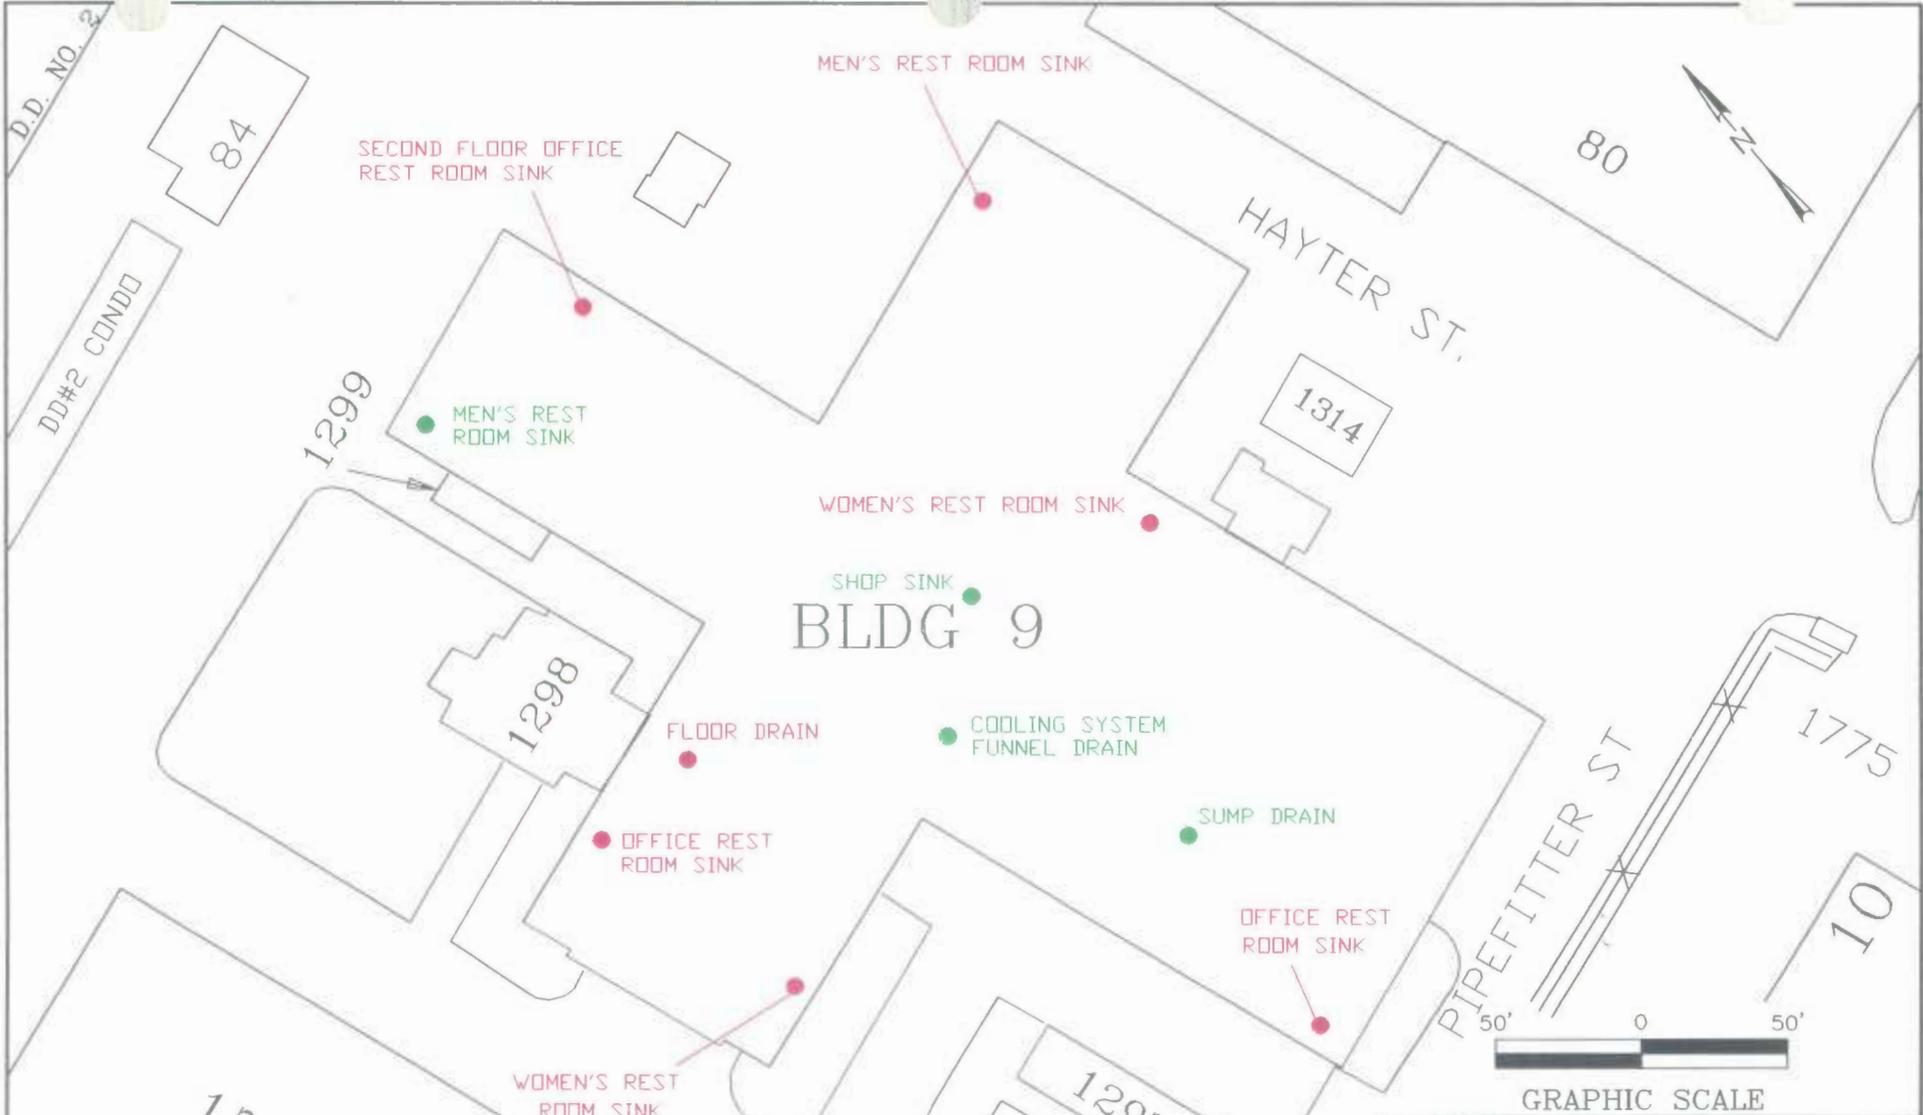
FIGURE A-1
 BUILDING 9
 DYE INJECTION SITES

Building 9 was dye injection tested on December 12, 1997. Eleven sites, 7 latrines, 1 floor drain, 1 sump drain, 1 funnel drain and a shop sink were simultaneously dye injected. A quality assurance check was performed at sanitary sewer Manholes 238, 247, and 250 to verify dye present. The storm sewer was monitored at Manhole 30/7. Test samples indicated dye present at storm sewer Manhole 30/7. A cross-connect exists to storm sewer Outfall 30.

Building 9 was dye injection tested on March 11 through March 19, 1998. Seven individual dye injection tests were done. The first test injected 4 latrines in the south wing and mid-section; no dye was found. The second test injected three shop latrines in the north wing and mid-section; dye was found at storm sewer Manhole 30/7. The third test injected one north wing latrine; no dye was found. The fourth test injected one mid-section shop sink; dye was found at storm sewer

Manhole 30/7. The fifth test injected one mid-section floor drain; no dye was found. The sixth test injected one south wing sump drain; dye was found at storm sewer Manhole 30/7. The seventh test injected one south wing cooling system funnel drain; dye was found at storm Manhole 30/7. The storm sewer was monitored at Manholes 30/7 for all tests. Test samples indicated dye present at storm sewer Manhole 30/7. Cross-connects exist from a latrine, shop sink, sump floor drain and numerous funnel drains throughout the south wing to storm sewer Outfall 30.

An addition to the other cross-connects found, a sink in north wing, which presently has plumbing disconnected, ties into the storm drain and is a cross-connect when the plumbing is reattached.

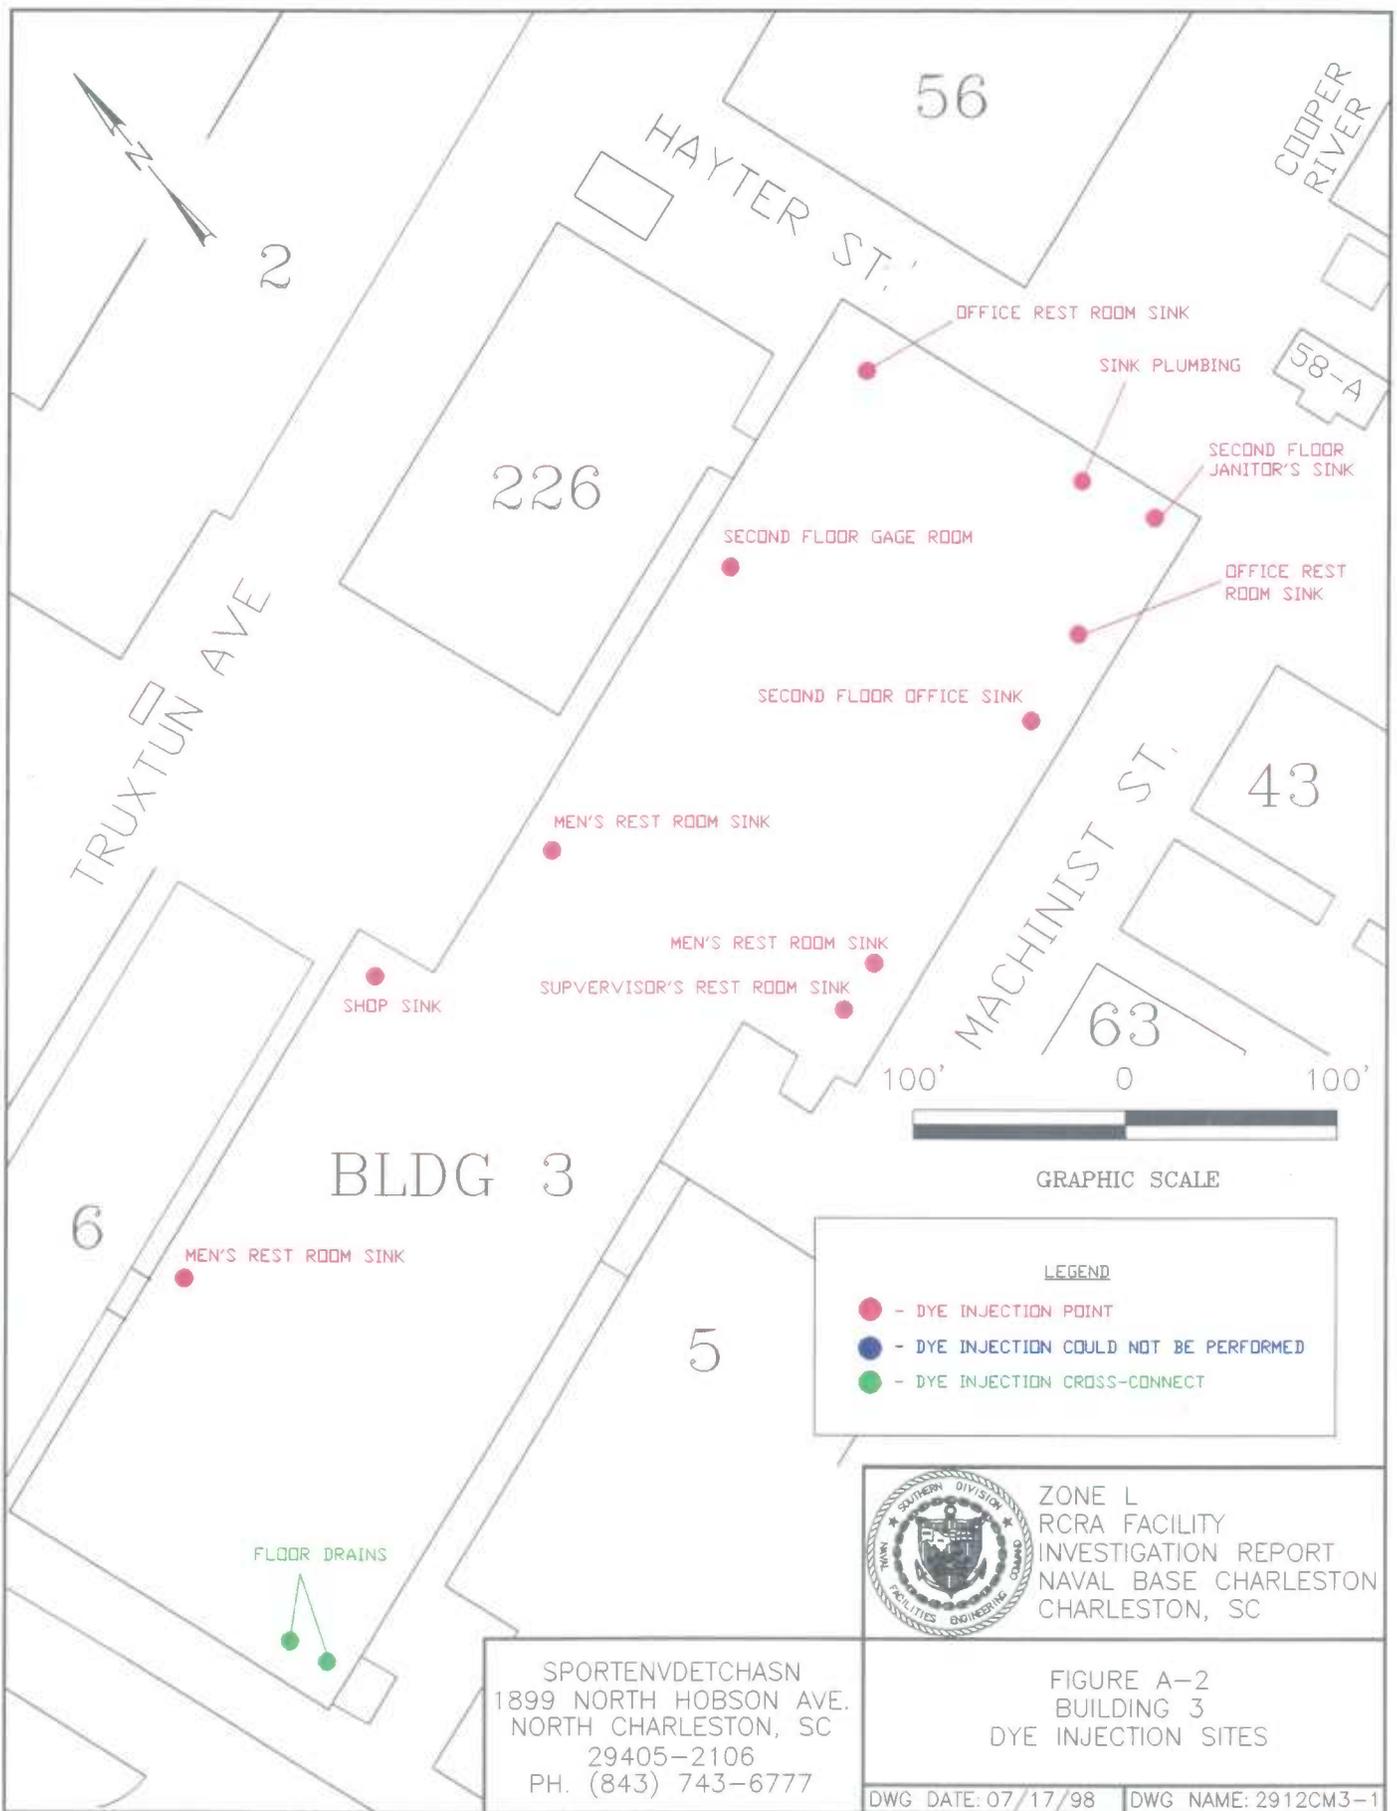
FIGURE A-2
 BUILDING 3
 DYE INJECTION SITES

Building 3 was dye injection tested on December 10, 1997. Twelve sites, 7 latrines, 1 floor drain, 1 janitor's sink and 3 shop sinks were simultaneously dye injected. A quality assurance check was performed at sanitary sewer Manholes 169-A and 204 to verify dye present. The storm sewer was monitored at Manholes 23/3 and 27/4. Test samples indicated dye present at storm sewer Manhole 23/3. A cross-connect exists to storm sewer Outfall 23.

Building 3 was dye injection tested on February 24 through February 26, 1998. Three individual dye injection tests were done. The first test injected 6 latrines and no dye was found. The second injected two shop floor drains in southwest corner and dye was found at storm Manhole 23/3. The third test injected five shop and latrine sinks and no dye was found. The storm sewer was monitored at Manholes 23/3 for all tests. Test samples indicated dye present at storm sewer Manhole 23/3. A cross-connect exists from shop floor drains in southwest corner to storm sewer Outfall 23.

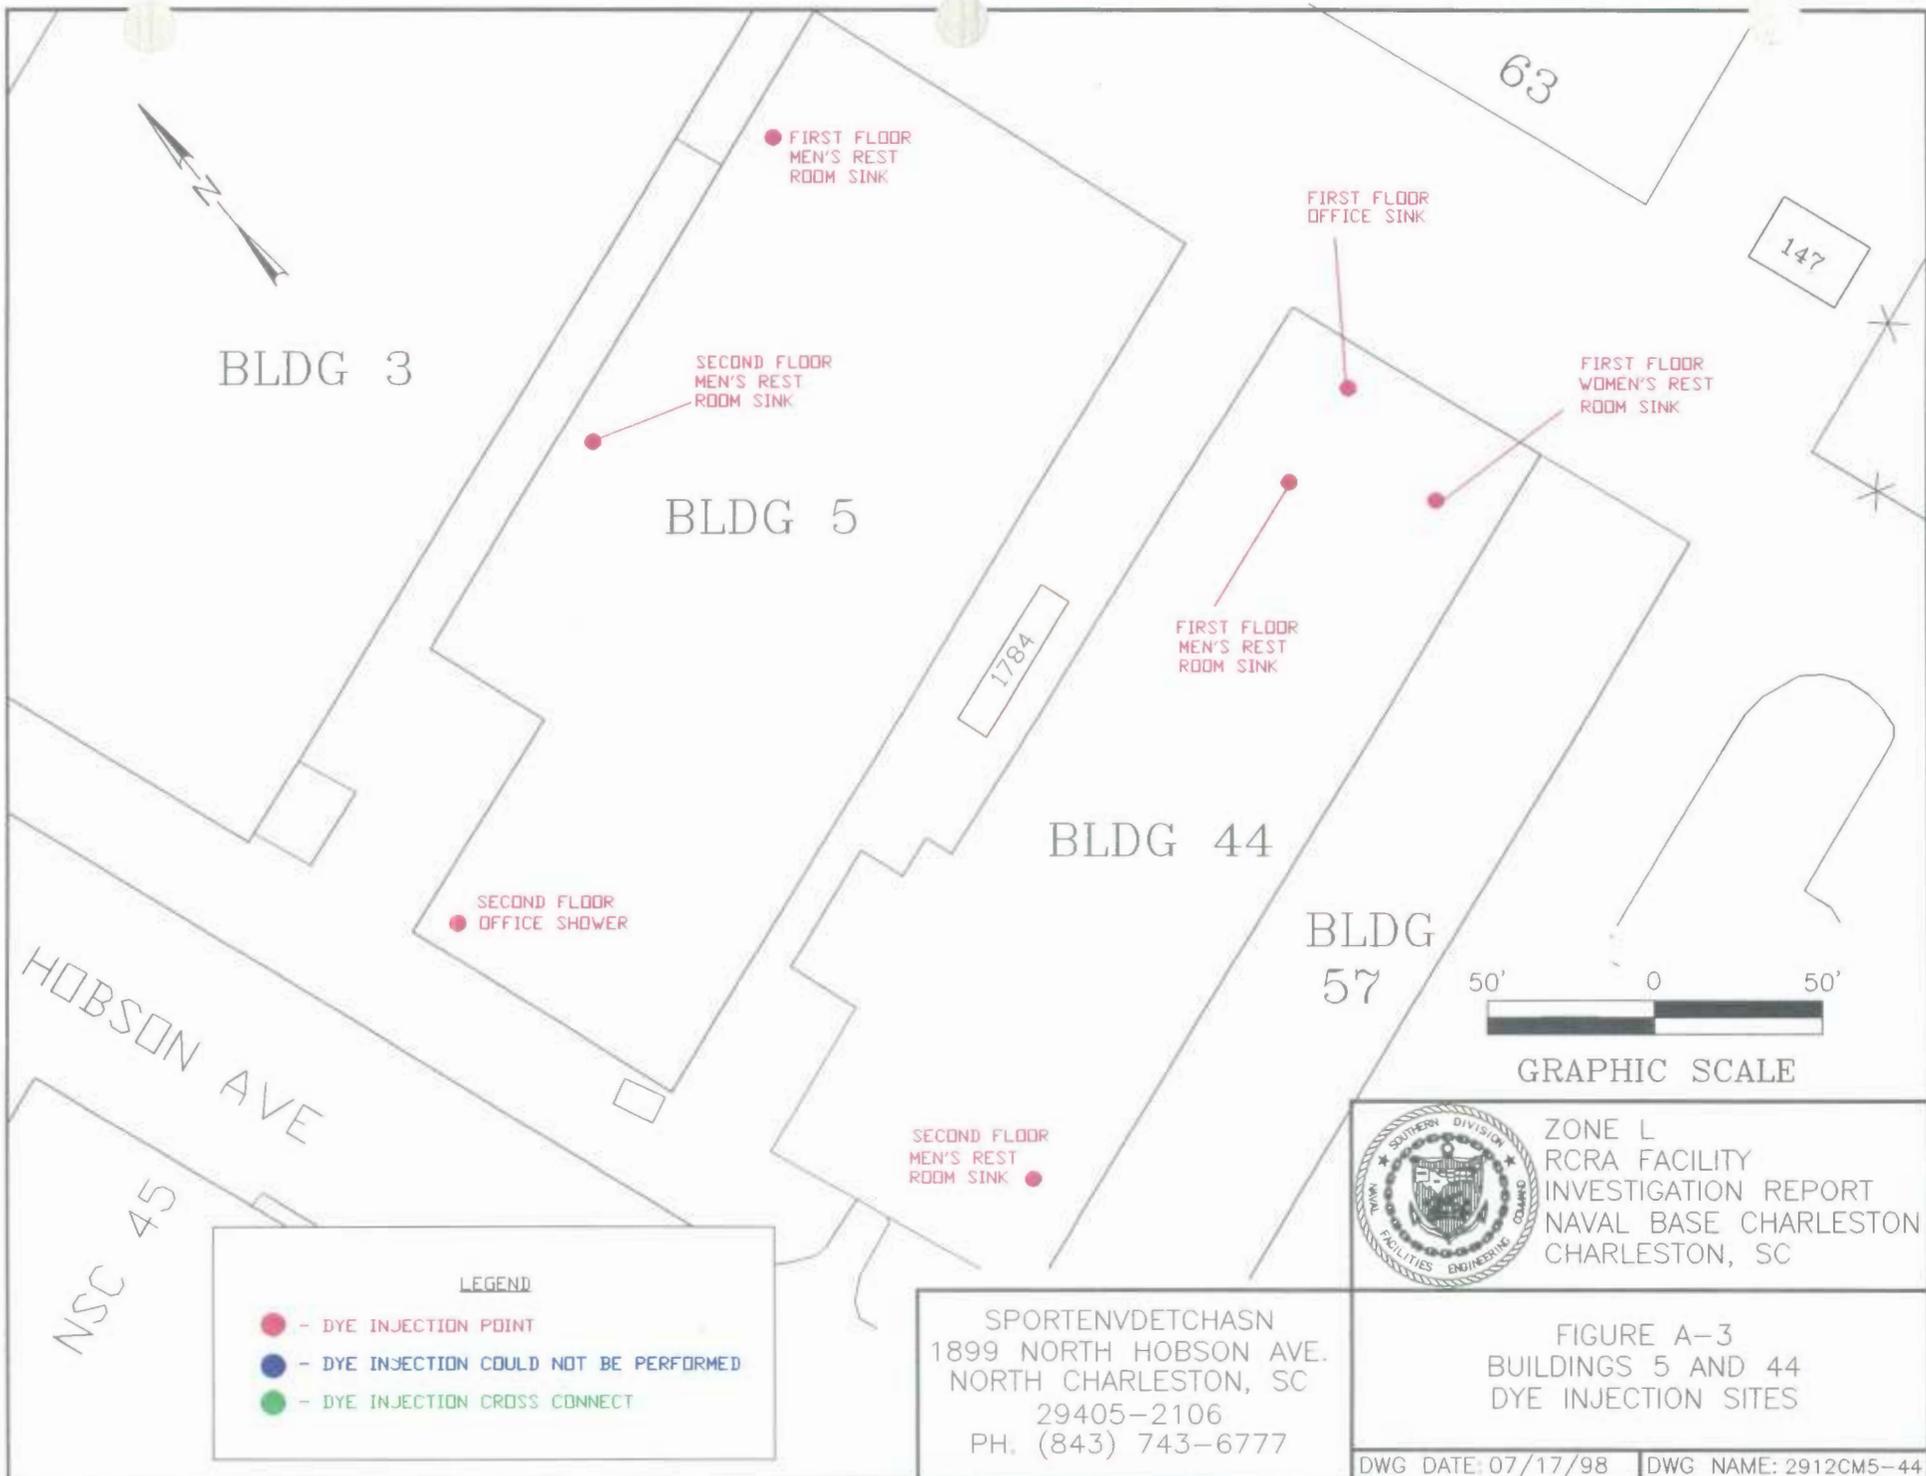
FIGURE A-3
BUILDINGS 5 AND 44
DYE INJECTION SITES

Building 5 was dye injection tested on December 12, 1997. Three sites, 2 latrines and an office shower were simultaneously dye injected. A quality assurance check was performed at sanitary sewer Manholes 192 and 204-A to verify dye present. The storm sewer was monitored at Manholes 23/9/4 and 27/4. Test samples indicated no dye present and no cross-connect exists.

Building 44 was dye injection tested on November 26, 1997. Four sites, 3 latrines and an office sink were simultaneously dye injected. A quality assurance check was performed at sanitary sewer Manholes 192 and 204-A to verify dye present. The storm sewer was monitored at Manhole 27/4. Test samples indicated no dye present and no cross-connect exists.

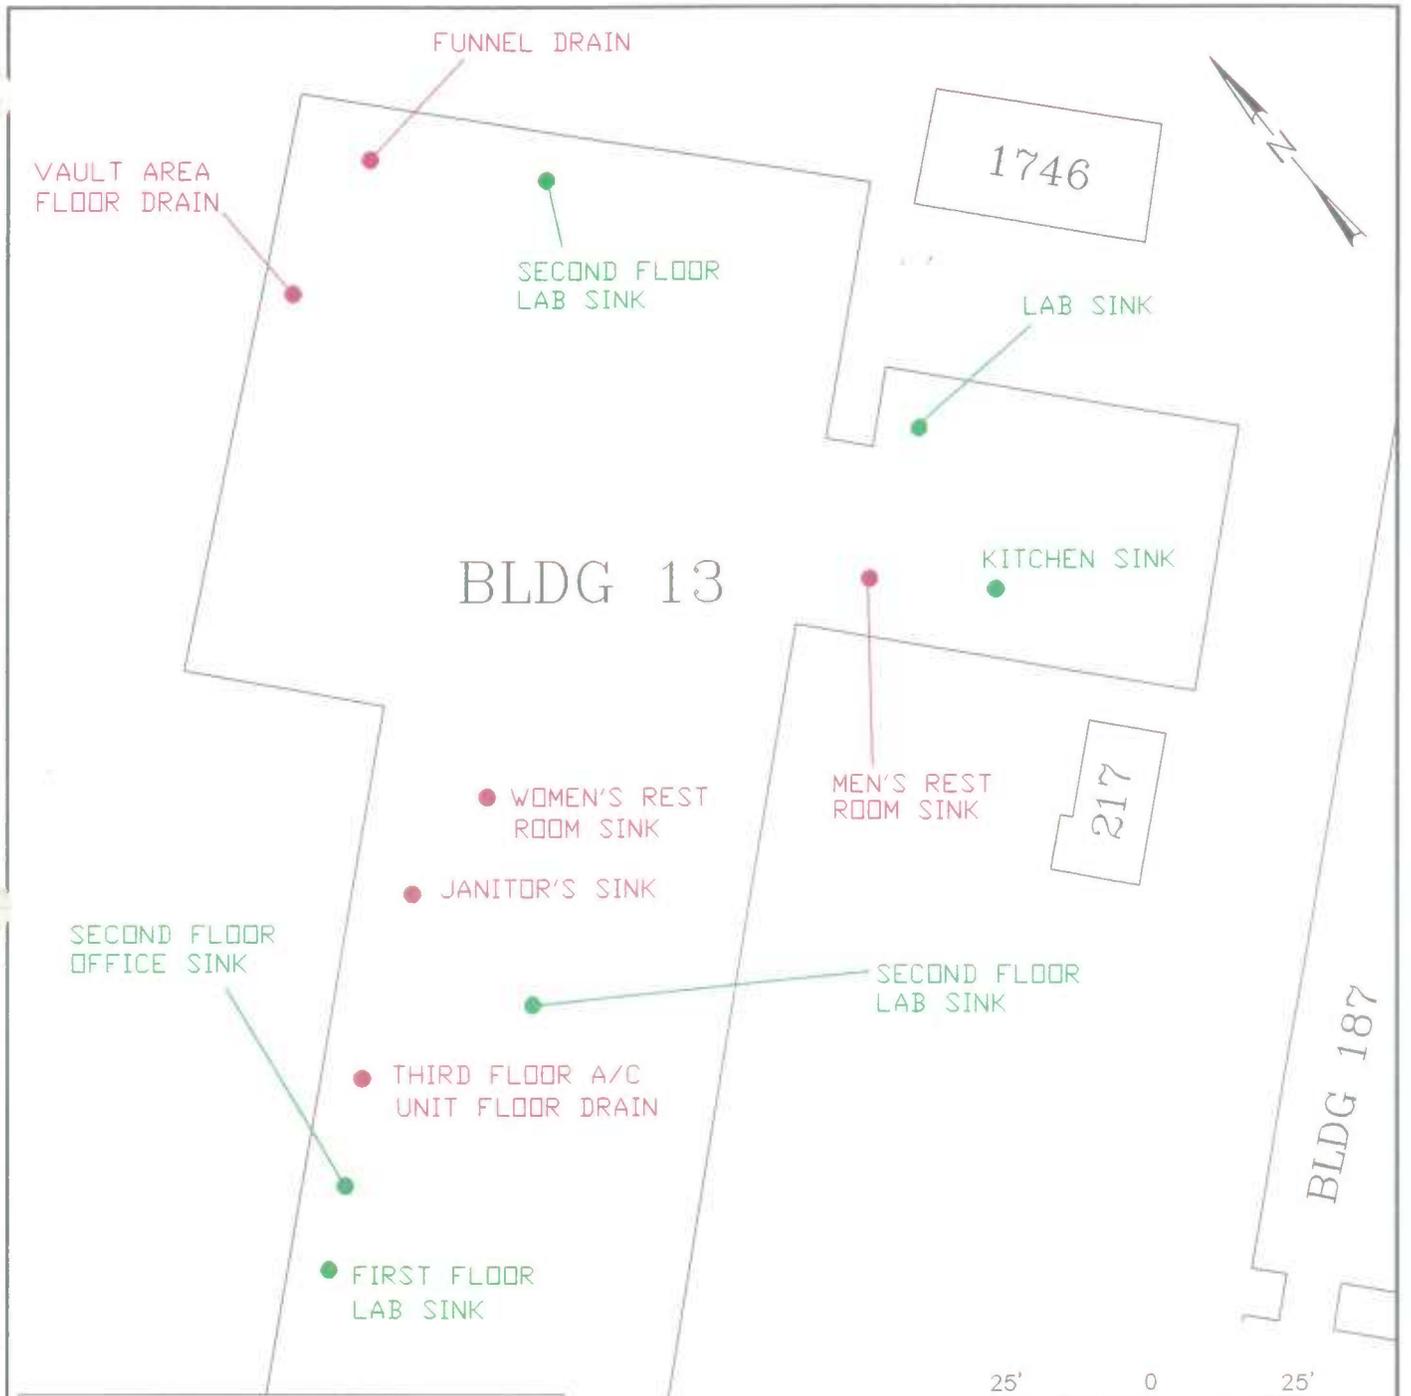
FIGURE A-6
BUILDING 13
DYE INJECTIONS SITES

Building 13 was dye injection tested on December 15, 1997. Twelve sites, 2 latrines, 2 floor drains, 1 funnel drain, 1 janitor's sink, 1 office sink and 5 laboratory sinks were simultaneously dye injected. A quality assurance check was performed at sanitary sewer Manhole 238 to verify dye present. The storm sewer was monitored at Manhole 30/7/1/5. Test samples indicated dye present at storm sewer Manhole 30/7/1/5. A cross-connect exists to storm sewer Outfall 30.

Building 13 was dye injection tested on March 2 through March 10, 1998. Six individual dye injection tests were done. The first test injected one floor drain in the vault area; no dye was found. The second test injected two latrines and a janitor's closet on the first floor and first floor annex; dye was not found. The third test injected one first floor annex sink and a second floor office sink; dye was found at storm sewer Manhole 30/7/1/3. The fourth test injected two second floor laboratory sinks; dye was found at storm sewer Manhole 30/7/1/3. The fifth test injected one first floor laboratory sink; dye was found at storm sewer Manhole 30/7/1/3. The sixth test injected one third floor Air Conditioning room drain; no dye was found. The storm sewer was monitored at Manholes 30/7/1/3 for all tests. Test samples indicated dye present at storm sewer Manhole 30/7/1/3. Cross-connects exist from a first floor annex sink and all office and laboratory sinks throughout the first and second floor to storm sewer Outfall 30.

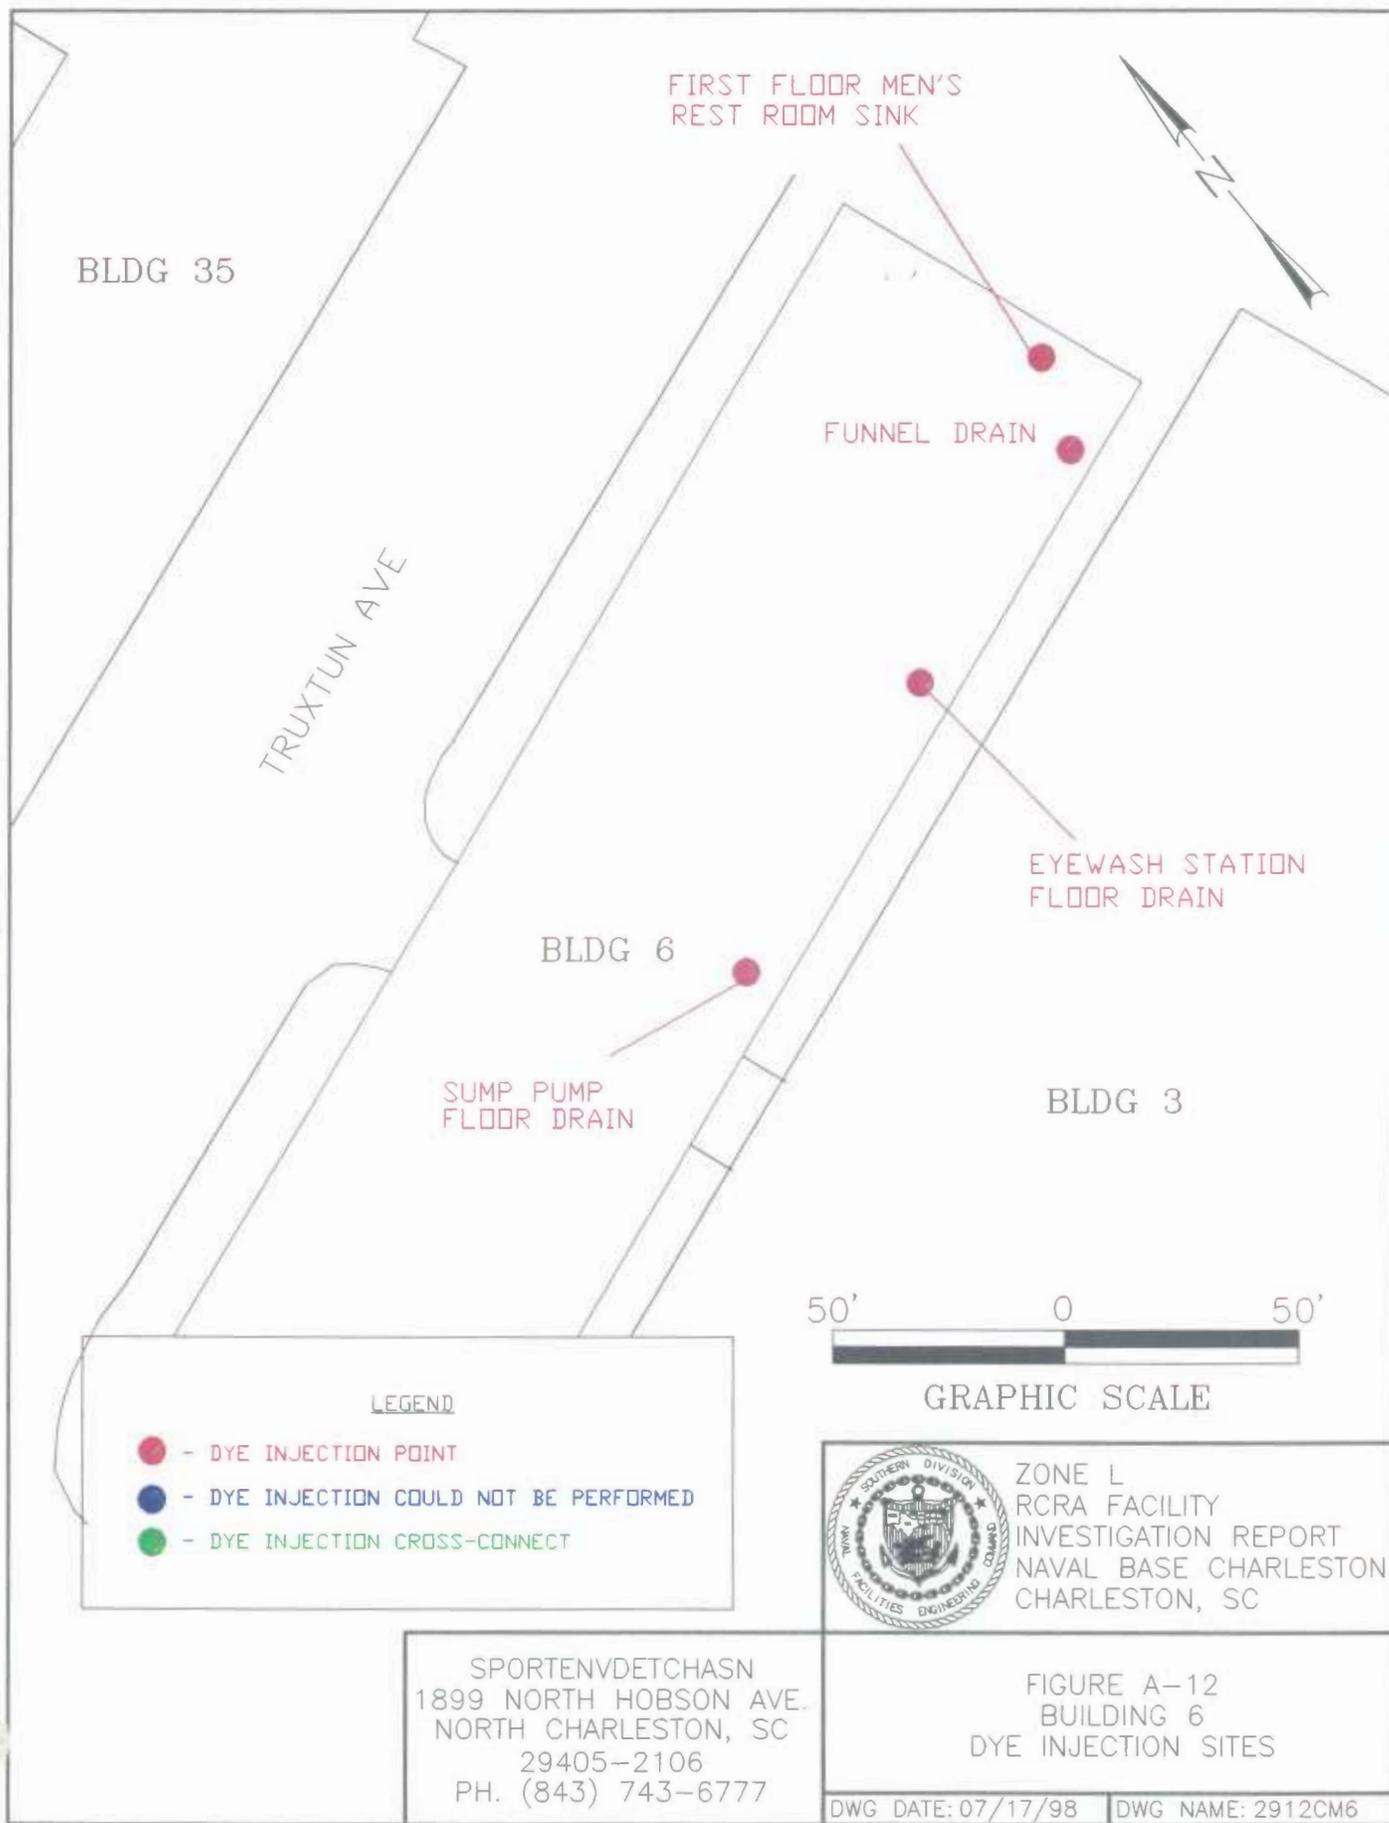
FIGURE A-12
BUILDING 6
DYE INJECTION SITES

Building 6 was dye injection tested on December 16, 1997. Four sites, 1 latrine, 2 floor drains, and a funnel drain were simultaneously dye injected. A quality assurance check was performed at sanitary sewer Manhole 166-C to verify dye present. The storm sewer was monitored at Manhole 23/6. Test samples indicated no dye present and no cross-connect exists.

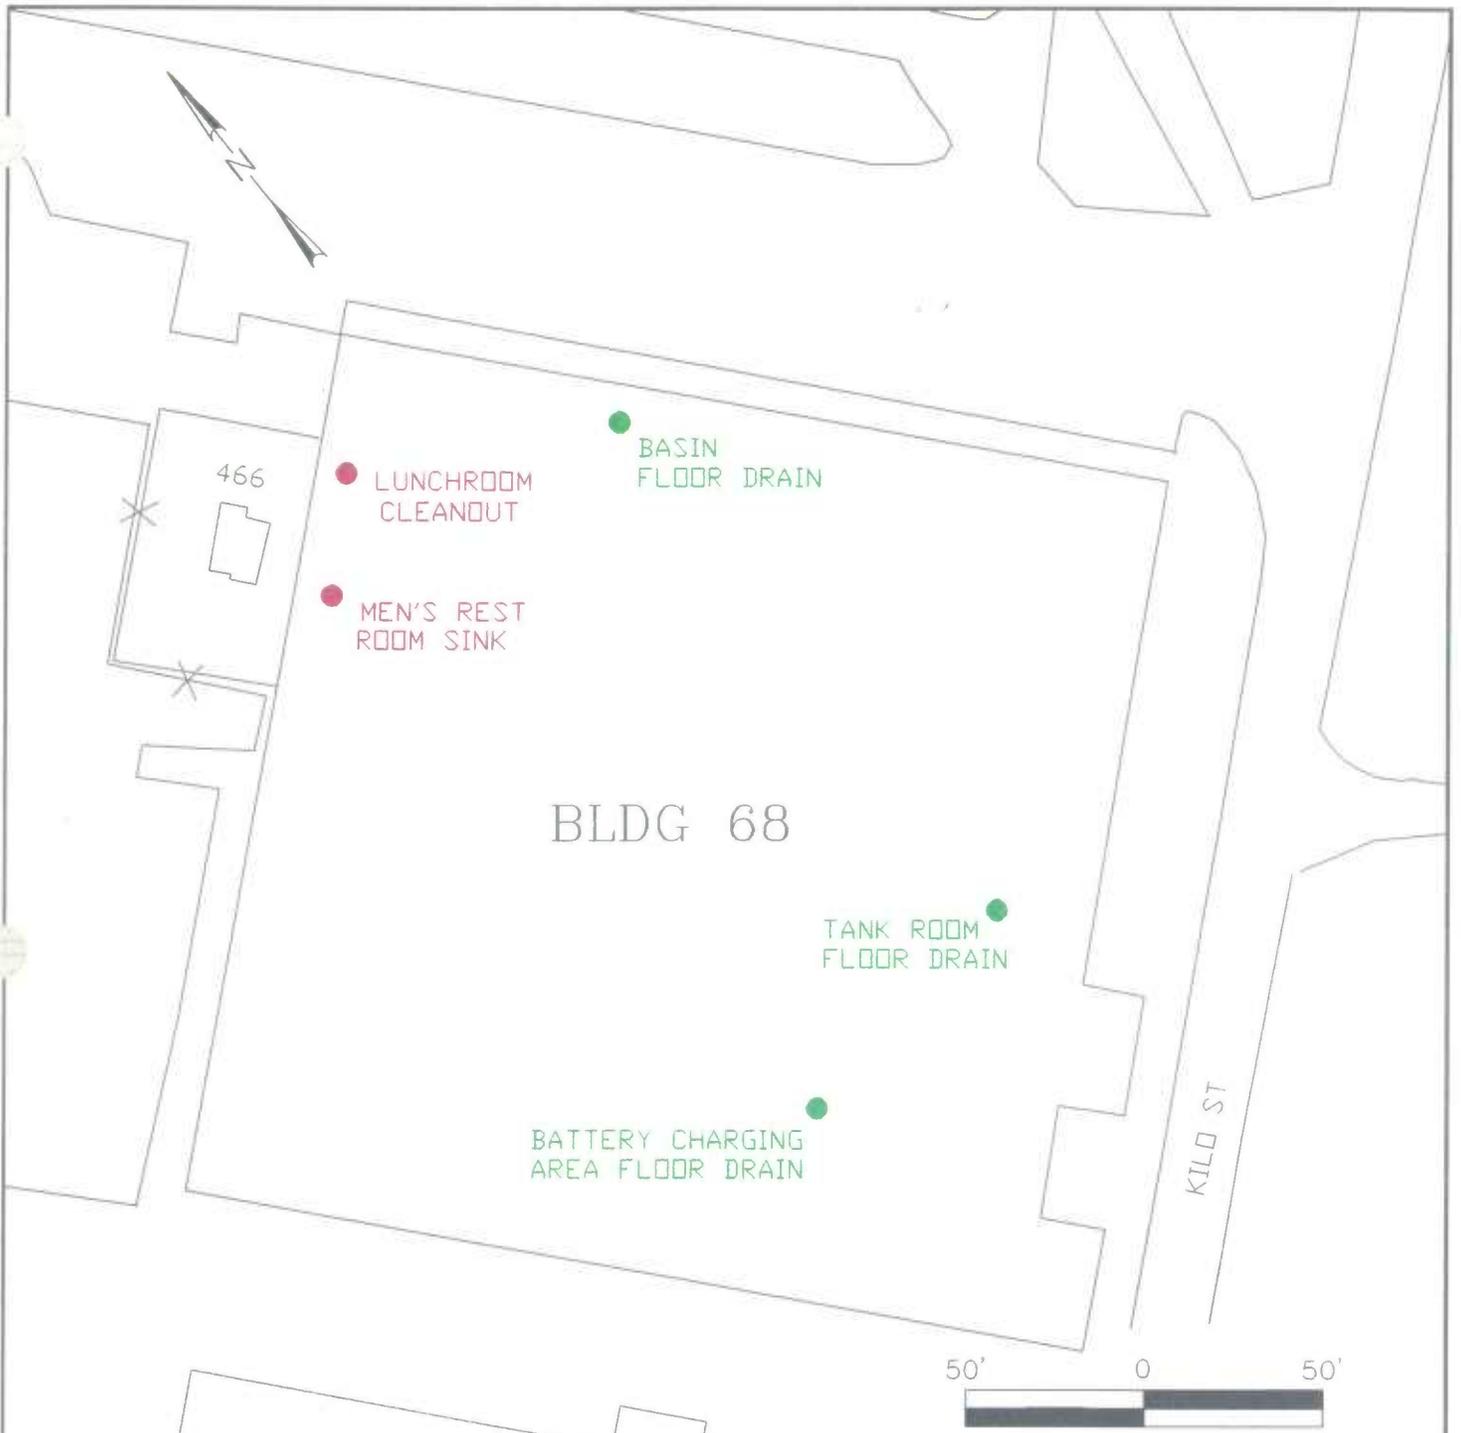
FIGURE A-13
BUILDING 68
DYE INJECTION SITES

Building 68 was dye injection tested on November 20 and 21, 1997. Five sites, 1 latrine and a drain clean-out on November 20 and 3 floor drains on November 21 were dye injected. A quality assurance check was performed at sanitary sewer Manhole 312 to verify dye present. The storm sewer was monitored at Manholes 41/1, 41/1-A and 41/2. Test samples indicated dye present at storm sewer Manhole 41/2. A cross-connect exists to storm sewer Outfall 41.

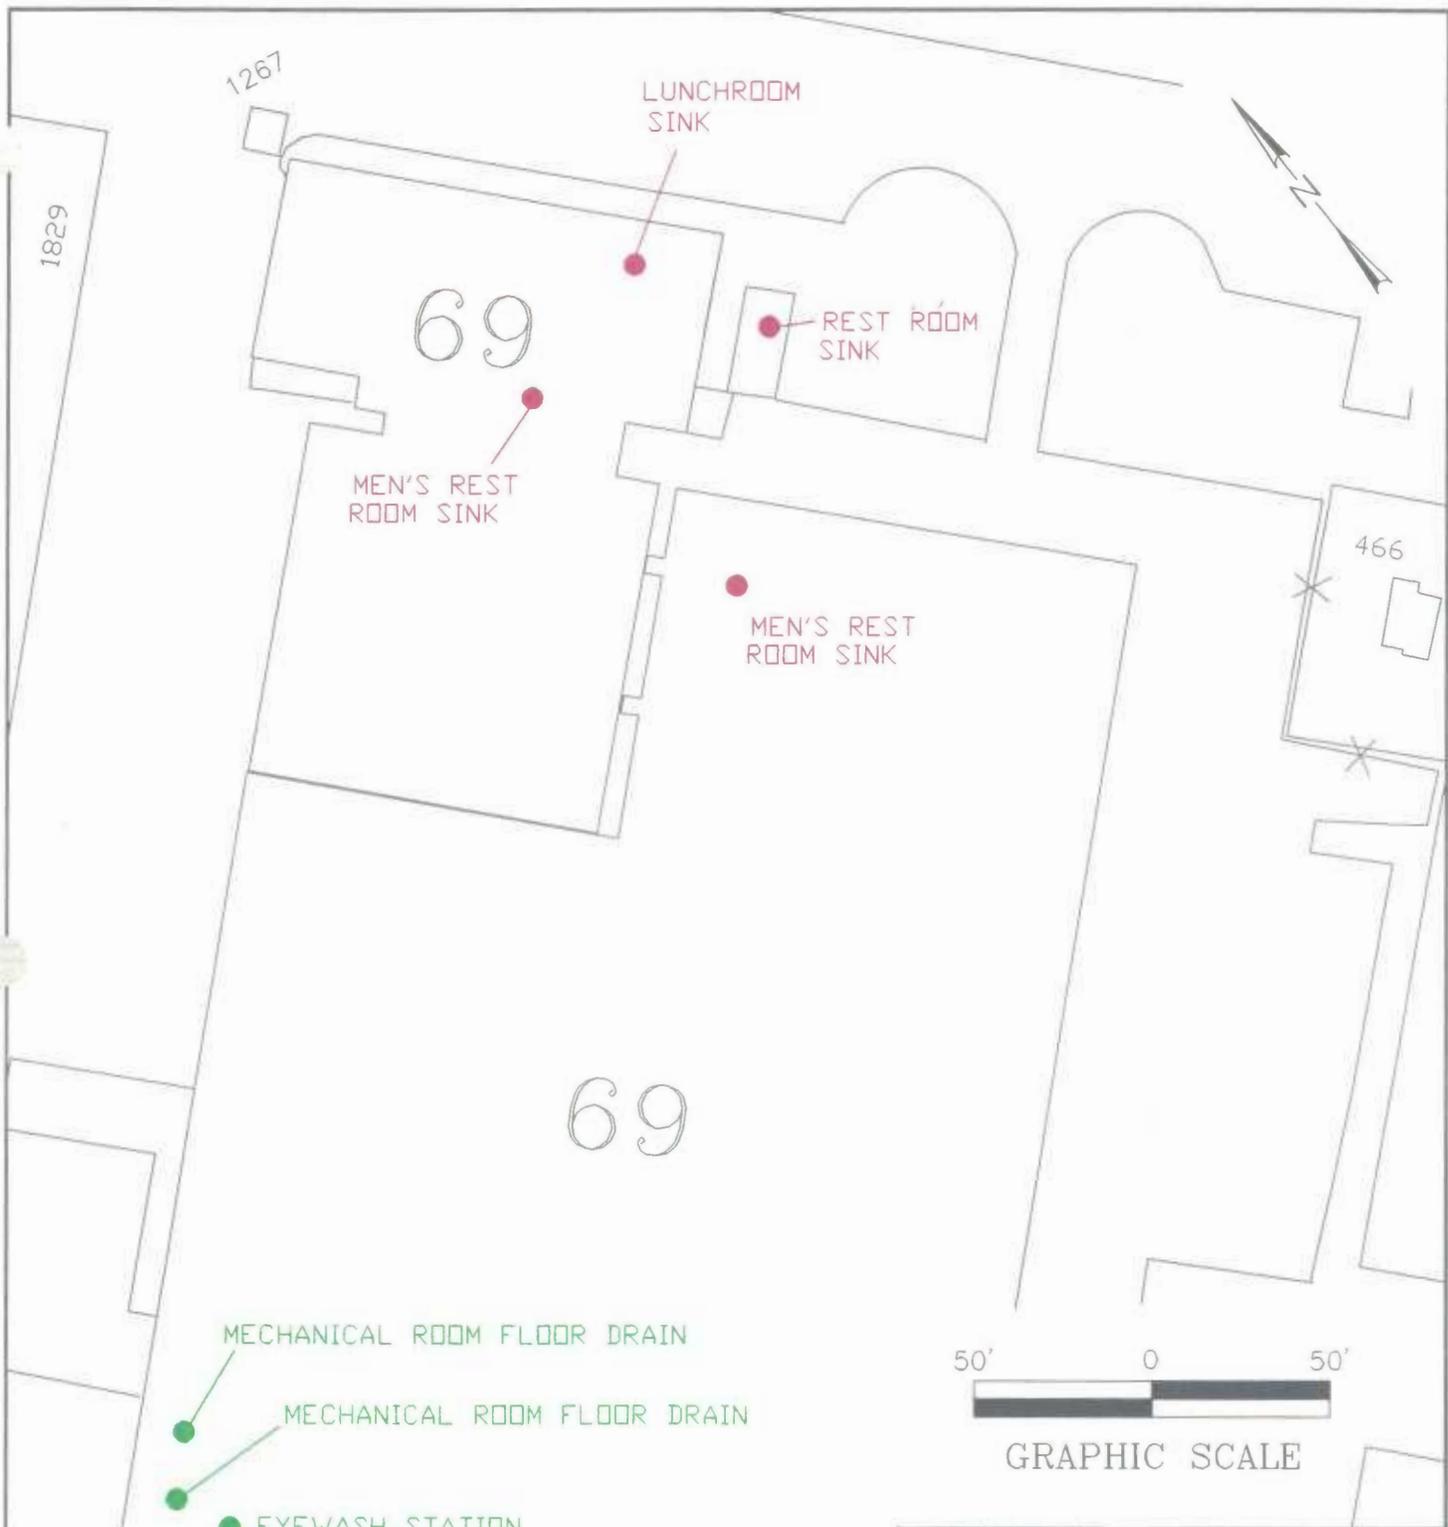
FIGURE A-14
 BUILDING 69
 DYE INJECTION SITES

Building 69 was dye injection tested on November 25, 1997. Four sites, 2 latrines, 1 lunch room sink and a floor drain were simultaneously dye injected. A quality assurance check was performed at sanitary sewer Manholes 300-A, and 313 to verify dye present. The storm sewer was monitored at Manhole 38/4. Test samples indicated dye present at storm sewer Manhole 38/4. A cross-connect exists to storm sewer Outfall 38.

Building 69 was dye injection tested on February 10 through February 17, 1998. Four individual dye injection tests were done. The first test injected two latrines, one in separate facility outside, the other in the newer section; no dye was found. The second test injected one latrine on east side; no dye was found. The third test injected one lunch room sink; no dye was found. The fourth test injected a mechanical room floor drain; dye was found at storm Manhole 38/4. The storm sewer was monitored at Manhole 38/4 for all tests. Test samples indicated dye present at storm sewer Manhole 38/4. A cross-connects exists from floor drains and eye wash station leaving the Building 69 mechanical room on the northwest end to storm sewer Outfall 38.
