LEAD BASE PAINT SURVEY OF 12 DUPLEX FAMILY UNITS SECTION 1 CNC  
CHARLESTON SC  
4/1/2001  
PRECISION ENVIRONMENTAL MANAGEMENT, INC.

**LEAD BASE PAINT SURVEY OF  
12 DUPLEX FAMILY UNITS AT  
CHARLESTON NAVAL COMPLEX  
CHARLESTON, SC**

**April 5, 2001**

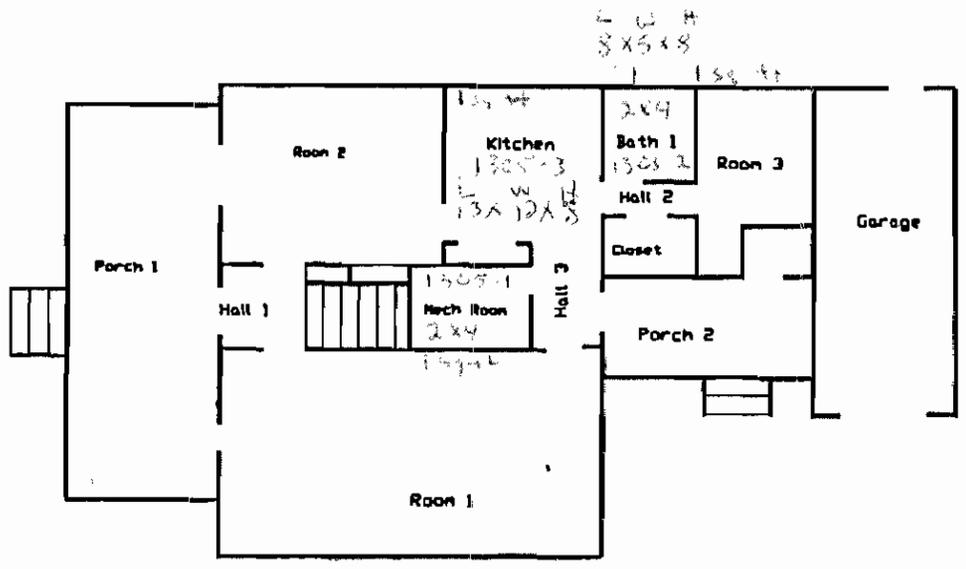
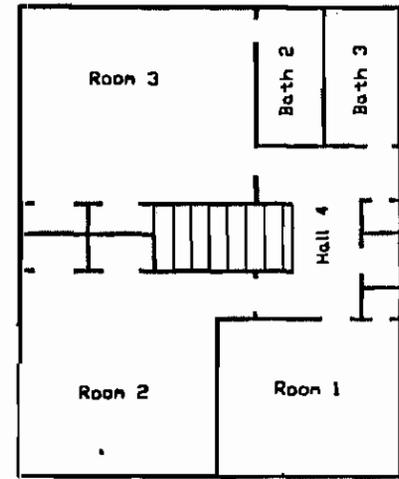
- 1305-1 Mech. Room door / substrate - wood 1 sq ft. damage area
- 1305-2 Bathroom #1 door / substrate - wood 1 sq ft. damage area
- 1305-3 Kitchen Ceiling - water damage - / substrate sheet rock 1 sq ft damage

Homogenous white paint throughout house  
 Kit new and Bathroom wallpaper except for ceiling & doors  
 New paint job  
 Overall Good condition

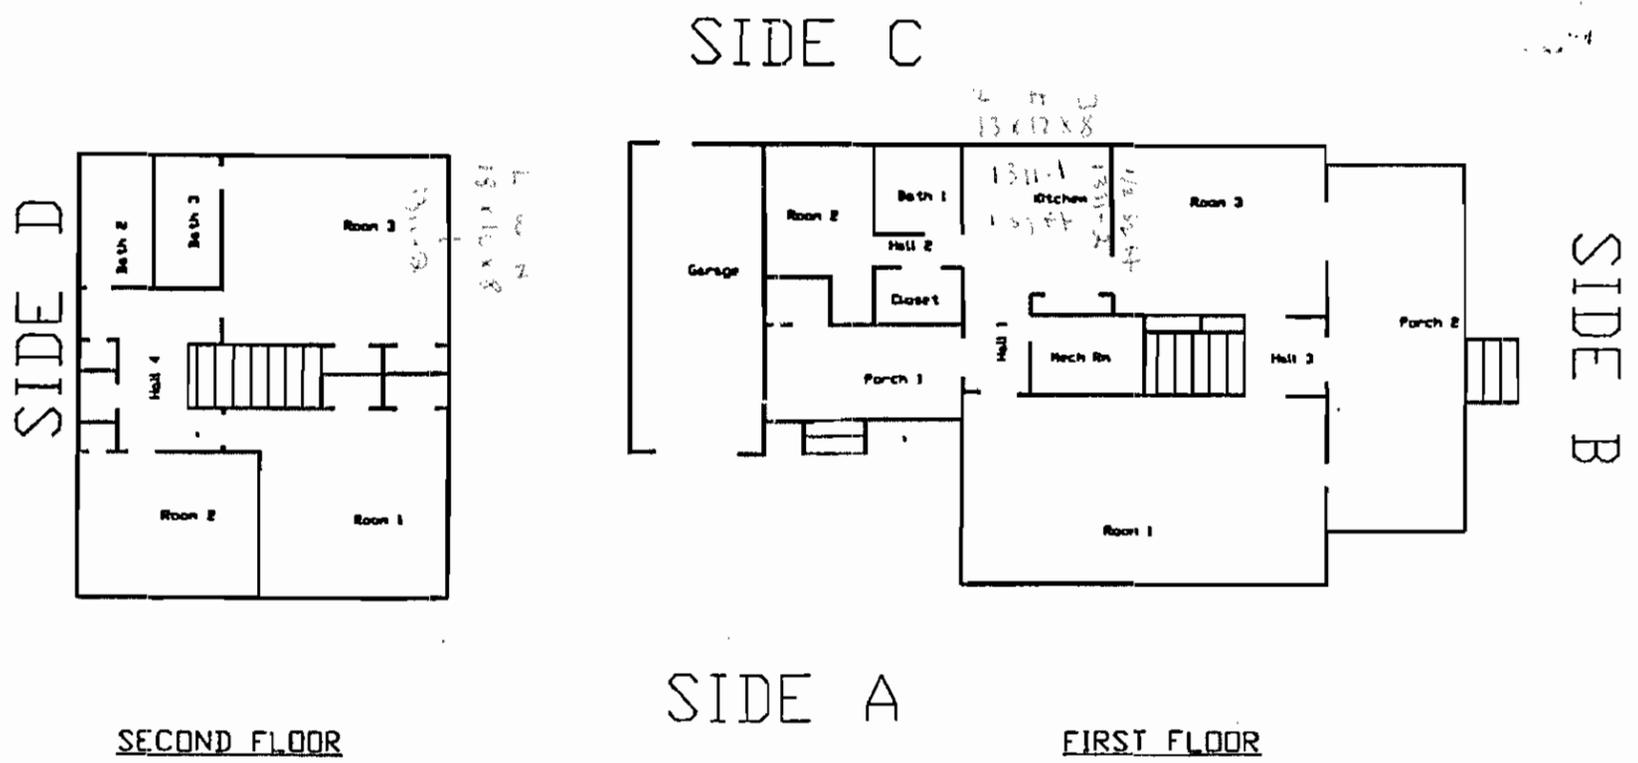
- 1311-1 Kitchen Ceiling - substrate sheetrock - close by water damage 1 sq ft
- 1311-2 Bedroom #3 Baseboard - (B wall) substrate - wood - 1/2 sq ft.
- 1311-3 Kitchen (A wall) Vent substrate - metal - 1/2 sq ft.

Wallpaper in Bathroom and Kitchen except for ceiling & doors, & molding  
 Hermynis white paint throughout the house  
 Overall New paint job and very good condition

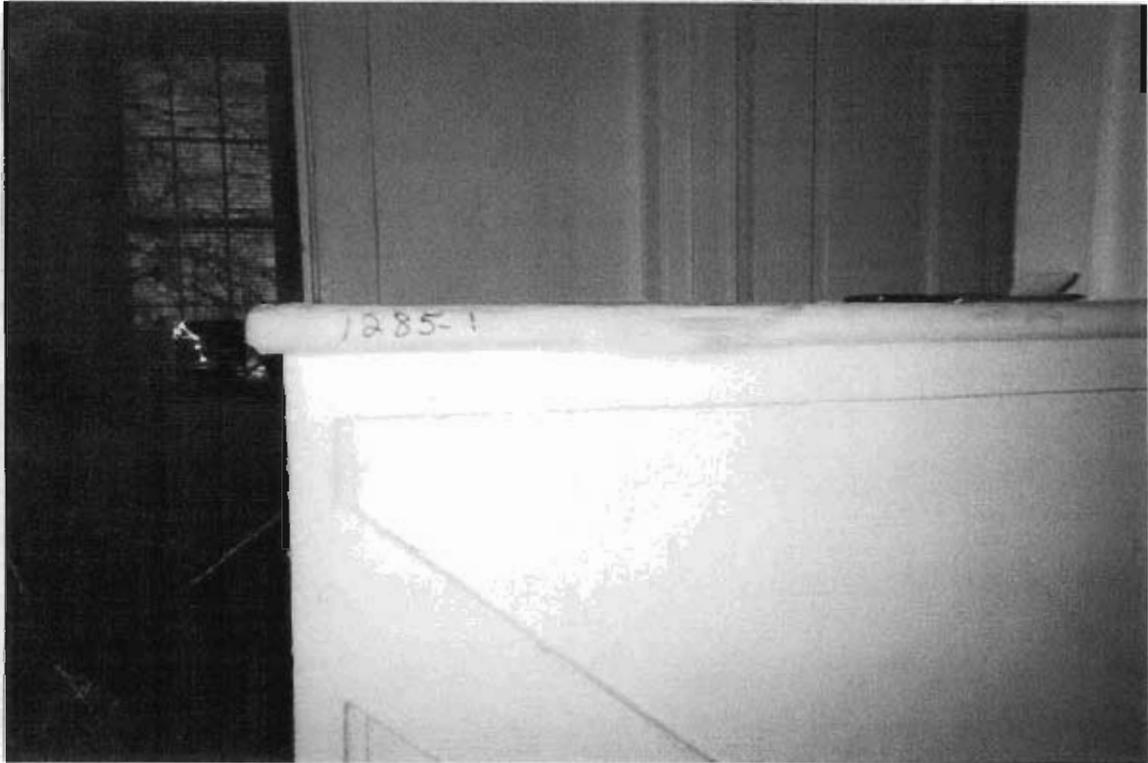
**SAMPLE # 1285-1 STAIRCASE LEFT SIDE**

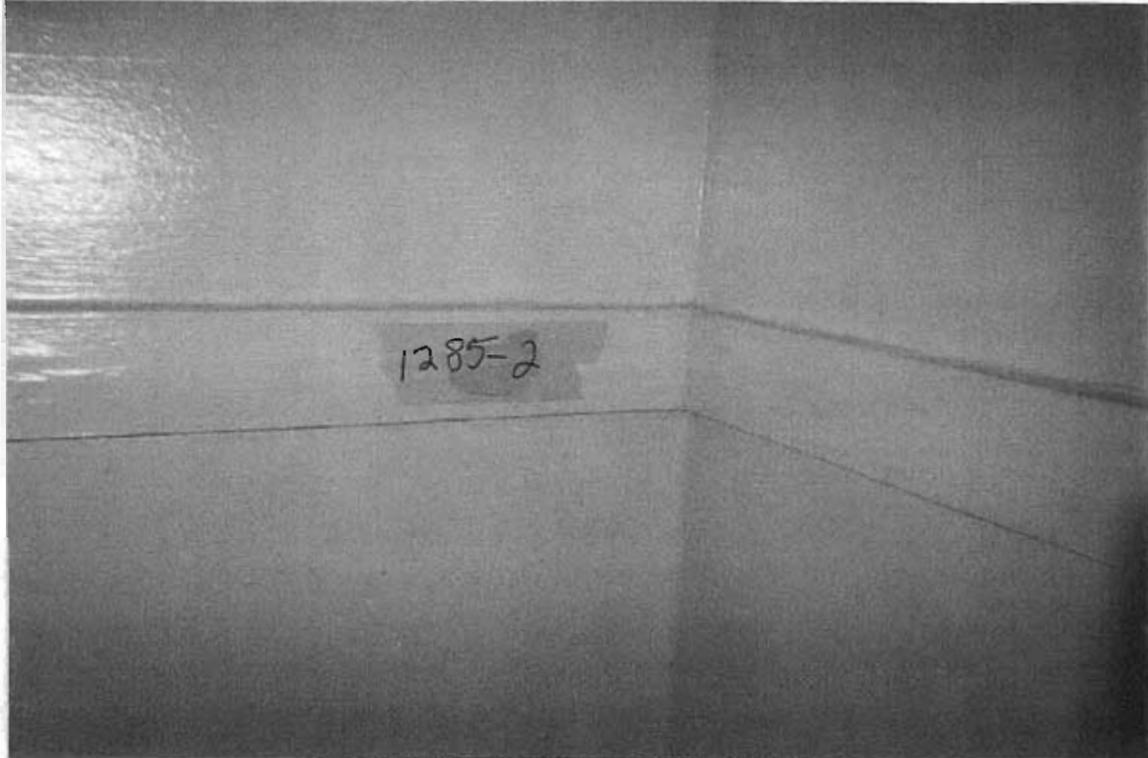
**SAMPLE # 1285-2 ROOM # 1 WALL D**

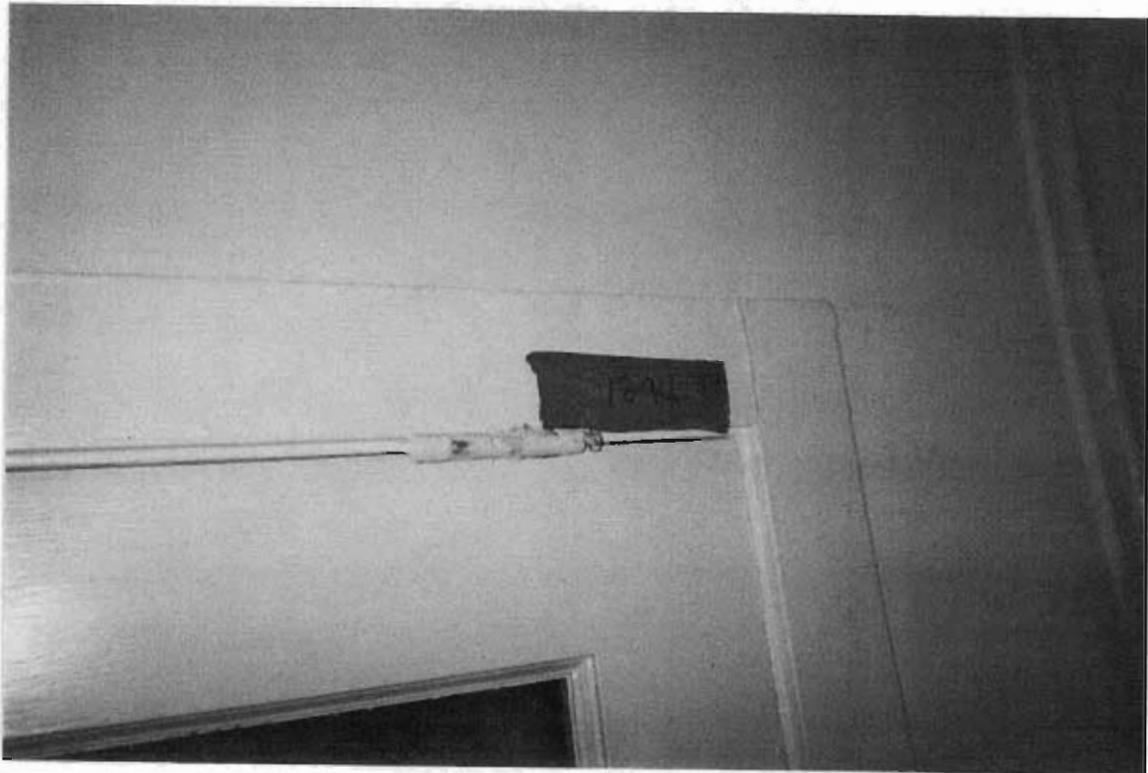
**SAMPLE # 1294-1 ROOM # 1, WALL - B (LIVING ROOM; PORCH DOOR**

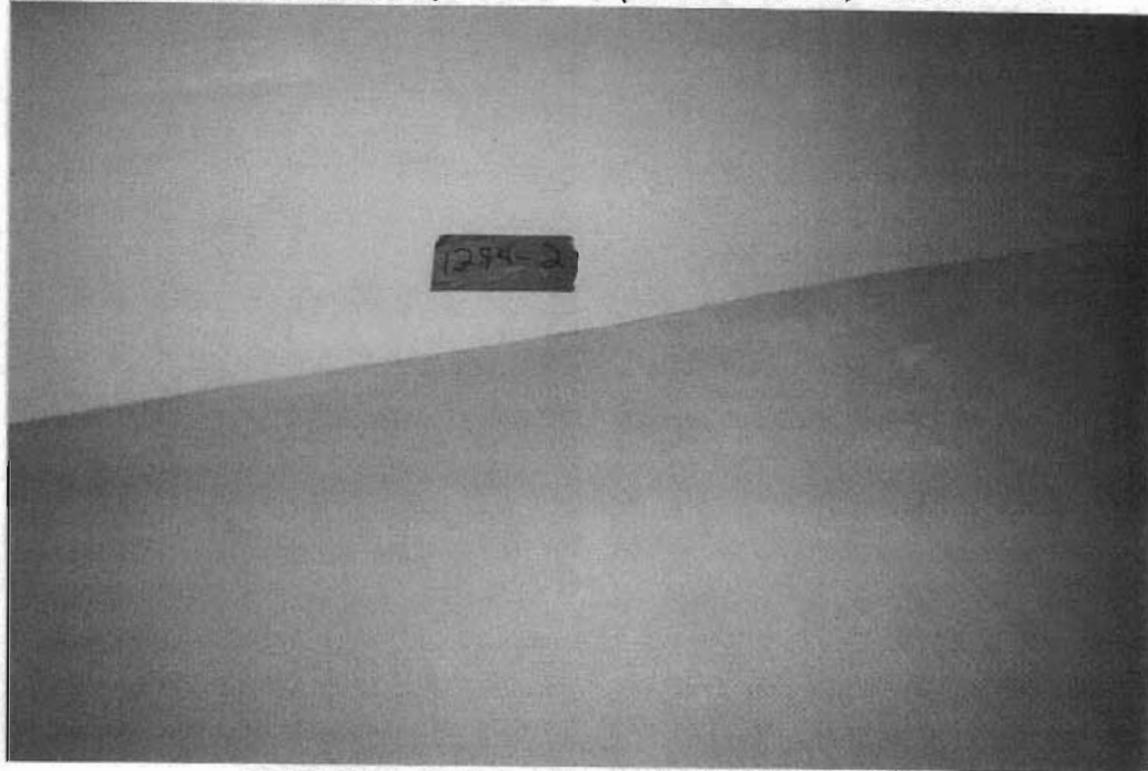
**SAMPLE # 1294-2 BATHROOM # 1, CEILING**

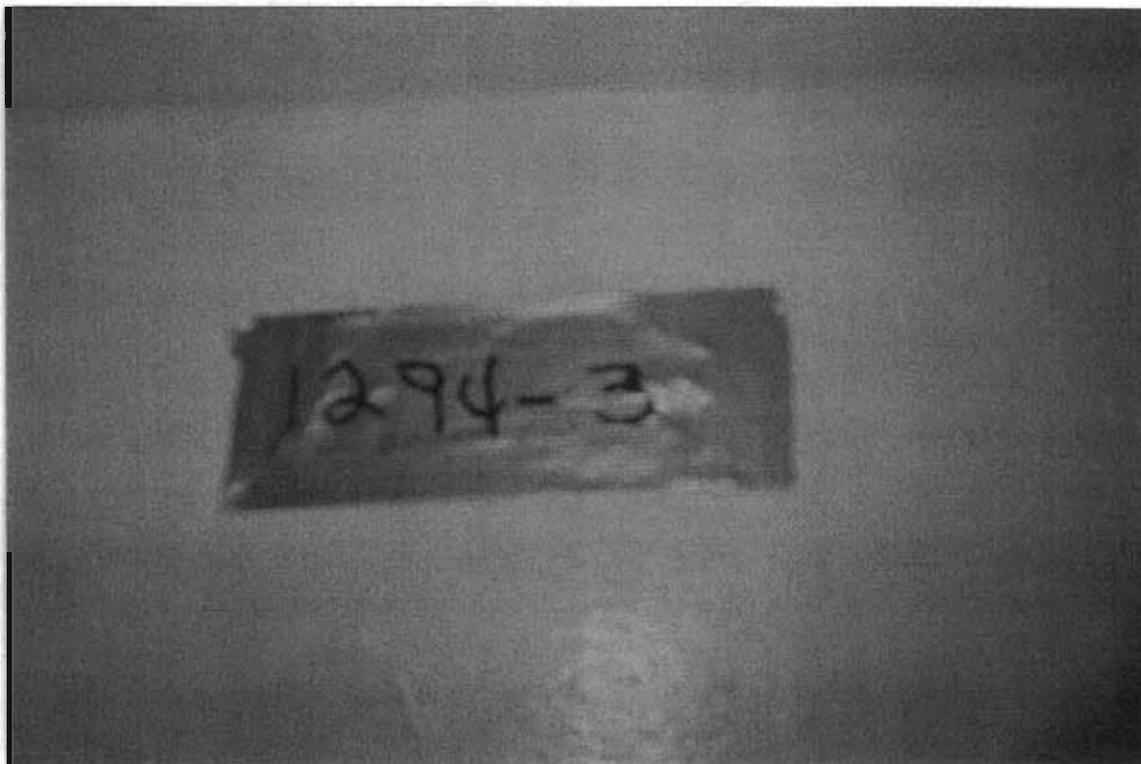
SAMPLE # 1294-3 BEDROOM # 2 B-WALL

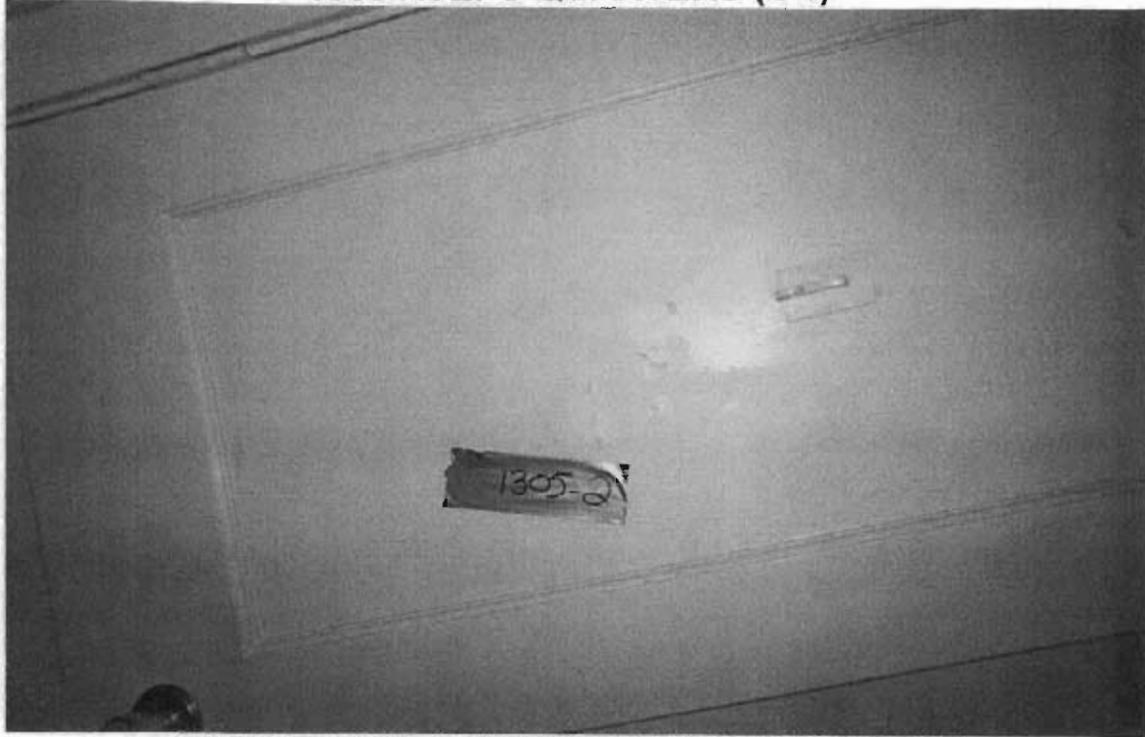
**SAMPLE # 1305-2 BATHROOM #1, INTERIOR DOOR**

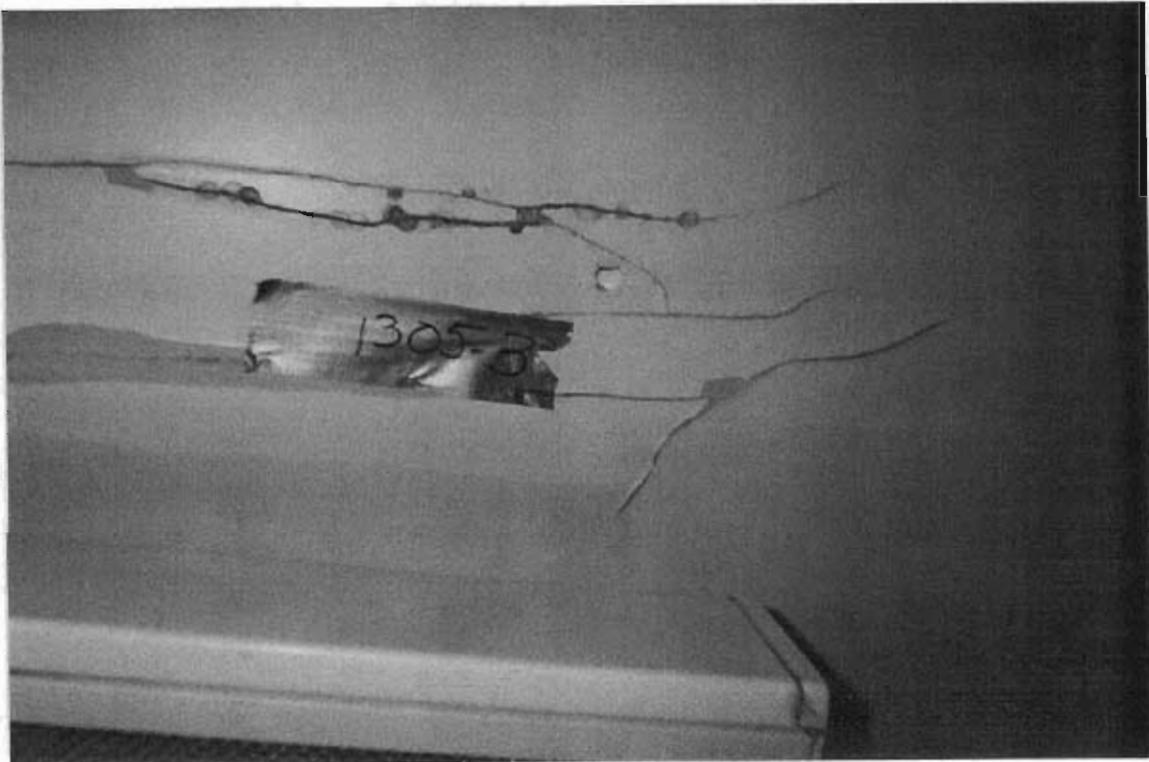
**SAMPLE # 1305-3, KITCHEN CEILING**

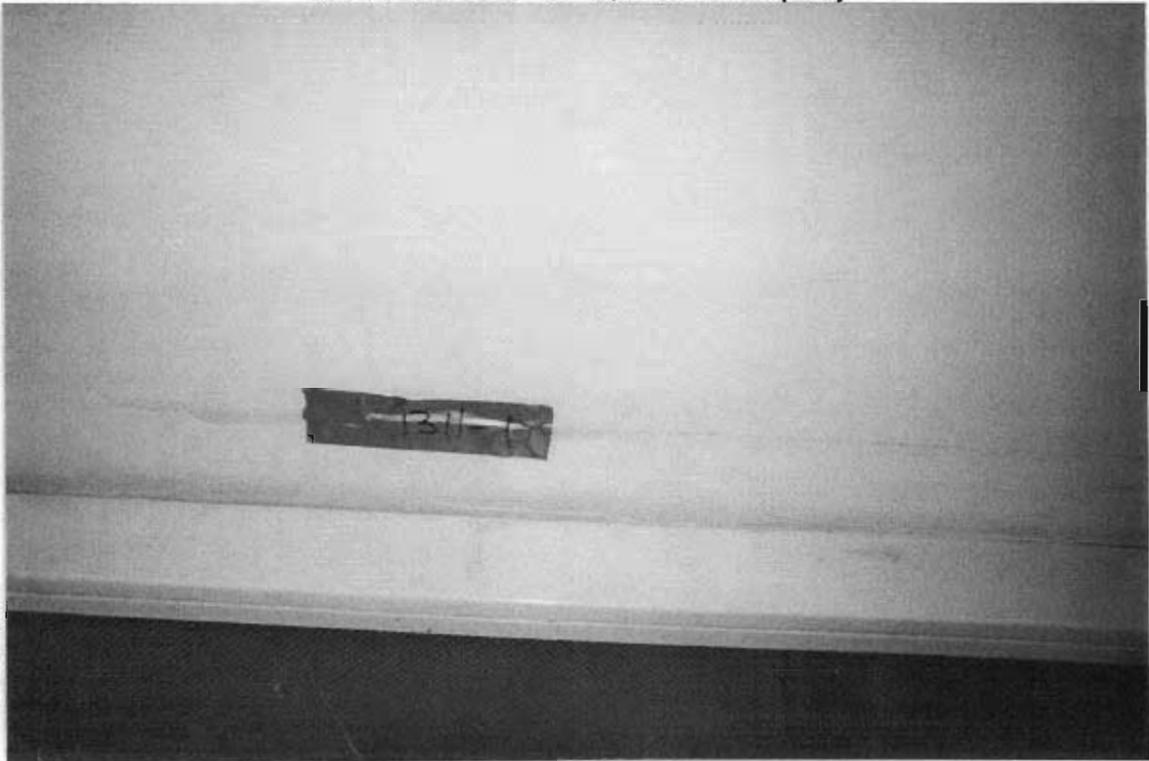
SAMPLE # 1311-1 KITCHEN CEILING

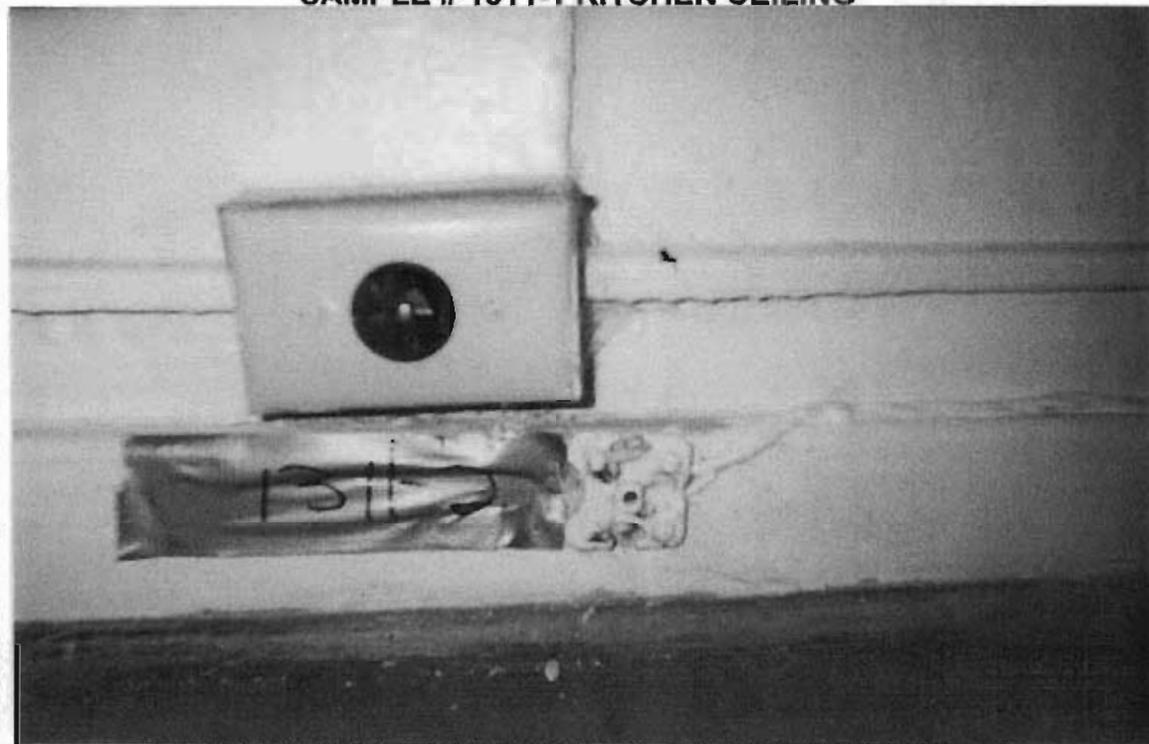
SAMPLE # 1311-2 BEDROOM # 3, BASEBOARD, WALL C

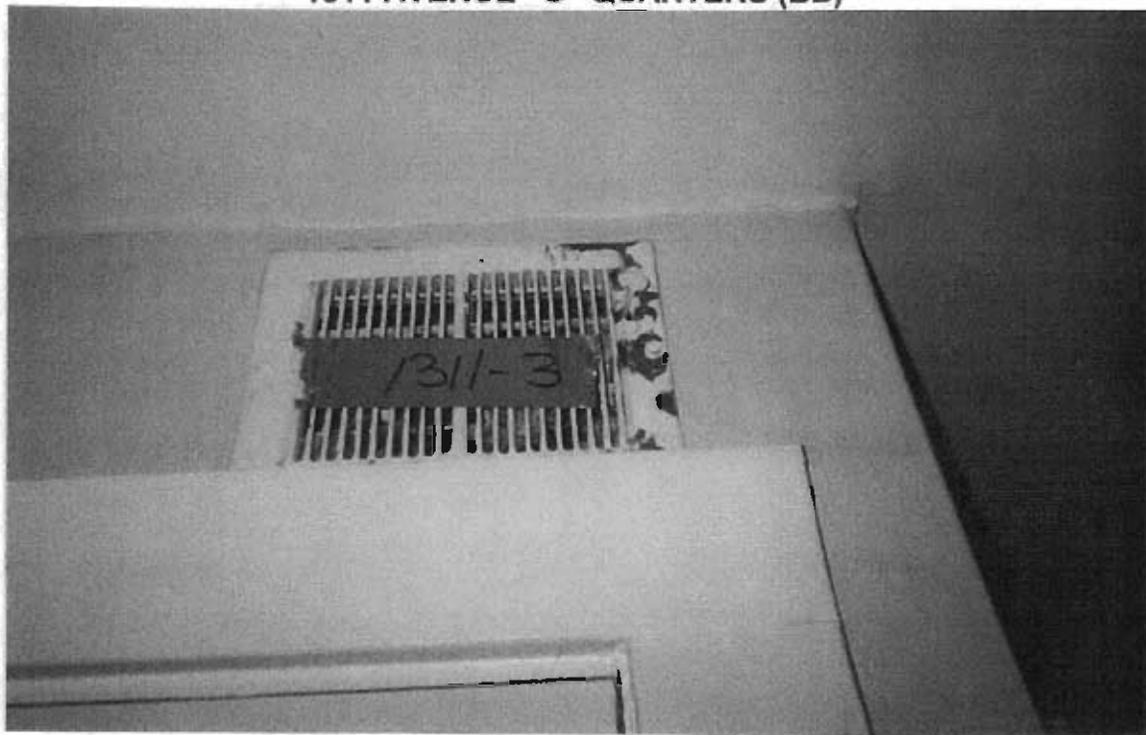
**SAMPLE # 1311-3, KITCHEN INTAKE VENT**

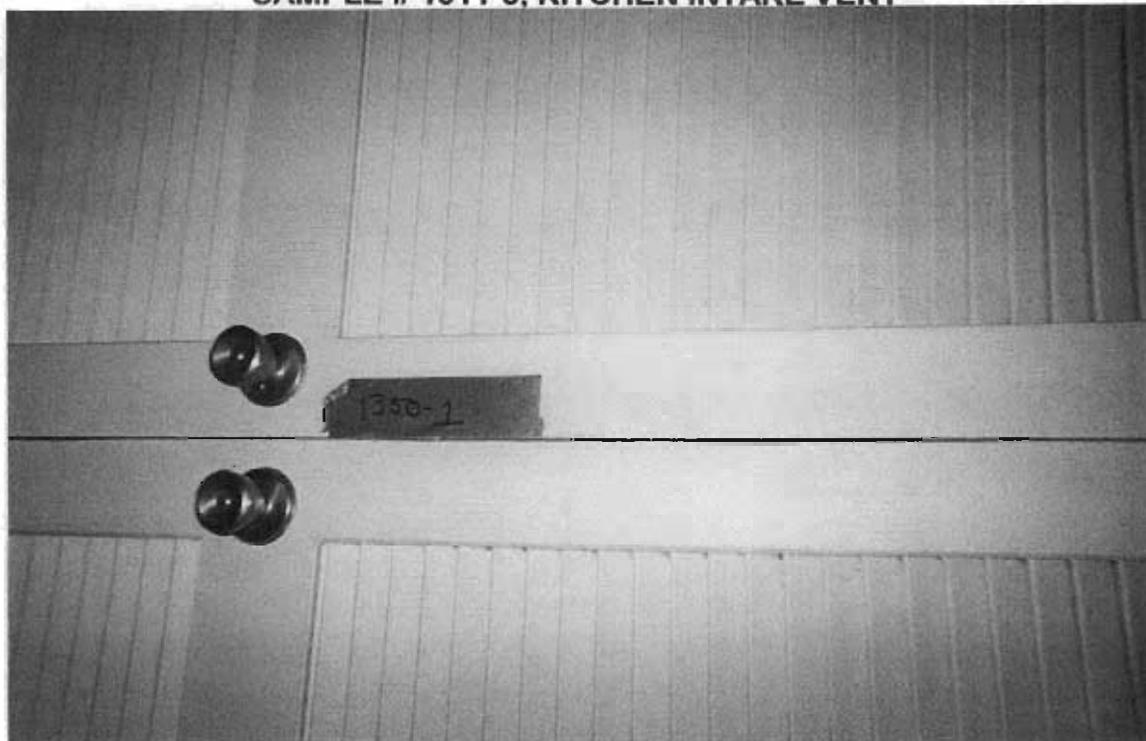
**SAMPLE # 1350-1, KITCHEN CLOSET MECHANICAL ROOM DOOR**

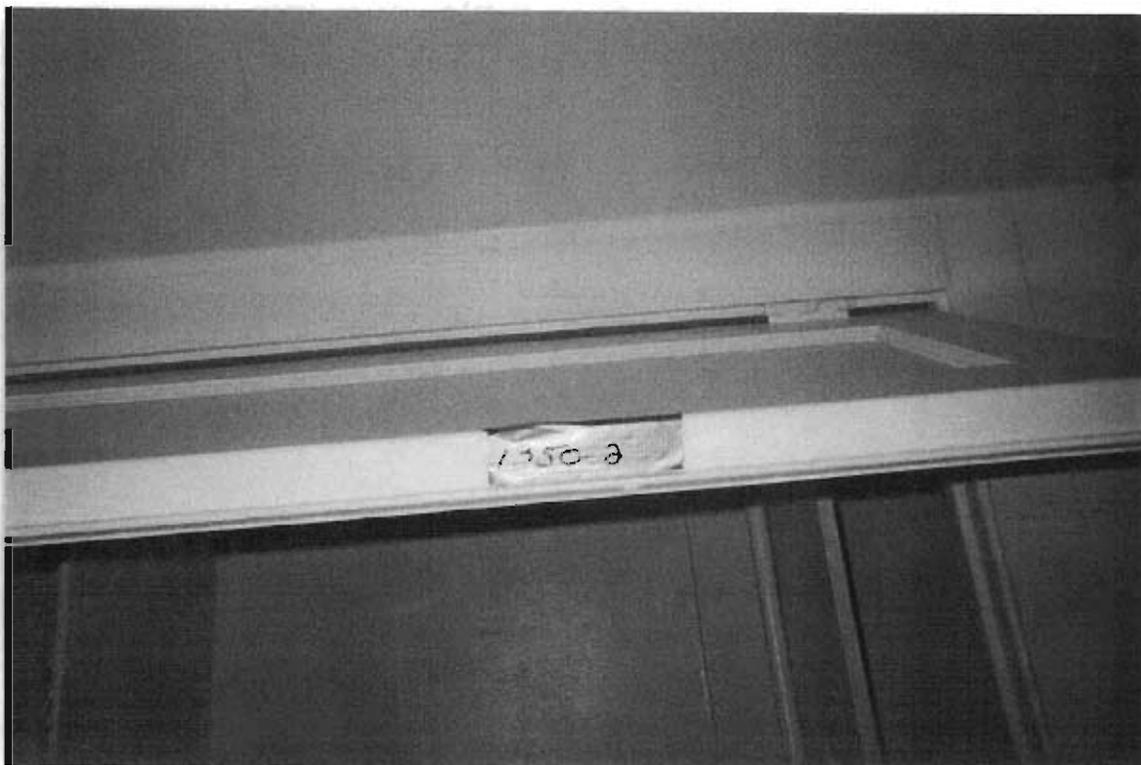
SAMPLE # 1350-2, ROOM 3, CLOSET DOOR EDGE

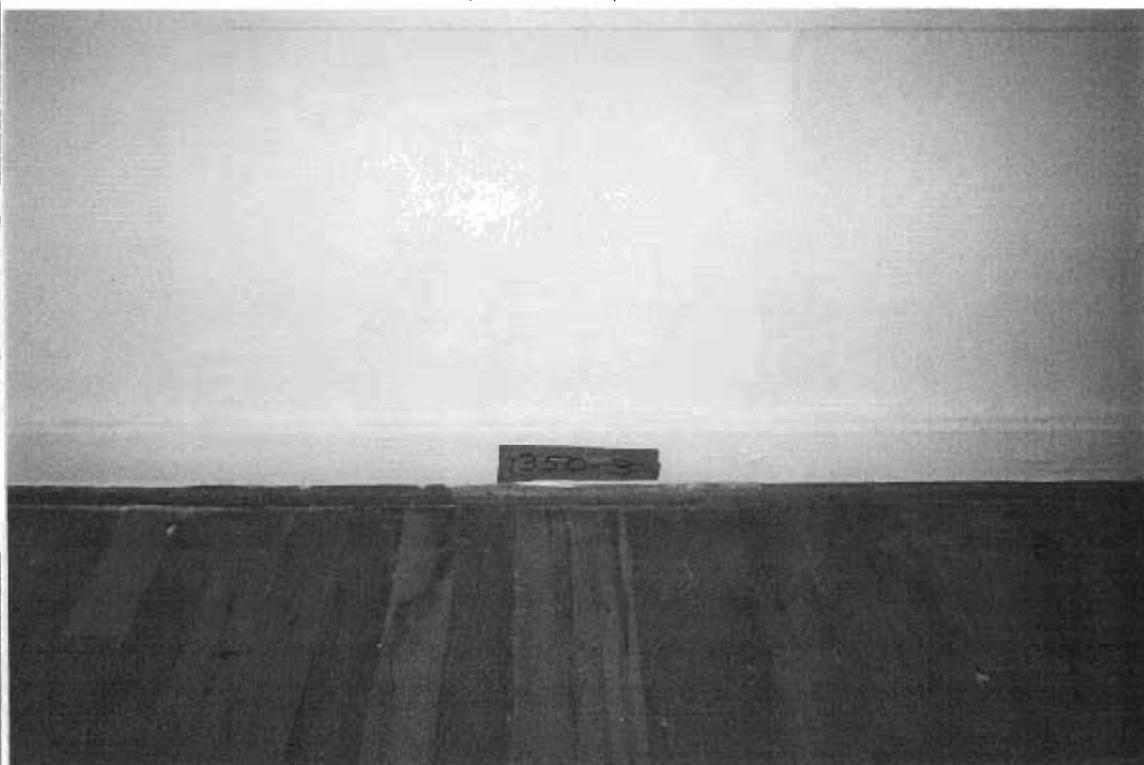
SAMPLE # 1350-3, ROOM 1, BASEBOARD

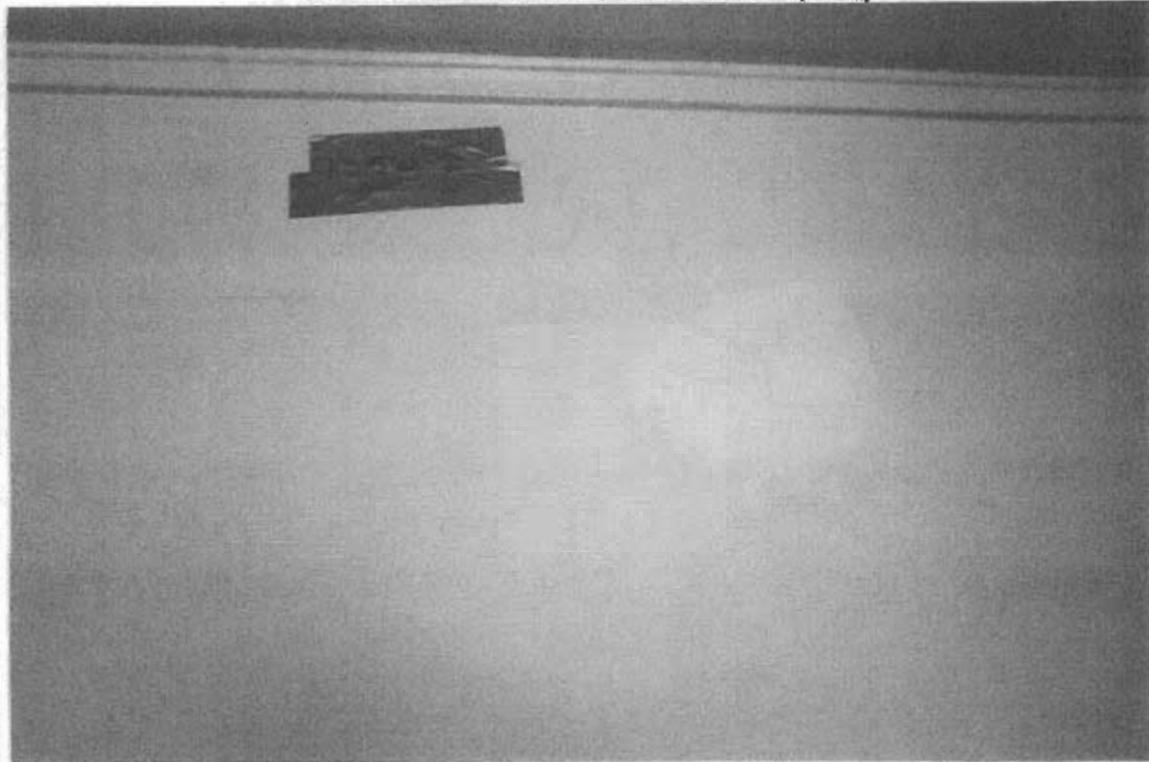
**SAMPLE # 1356-2, BEDROOM # 1, WALL D, 2<sup>ND</sup> FLOOR, ROOM 1D**

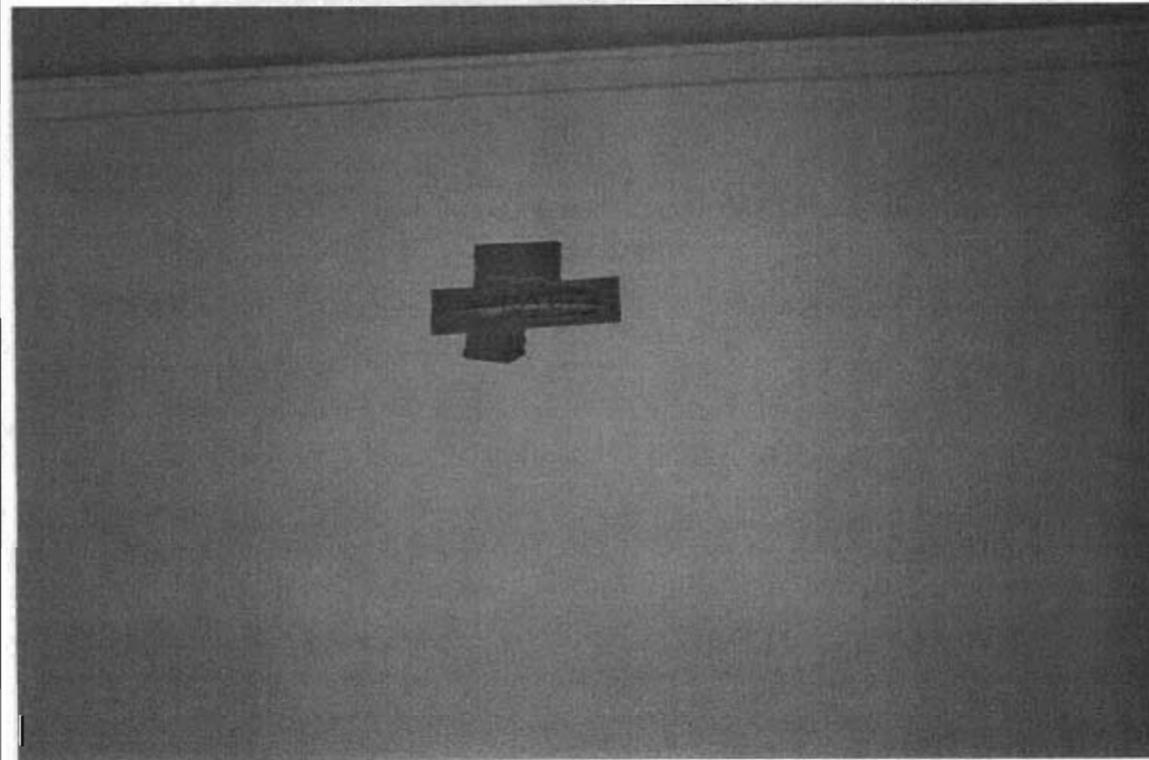
**SAMPLE # 1356-3, BEDROOM # 2, WALL D, ROOM 2B**
