LEAD BASE PAINT SURVEY OF 12 DUPLEX FAMILY UNITS SECTION 3 CNC
CHARLESTON SC
4/1/2001
PRECISION ENVIRONMENTAL MANAGEMENT, INC.

**LEAD BASE PAINT SURVEY OF
12 DUPLEX FAMILY UNITS AT
CHARLESTON NAVAL COMPLEX
CHARLESTON, SC**

April 5, 2001

1.0 Executive Summary

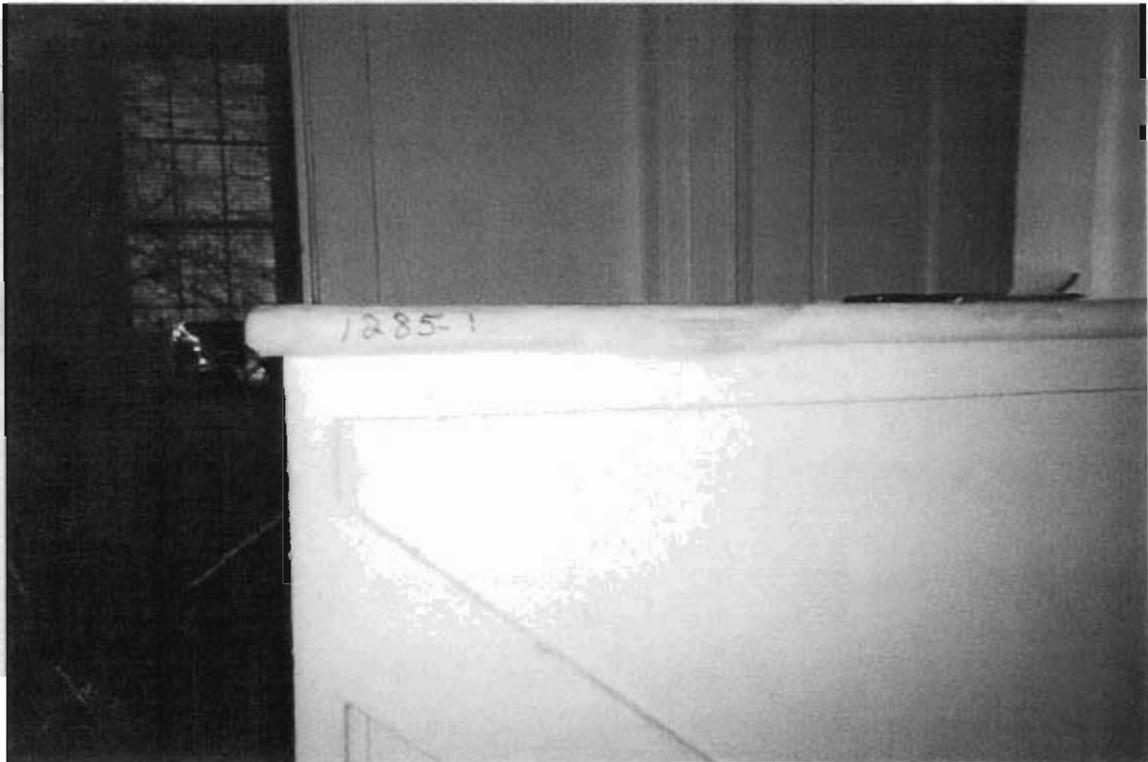
SAMPLE # 1285-1 STAIRCASE LEFT SIDE

Sample ID	Room	Building Component	Matrix	Date Collected	Damaged surface area-sq.ft
1285-1	Staircase	Staircase left side	Chips	03/13/01	8.7
1285-2	Room 3 1	Wall B	Chips	03/13/01

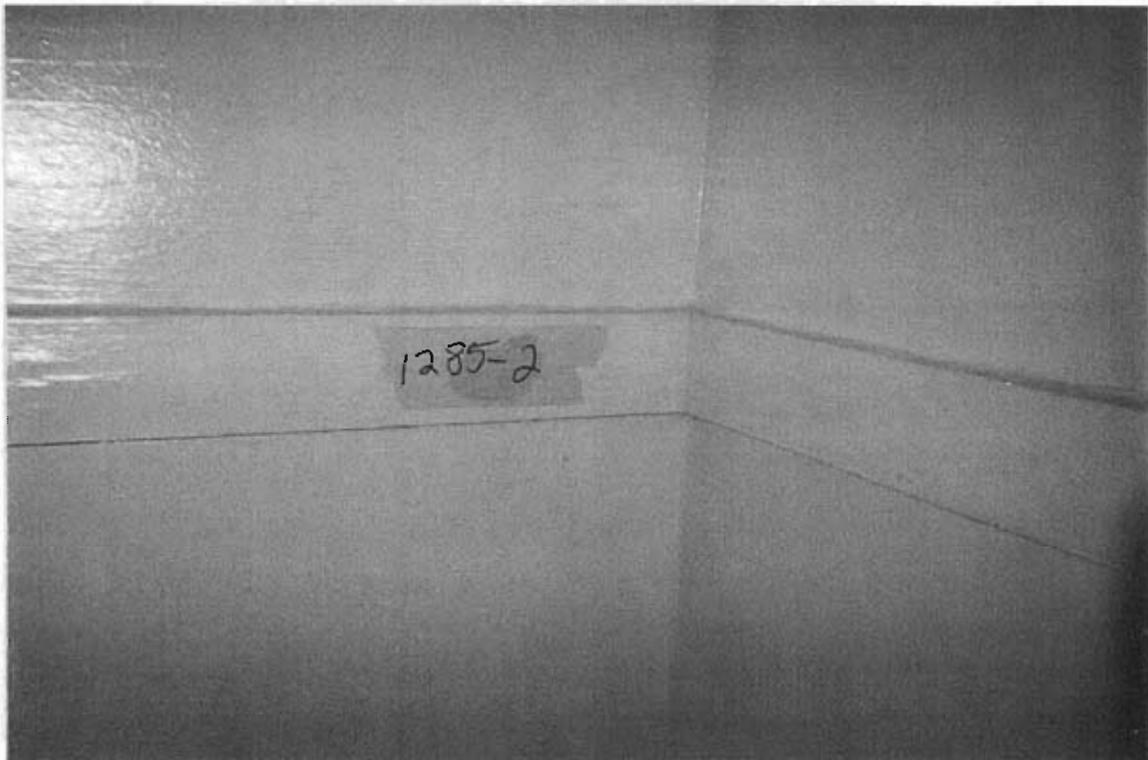
SAMPLE # 1285-2 ROOM # 1 WALL D

Lab ID	Client ID	Result	Report Limit
281686	1285-1	0.30	0.03
281687	1285-2	0.06	0.03

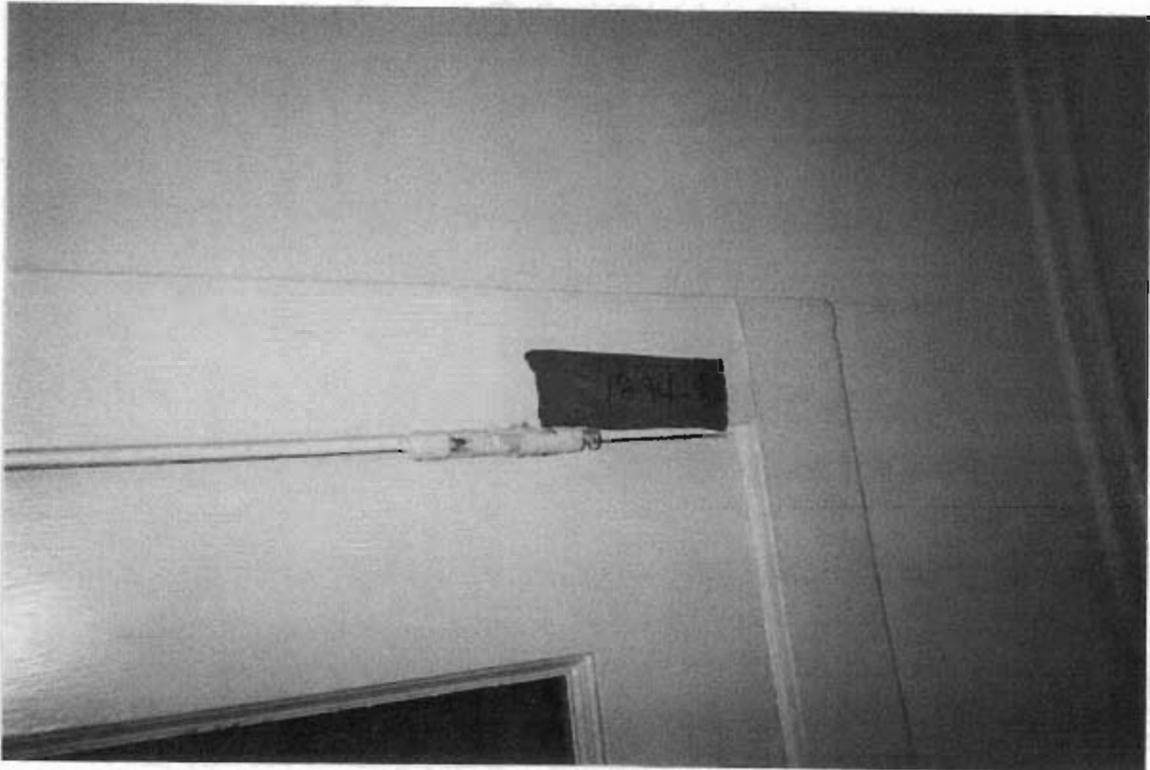
SAMPLE # 1294-1 ROOM # 1, WALL - B (LIVING ROOM; PORCH DOOR

Sample ID	Room	Building Component	Matrix	Date Collected	Damaged surface area-sq.ft
1294-1	Room # 1	Molding on Porch door	Chips	03/09/01	0.05
1294-2	Bathroom # 1	Ceiling	Chips	03/09/01	0.05
1294	Bathroom # 2	Bedroom wall		03/09/01	0.05

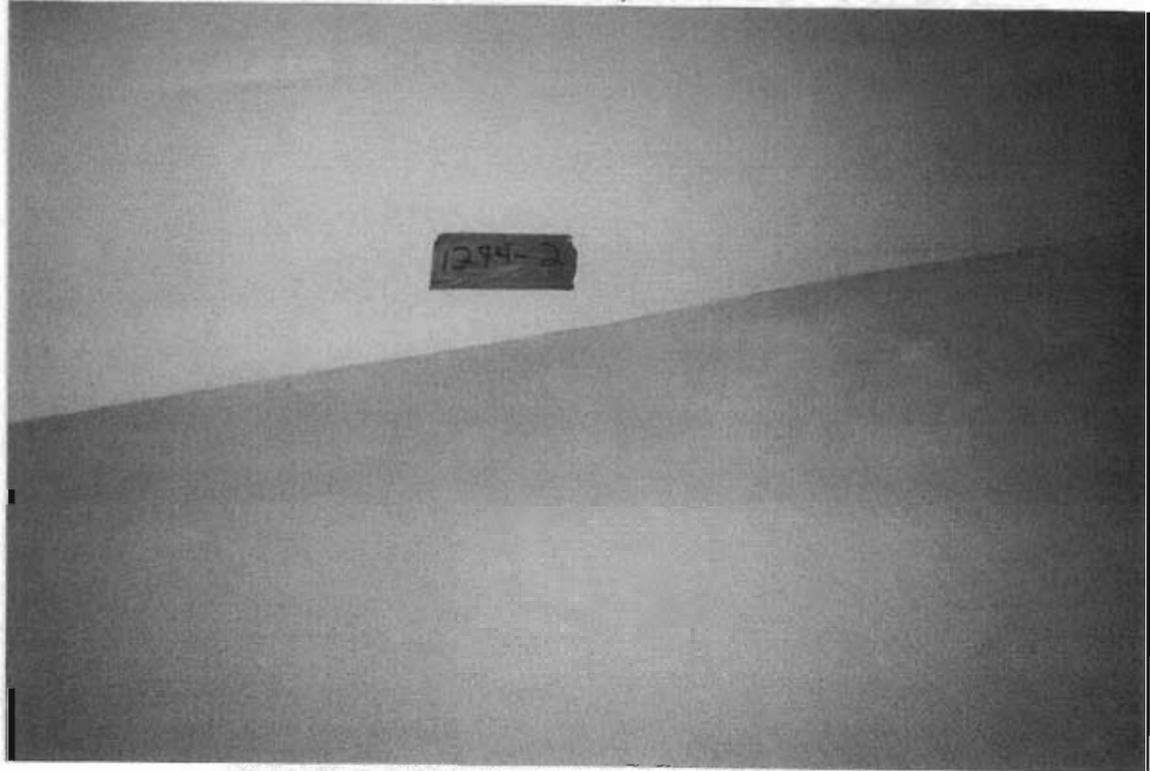
SAMPLE # 1294-2 BATHROOM # 1, CEILING

<u>Lab ID</u>	<u>Client ID</u>	<u>Result</u>	<u>Report Limit</u>
281658	1294-1	0.05	0.05
281659	1294-2	0.08	0.08
281660	1294	BRL	0.03

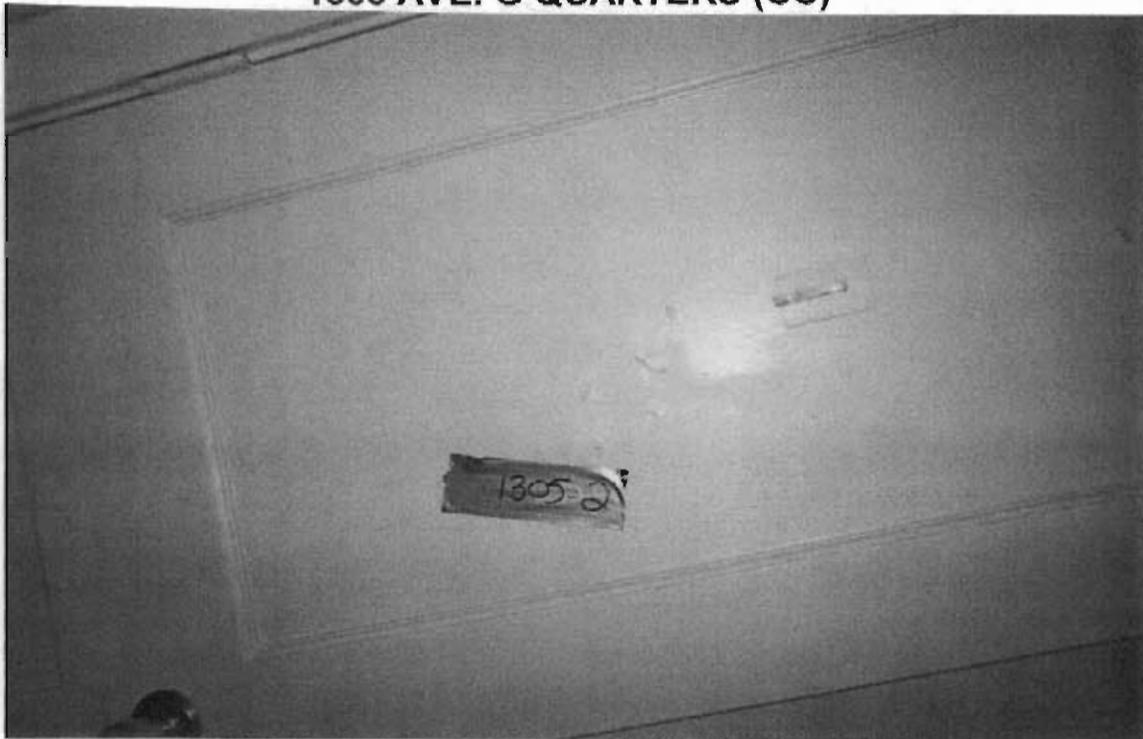
SAMPLE # 1305-2 BATHROOM #1, INTERIOR DOOR

- 1305-1 Mech Room door / substrate - wood 1 sq ft. damage area
- 1305-2 Bathroom #1 door / substrate - wood 1 sq ft. damage area
- 1305-3 Kitchen Ceiling - water damage - / substrate - sheet rock 1 sq ft damage

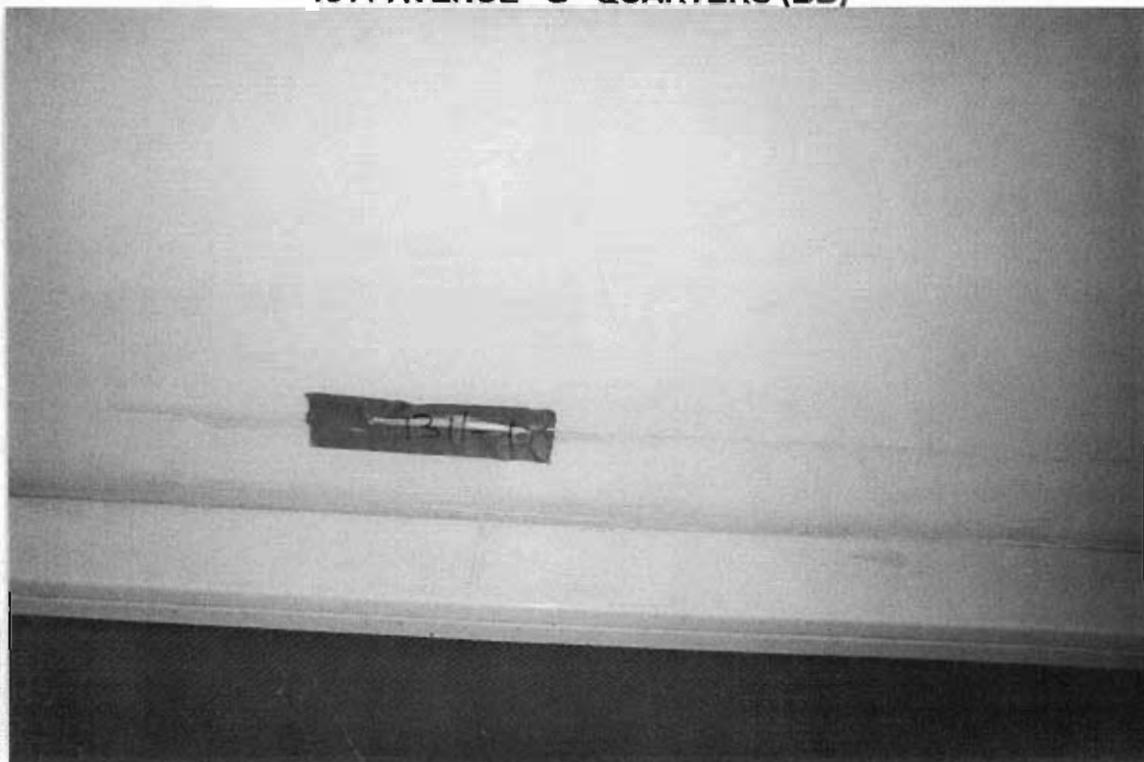
SAMPLE # 1311-1 KITCHEN CEILING

- 1311-1 Kitchen Ceiling - substrate sheetrock - Change by water damage 1 sq ft
- 1311-2 Bedroom #3 Base board - (B wall) substrate - wood - 1/2 sq ft
- 1311-3 Kitchen (A wall) Vent substrate - Metal - 1/2 sq ft.

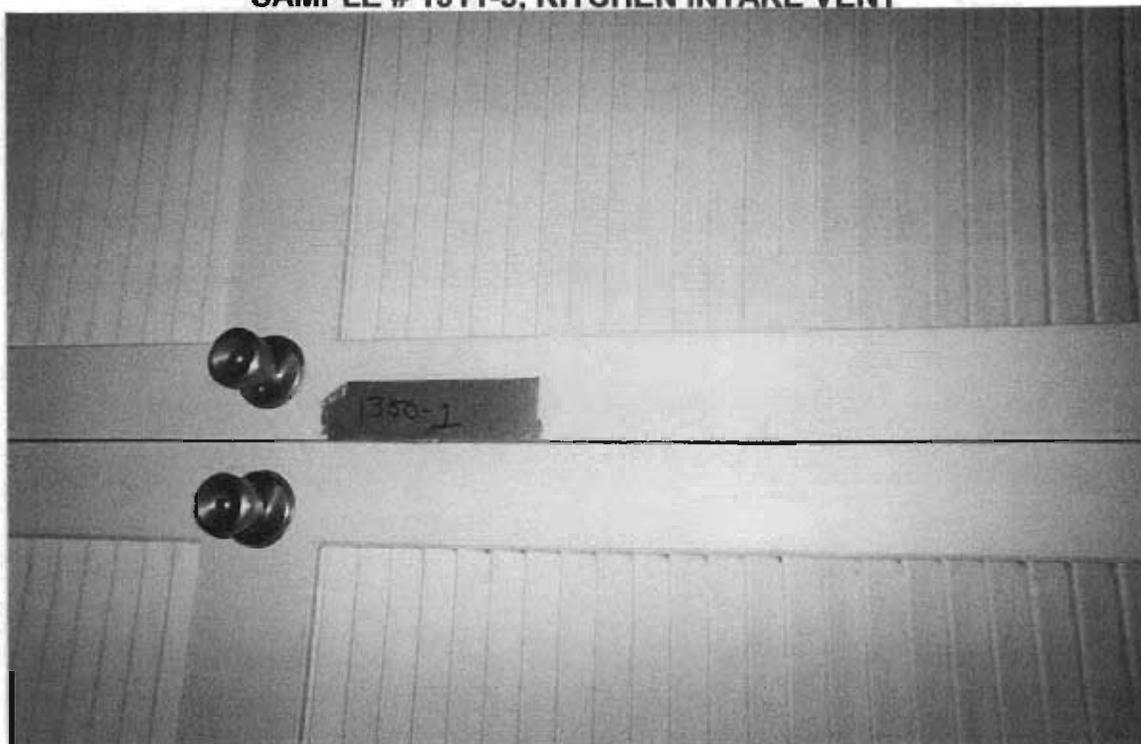
SAMPLE # 1350-1, KITCHEN CLOSET MECHANICAL ROOM DOOR

Sample ID	Room	Building Component	Matrix	Date Collected	Damaged surface area-sq.ft
1350-1	Kitchen	(A) Closet Mech room door	Chips	03/08/01	1.0
1350-2	Room # 3	(C) Closet door edge	Chips	03/08/01	1.0
1350-3	Room # 1	(B) Basement	Chips	03/08/01	1.0

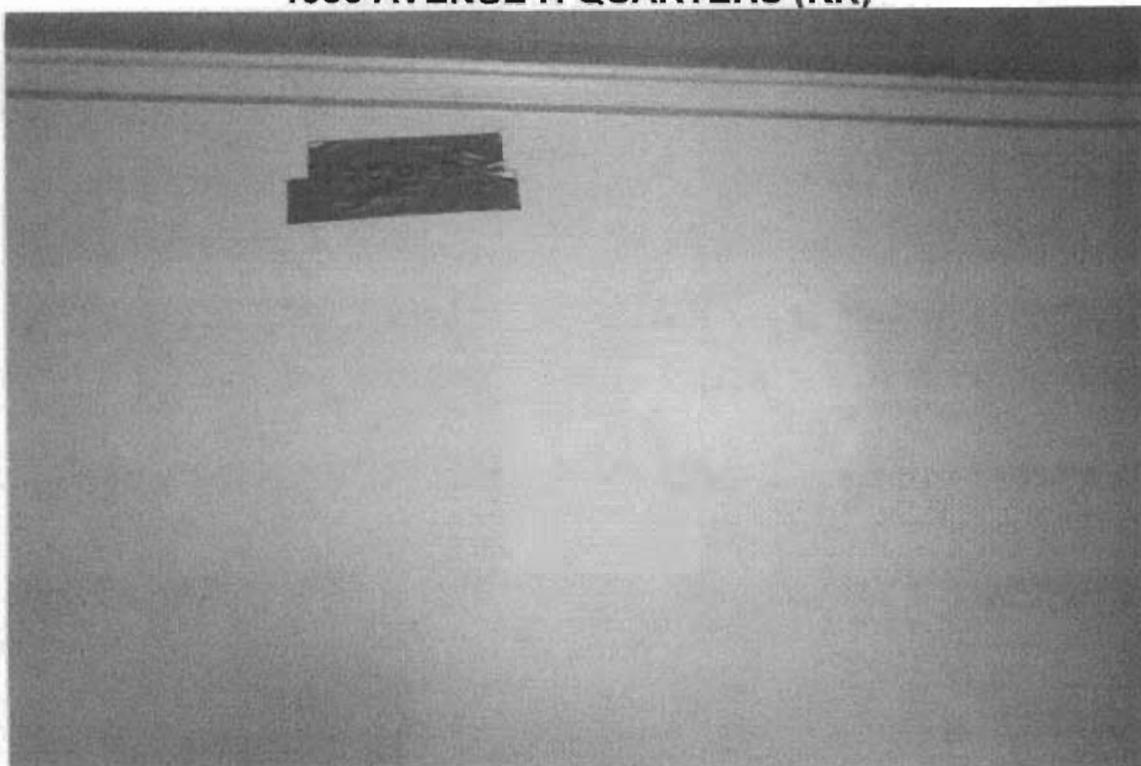
SAMPLE # 1356-2, BEDROOM # 1, WALL D, 2ND FLOOR, ROOM 1D

Sample ID	Room	Building Component	Matrix	Date Collected	Damaged surface area-sq.ft
1356-1	Living room # 1	Wall D	Chips	03/08/01	1.0
1356-2	Bedroom # 1	Wall D-2 nd floor room #1D	Chips	03/08/01	1.0
1356-3	Bedroom # 2	Wall D- Room 2 B	Chips	03/08/01	1.0
