ASBESTOS-CONTAINING MATERIAL RE-INSPECTION FOR BUILDING 1601B VOLUME 17
CNC CHARLESTON SC
1/15/2000
BAT ASSOCIATES, INC.

**Asbestos-Containing Material Re-inspection
For Building 1601B
Charleston Naval Shipyard
Charleston, South Carolina**

January 15, 2000

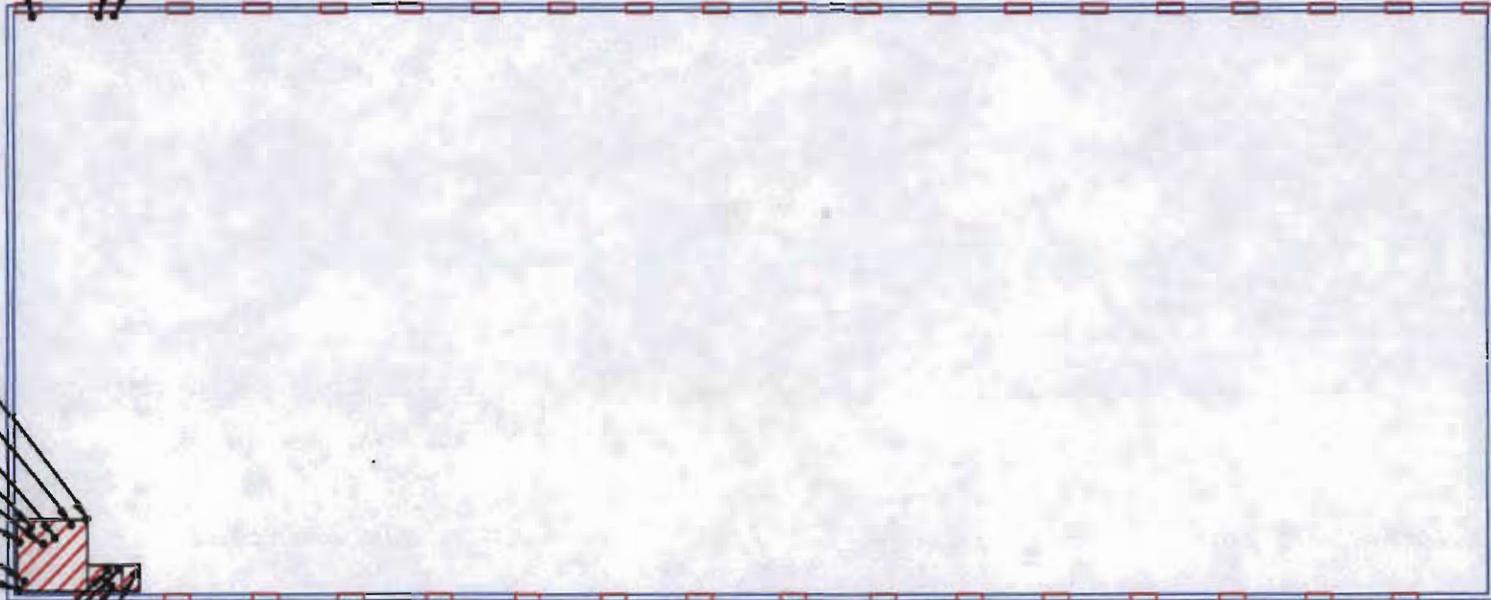
Sample and Asbestos-Containing Material Locations

1601-5-1 (-)

1601-4-2 (-)

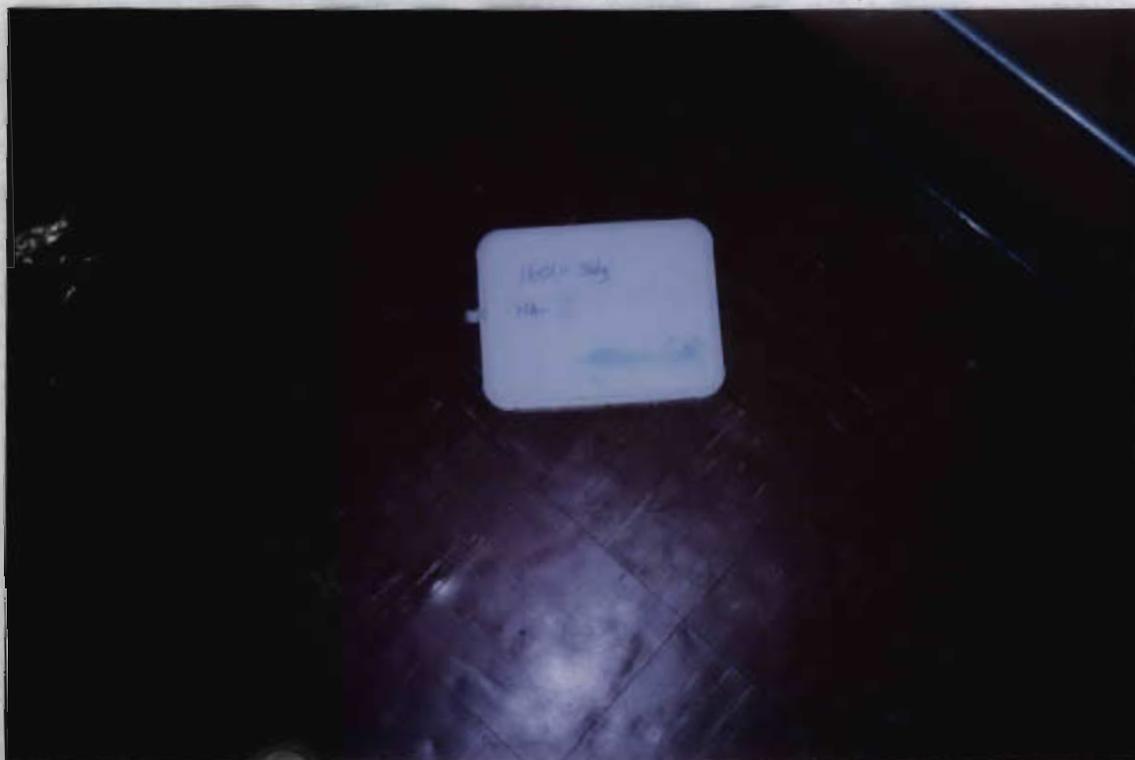
HA No.	Material Description	Sample Analysis Results	Approx. Quantity of ACM	NESHAP Category
2	Floor Tile, 9" x 9" brownish red with white streaks w/ black mastic	Tile = 1-2% chrysotile, Mastic = 5% chrysotile	500 SF	Category I, non-friable

Percent Damage: 10 % Damage Localized X Distributed

Type of Damage: X Deterioration Water Physical

Floor Tile, 9" x 9" brownish red with white streaks w/ black mastic, HA # 2

HA No.	Material Description	Recommended Response Action
2	Floor Tile, 9" x 9" brownish red with white streaks w/ black mastic	Repair and O&M Plan

| (4) Damaged plus low potential for damage | <input checked="" type="checkbox"/> (4) Repair |
