ASBESTOS-CONTAINING MATERIAL RE-INSPECTION FOR BUILDING 234 VOLUME 14
CNC CHARLESTON SC
2/15/2000
BAT ASSOCIATES, INC.

**Asbestos-Containing Material Re-inspection
For Building 234
Charleston Naval Shipyard
Charleston, South Carolina**

Contract No. N2467-96-D-0998
Delivery Order No. 0013

February 15, 2000

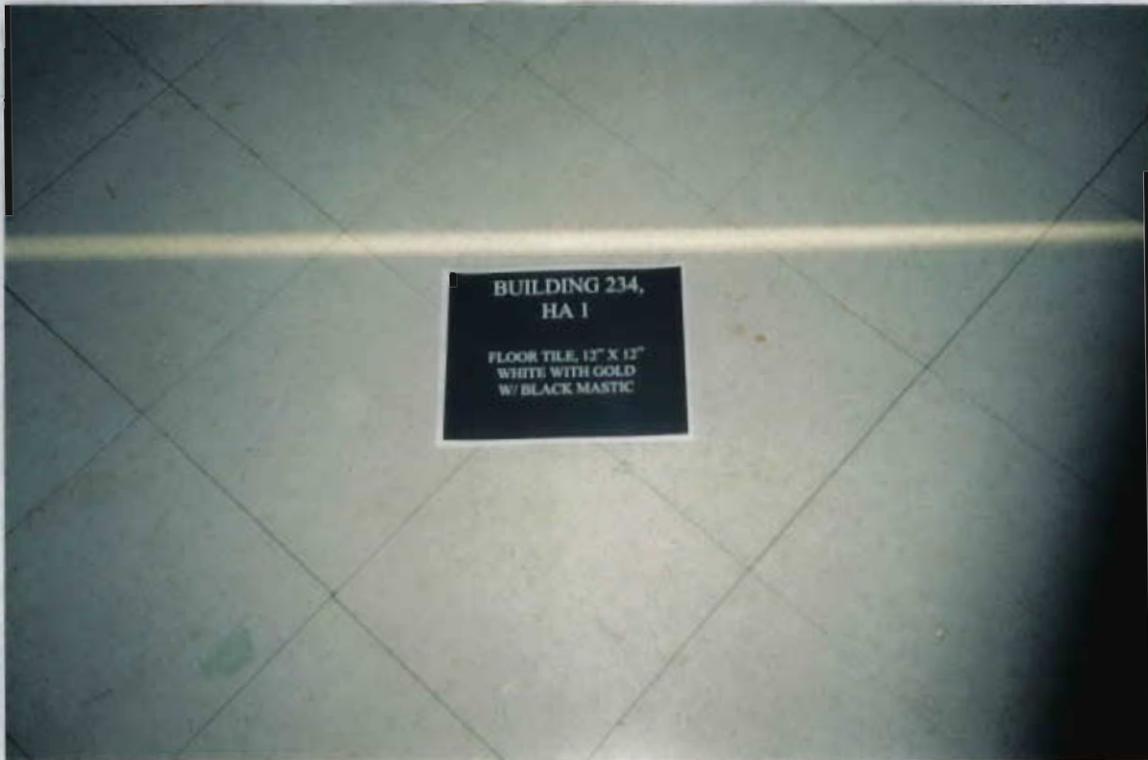
Floor Tile, 12" x 12" white with gold w/ black mastic, HA # 1

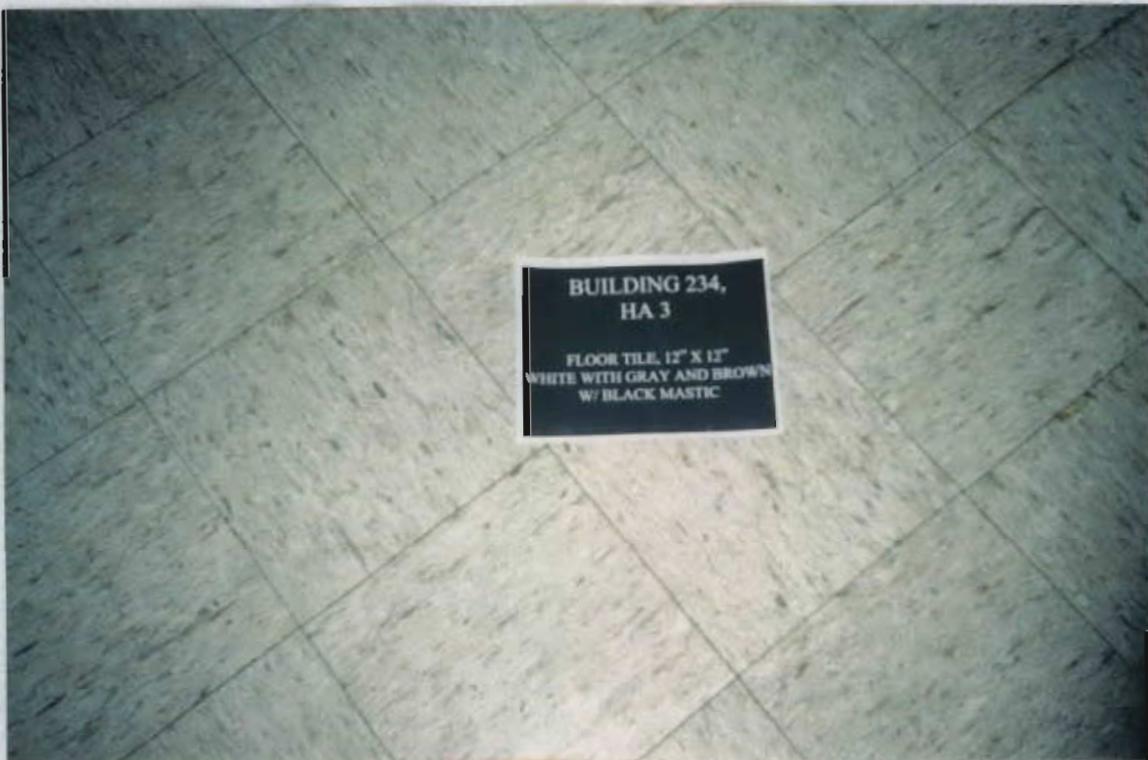
Floor Tile, 12" x 12" white with gray and brown w/ black mastic, HA # 3

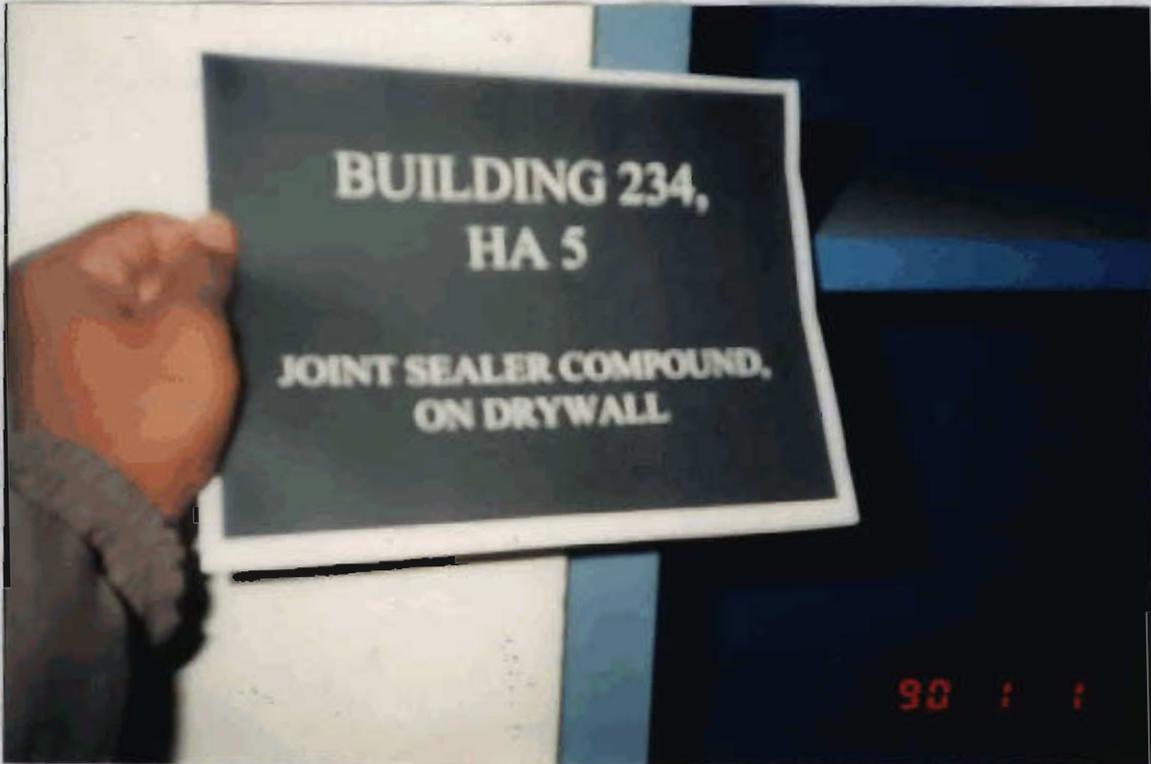
Joint Sealer Compound, on drywall, HA # 5

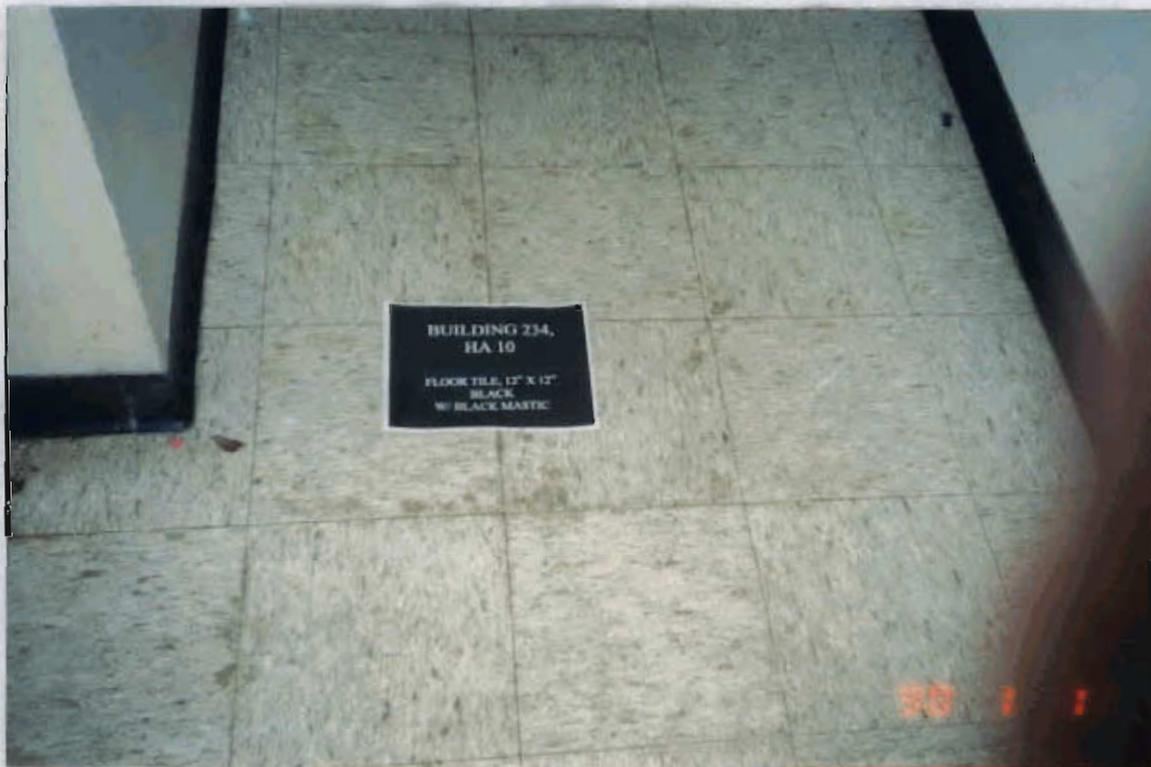
Floor Tile, 12" x 12" black w/ black mastic, HA # 10

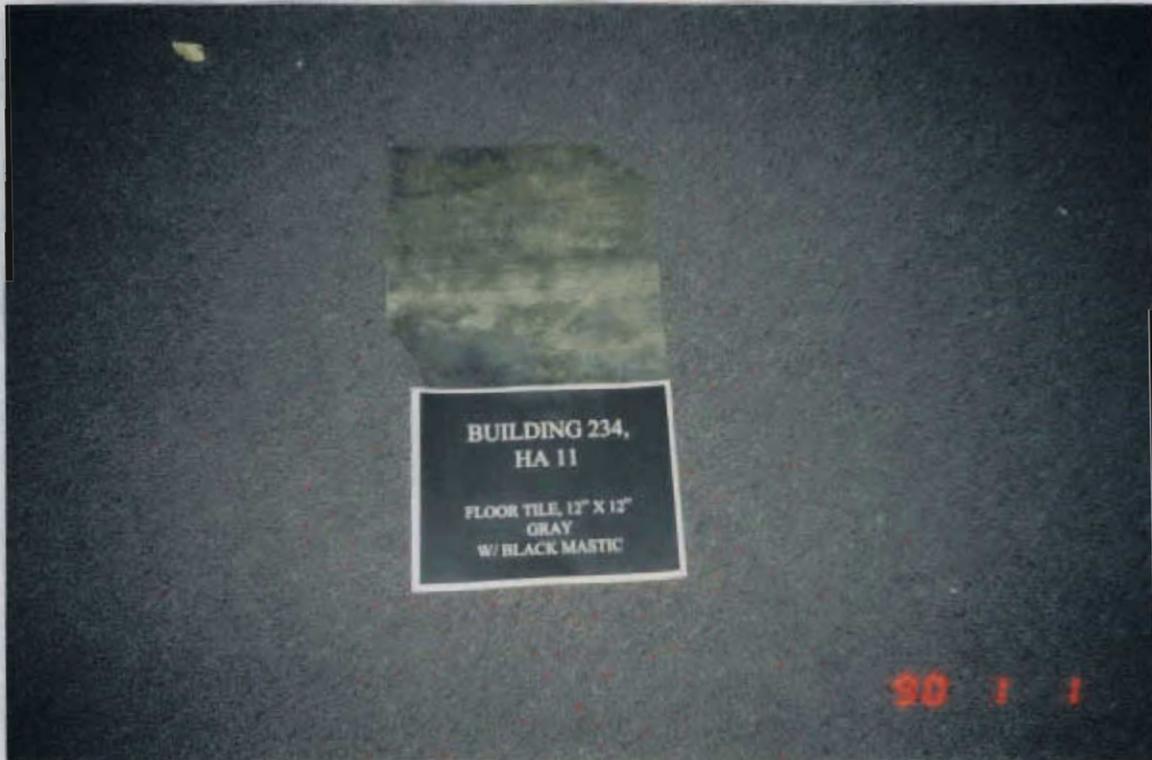
Floor Tile, 12" x 12" gray w/ black mastic, HA # 11

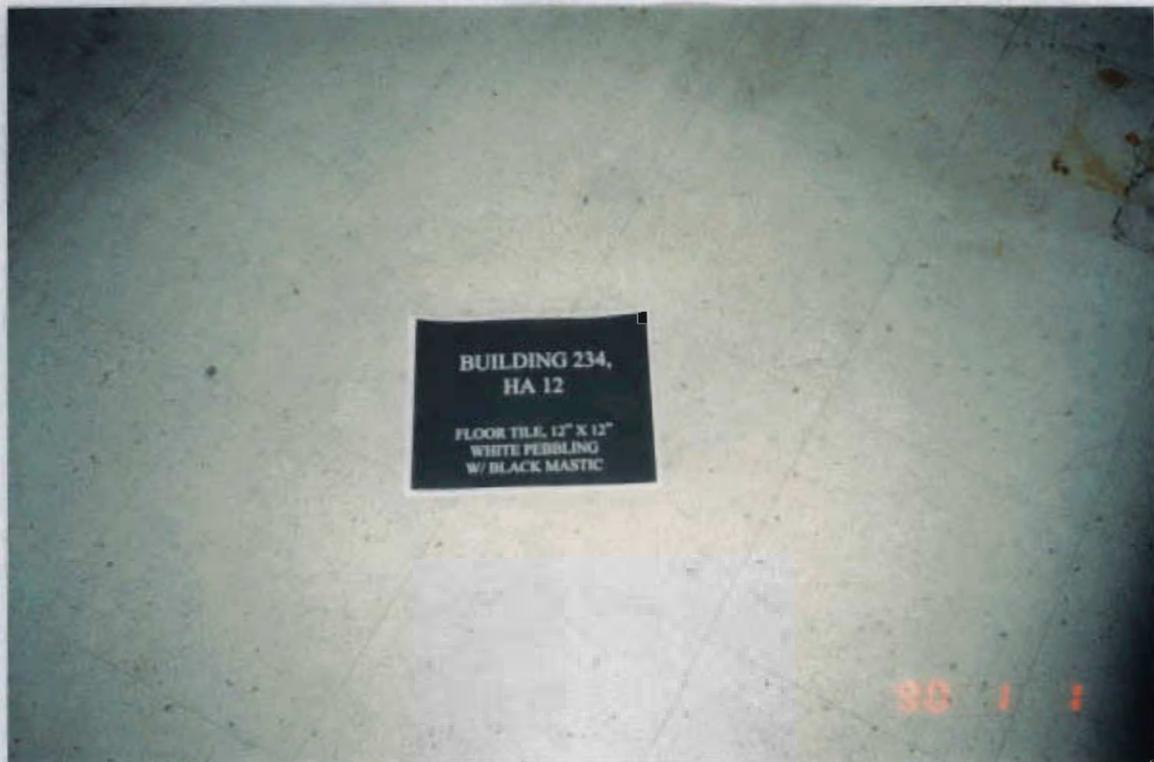
Floor Tile, 12" x 12" white pebbling w/ black mastic, HA # 12

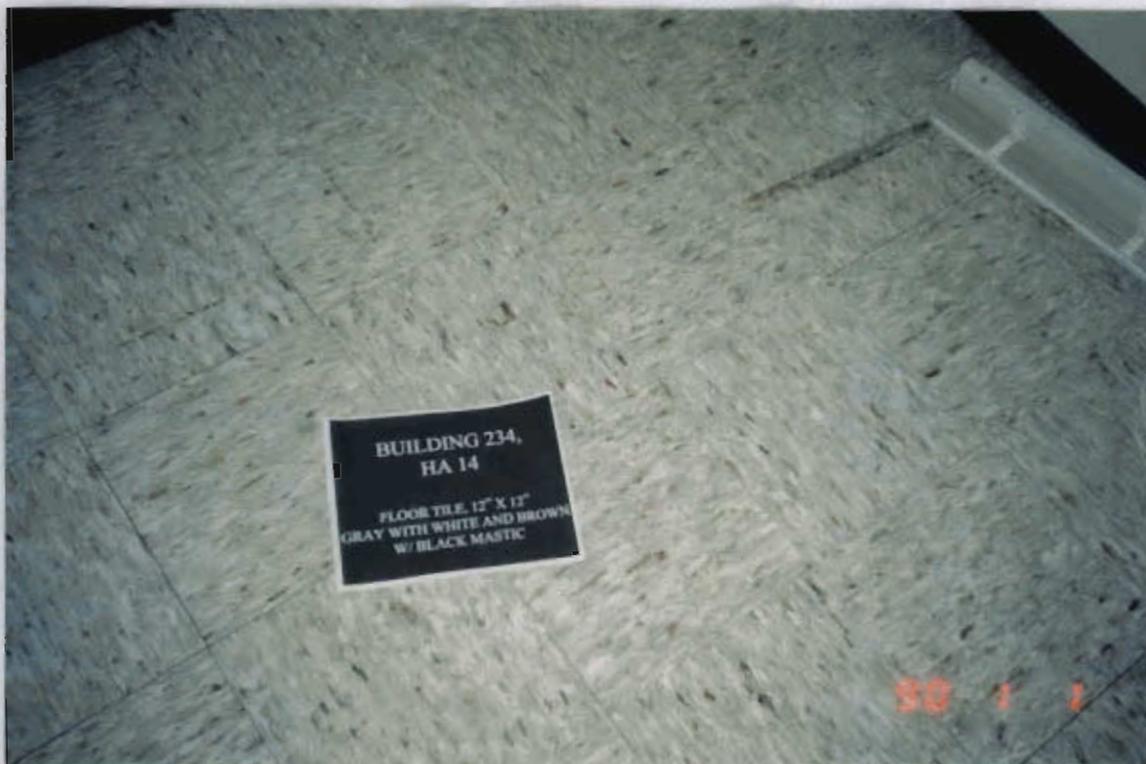
Floor Tile, 12" x 12" gray with white and brown w/ black mastic, HA # 14

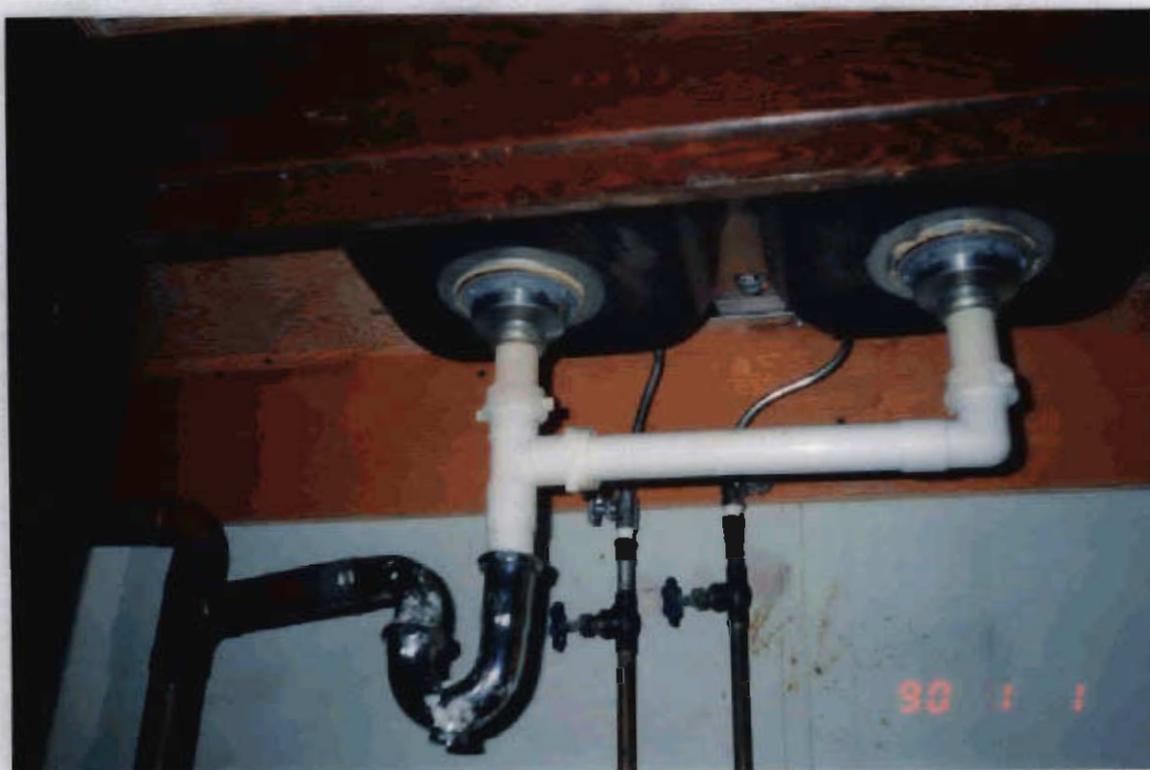
Mastic on Sink, black, HA # 15

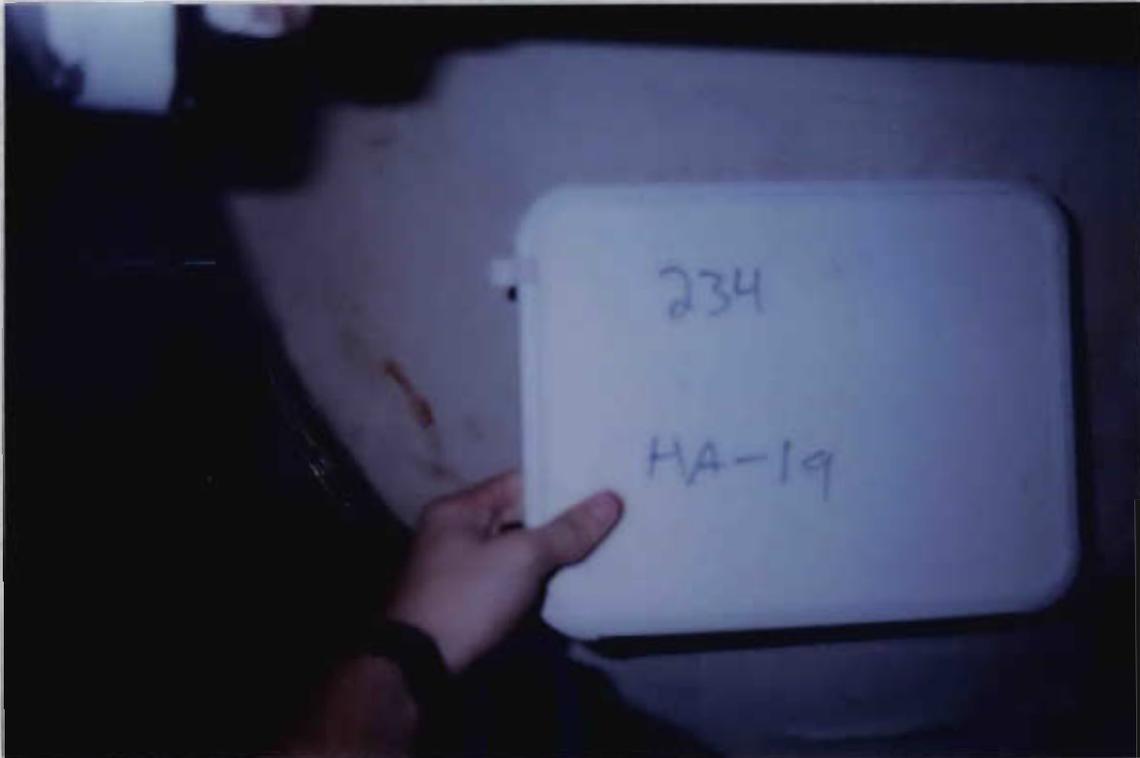
Boiler Insulation, white, HA # 19

COMMENTS: Material should be repaired and included in the facility O&M Plan until removal is accomplished.
