ASBESTOS-CONTAINING MATERIAL RE-INSPECTION FOR BUILDING NS69 VOLUME 10
CNC CHARLESTON SC
2/15/2000
BAT ASSOCIATES, INC.

**Asbestos-Containing Material Re-inspection
For Building NS69
Charleston Naval Shipyard
Charleston, South Carolina**

Contract No. N2467-96-D-0998
Delivery Order No. 0013

February 15, 2000

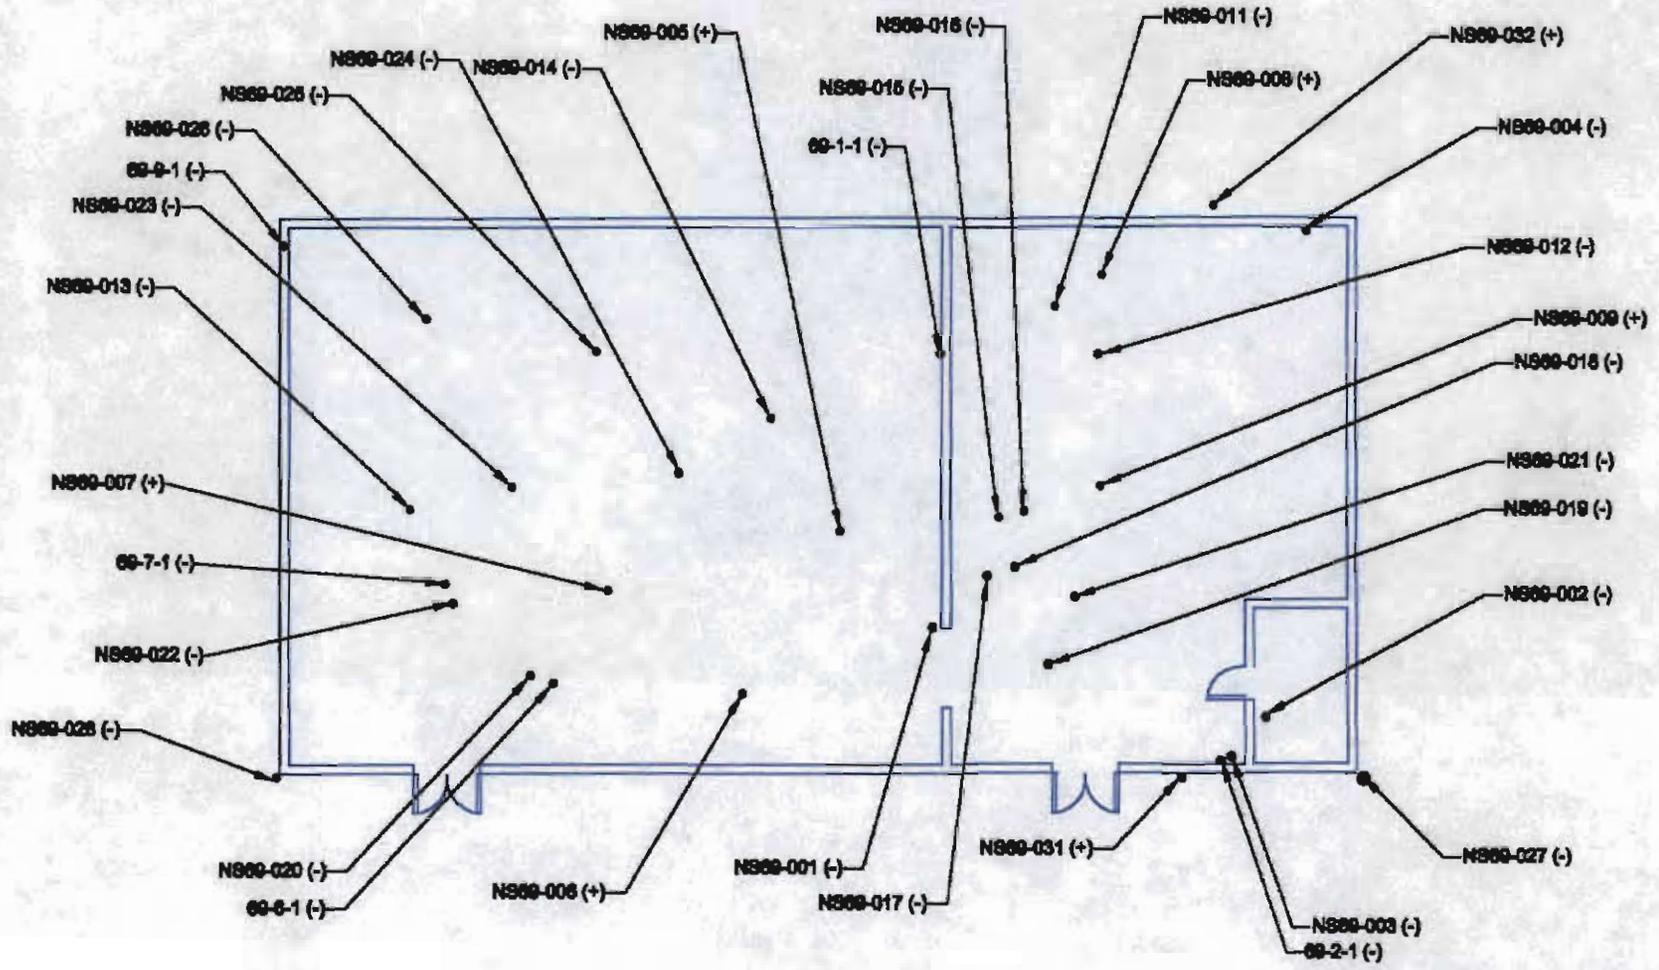
BUILDING NS69
Sample Locations

NOTE 2: Cloth Wrapped Pipe Fitting Insulation Should Be Considered Asbestos-Containing.

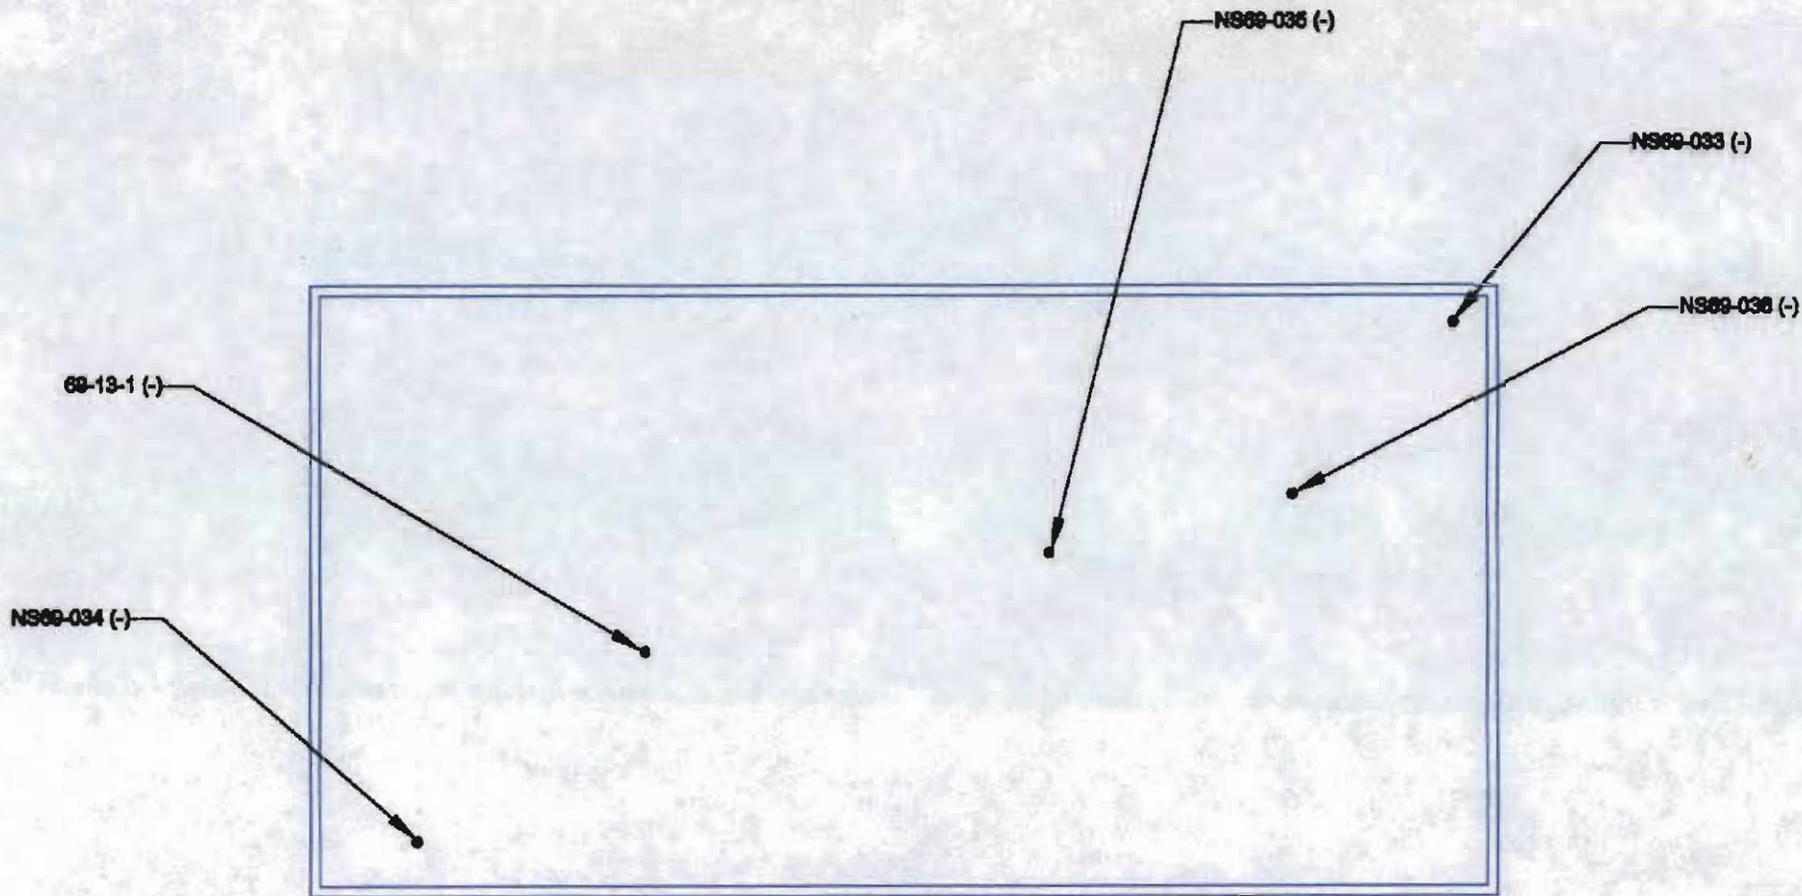
BUILDING NS69

**NOTE: No Asbestos-Containing
Materials Identified on
the Roof.**

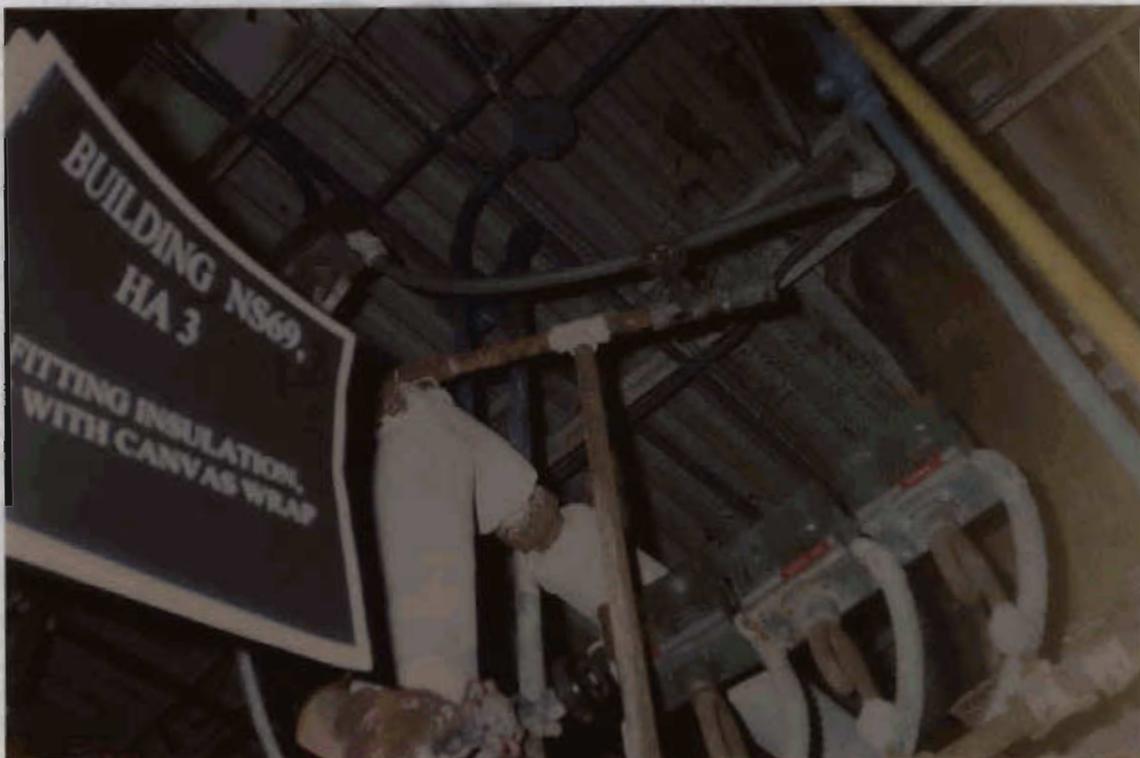
HA No.	Material Description	Sample Analysis Results	Approx. Quantity of ACM	NESHAP Category
3	Pipe Fitting Insulation, white with cloth wrap	5% chrysotile	210 EA	Regulated, friable
11	Caulking, gray	2% chrysotile	140 LF	Regulated, friable

Pipe Fitting Insulation, white with cloth wrap, HA # 3

HA No.	Material Description	Recommended Response Action
3	Pipe Fitting Insulation, white with cloth wrap	Removal Prior to Renovation or Demolition
11	Caulking, white	Removal Prior to Renovation or Demolition

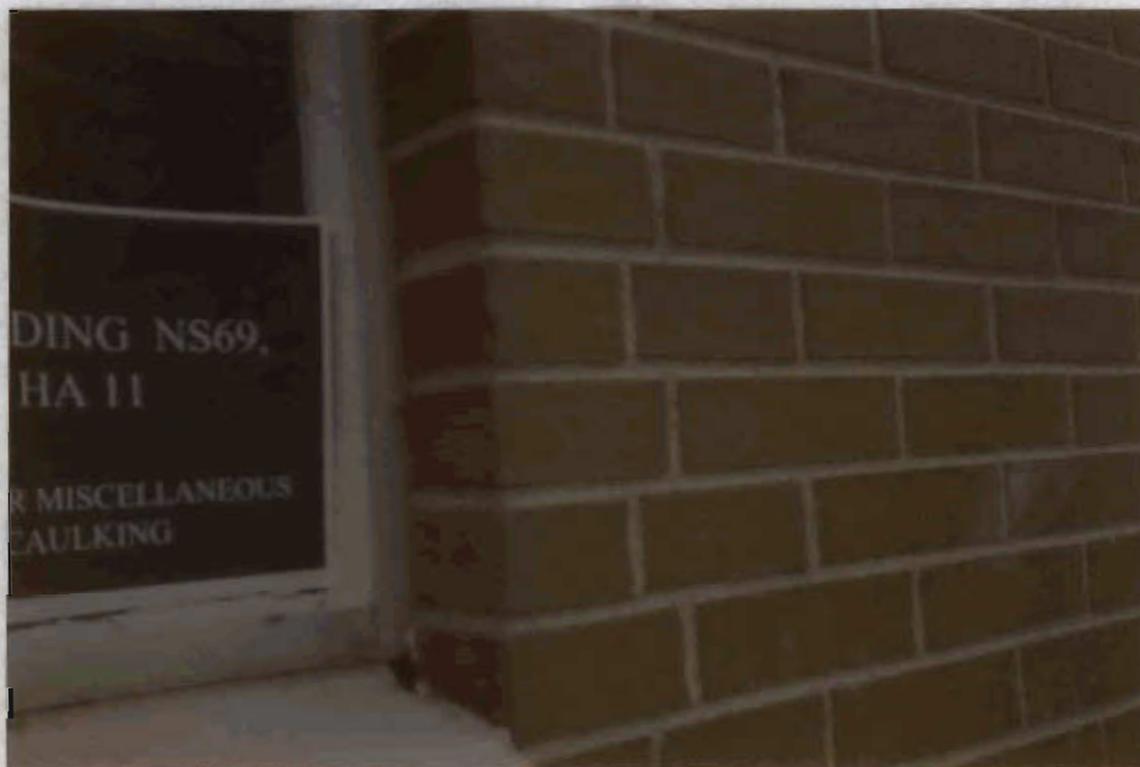
Caulking, white, HA # 11
