ASBESTOS-CONTAINING MATERIALS SURVEY LEAD-BASED PAINT INSPECTION AND
RISK ASSESSMENT AT BUILDING NH-61 CNC CHARLESTON SC
7/1/2000
CAPE ENVIRONMENTAL MANAGEMENT, INC.

**ASBESTOS-CONTAINING MATERIALS SURVEY,
LEAD-BASED PAINT INSPECTION AND
RISK ASSESSMENT AT BUILDING NH-61
CHARLESTON NAVAL SHIPYARD
CHARLESTON, SOUTH CAROLINA**

Contract # N62467-00-D-0341
Delivery Order # 0008
CAPE Project # 00009.006.000

JULY 2000

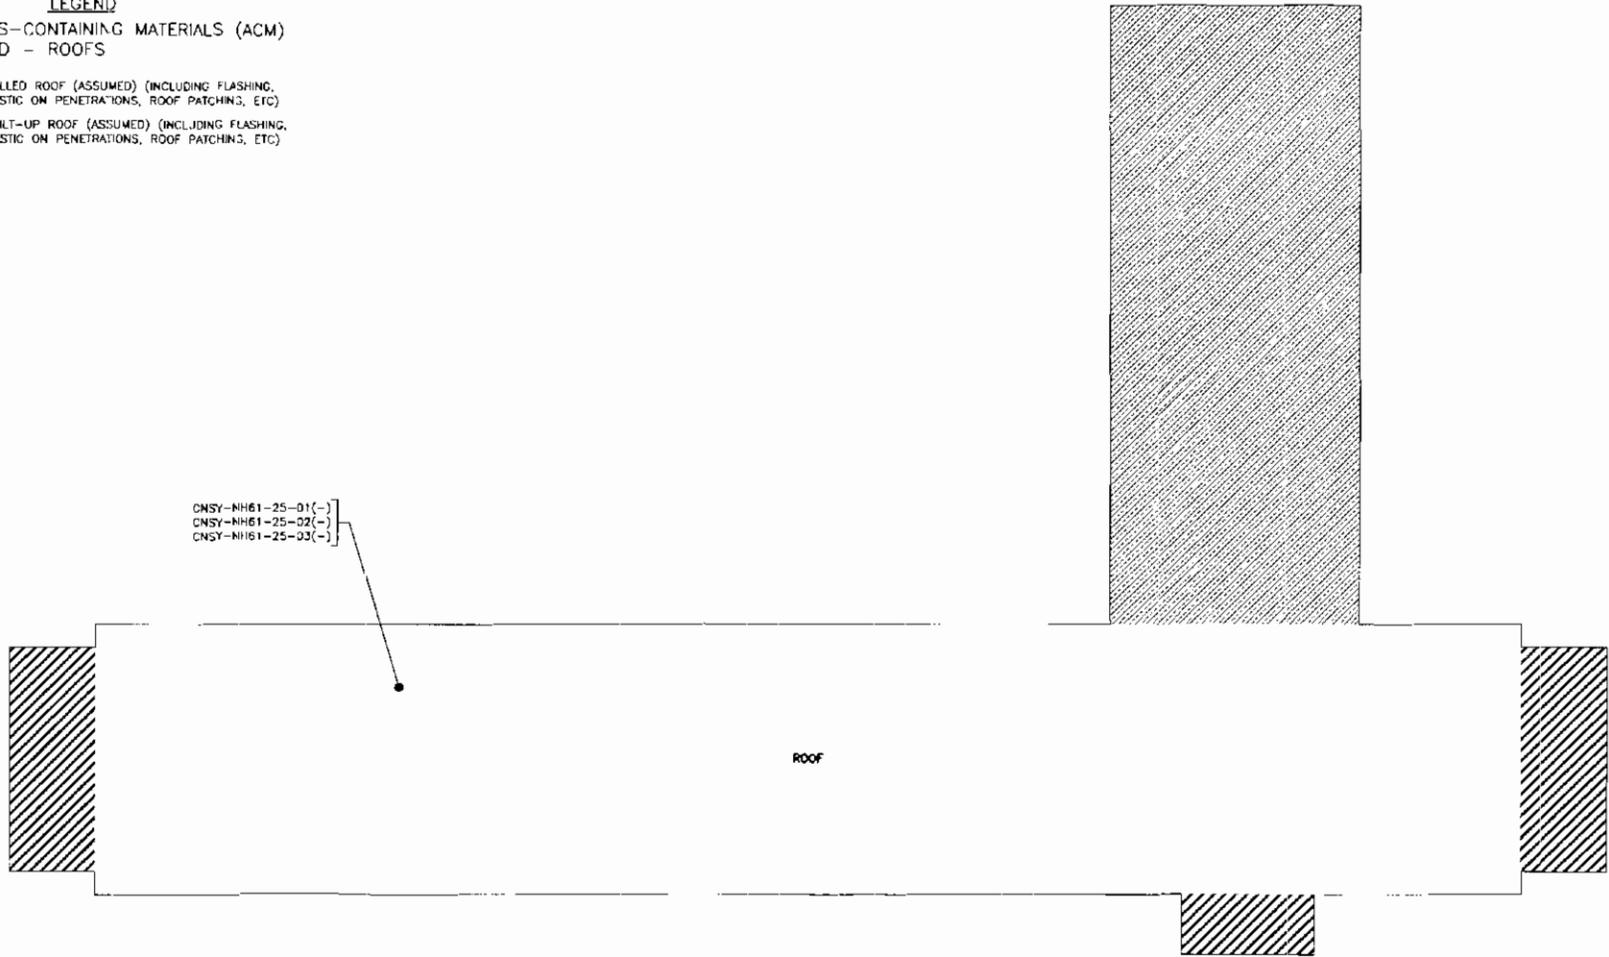
BUILT-UP ROOF (ASSUMED) (INCLUDING FLASHING, MASTIC ON PENETRATIONS, ROOF PATCHING, ETC)

CNSY-NH61-25-01(-)
CNSY-NH61-25-02(-)
CNSY-NH61-25-03(-)

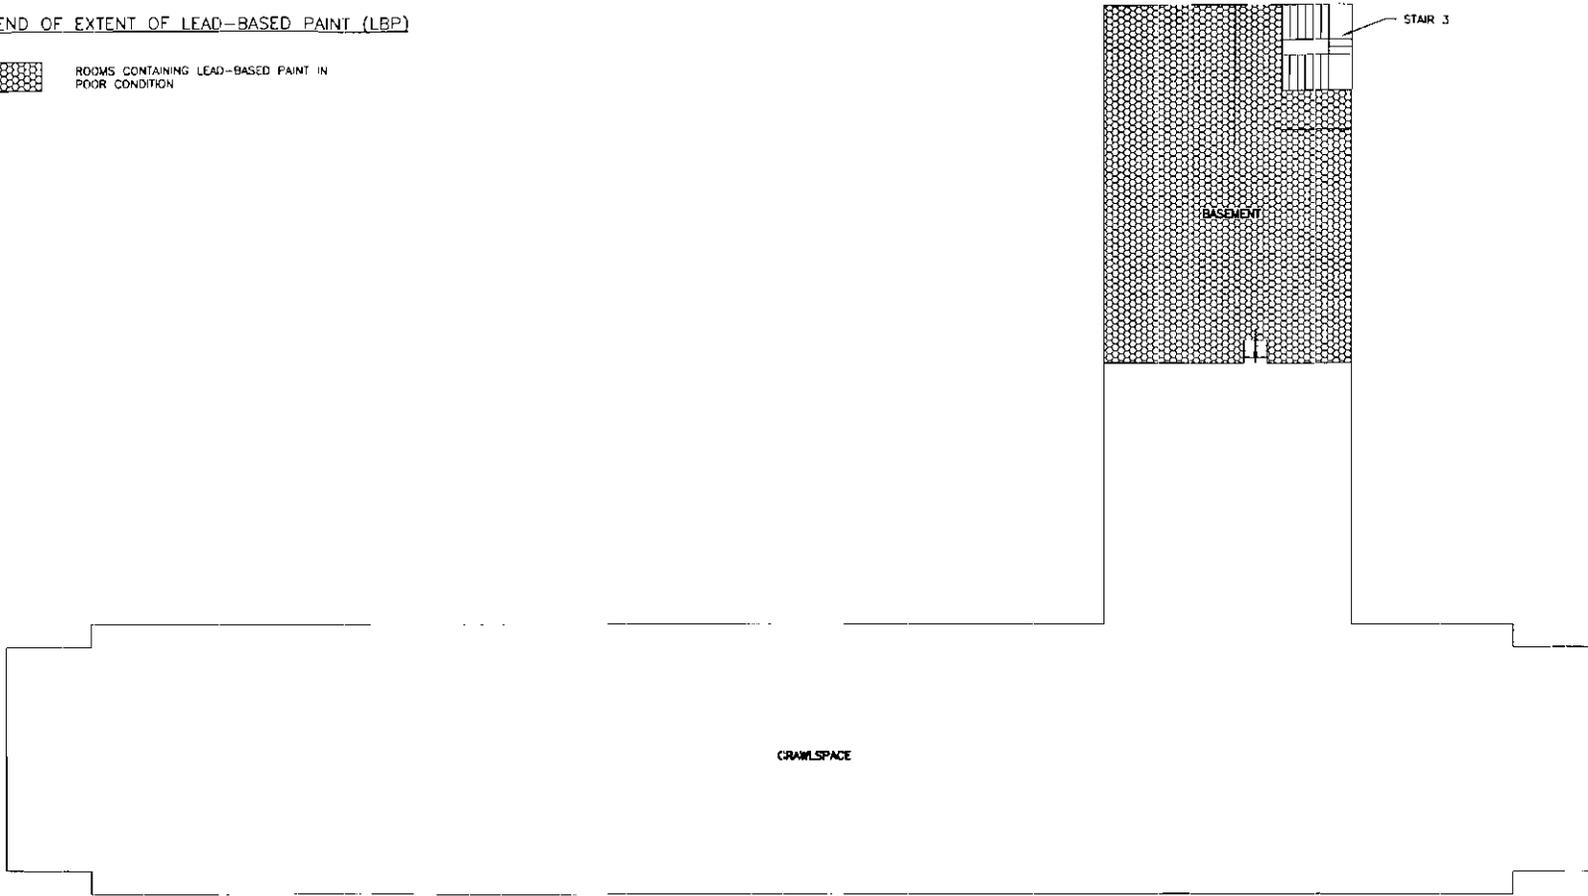
BUILDING NH-61 -- CRAWLSPACE PLAN

ROOMS CONTAINING LEAD-BASED PAINT IN POOR CONDITION

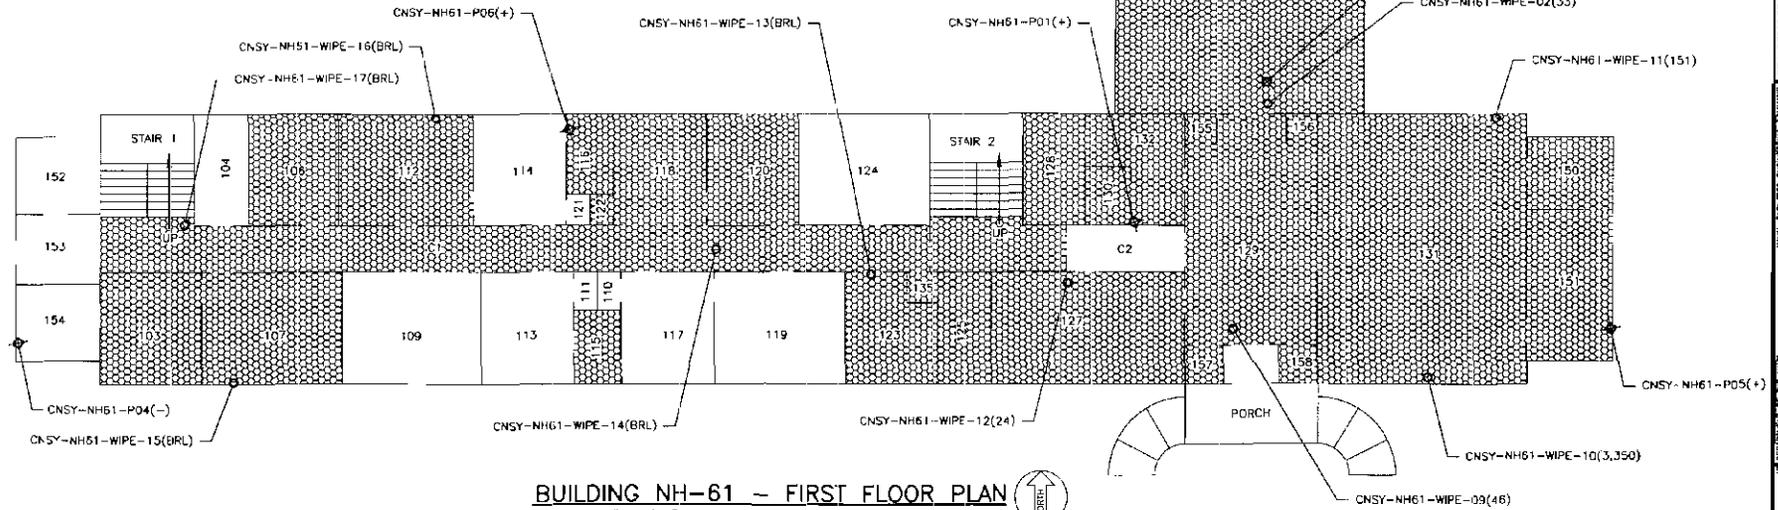
BUILDING NH-61 - FIRST FLOOR PLAN

ROOMS CONTAINING LEAD-BASED PAINT IN POOR CONDITION

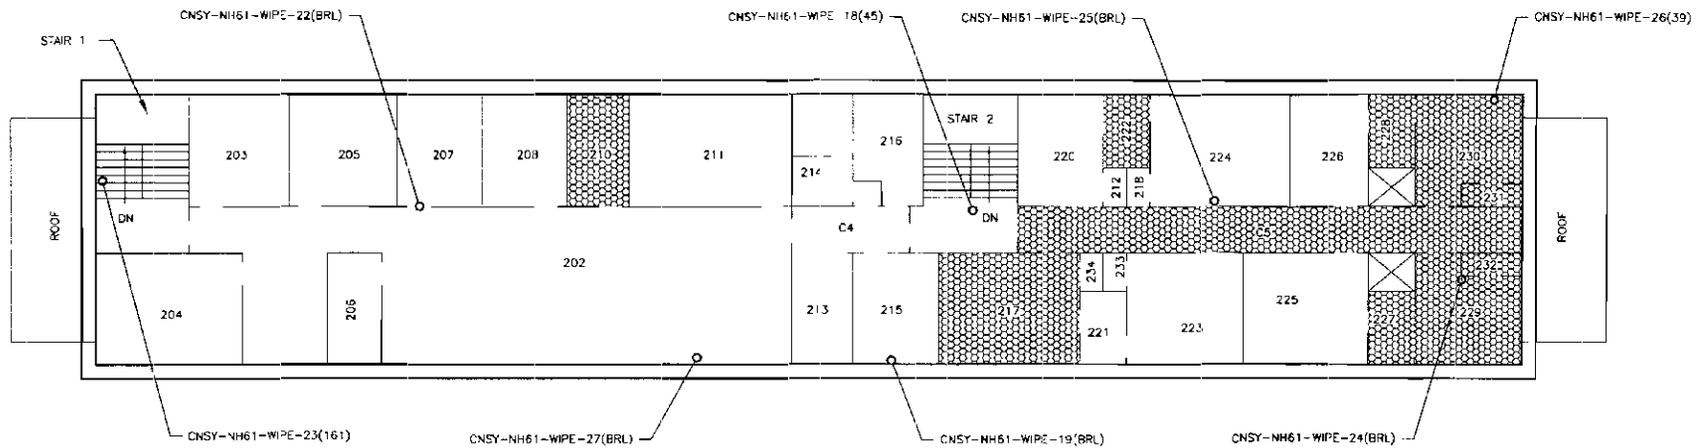
BUILDING NH-61 - SECOND FLOOR PLAN

ROOMS CONTAINING LEAD-BASED PAINT IN POOR CONDITION

SOFFIT (ASSUMED LBP) IN POOR CONDITION
