ASBESTOS CONTAINING MATERIALS STUDY LEAD BASED PAINT INSPECTION AND  
RISK ASSESSMENT BUILDING NH-61 CNC CHARLESTON SC  
7/1/2000  
CAPE ENVIRONMENTAL MANAGEMENT, INC.

**ASBESTOS-CONTAINING MATERIALS SURVEY,  
LEAD-BASED PAINT INSPECTION AND  
RISK ASSESSMENT AT BUILDING NH-61  
CHARLESTON NAVAL SHIPYARD  
CHARLESTON, SOUTH CAROLINA**

Contract # N62467-00-D-0341  
Delivery Order # 0008  
CAPE Project # 00009.006.000

**JULY 2000**

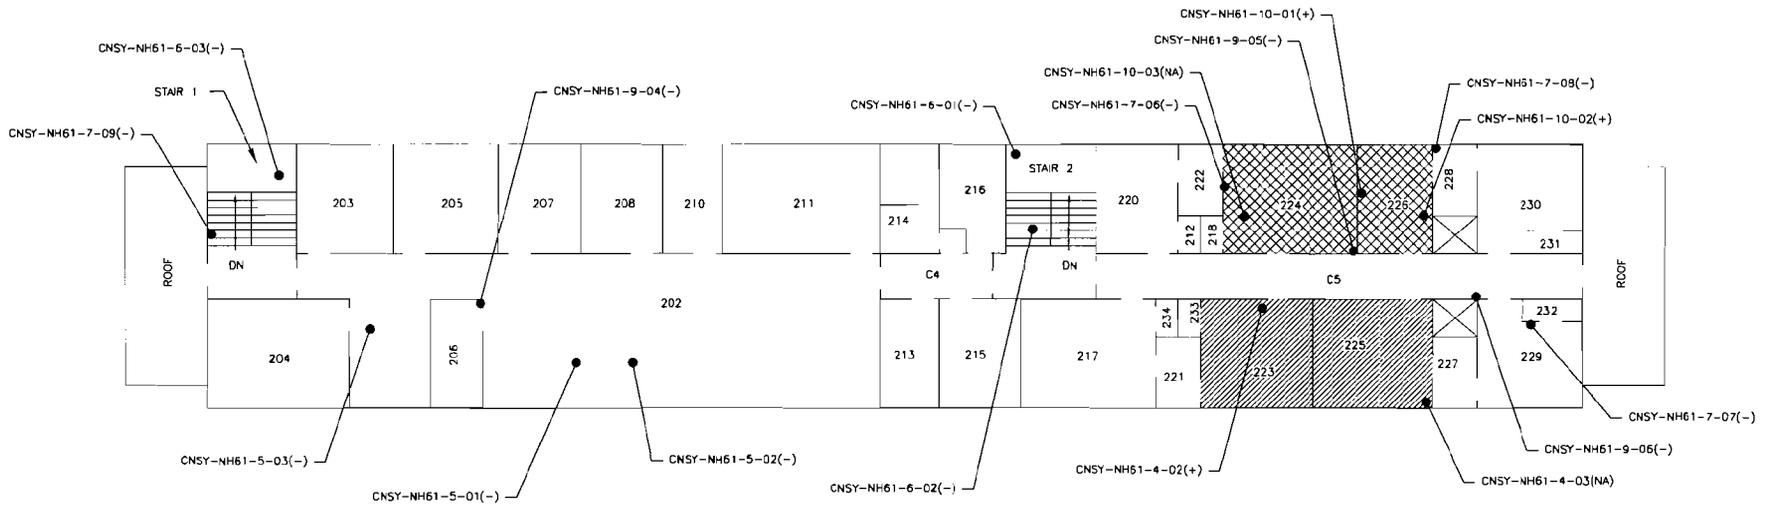
### BUILDING NH-61 - SECOND FLOOR PLAN

## **Survey Drawings: Extent of ACM Identified and Suspect ACM Bulk Sample Locations**

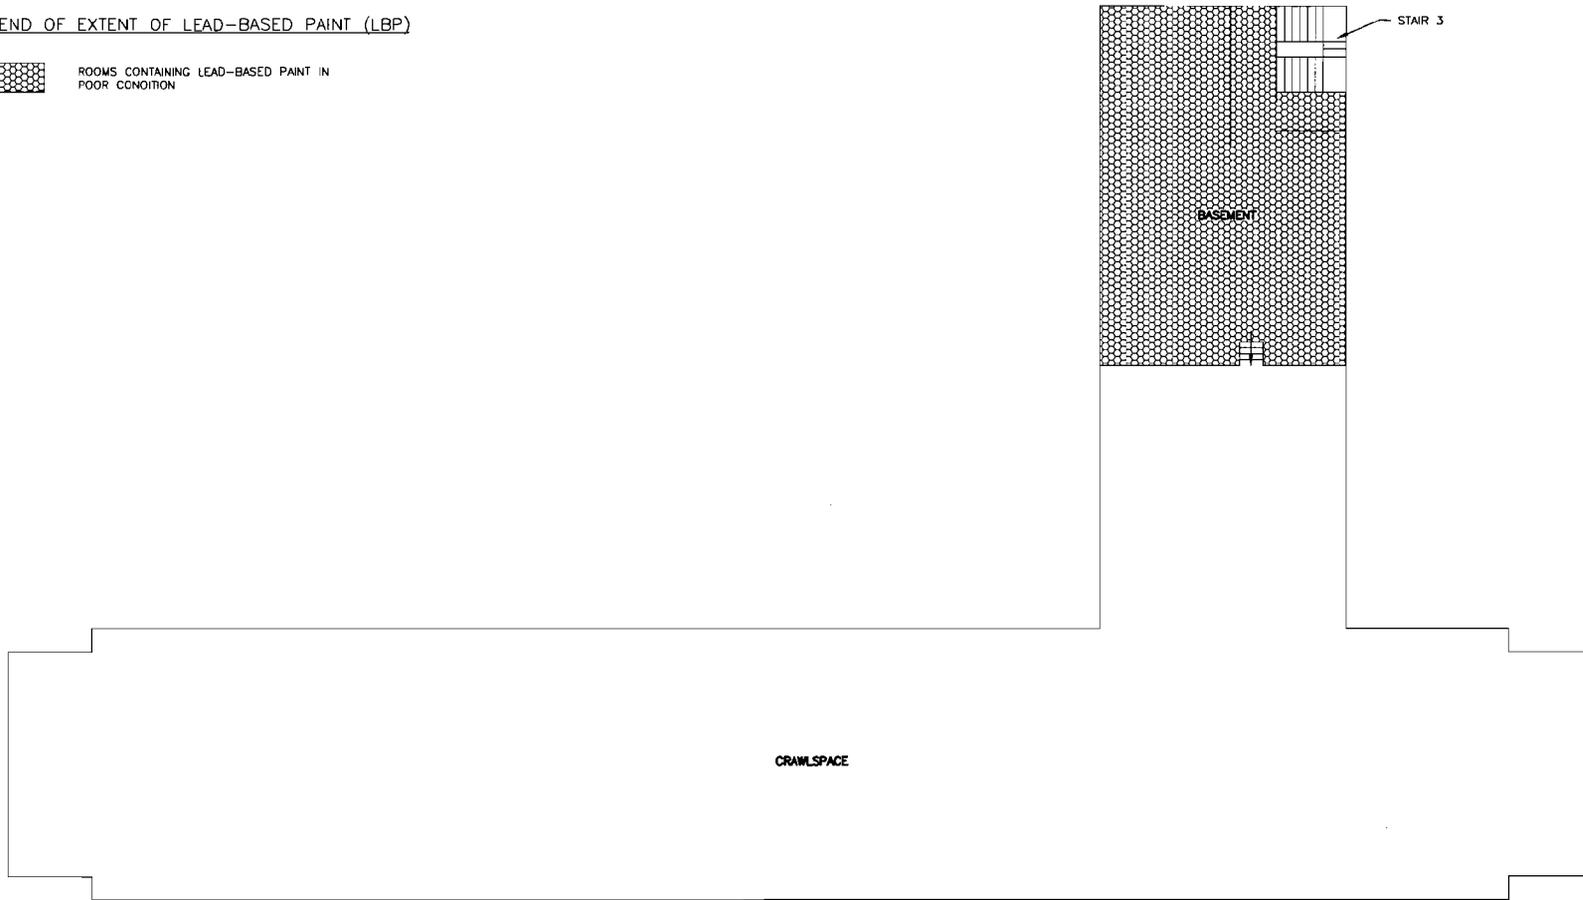
BUILDING NH-61 - CRAWLSPACE PLAN

**Survey Drawings: Extent of LBP Identified in Poor Condition and Paint Chip and Wipe Sample Locations**

ROOMS CONTAINING LEAD-BASED PAINT IN POOR CONDITION
