ASBESTOS CONTAINING MATERIAL RE INSPECTION BUILDING 199 VOLUME 25 CNC
CHARLESTON SC
2/15/2000
BAT ASSOCIATES, INC.

**Asbestos-Containing Material Re-inspection
For Building 199
Charleston Naval Shipyard
Charleston, South Carolina**

Contract No. N2467-96-D-0998
Delivery Order No. 0013

February 15, 2000

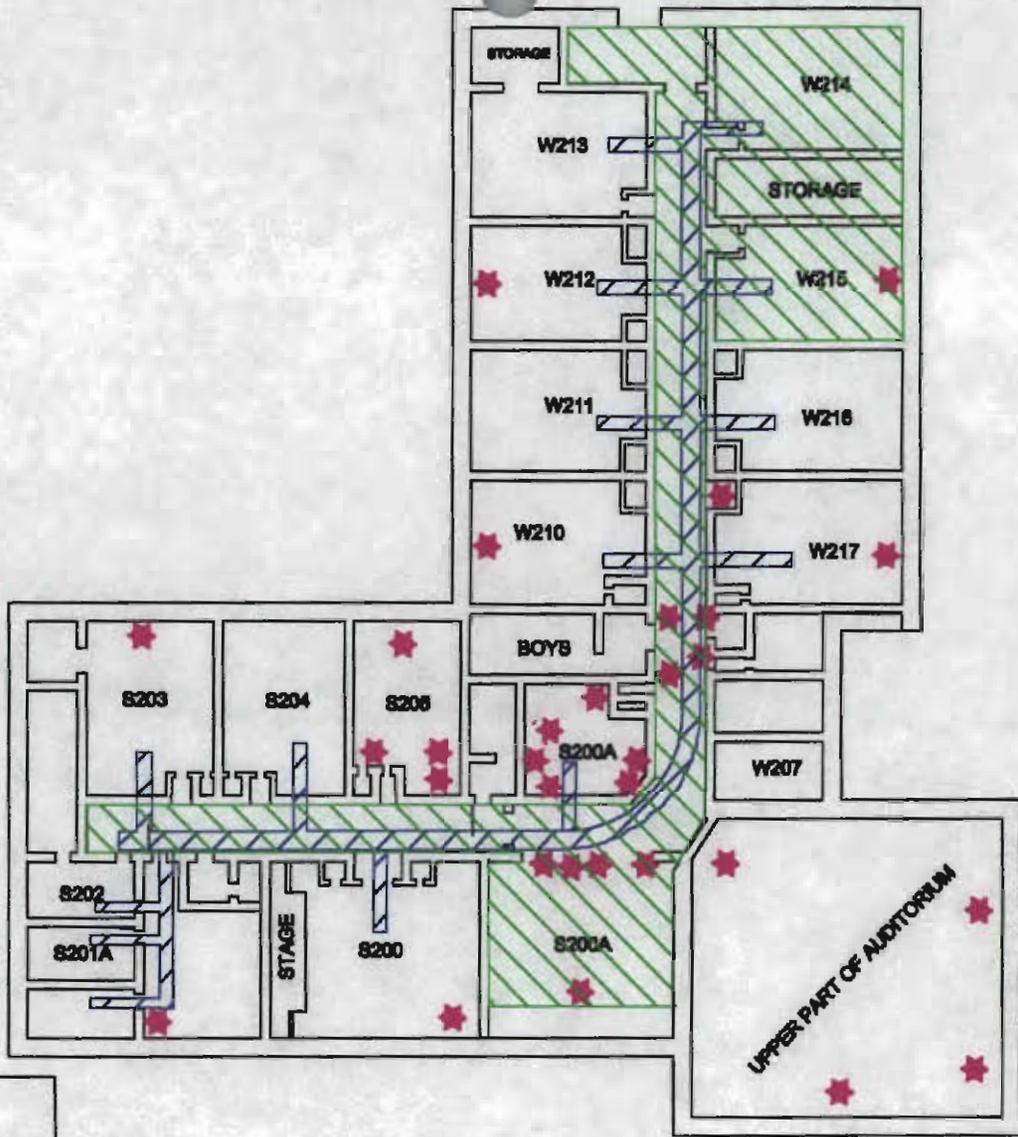
- ★ - Asbestos-Containing Pipe Fittings
- ▨ - Asbestos-Containing Floor Tile and Mastic
- ▧ - Asbestos-Containing Black Mastic on Ductwork

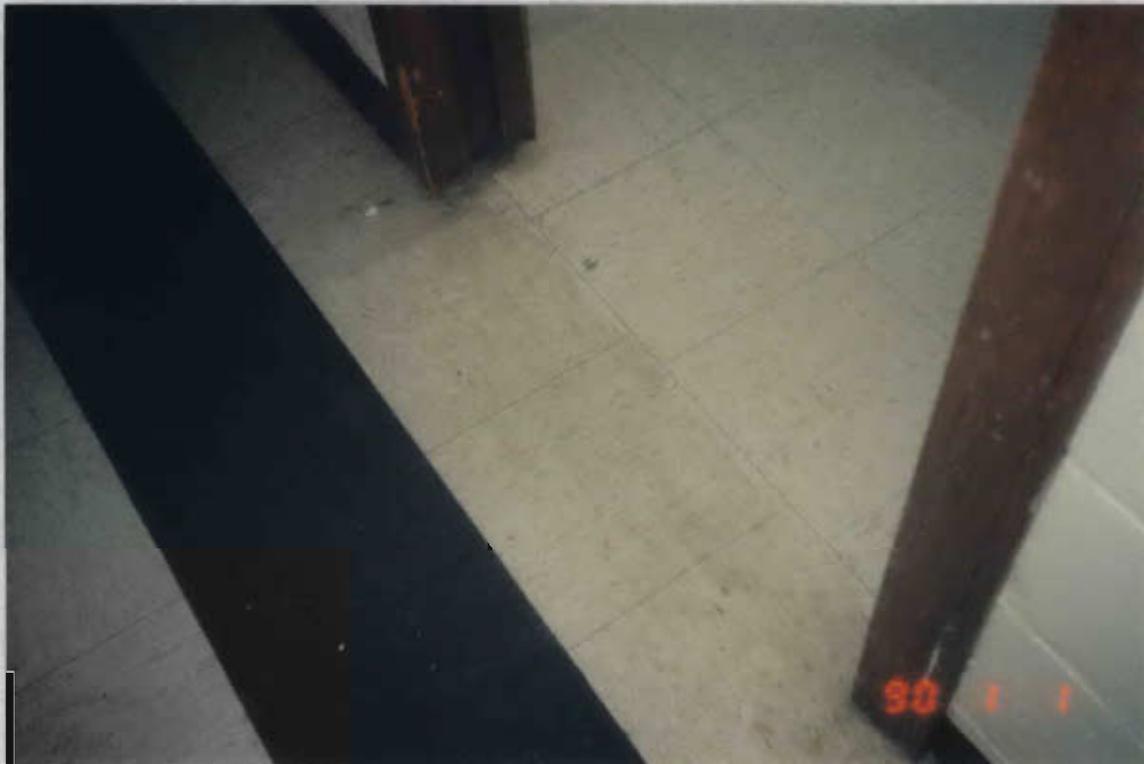
All of the identified and/or assumed asbestos-containing materials observed in this building were in good condition on the day of the survey.

Floor Tile, 12" x 12" black w/ black mastic, HA # 3

HA No.	Material Description	Recommended Response Action
1	Floor Tile, 12" x 12" blue w/ brown mastic	O&M Plan
3	Floor Tile, 12" x 12" black w/ black mastic	O&M Plan
8	Pipe Fitting Insulation, 6" roof drains	O&M Plan
9	Pipe Fitting Insulation, 2" domestic water	O&M Plan
10	Duct Joint Sealer, black	O&M Plan

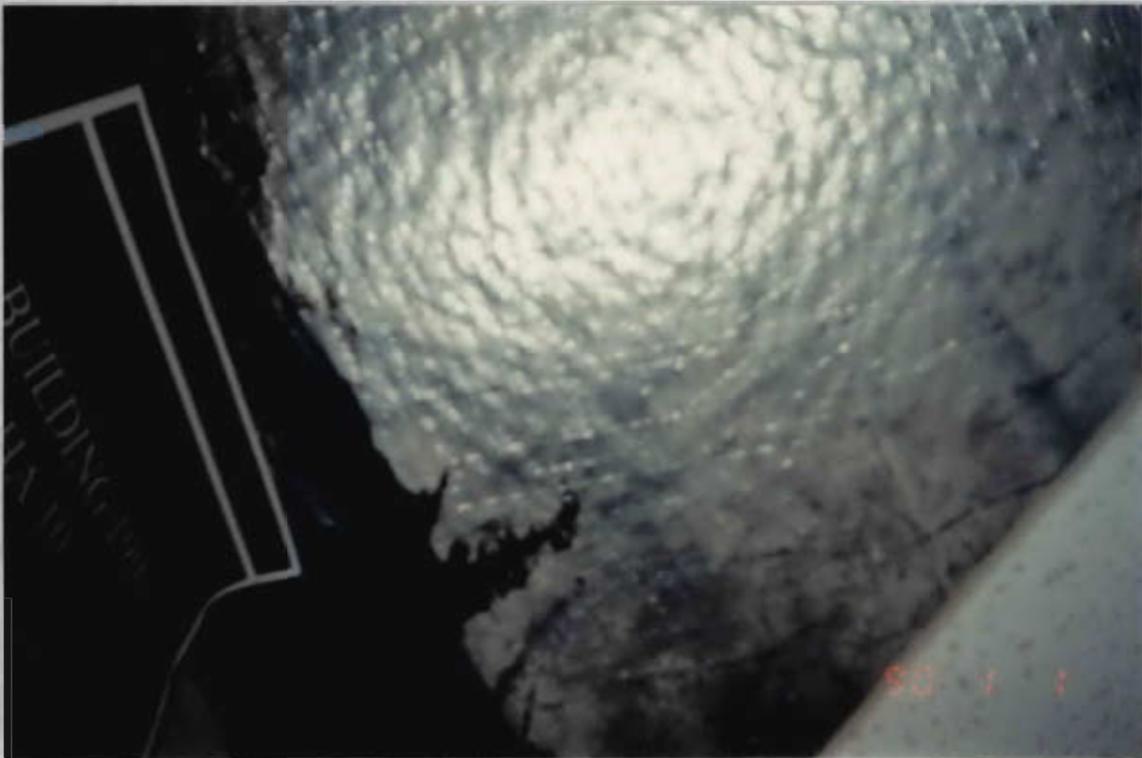
Duct Joint Sealer, black, HA #10
