ASBESTOS CONTAINING MATERIAL RE-INSPECTION BUILDING 8 VOLUME 2 CNC
CHARLESTON SC
2/15/2000
BAT ASSOCIATES, INC.

**Asbestos-Containing Material Re-inspection
For Building 8
Charleston Naval Shipyard
Charleston, South Carolina**

**Contract No. N2467-96-D-0998
Delivery Order No. 0013**

February 15, 2000

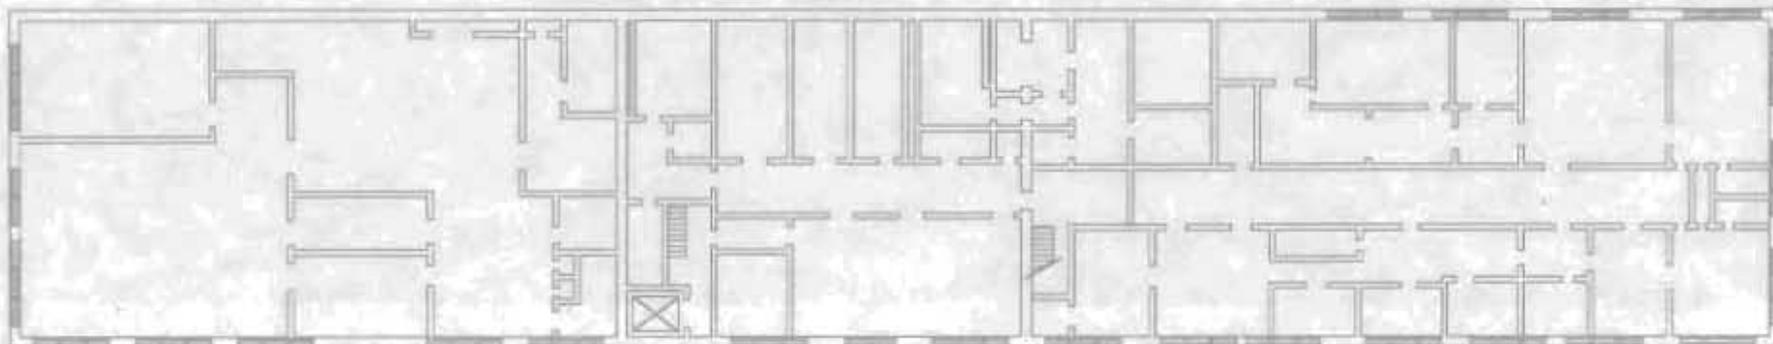
BUILDING 8 FLOOR 2
Sample and
Asbestos-Containing
Material Locations

NOTE: No Asbestos-Containing
Materials Identified on This Floor.

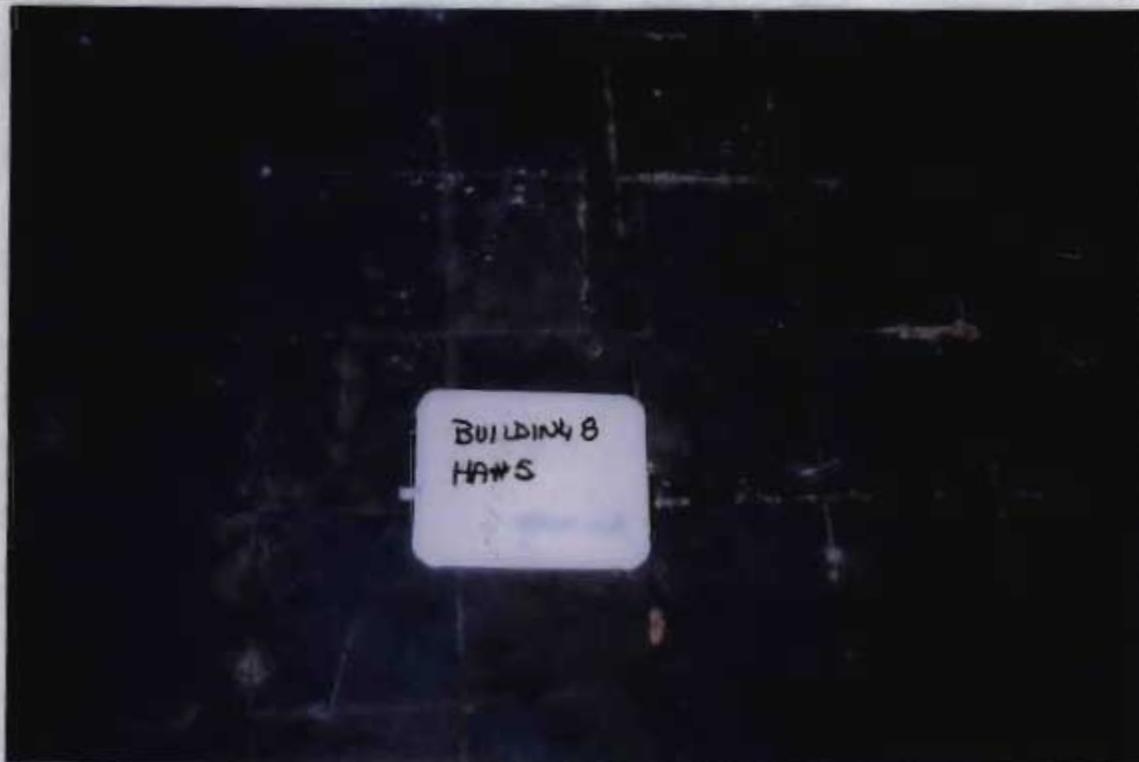
Floor Tile, 9" x 9" black and brown w/ black mastic, HA # 5

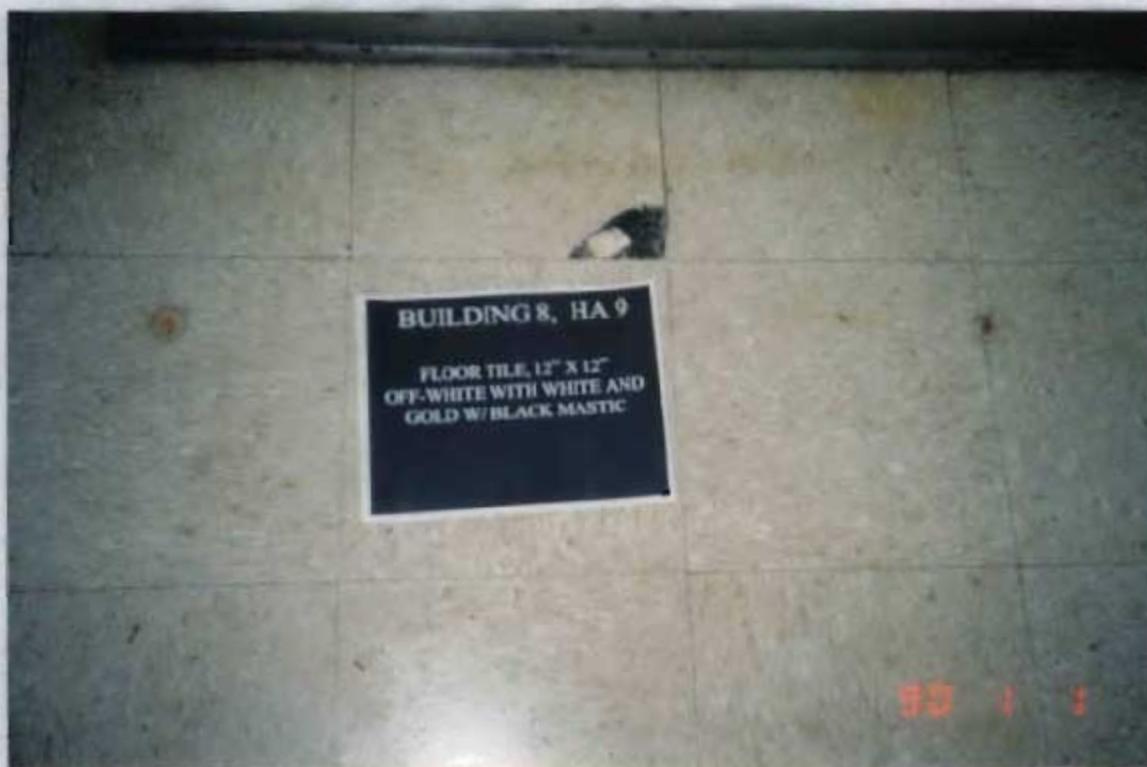
Floor Tile, 12" x 12" off-white with white and gold w/ black mastic, HA # 9

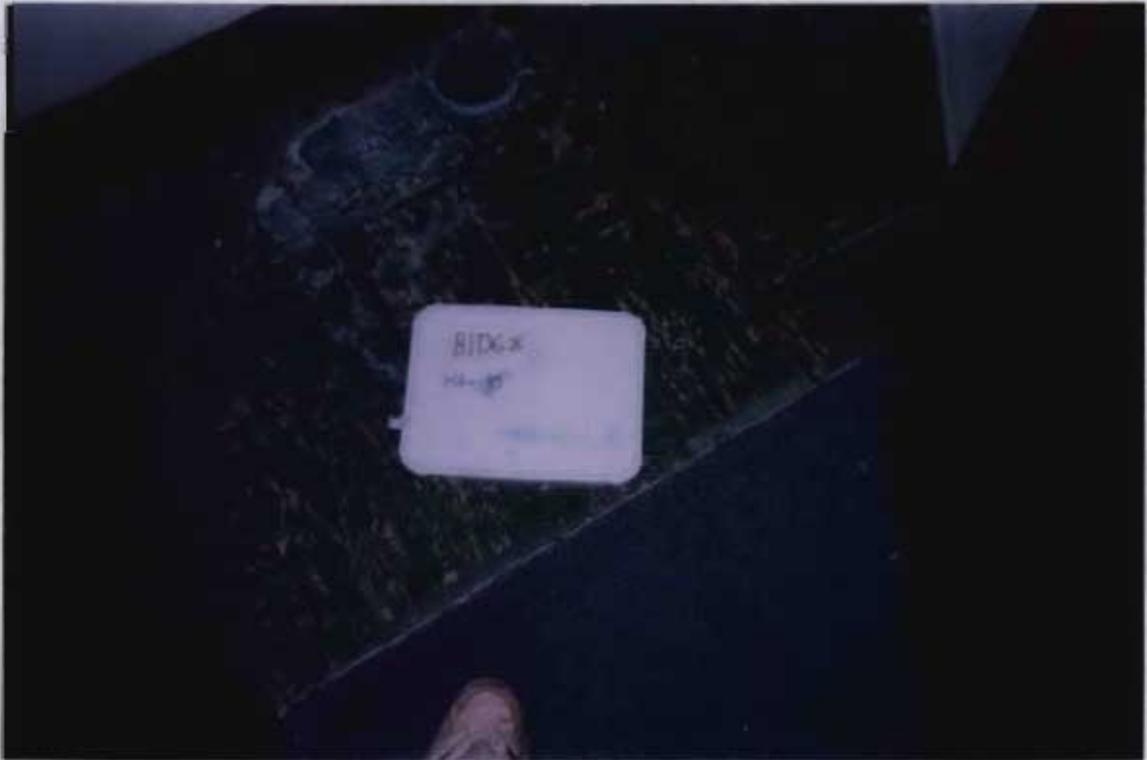
Floor Tile, 9" x 9" green with black w/ brown mastic, HA # 10

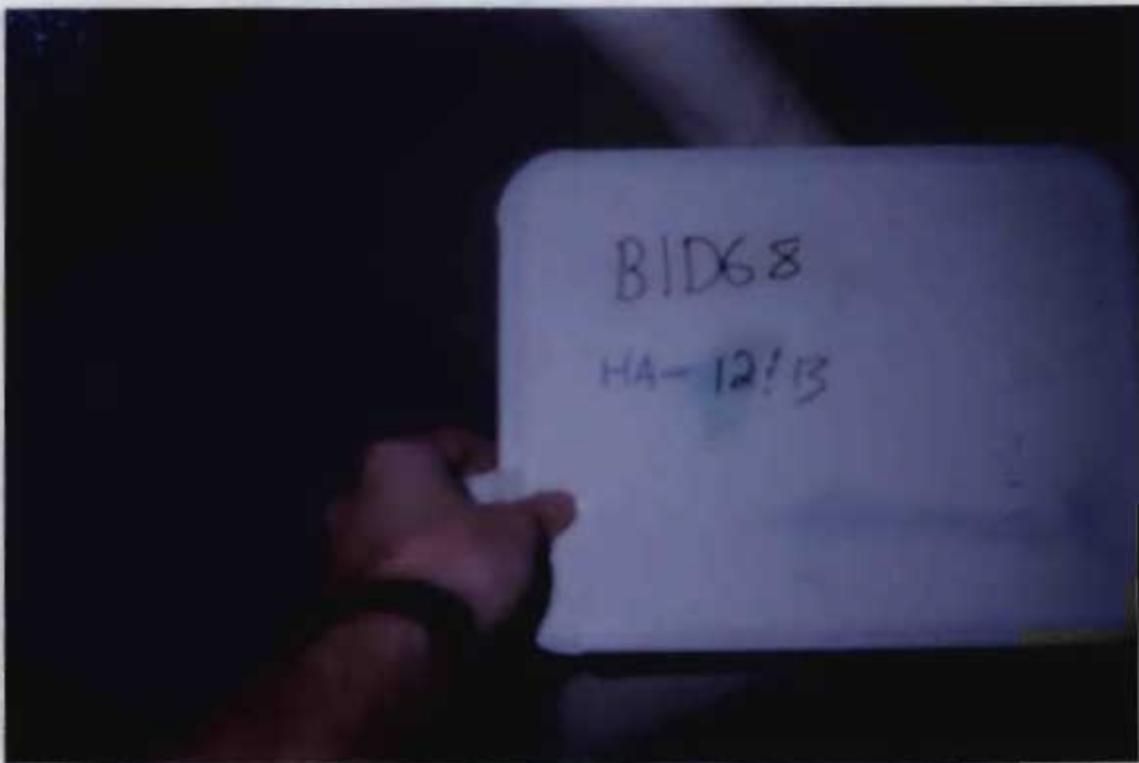
Pipe Fitting Insulation, 3" domestic water, HA # 13
