LABORATORY EQUIPMENT DECONTAMINATION AND WASTE DISPOSAL COMPLETION  
REPORT FOR BUILDING 13  
5/30/2014

**RE: Laboratory Equipment Decontamination and  
Waste Disposal Completion Report  
Building 13 — Former Charleston Naval Complex  
North Charleston, South Carolina**

STRUCTURAL EVALUATION REPORT  
BUILDING 13 - CHARLESTON NAVAL COMPLEX  
SOW No. JM16CNCRFP2

Re: Update of the Structural Condition Assessment of  
Building 13 - Charleston Naval Shipyard  
Charleston, South Carolina  
SOW No. 888814364 MS MS  
BPA #14024

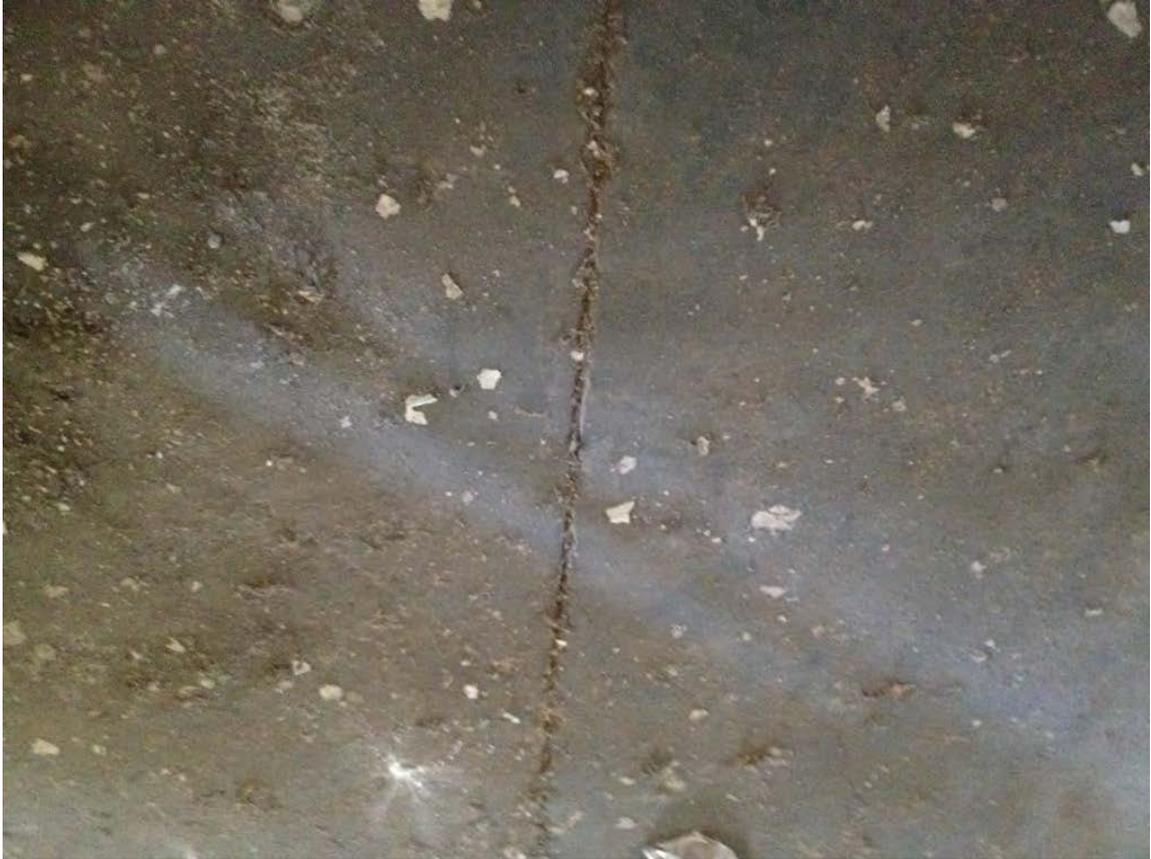
EXHIBIT 7

Based upon our review of the existing structural drawings, the foundation for the building consists of deep pile foundations. The existing slab is supported at grade and has regularly spaced control joints. Some minor shrinkage cracking was observed in the slab-on-grade, but no active signs of distress were noted. In our opinion, the slabs and control joints are in good condition (reference exhibit 7). Some of the floor finishes have deteriorated (reference exhibit 8).

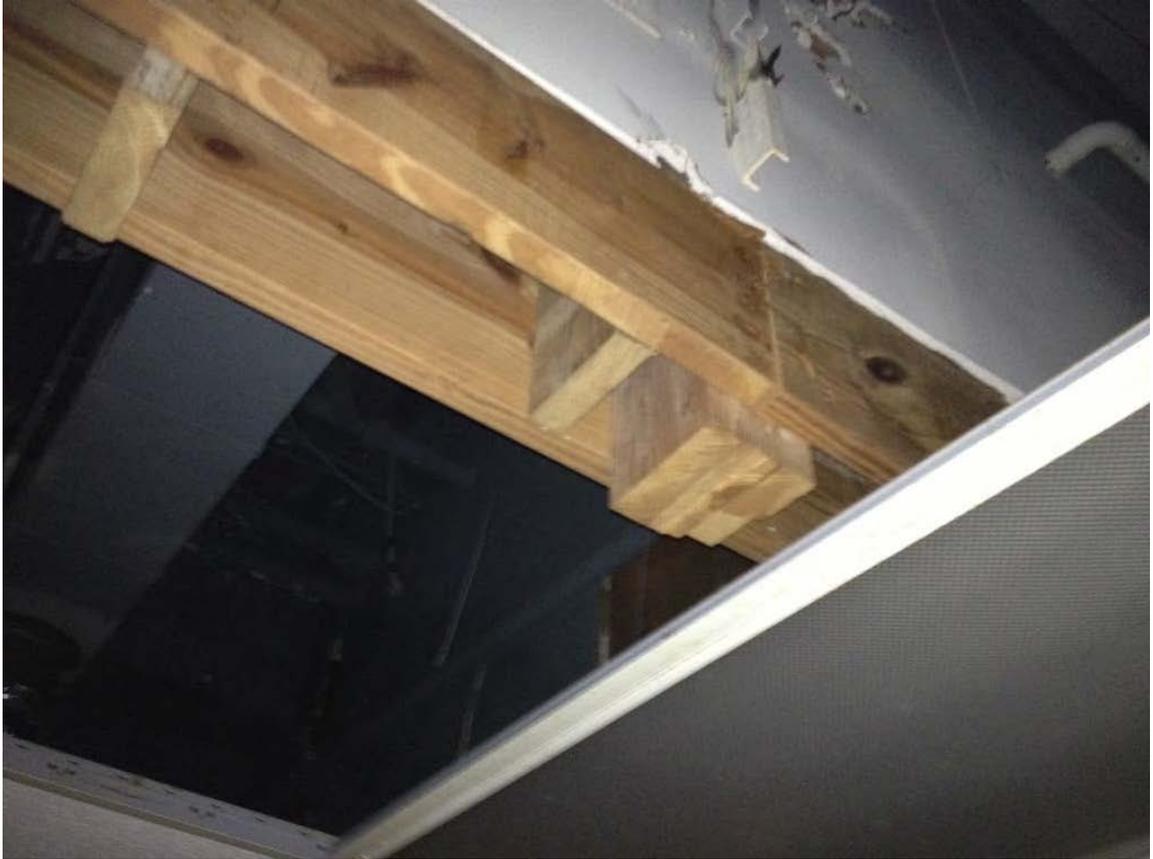
EXHIBIT 10

In general, the architectural finishes and non-structural ceiling framing have suffered the most from the elements (reference exhibits 10, 13,14, and 16). The Facility Manager for CMMC mentioned termite damage in the offices. We observed moisture damage to the floor underlayment and piles of debris built up in some of the rooms (room 202). Some rooms had contained corrosive chemicals (room 203) that may or may not have contributed to some of the concrete flaking.

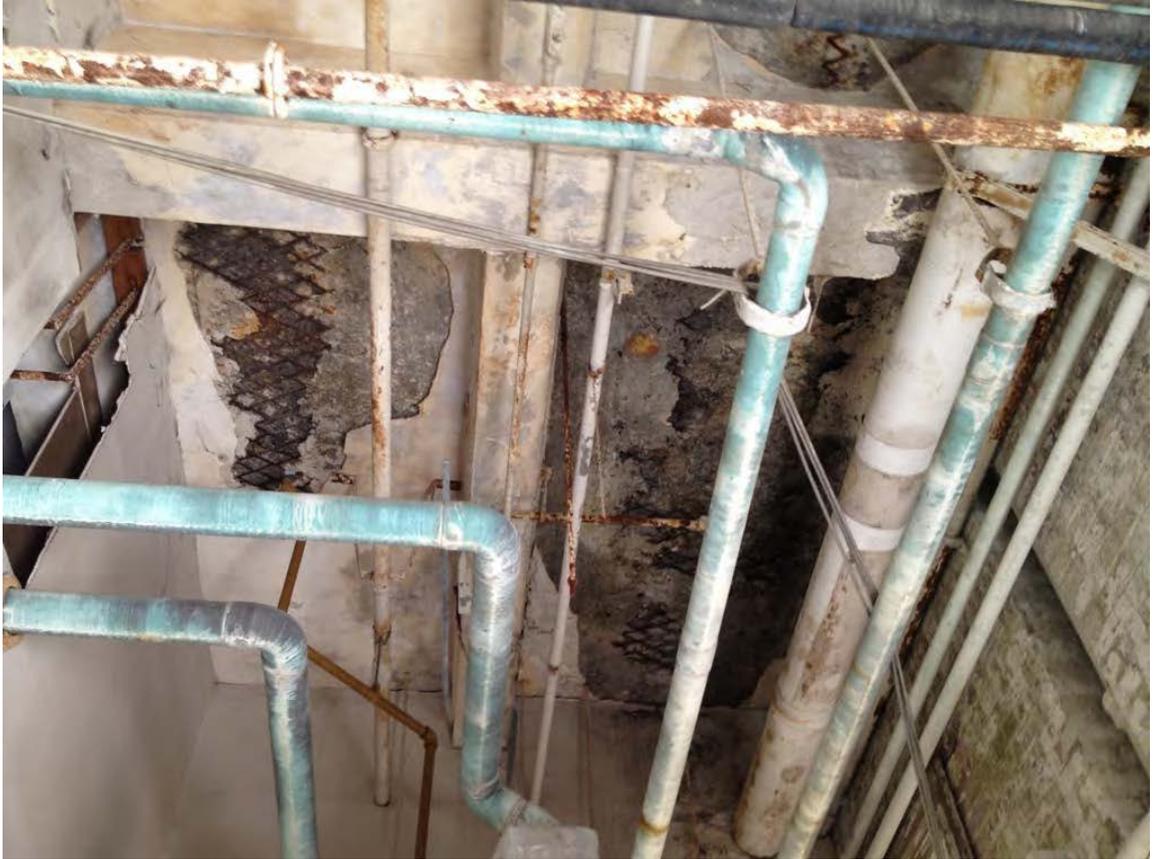
EXHIBIT 17

During our walk-through survey, we observed deferred maintenance issues and water intrusion issues. In addition, flaking of the underside of the concrete slab or plaster finish, it was difficult to tell, was noted and corroded reinforcing was exposed (reference exhibit 17).

Under room 203 and 206, flaking (reference exhibit 17) along the underside of the concrete slab was observed and appeared to be caused by moisture damage to the reinforcing. It was unclear during our visit if the damage was to the concrete or to the plaster finish. In either case, the wire mesh reinforcing was corroded. No significant cracking was observed in the elevated floor slabs.

Some rooms are filled with laboratory equipment (rooms 201 and 203 and 206). Some rooms are filled with debris from where the ceiling had collapsed (room 204). We recommend extreme caution if these rooms must be entered as the top of the floor slab could not be observed. We did observe the underside of the floor slab and noted flaking of the concrete or plaster under rooms 203 and 206. Because of the uncertainty in these rooms, we recommend a limited number of people (2 to 3) be used to remove any equipment. However, shoring of the floor system should not be required. Heavy equipment (over 250 lbs) should be broken down into smaller components to limit the load on the floor and stairs.

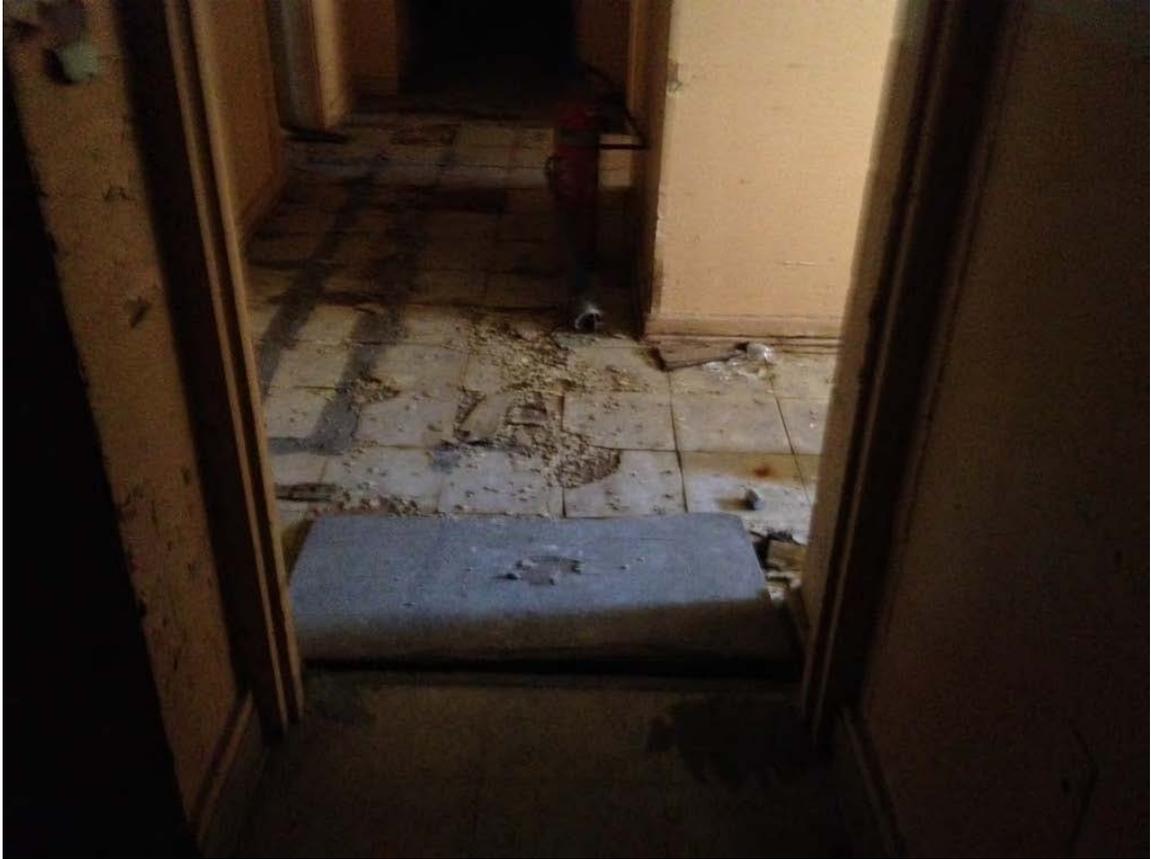
EXHIBIT 18

We did not observe the Boiler House (reference exhibit 18). However, the floor finishes appeared to be more deteriorated than the main building.

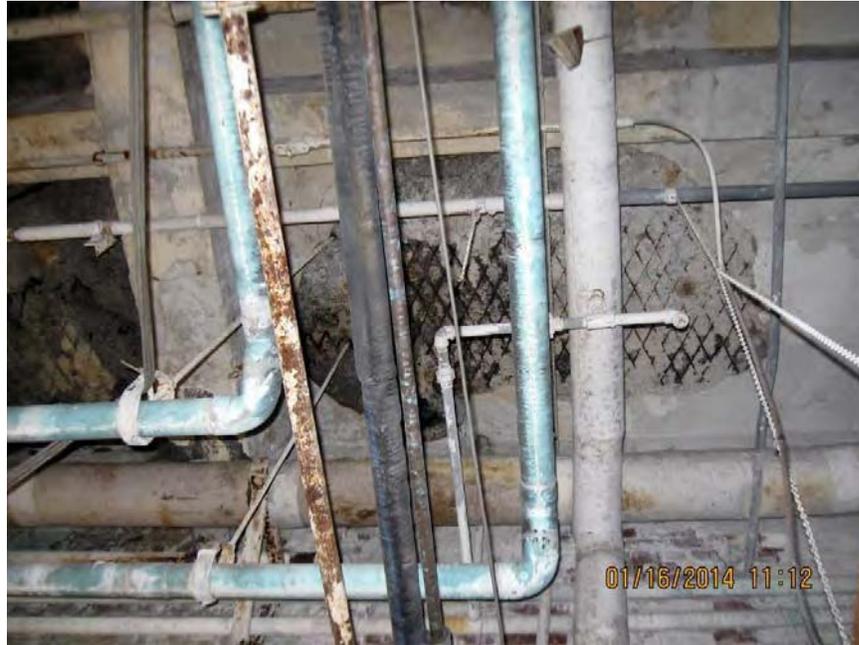
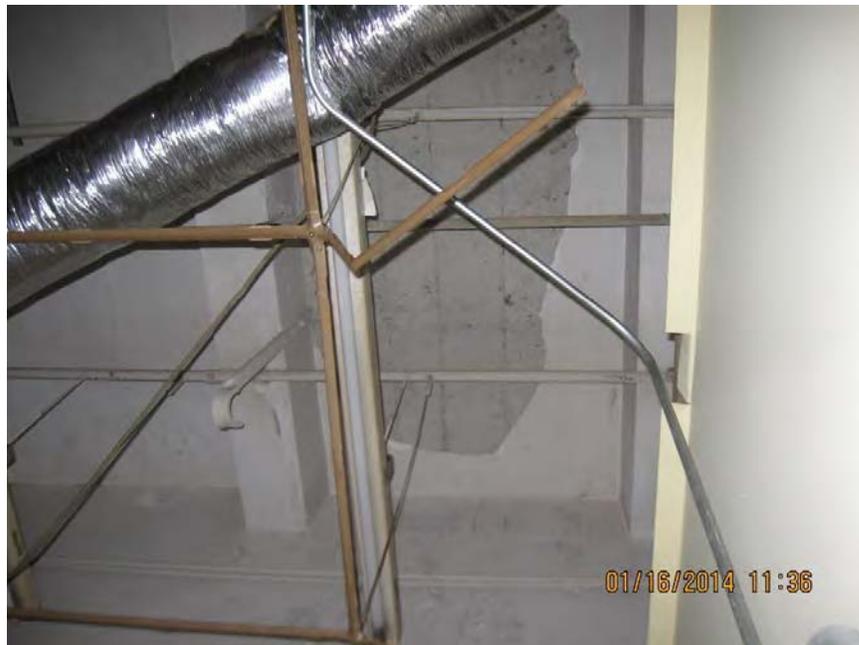
In rooms 201 and 203, significant damage due to water intrusion was observed. These rooms are more or less over the damaged plaster finish observed in the top picture on the previous page. Due to the uncertainty in this area, we recommend limiting the number of people (2 to 3) inside to remove equipment. We do not recommend allowing heavy equipment in these rooms.

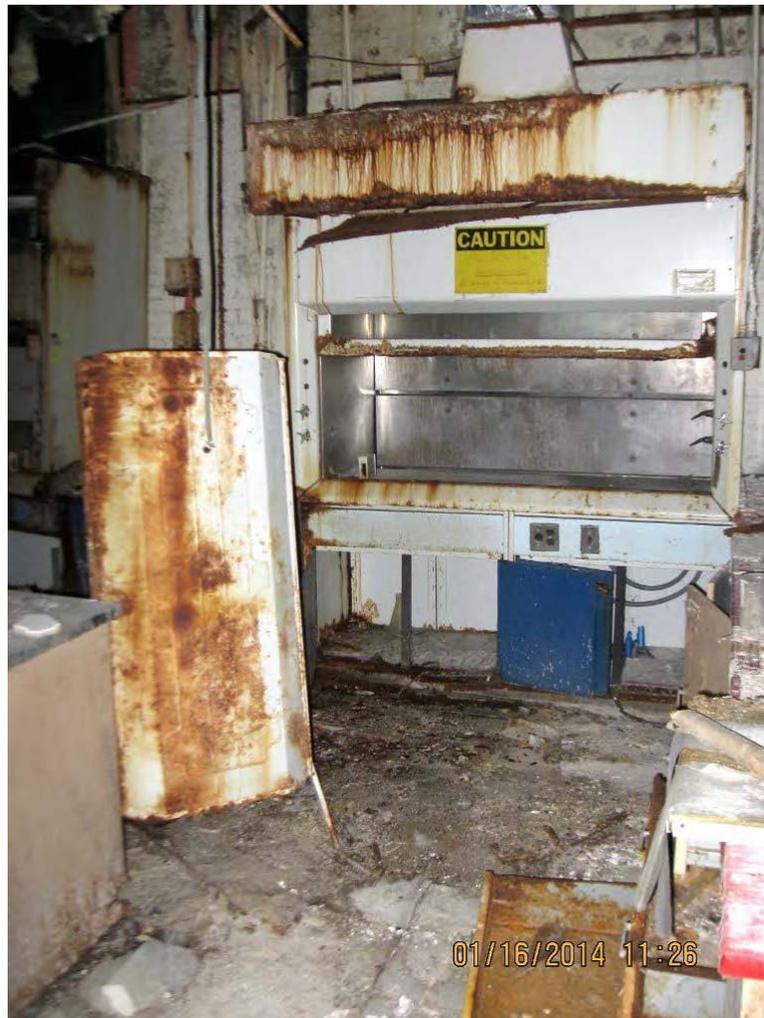
In room 202, significant damage due to water intrusion was observed. Due to the uncertainty in this area, we recommend limiting the number of people (2 to 3) inside to remove equipment. We do not recommend allowing heavy equipment in this room.
