**FRIABLE AND DAMAGED FRIABLE ASBESTOS-CONTAINING  
MATERIALS SURVEY AT THE  
CHARLESTON NAVAL SHIPYARD  
CHARLESTON, SOUTH CAROLINA**

**CONTRACT NUMBER N62467-00-D-0345**

**SEPTEMBER 2000**

**Friable and Damaged Friable Asbestos-Containing Materials Survey for  
Buildings 81, 86, 141, 180, 199, 220, 658, 1079, 1509, 1777, 1884, 1886,  
1892, NS67, and NS675 at Charleston Naval Shipyard  
Charleston, South Carolina**

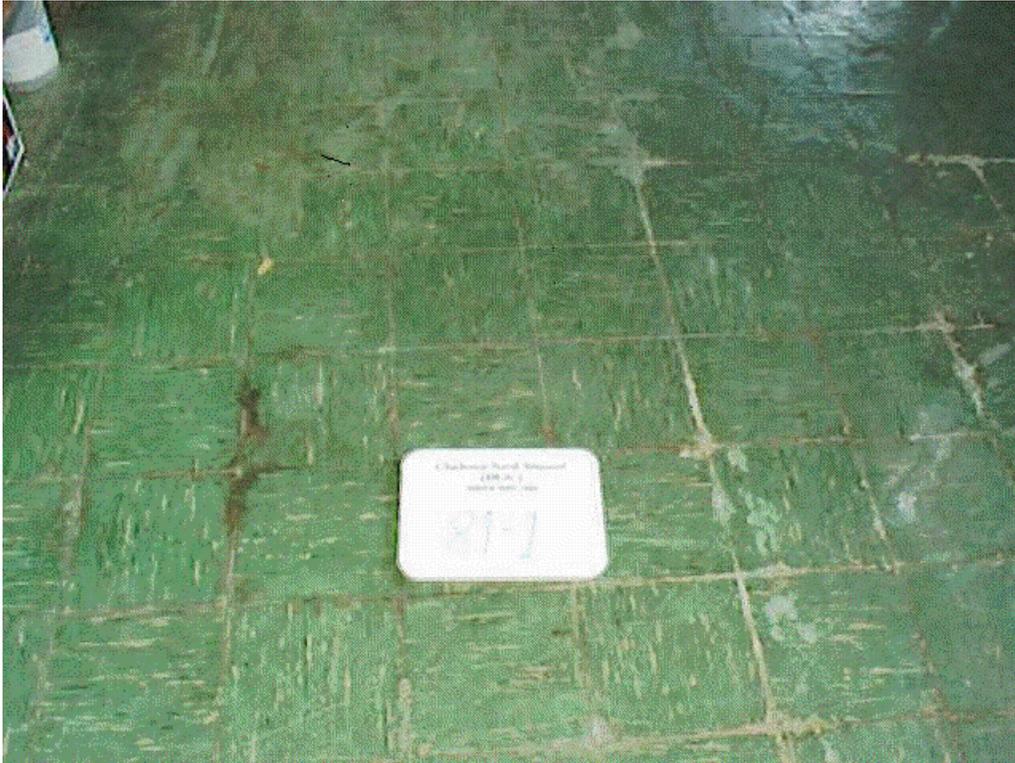
HA #	Material Description	Material Location	ACM (YES/NO)
1	Damaged 9"x9" floor tile and mastic, green	101	YES

<b>HA#</b>	<b>Material Description</b>	<b>Damage Location</b>	<b>Damage Quantity</b>	<b>Abatement Response Action</b>
1	9"x9" floor tile and mastic, green	101	230 SF	Remove/replace
3	Window putty	Interior windows	650 LF	Remove/replace

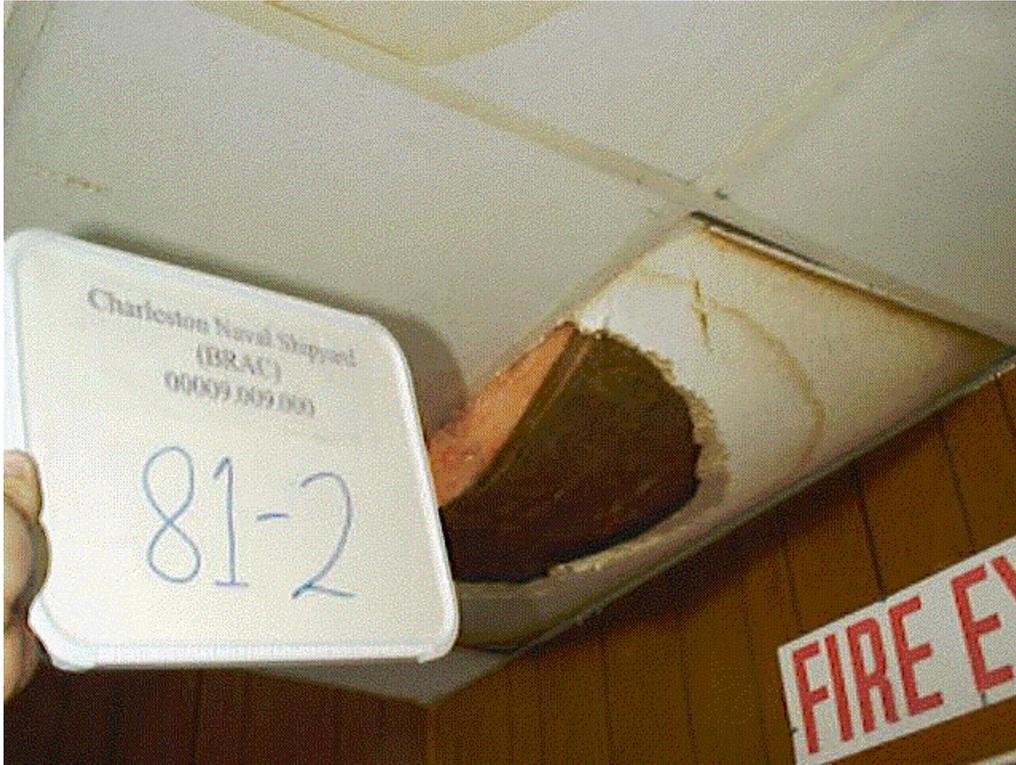
HA #	Material Description	Material Location	ACM (YES/NO)
2	2'x4' ceiling tile, pinhole	101, 107	NO

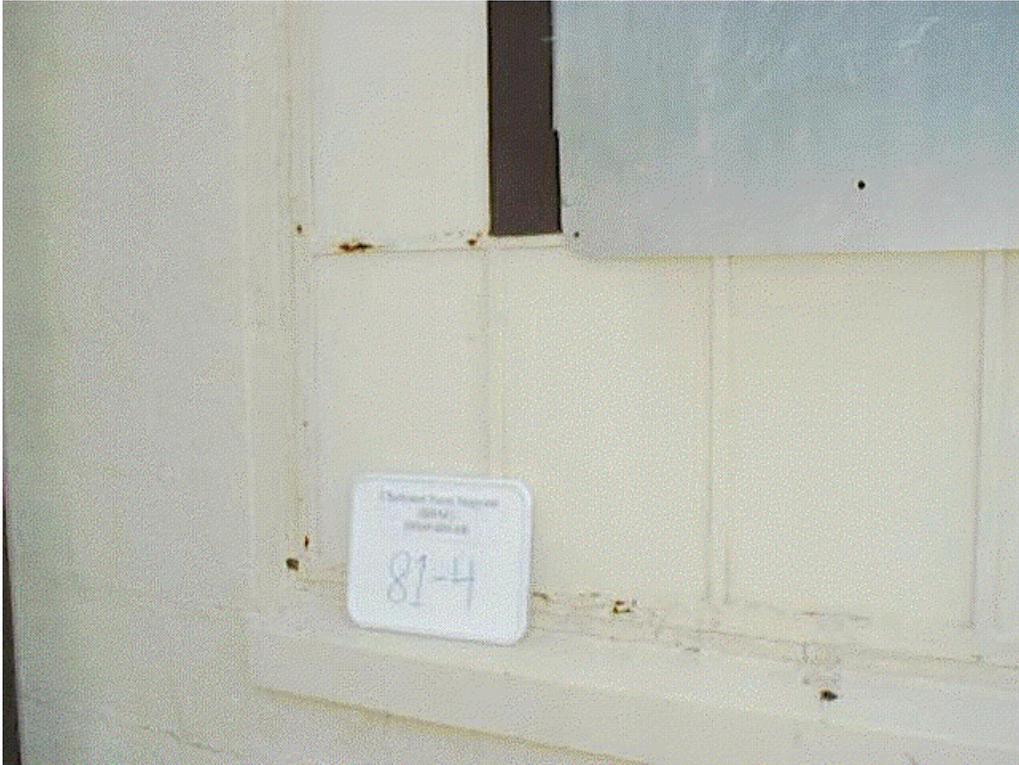
HA #	Material Description	Material Location	ACM (YES/NO)
4	Damaged window caulk	Exterior windows	NO

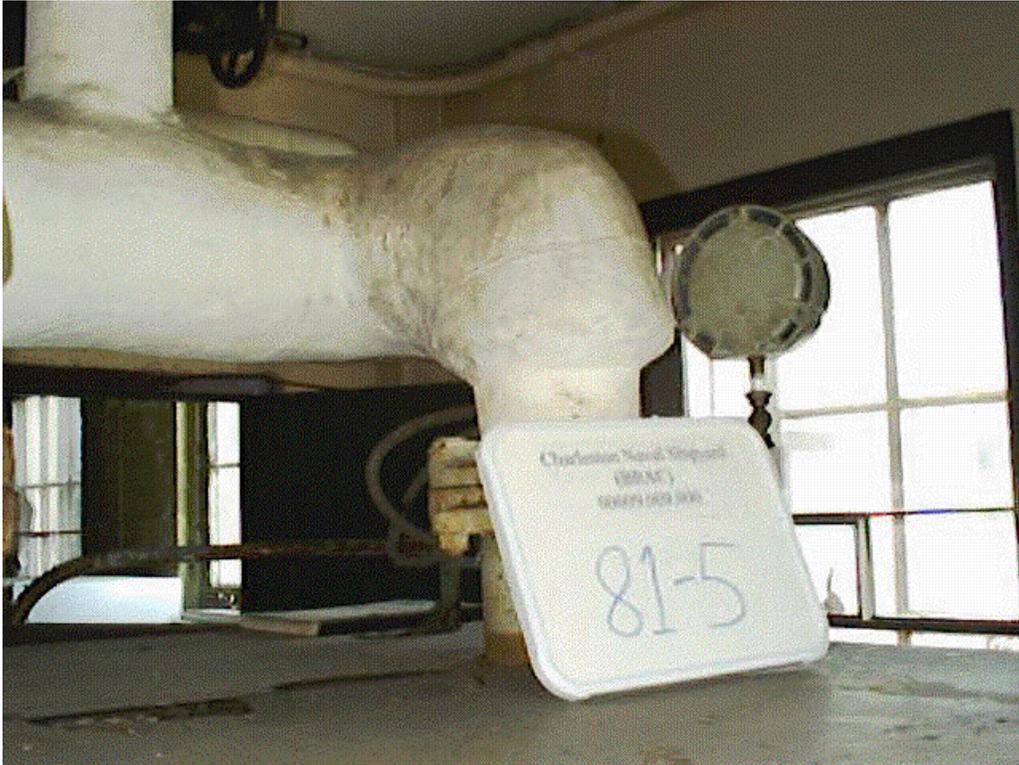
HA #	Material Description	Material Location	ACM (YES/NO)
5	Pipe fitting insulation on steam lines	103	YES

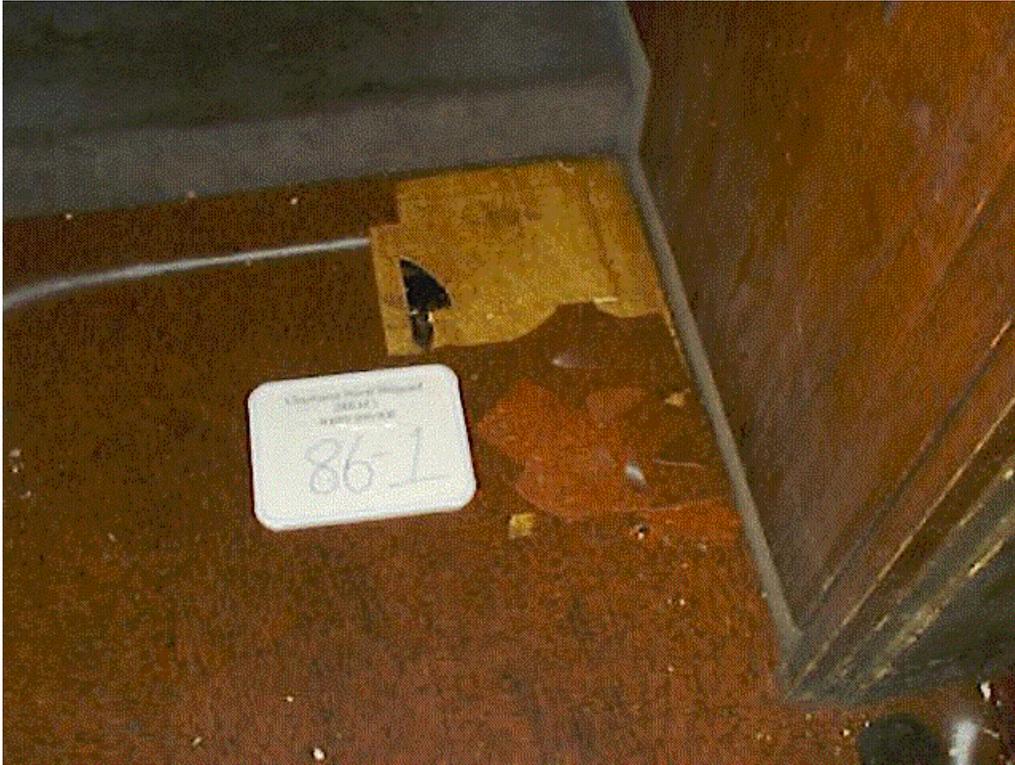
HA #	Material Description	Material Location	ACM (YES/NO)
1	Damaged 9"x9" floor tile and mastic, white	100A	YES

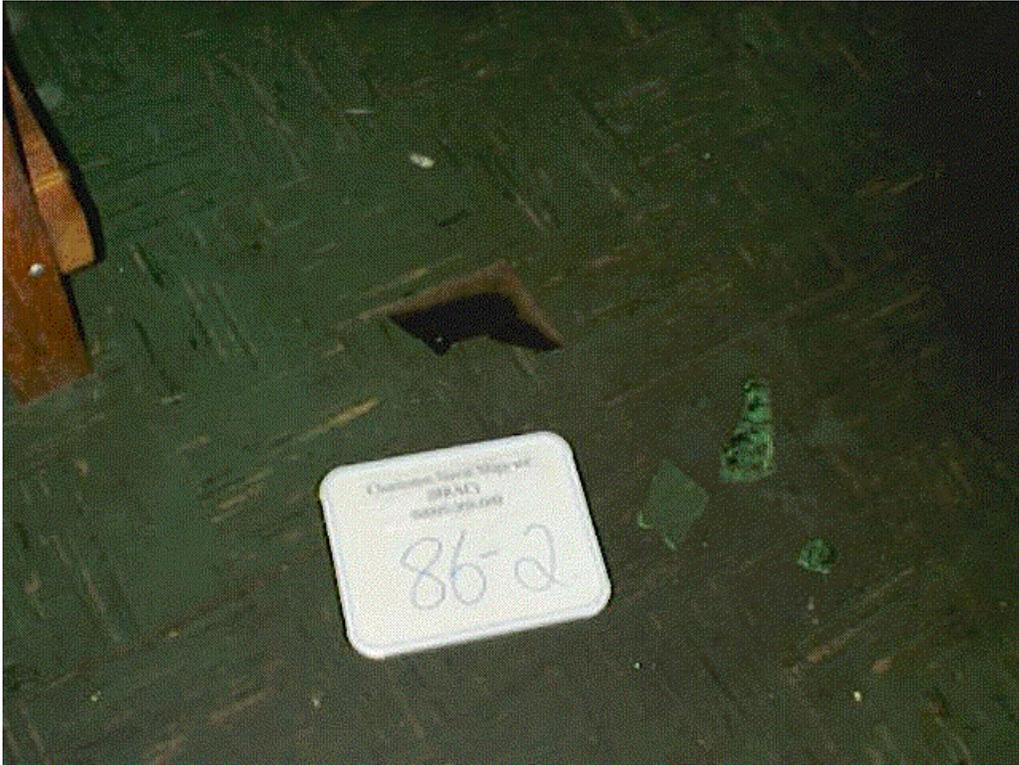
HA #	Material Description	Material Location	ACM (YES/NO)
2	Damaged 9"x9" floor tile and mastic, green	A1	YES

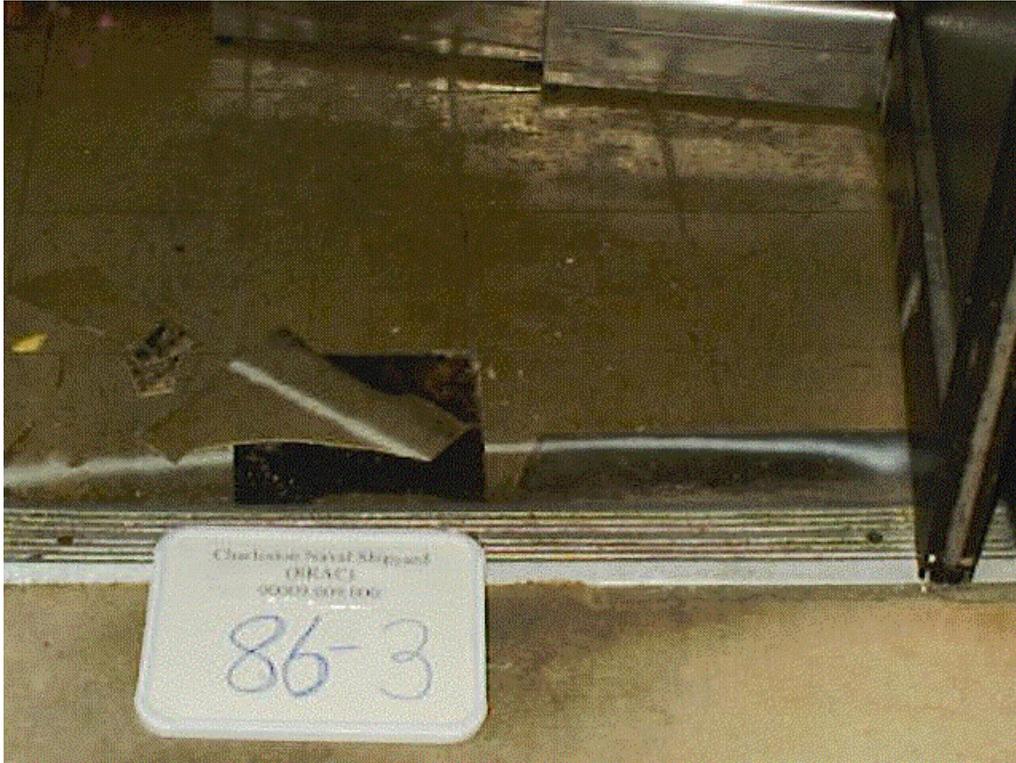
HA #	Material Description	Material Location	ACM (YES/NO)
3	Damaged 9"x9" floor tile and mastic, tan	C3	YES

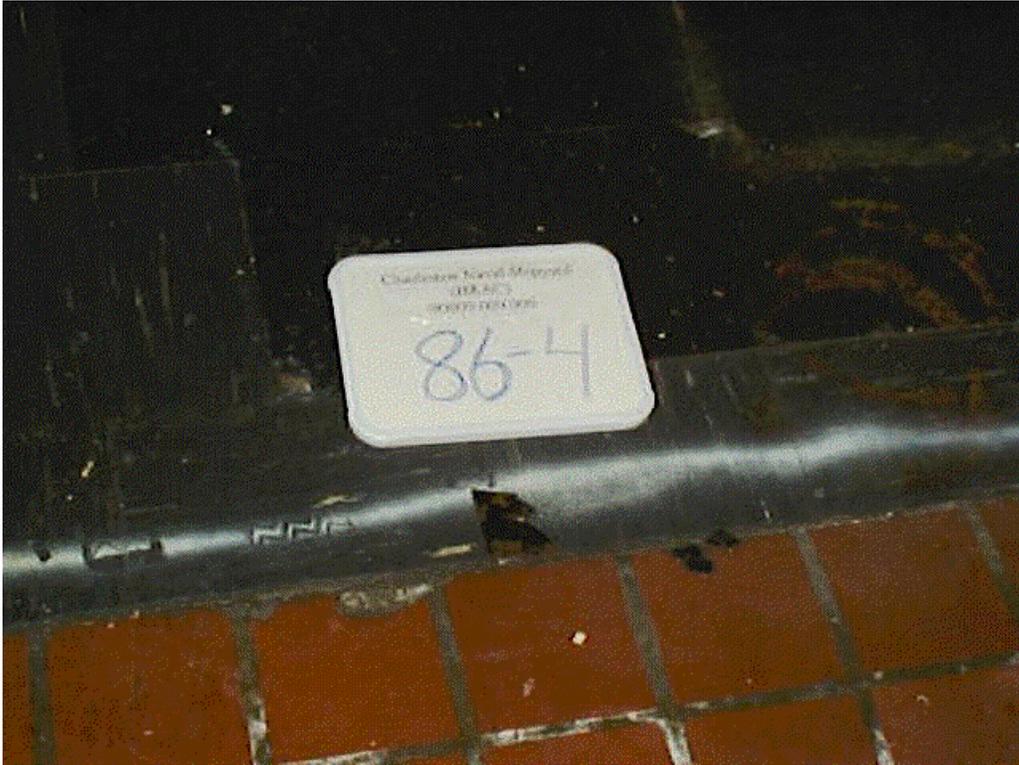
HA #	Material Description	Material Location	ACM (YES/NO)
4	Damaged 12"x12" floor tile and mastic, brown	102	YES

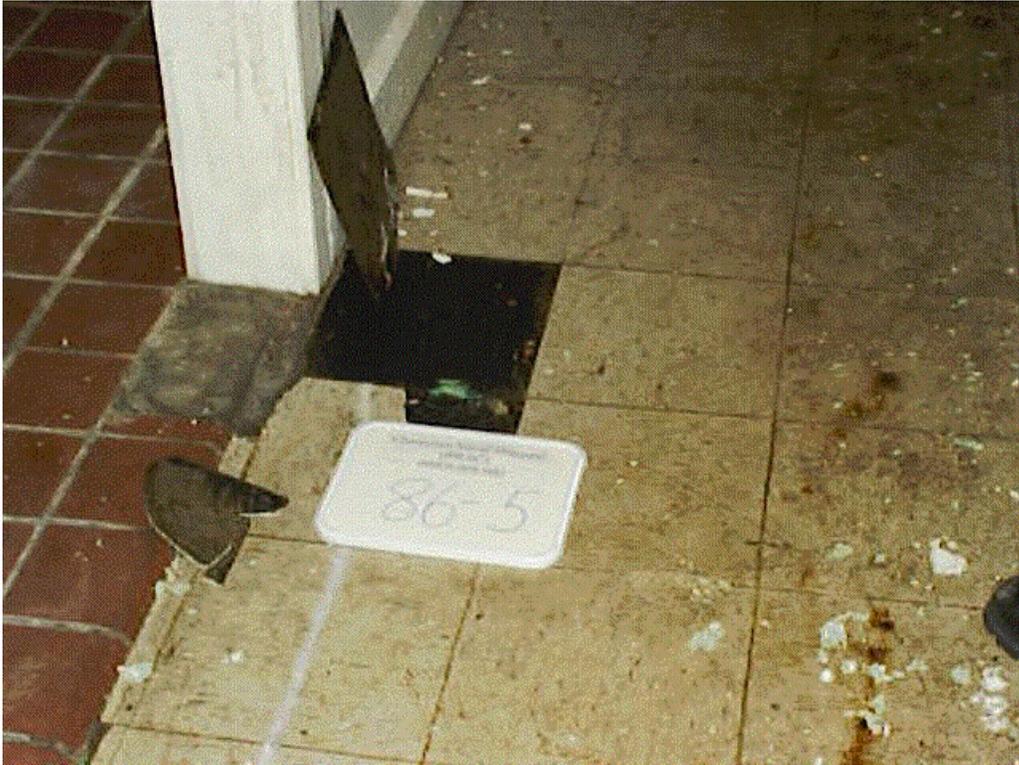
HA #	Material Description	Material Location	ACM (YES/NO)
5	Damaged 12"x12" floor tile and mastic, white w/ black spots	B1, C5	YES

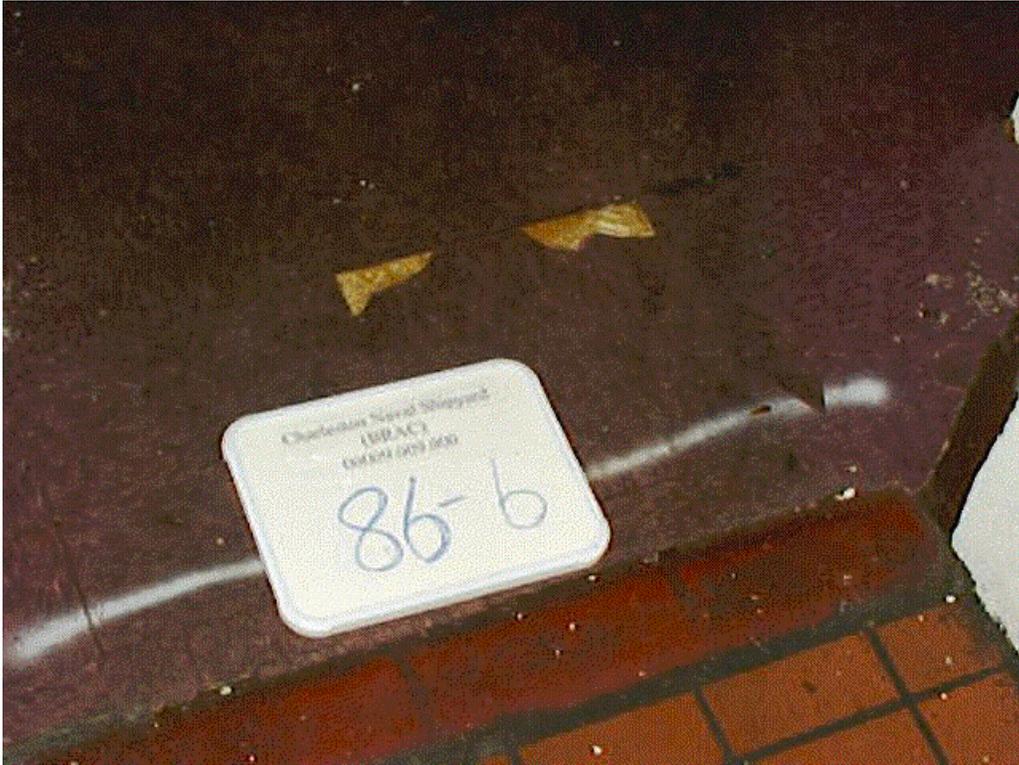
HA #	Material Description	Material Location	ACM (YES/NO)
6	Damaged 12"x12" floor tile and mastic, brick red	100A, 103	NO

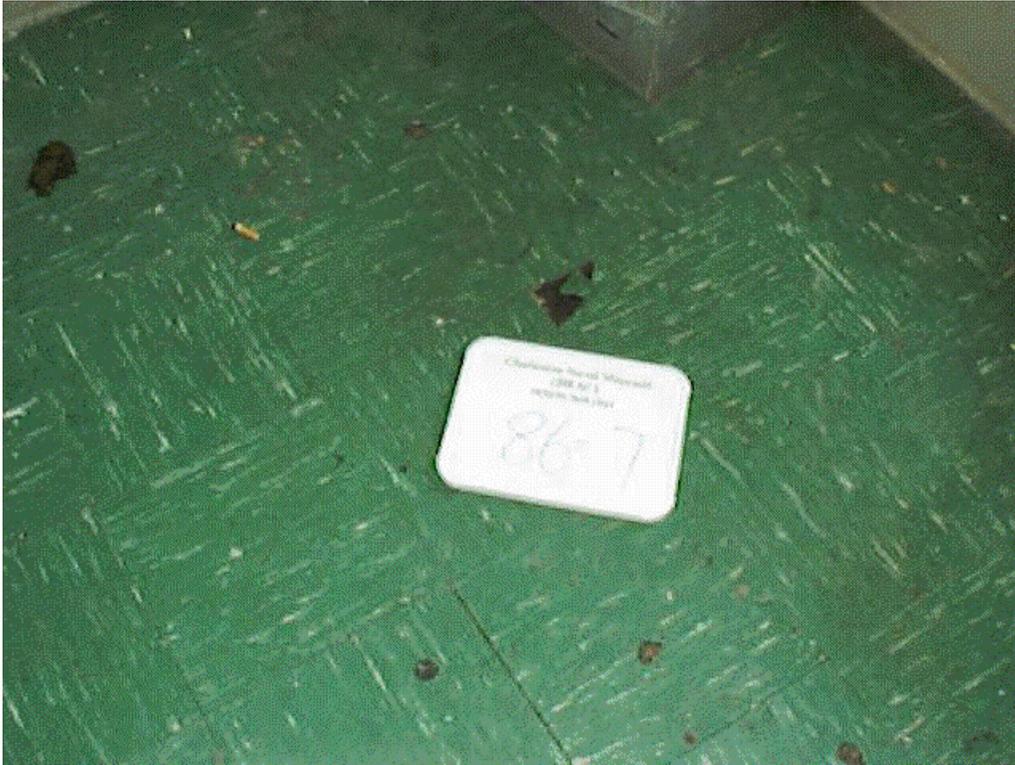
HA #	Material Description	Material Location	ACM (YES/NO)
7	Damaged 12"x12" floor tile and mastic, green w/ white streaks	A3	YES

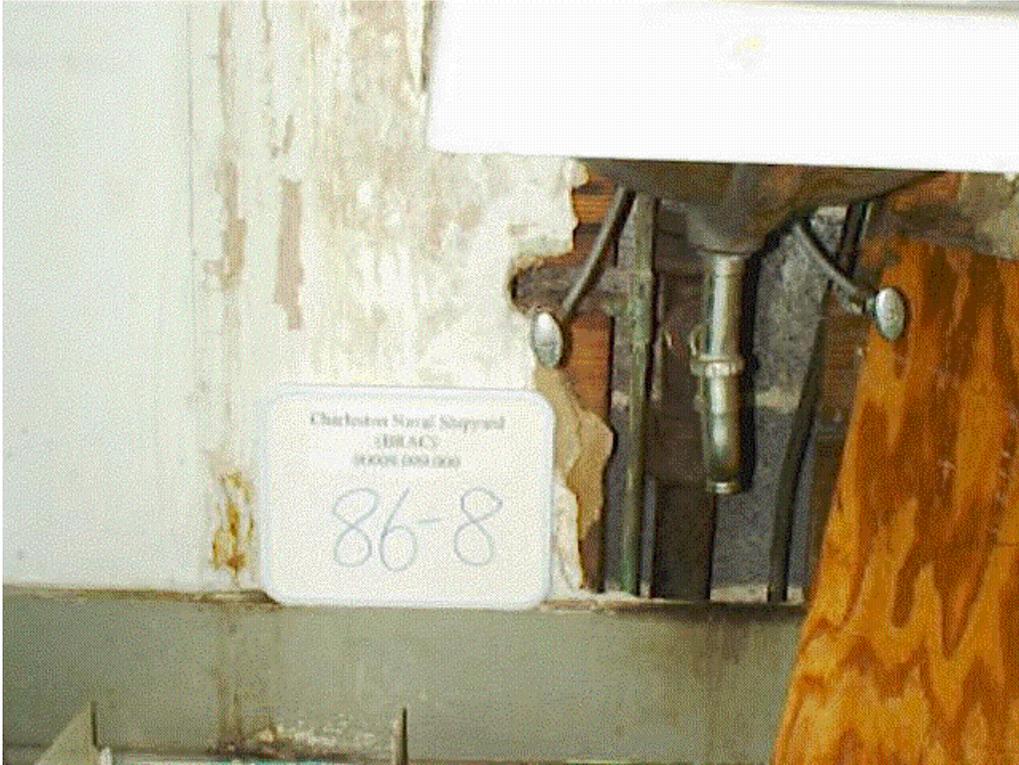
HA #	Material Description	Material Location	ACM (YES/NO)
8	Damaged joint compound associated with gypsum wallboard	A3, 102	YES

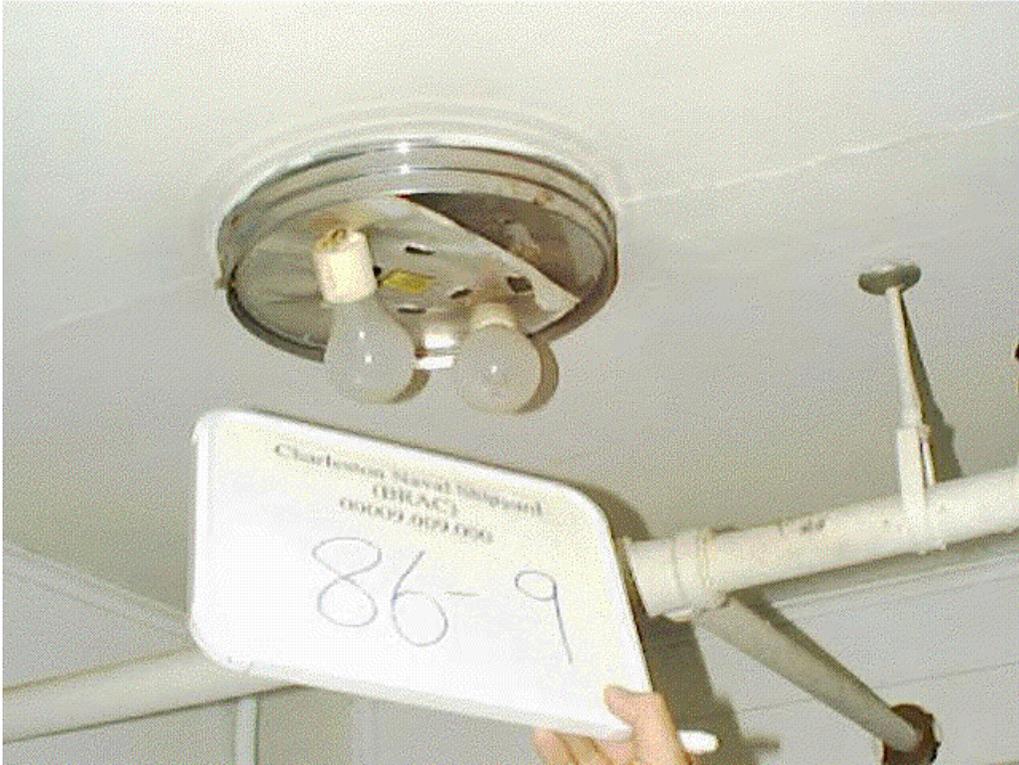
HA #	Material Description	Material Location	ACM (YES/NO)
9	Light fixture insulation	A2, 104	YES

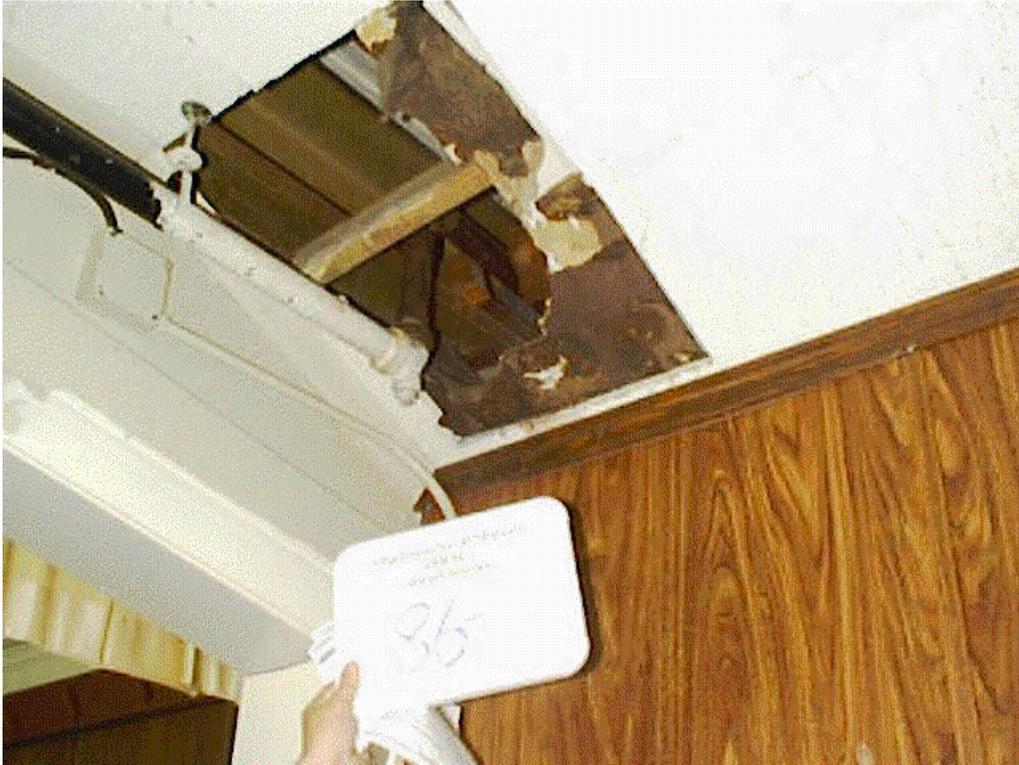
HA #	Material Description	Material Location	ACM (YES/NO)
15	Damaged joint compound associated with gypsum ceiling	116, C1	YES

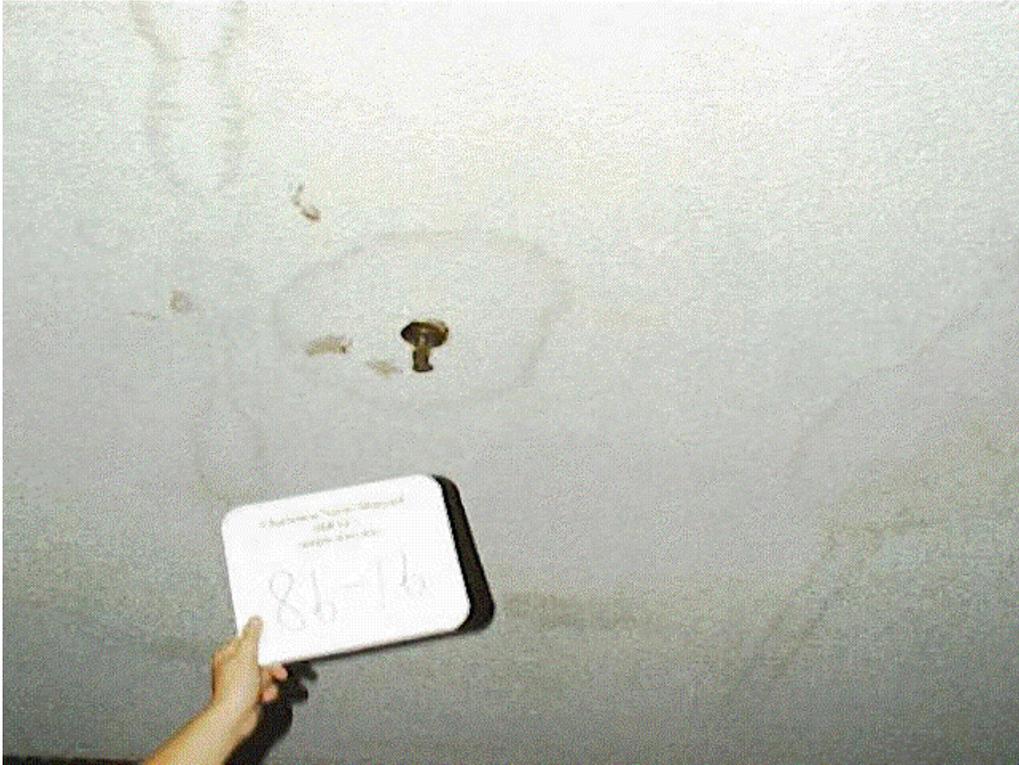
16	Spray-applied ceiling material	100A, 120	Surf	600 SF	Damaged

HA #	Material Description	Material Location	ACM (YES/NO)
16	Damaged spray- applied ceiling material	100A, 120	YES

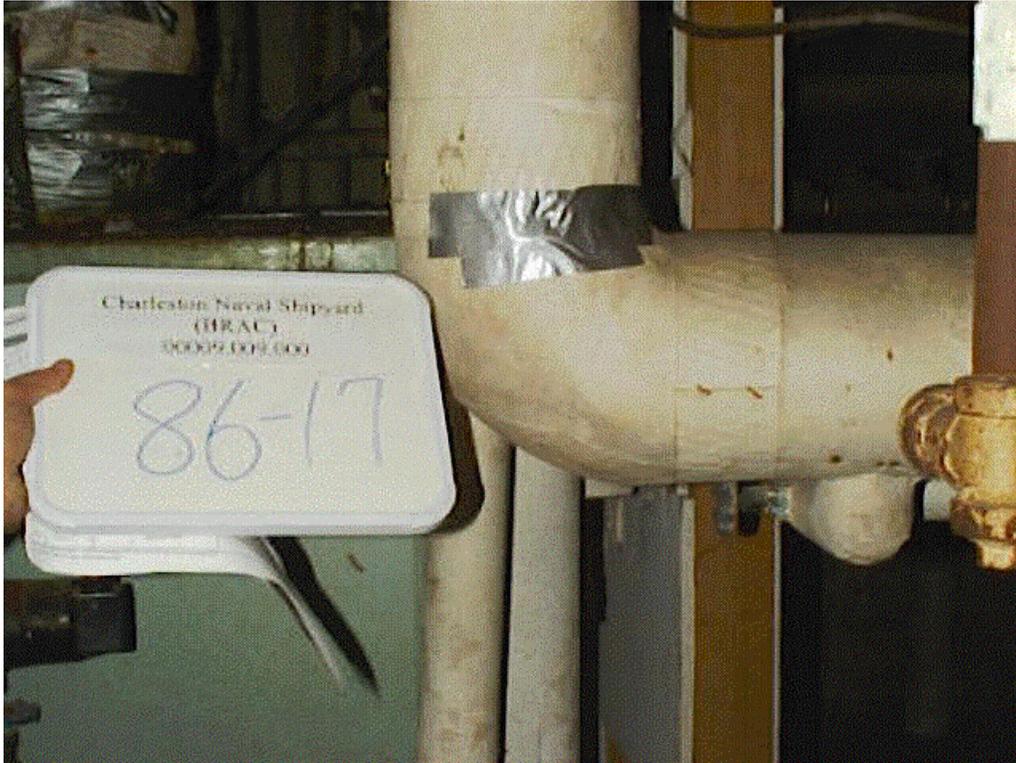
HA #	Material Description	Material Location	ACM (YES/NO)
17	Pipe fitting insulation on steam lines	M1	NO

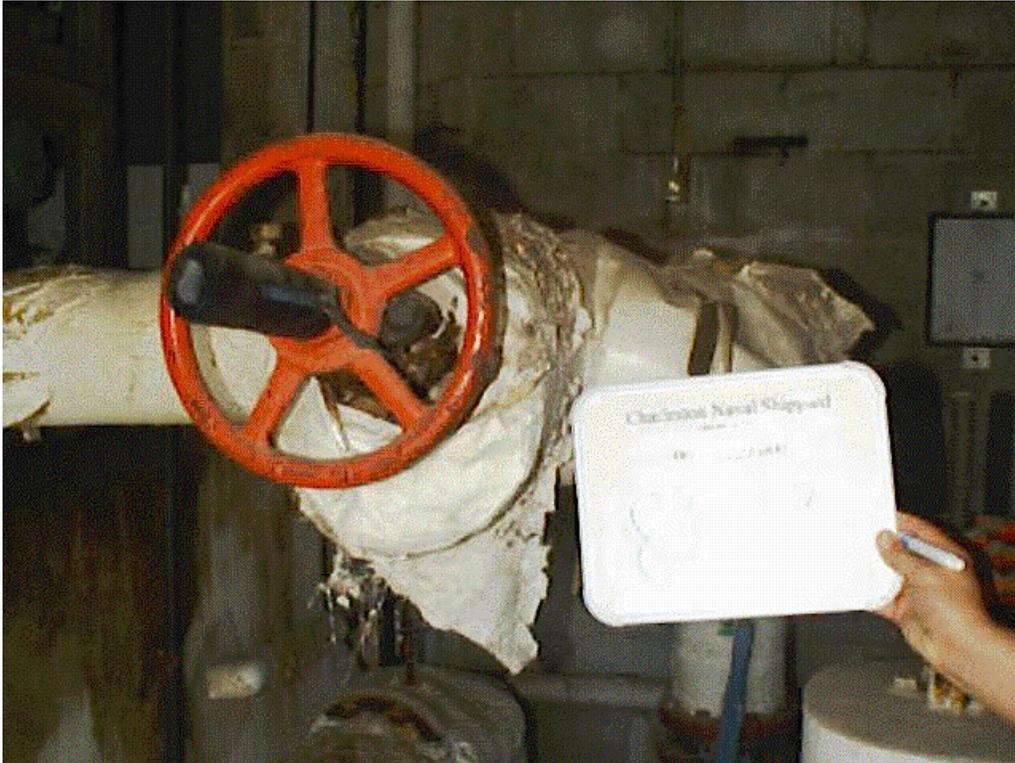
HA #	Material Description	Material Location	ACM (YES/NO)
19	Damaged capping insulation on chilled water lines	105	NO

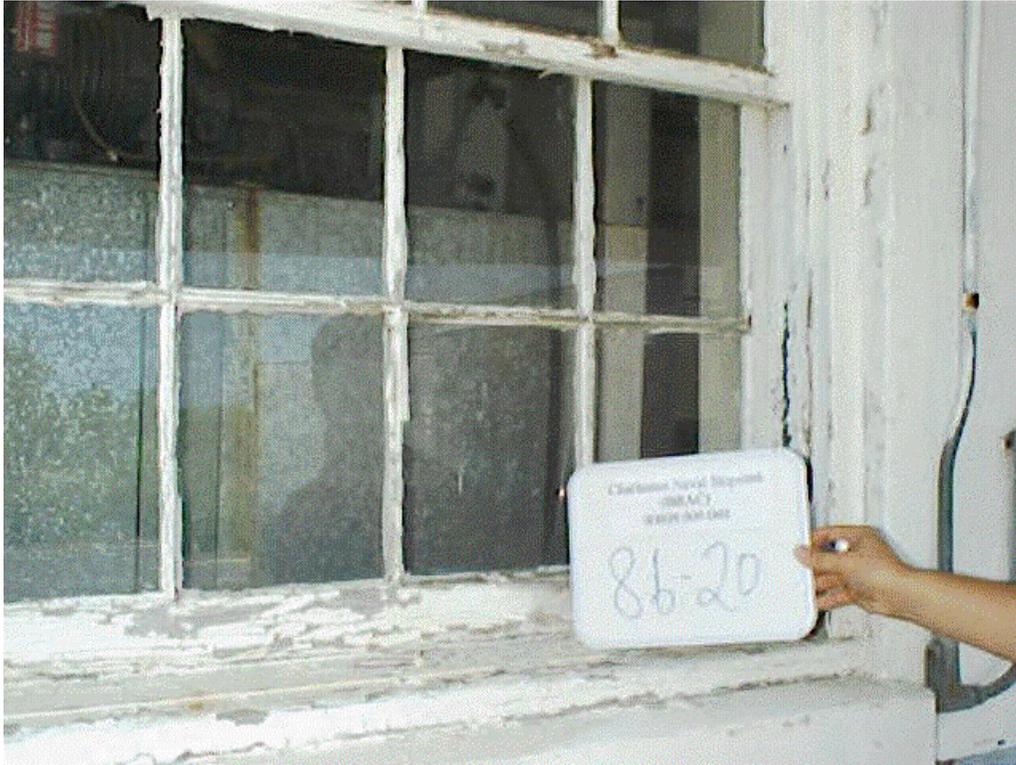
HA #	Material Description	Material Location	ACM (YES/NO)
20	Damaged window putty	Exterior windows	YES

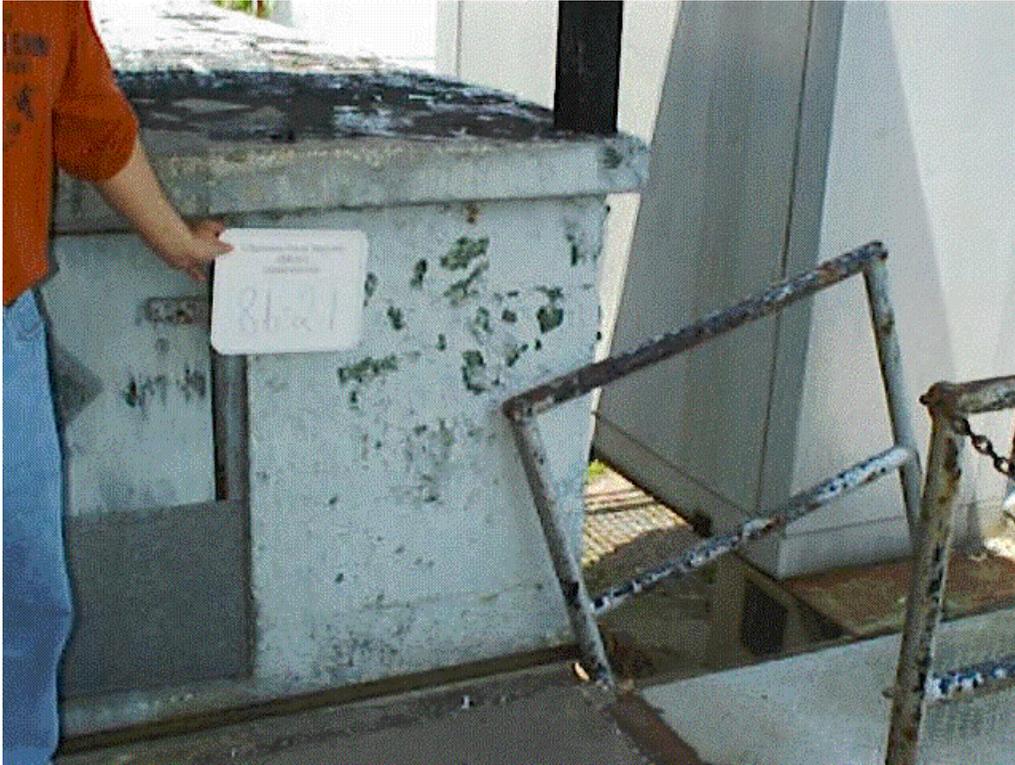
HA #	Material Description	Material Location	ACM (YES/NO)
21	Damaged silver paint	106	NO

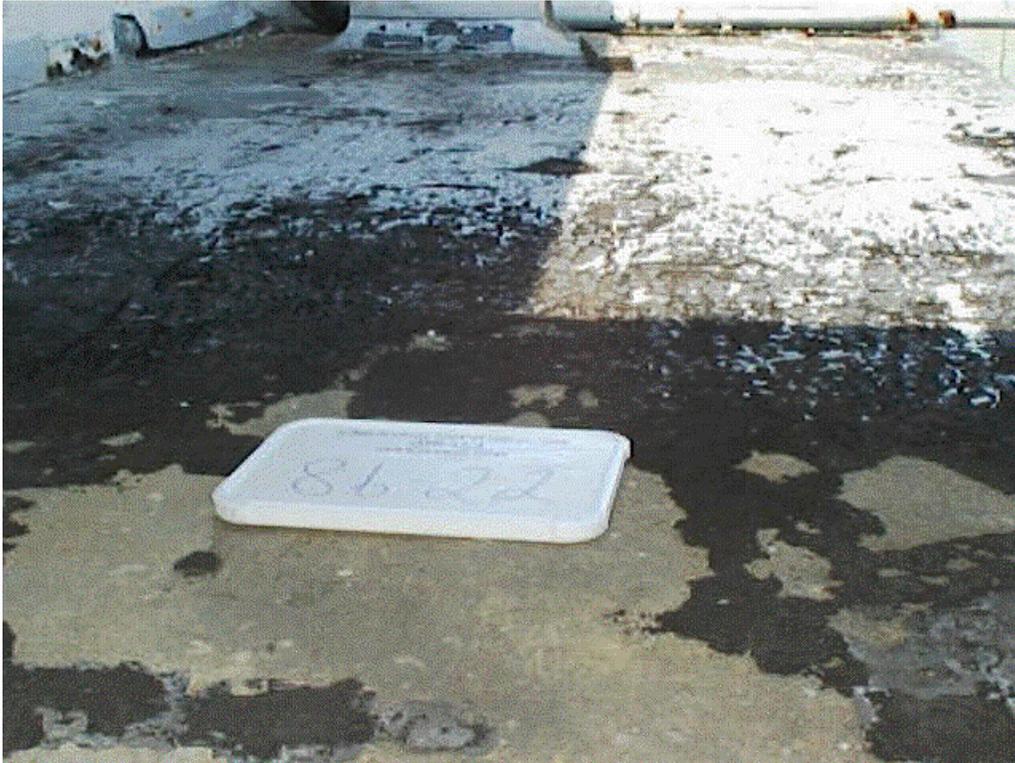
HA #	Material Description	Material Location	ACM (YES/NO)
22	Damaged roofing material	Roof	YES

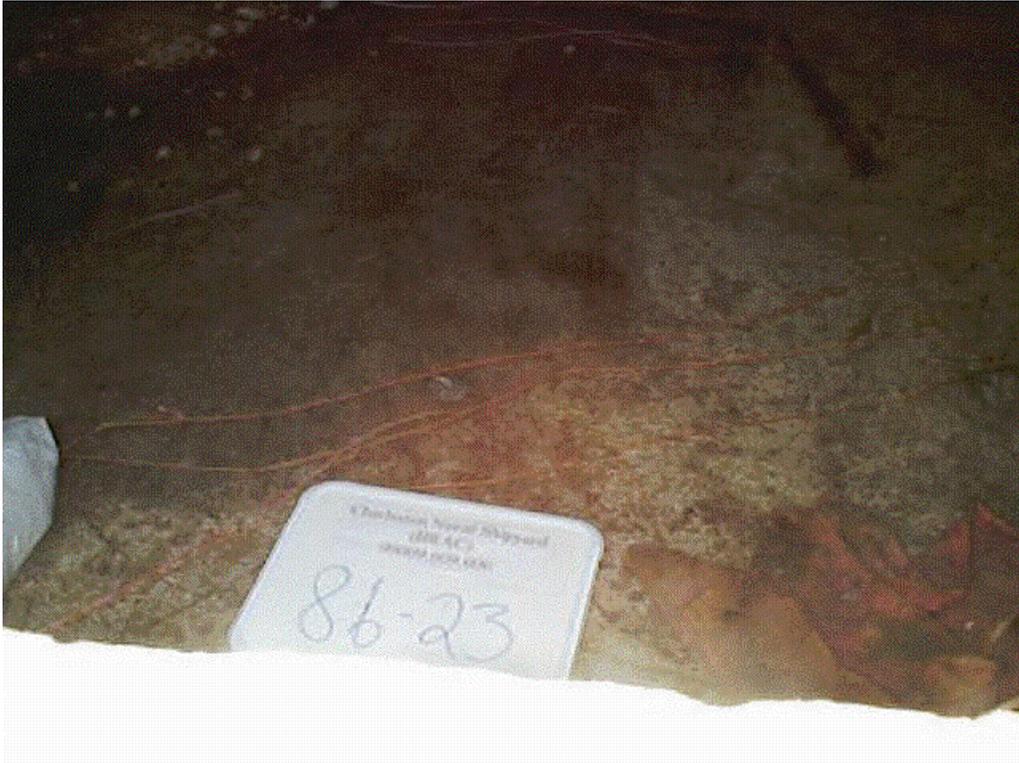
HA #	Material Description	Material Location	ACM (YES/NO)
23	Contaminated soil	Crawlspace	YES

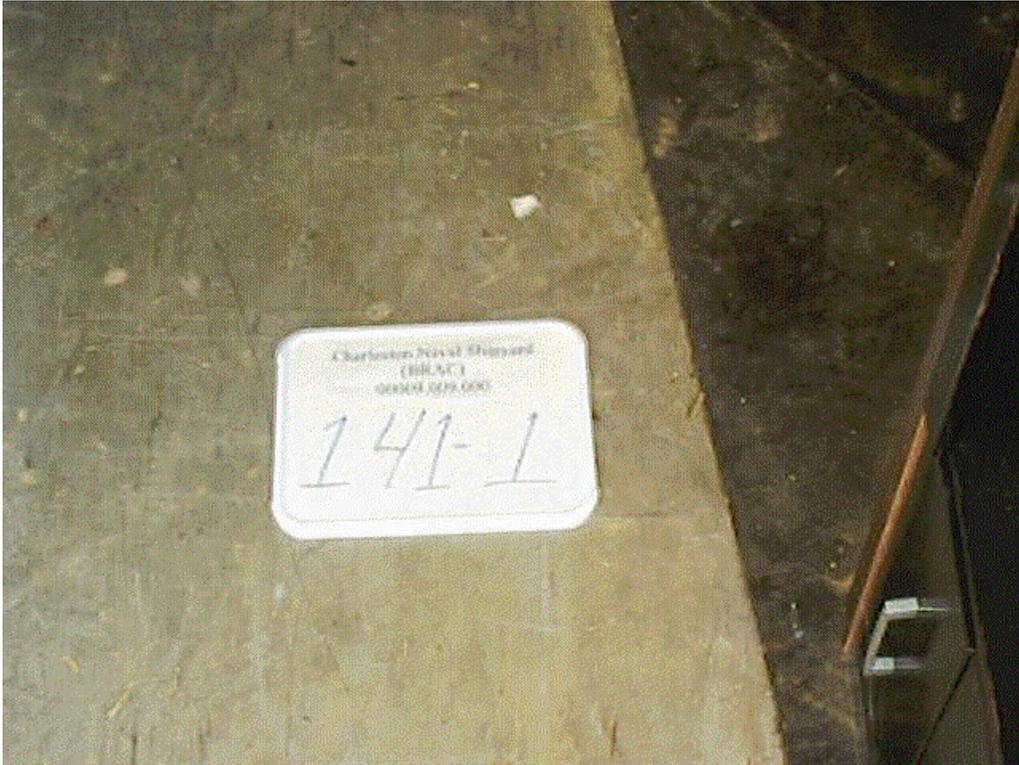
HA #	Material Description	Material Location	ACM (YES/NO)
1	Damaged 9"x9" floor tile and mastic, grey	100	YES

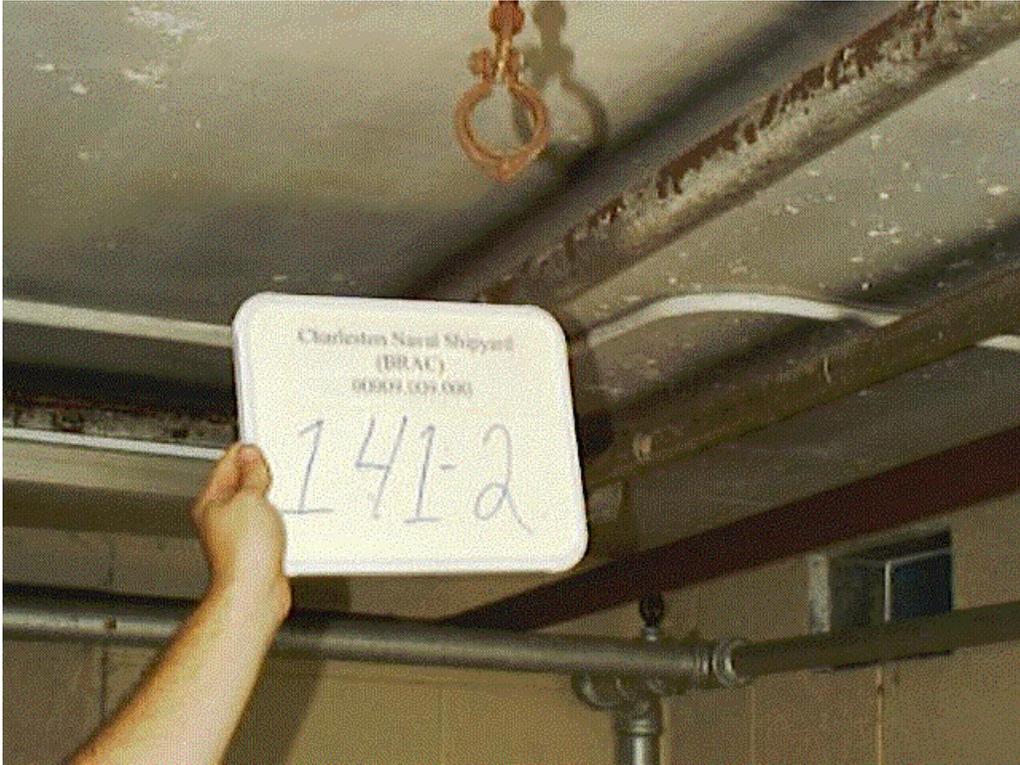
HA #	Material Description	Material Location	ACM (YES/NO)
2	Damaged silver paint	100	NO

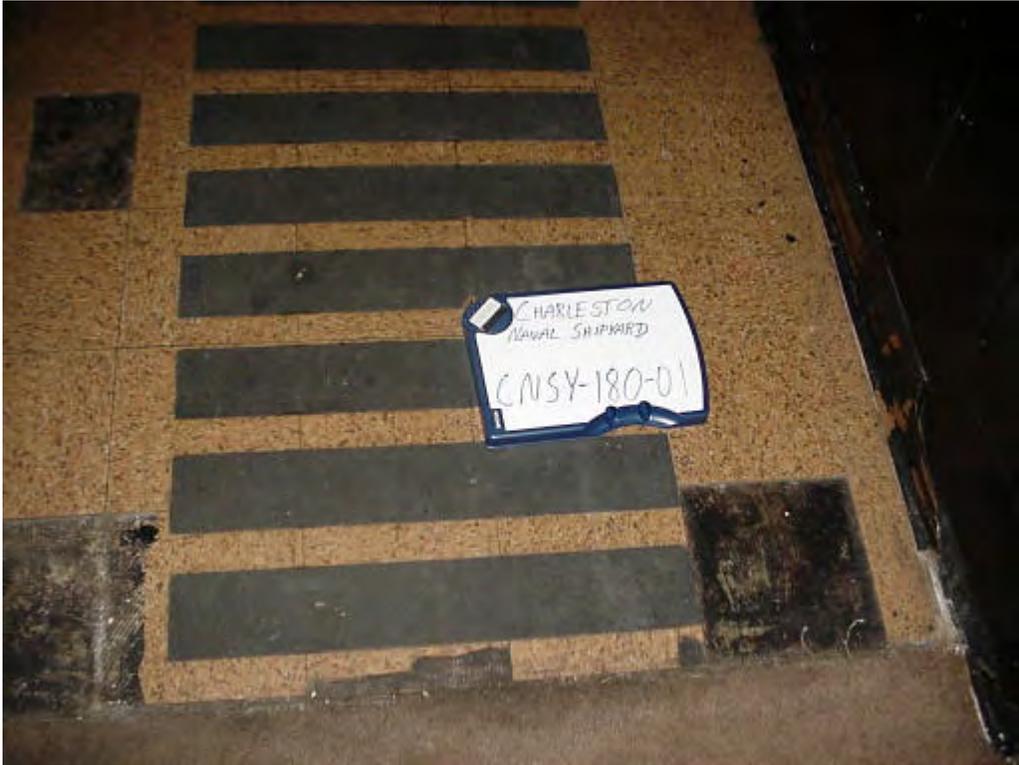
HA #	Material Description	Material Location	ACM (YES/NO)
1	Damaged 9" x 9" floor tile and mastic, orange w/ brown smudges	S1, S2, 206	Yes

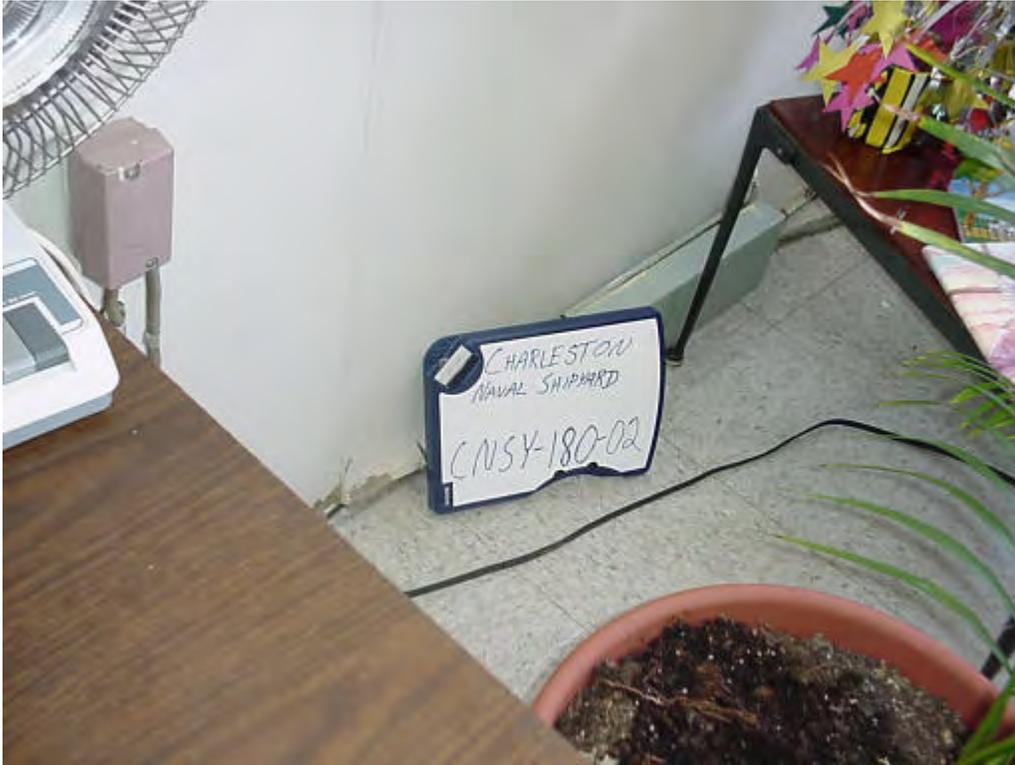
HA #	Material Description	Material Location	ACM (YES/NO)
2	Damaged joint compound with associated gypsum wallboard	Storage 3, Office 30	No

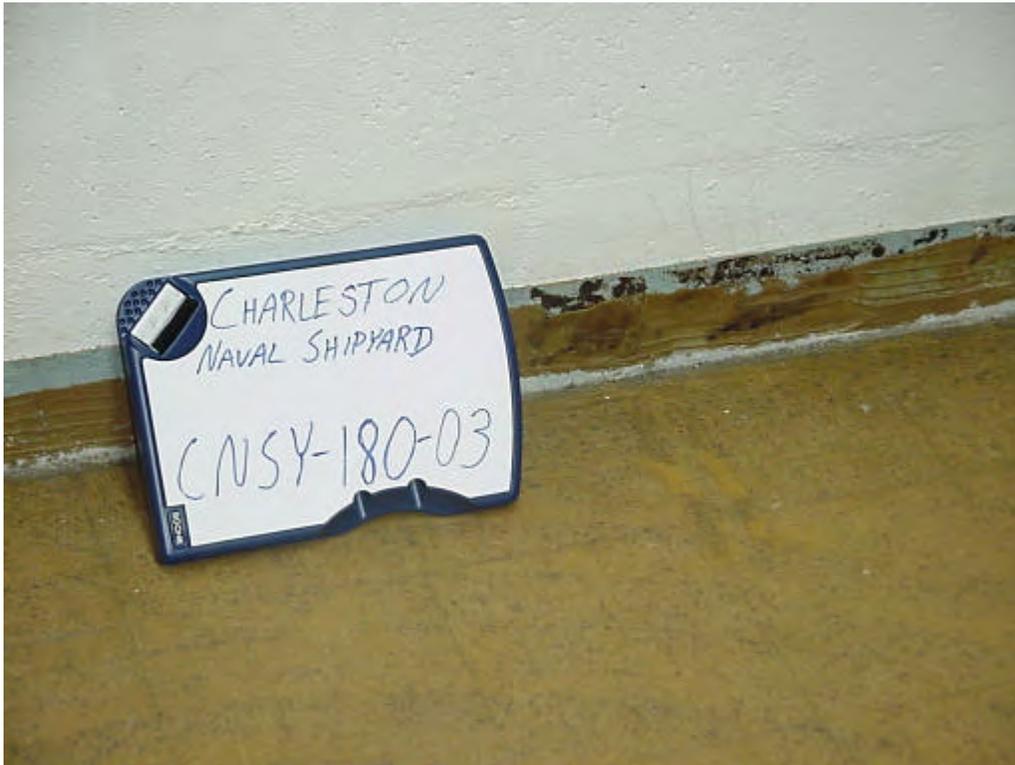
HA #	Material Description	Material Location	ACM (YES/NO)
3	Damaged residual base cove mastic	Closet 1, various rooms (2 <sup>nd</sup> floor)	No

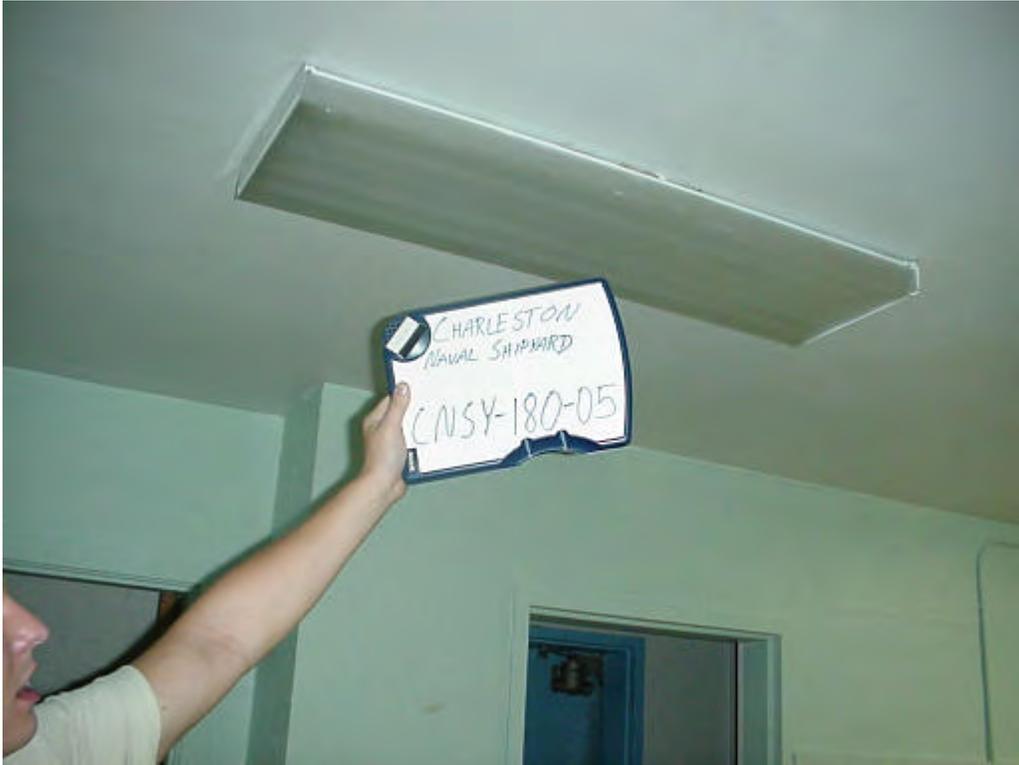
HA #	Material Description	Material Location	ACM (YES/NO)
5	Damaged plaster ceiling	Storage 4	No

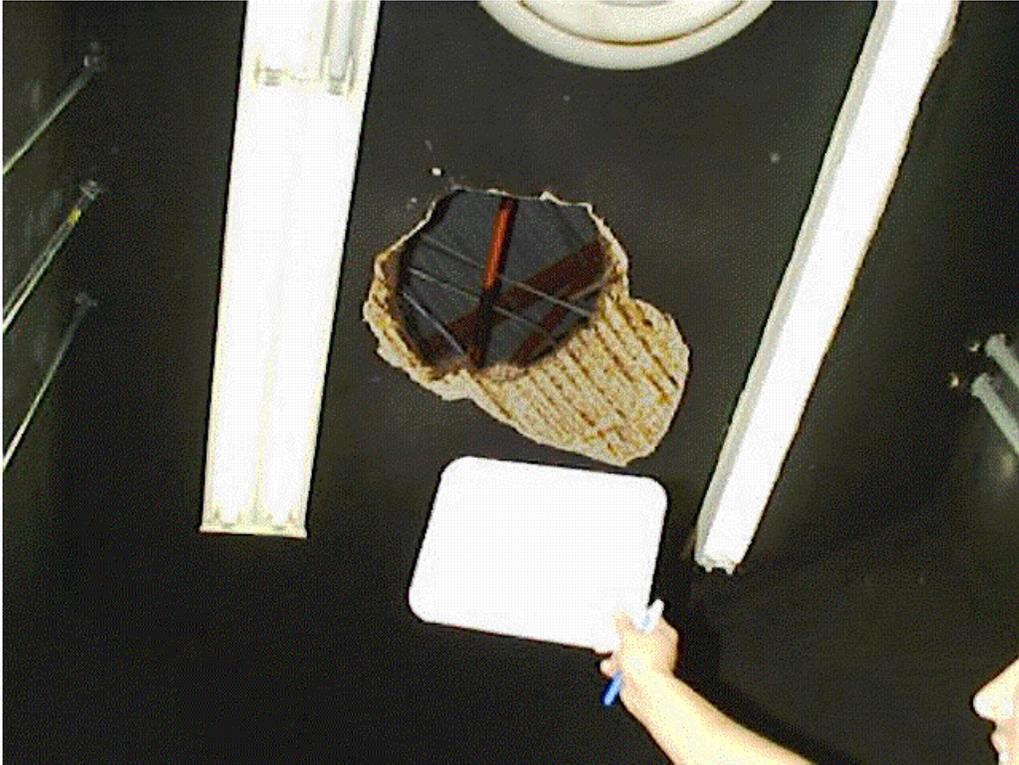
HA #	Material Description	Material Location	ACM (YES/NO)
1	Damaged plaster ceiling	Projection room (auditorium)	NO
