**FRIABLE AND DAMAGED FRIABLE ASBESTOS-CONTAINING  
MATERIALS SURVEY AT THE  
CHARLESTON NAVAL SHIPYARD  
CHARLESTON, SOUTH CAROLINA**

**CONTRACT NUMBER N62467-00-D-0345**

**SEPTEMBER 2000**

**Friable and Damaged Friable Asbestos-Containing Materials Survey for  
Buildings 81, 86, 141, 180, 199, 220, 658, 1079, 1509, 1777, 1884, 1886,  
1892, NS67, and NS675 at Charleston Naval Shipyard  
Charleston, South Carolina**

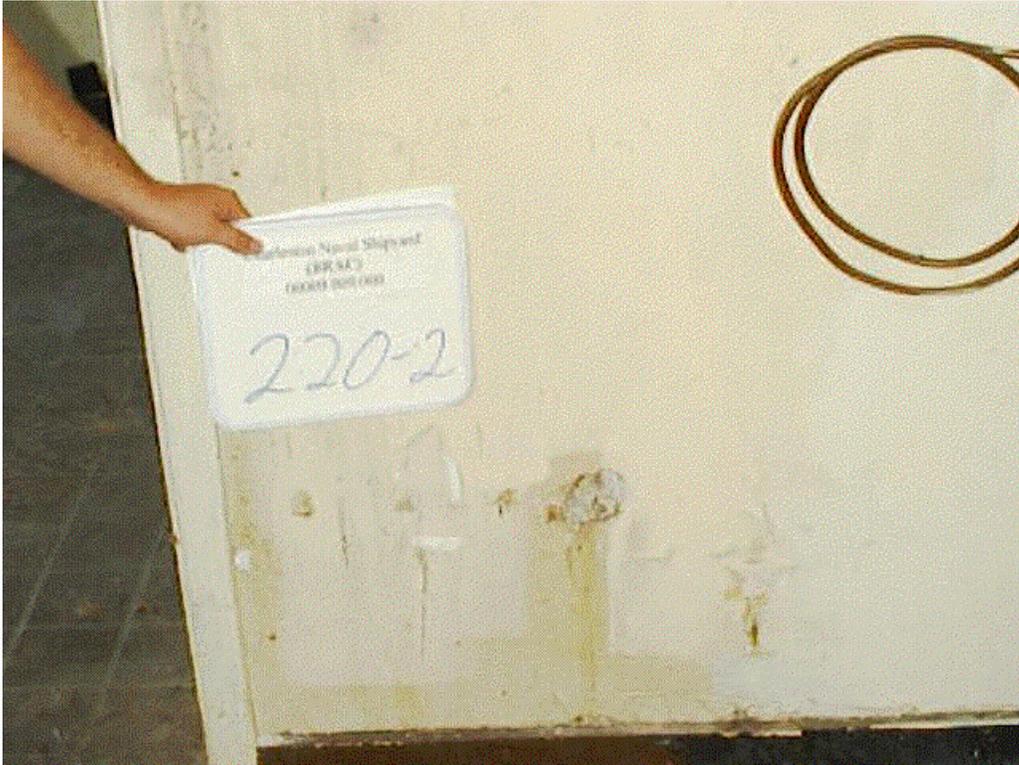
HA #	Material Description	Material Location	ACM (YES/NO)
2	Damaged joint compound with associated gypsum wallboard	110	YES

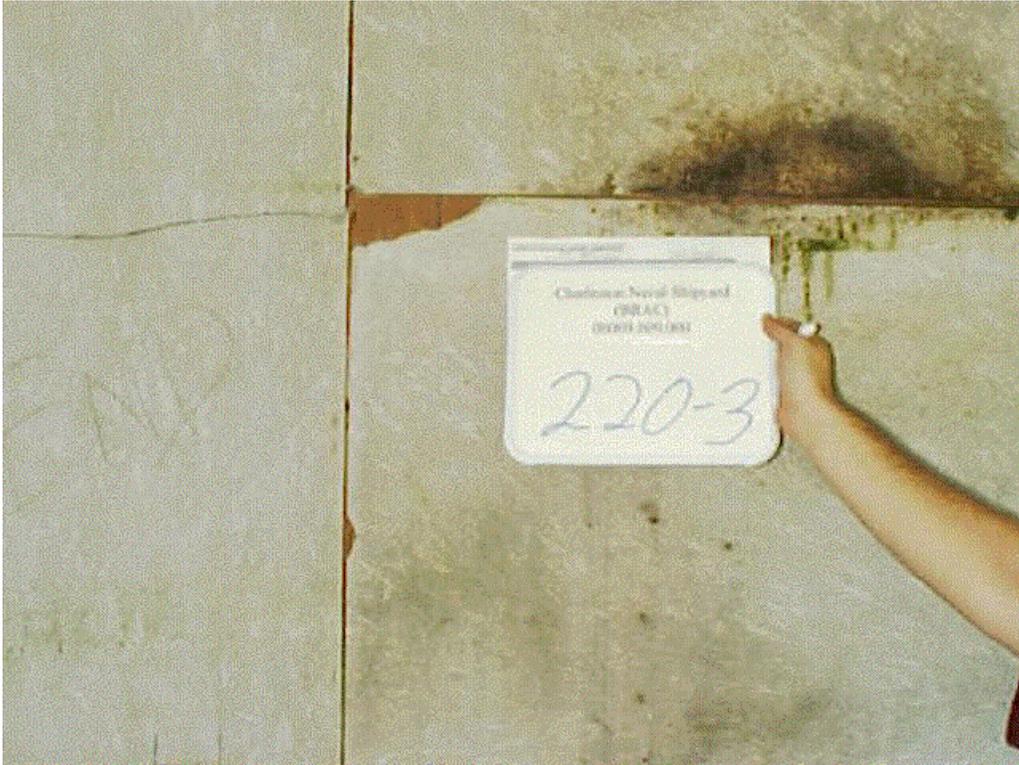
HA #	Material Description	Material Location	ACM (YES/NO)
3	Damaged transite-type wall panels	112	YES

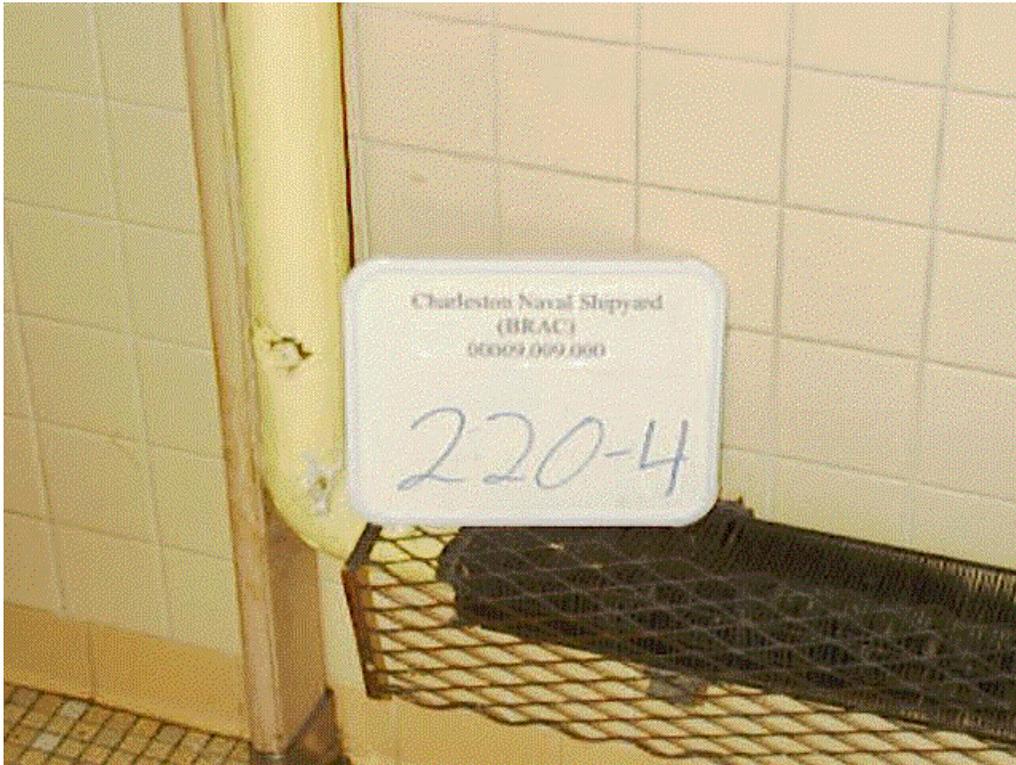
HA #	Material Description	Material Location	ACM (YES/NO)
4	Pipe fitting insulation on steam lines	104, 106	YES

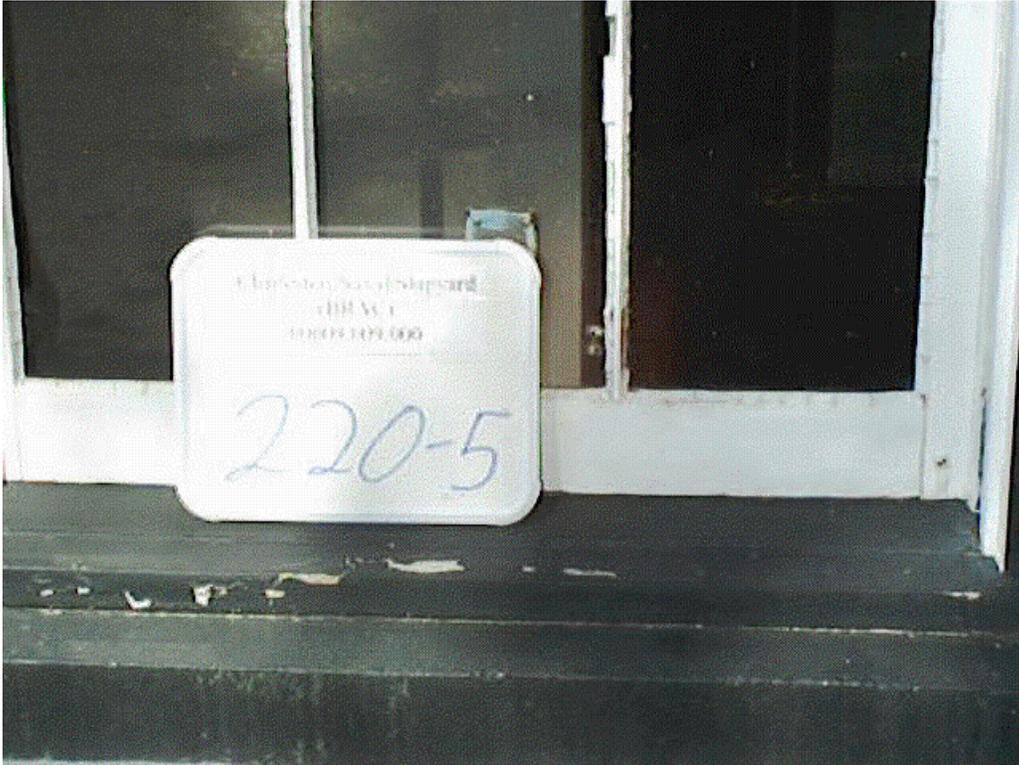
HA #	Material Description	Material Location	ACM (YES/NO)
5	Damaged window putty	Exterior windows	NO

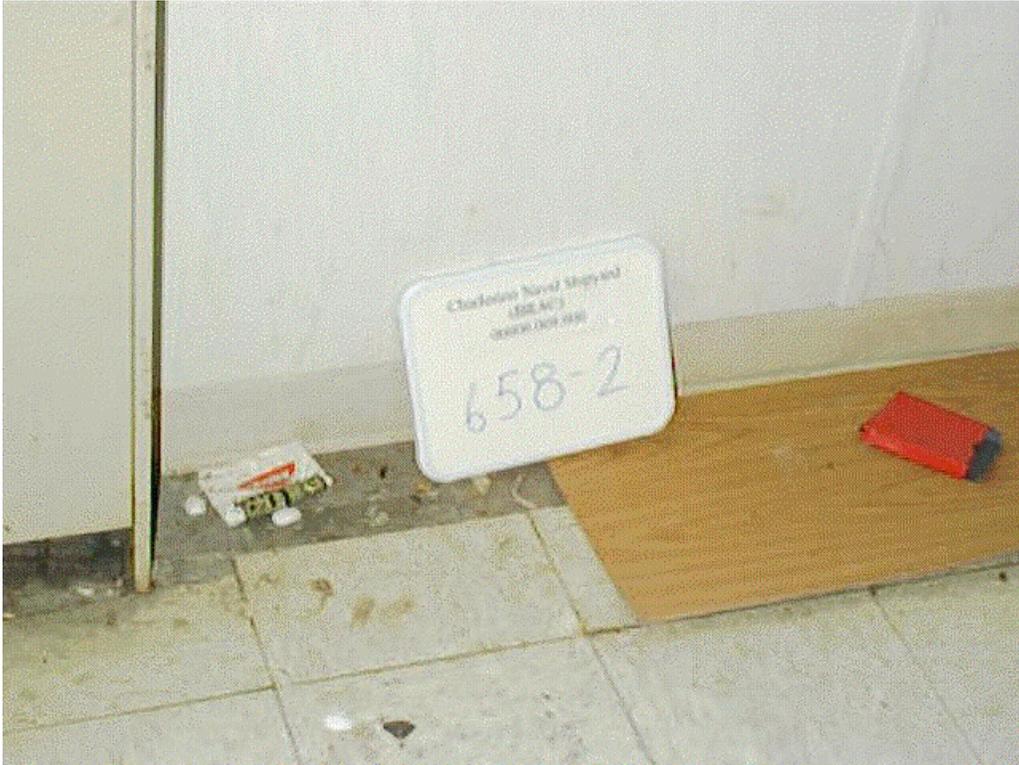
HA #	Material Description	Material Location	ACM (YES/NO)
2	Damaged 12"x12" floor tile and mastic, white	121, 122	YES

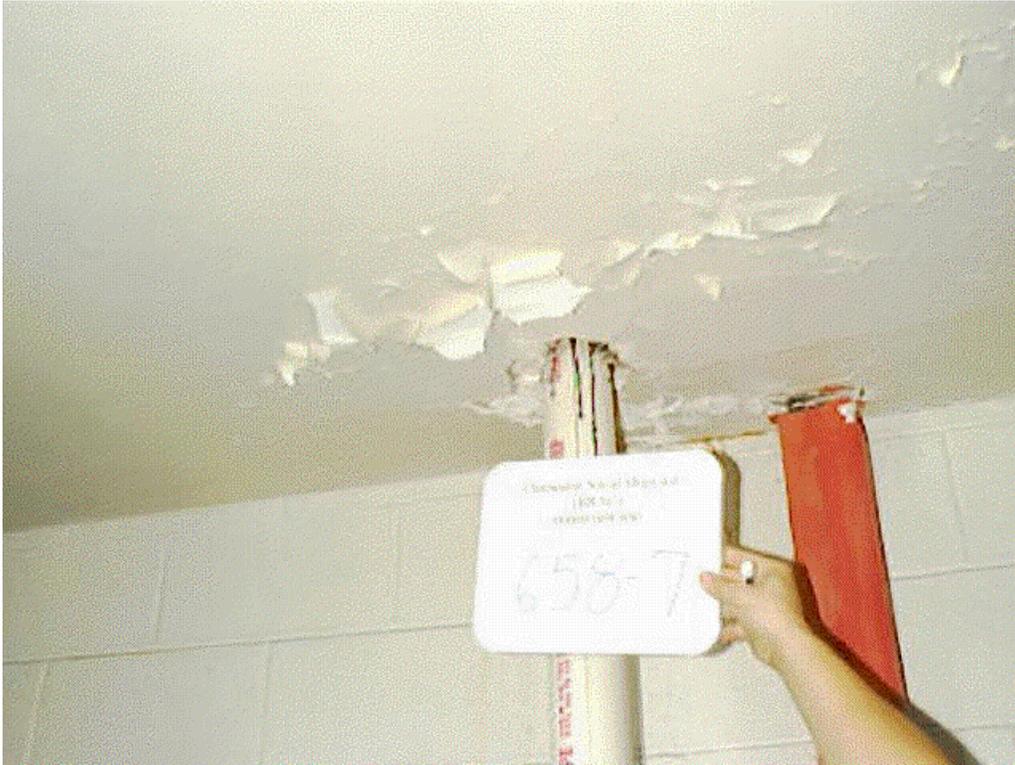
HA #	Material Description	Material Location	ACM (YES/NO)
7	Damaged plaster ceiling	227	NO

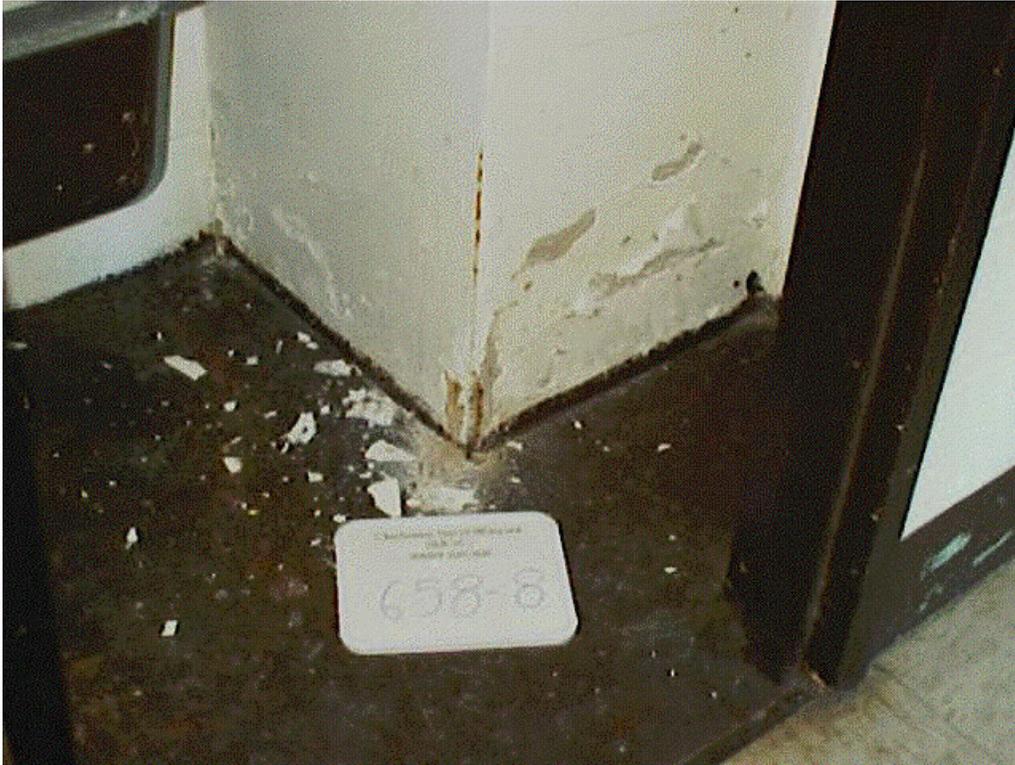
HA #	Material Description	Material Location	ACM (YES/NO)
8	Damaged plaster wall	B5	NO

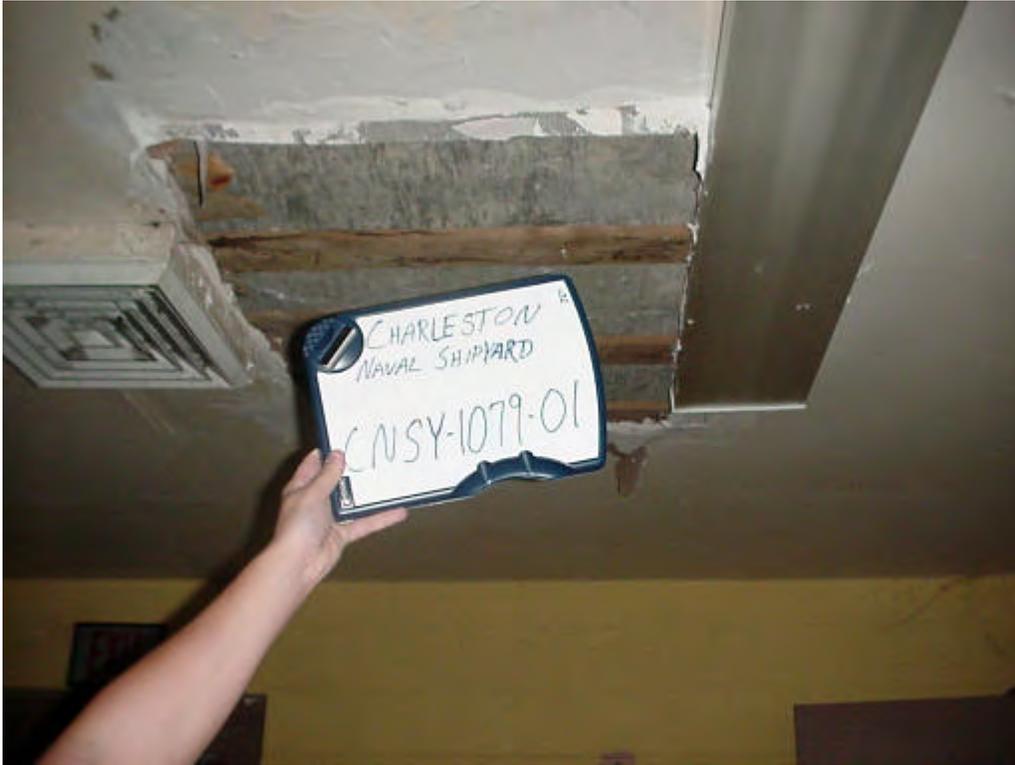
HA #	Material Description	Material Location	ACM (YES/NO)
1	Damaged gypsum ceiling with associated joint compound	102	No

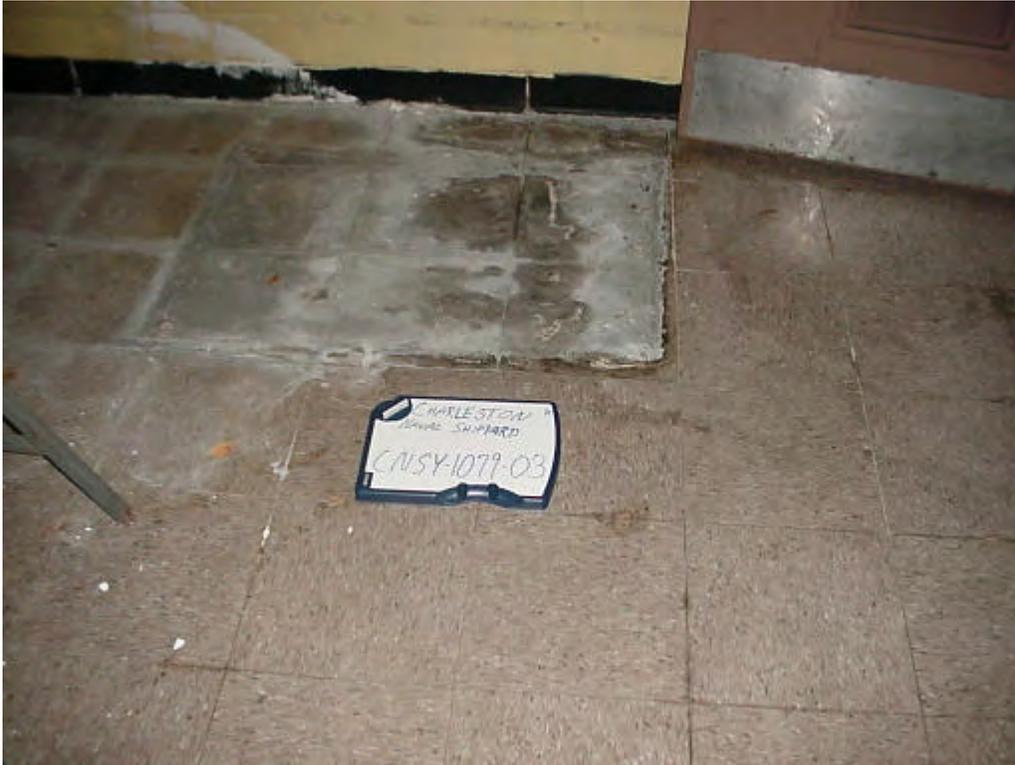
HA #	Material Description	Material Location	ACM (YES/NO)
3	Damaged 12" x 12" floor tile and mastic, brown	101, 102	No

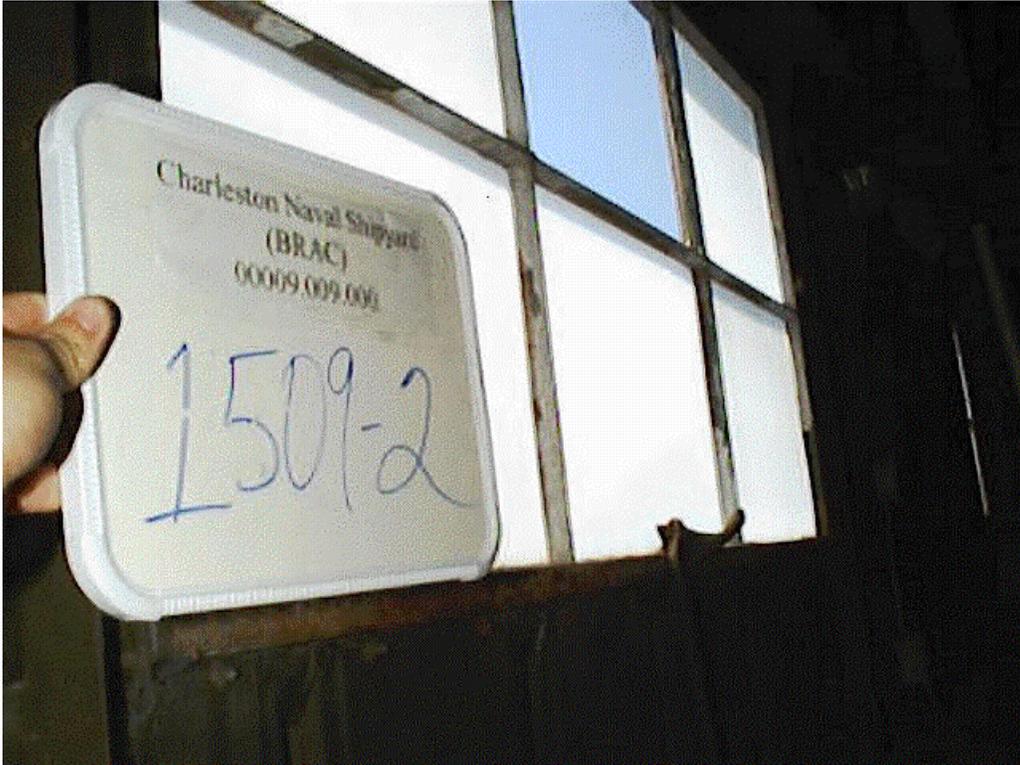
HA #	Material Description	Material Location	ACM (YES/NO)
2	Damaged window putty	Interior windows	YES

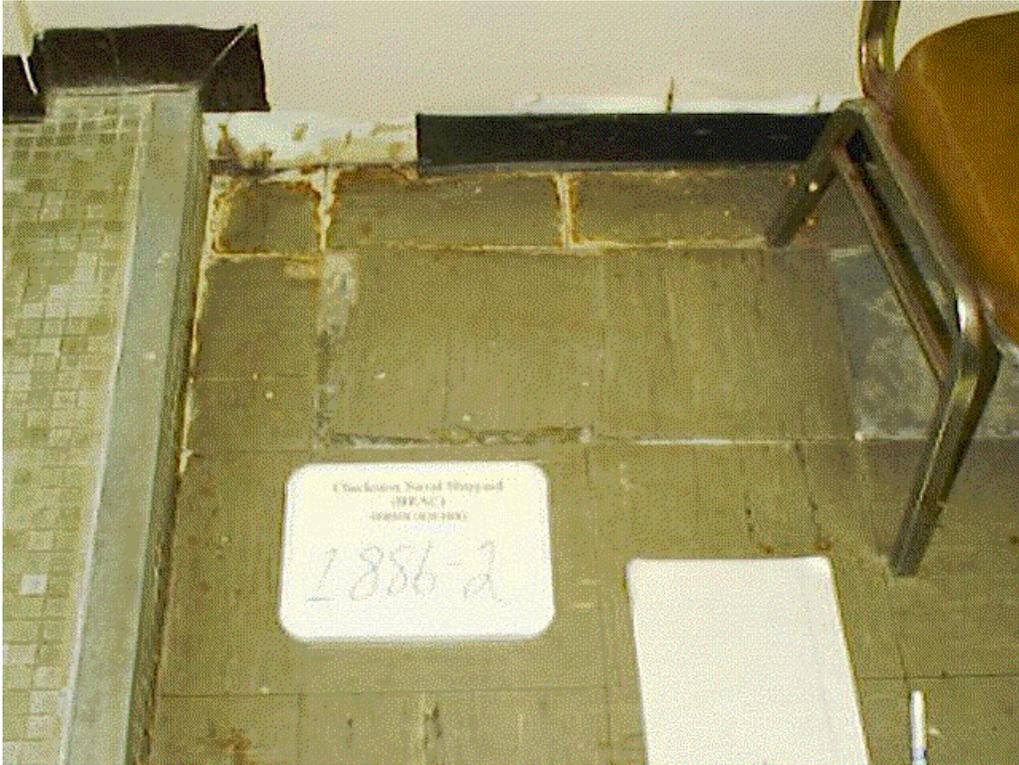
HA #	Material Description	Material Location	ACM (YES/NO)
2	Damaged 12"x12" floor tile and mastic, gray	104	NO

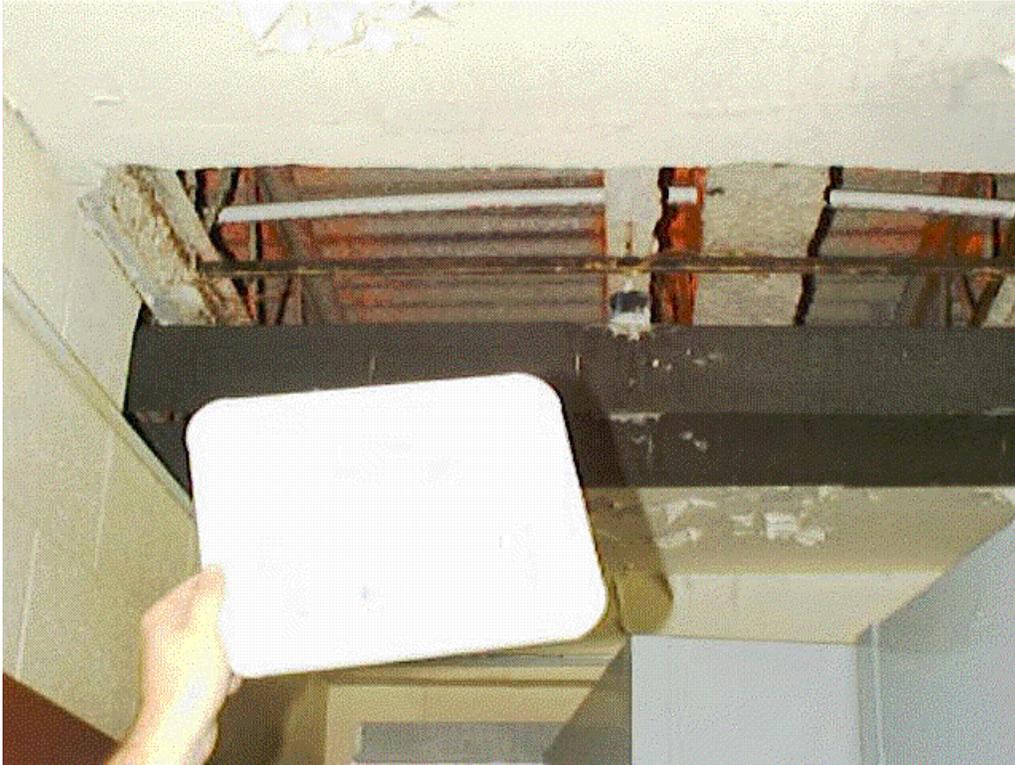
HA #	Material Description	Material Location	ACM (YES/NO)
4	Damaged plaster ceiling	All rooms except restrooms and corridors	NO

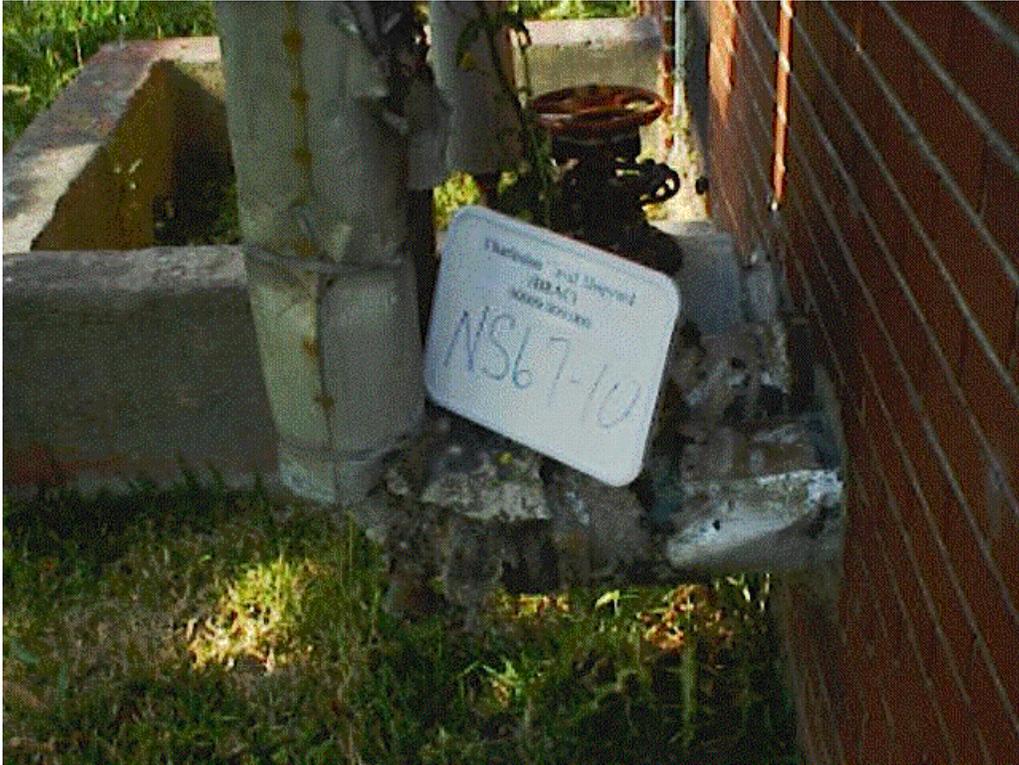
HA #	Material Description	Material Location	ACM (YES/NO)
10	Damaged pipe fitting insulation on steam lines	Exterior (east side of building)	YES

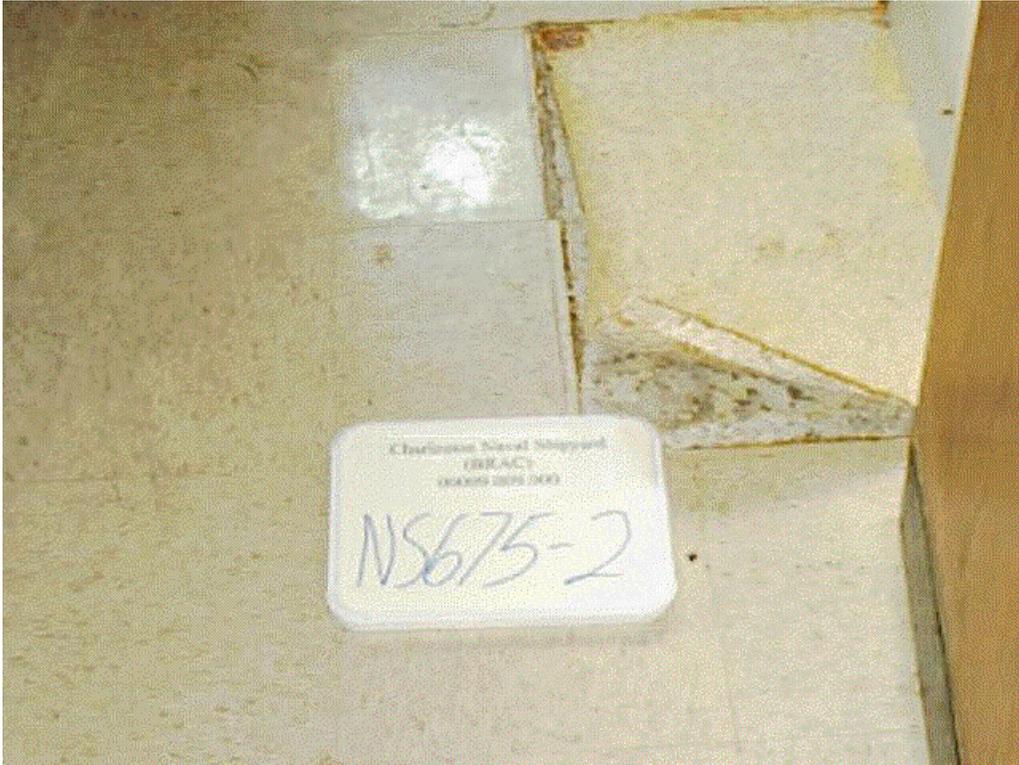
HA #	Material Description	Material Location	ACM (YES/NO)
2	Damaged linoleum flooring with adhesive, yellow	137A, 125, 212, 219, 224, 226	YES

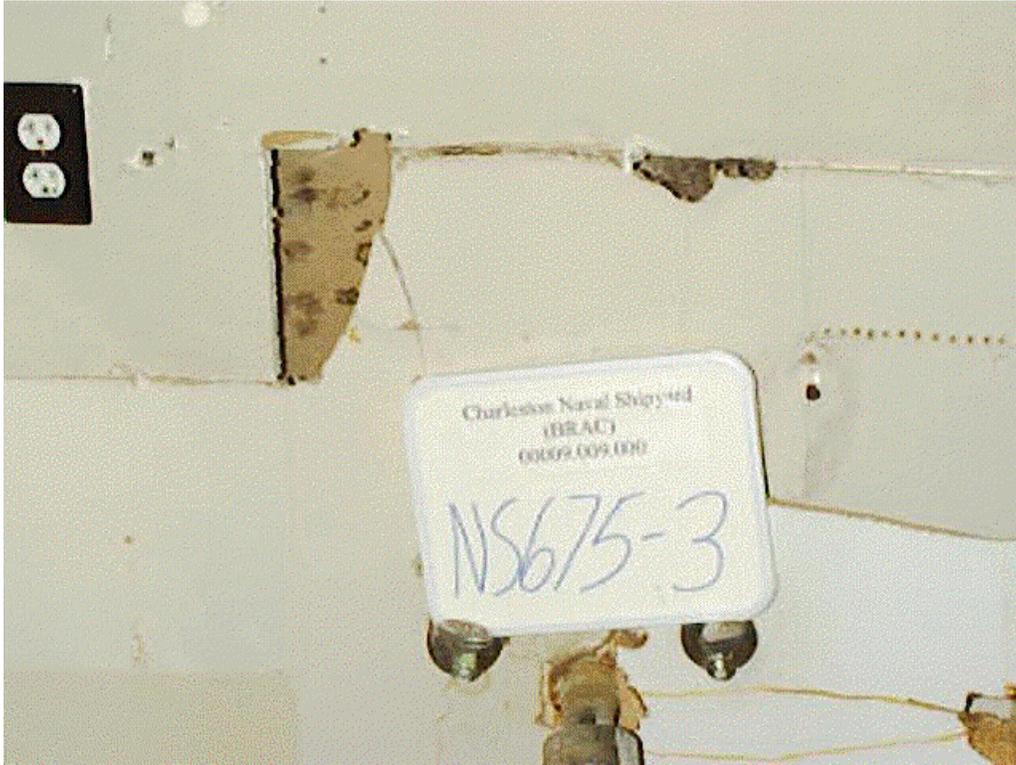
HA #	Material Description	Material Location	ACM (YES/NO)
4	Damaged gypsum wallboard with joint compound	136A, 206, 212	No

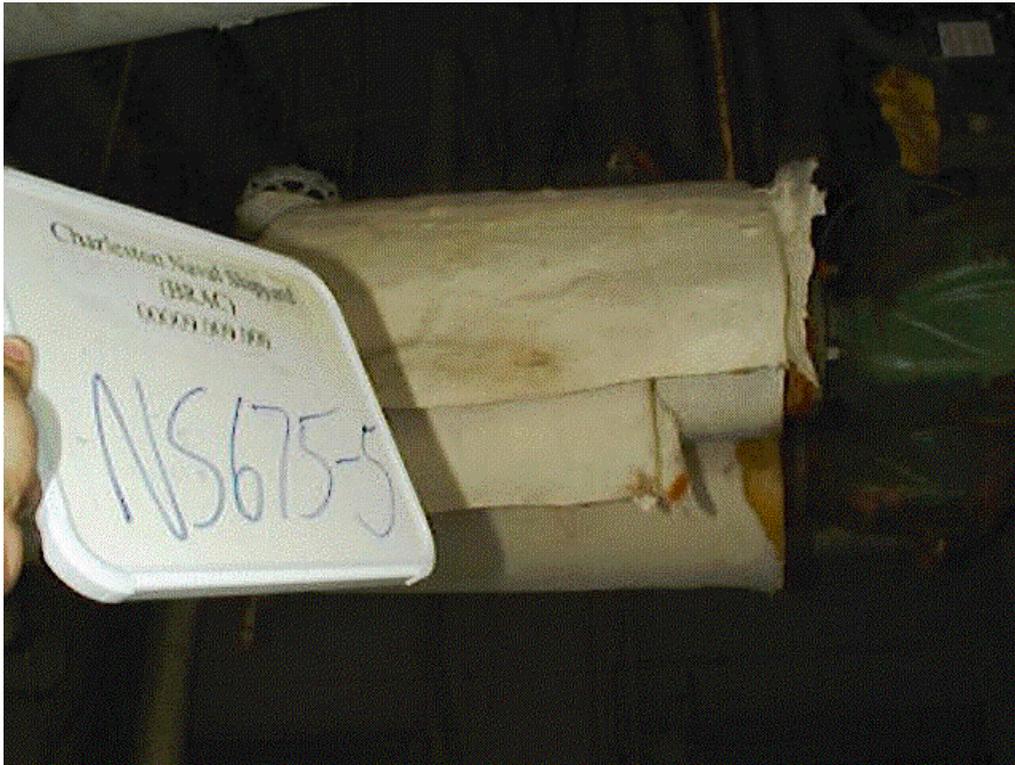
HA #	Material Description	Material Location	ACM (YES/NO)
5	Damaged canvas wrap on tank	146	NO

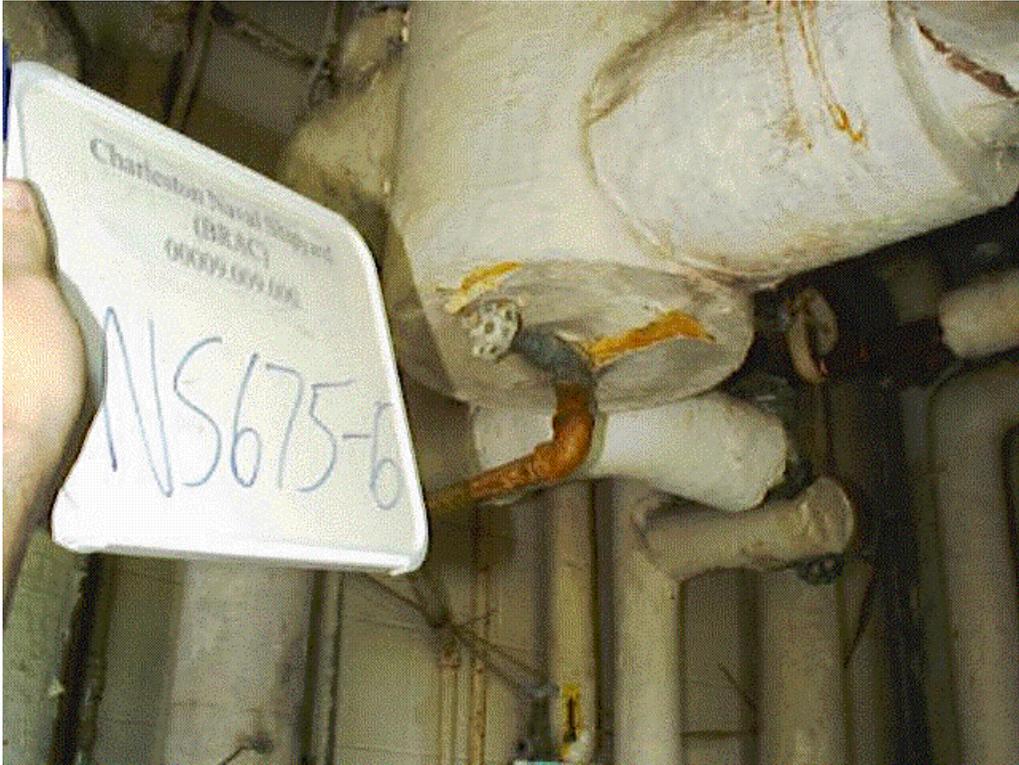
HA #	Material Description	Material Location	ACM (YES/NO)
6	Damaged capping mastic on hot water lines	146	NO
