COMPLETION REPORT FOR TANK P AND PUMP ROOM AT CHICORA TANK FARM CNC
CHARLESTON SC
04/16/1999
ENVIRONMENTAL DETACHMENT CHARLESTON

**COMPLETION REPORT FOR TANK P
AND PUMP ROOM AT
CHICORA TANK FARM IN
NORTH CHARLESTON, S.C.**

ENVIRONMENTAL DETACHMENT
CHARLESTON
1899 NORTH HOBSON AVE.
NORTH CHARLESTON, S.C. 29405-2106

April 1999

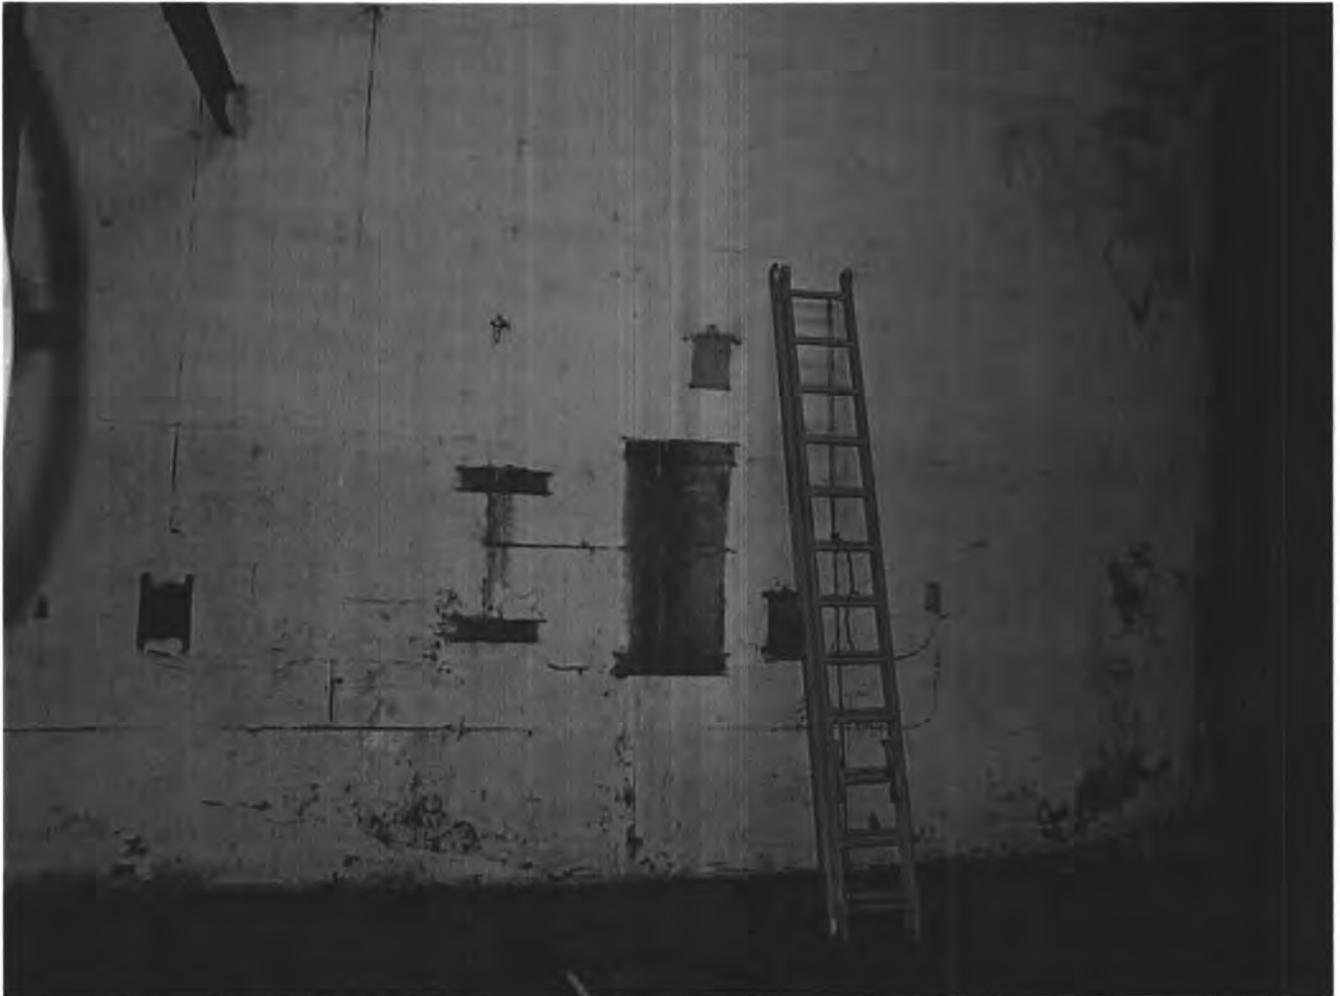
7.2 PUMP ROOM STRIPPED OUT

Soil was excavated from the top of pump room. The pump room removable roof sections were removed. With the pump room opened, all pumps, motors, piping, and other components were rigged out and recycled as scrap metal. Then the pump room was cleaned by high pressure hot water (200degrees Fahrenheit) washing.

Components which were removed for disposal included electrical conduit and associated breaker panels, a dehumidifier system, piping and valves, the ventilation exhaust system, foundations for pumps and motors, personnel ladders and platforms. The pump room was high pressure cleaned and the wash water was pumped out and processed through the oily water separator. The pump room cleaning was completed and inspected by engineers from the DET and SOUTH DIV on 28 July 1998.

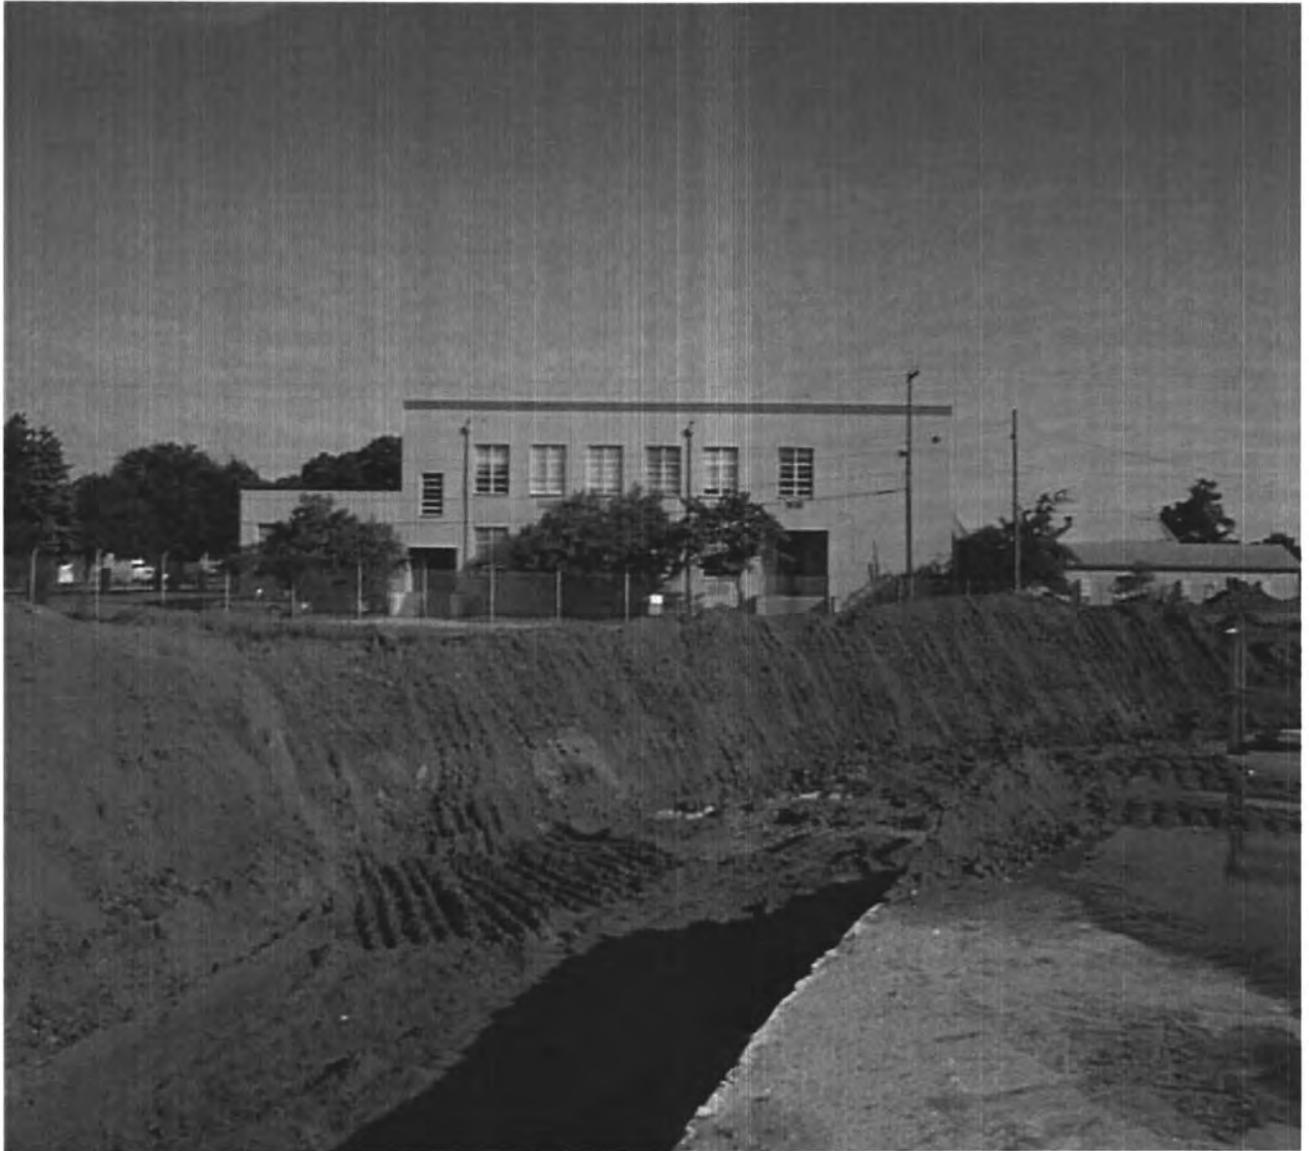
7.3 TANK TOP EXCAVATION

The top and approximately four feet down the sides of tank were excavated.

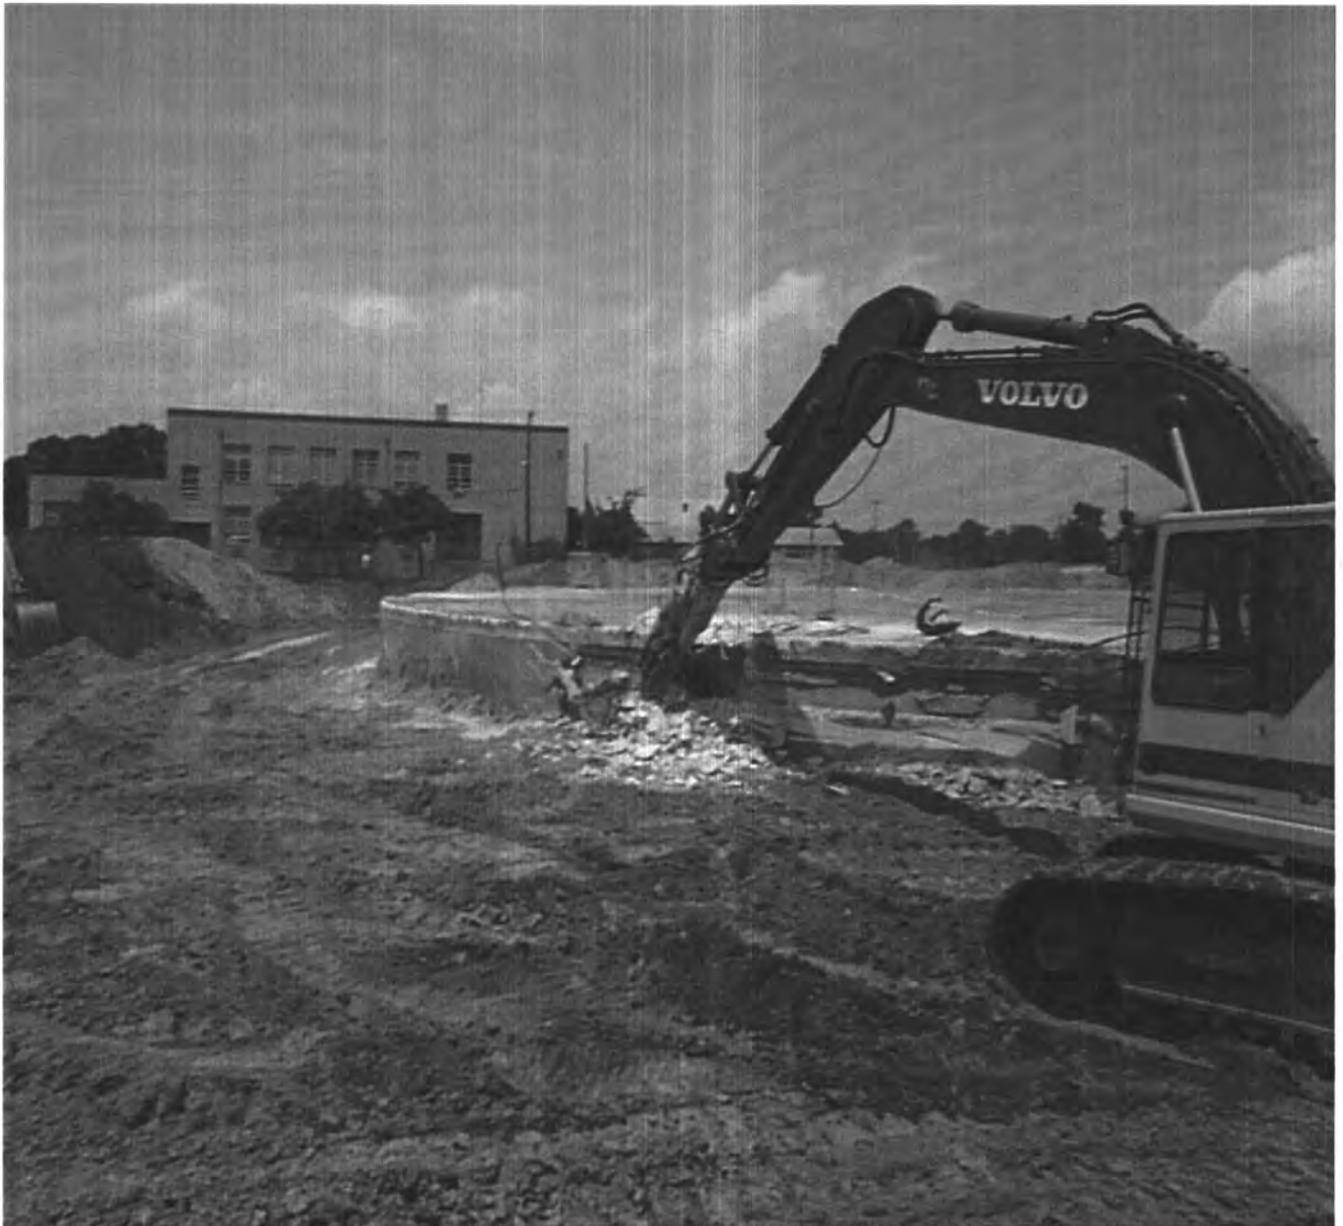
7.4 TANK DEMOLITION

The Volvo trackhoe was equipped with the hydraulic crusher/shear. The crusher broke up and reduced the concrete to small sizes. The crushed concrete was put into the remaining tank bottom section and was compacted with backfill to eliminate voids. The tank and pump room was constructed from concrete heavily reinforced with steel.

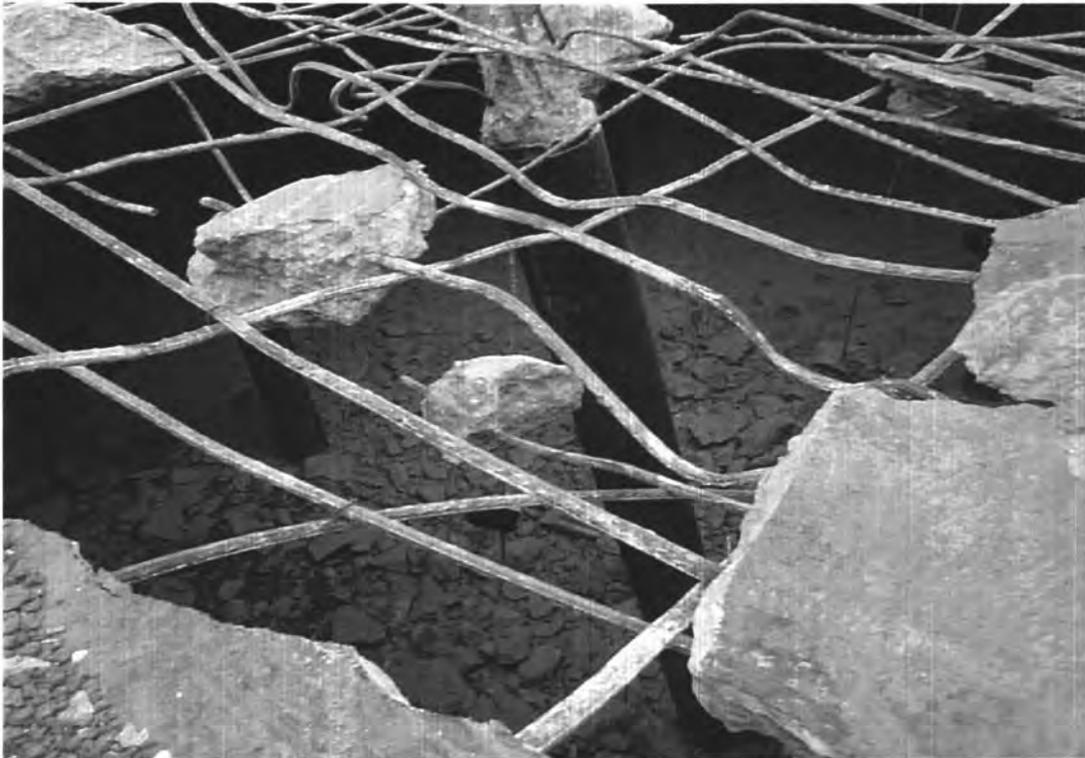
7.5 REBAR REMOVED

The steel rebar was cut up with the hydraulic shear.

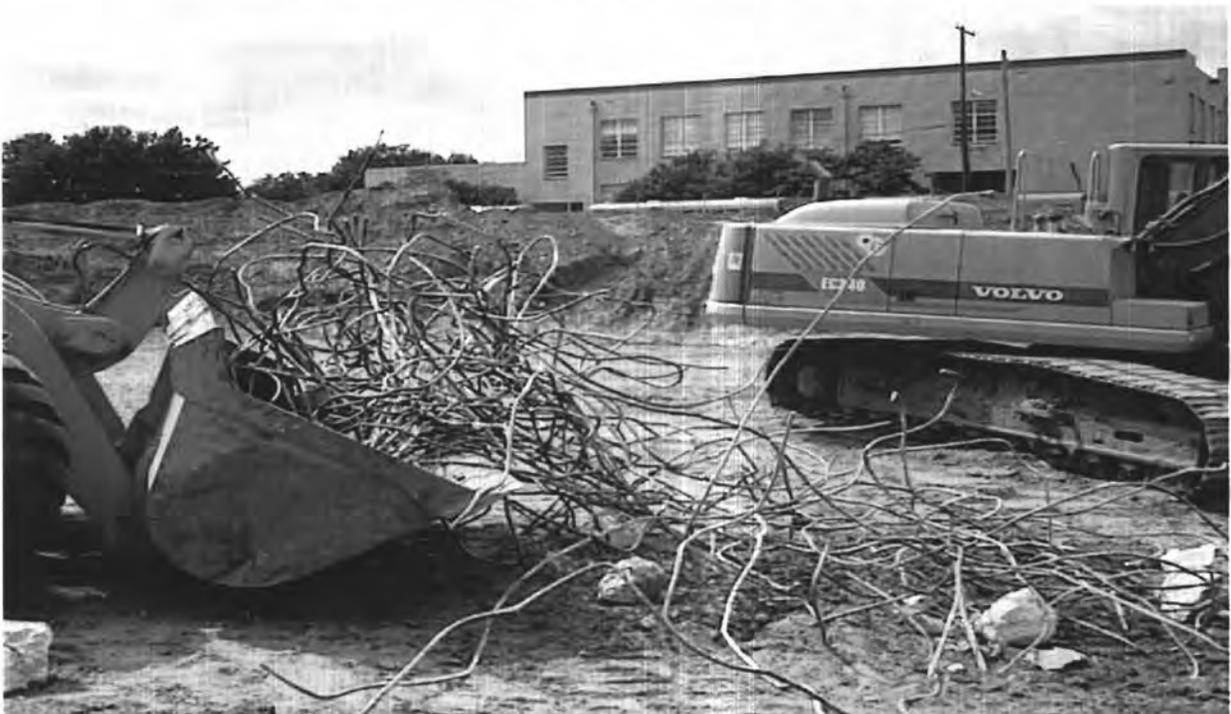
Rebar was segregated and recycled as scrap.

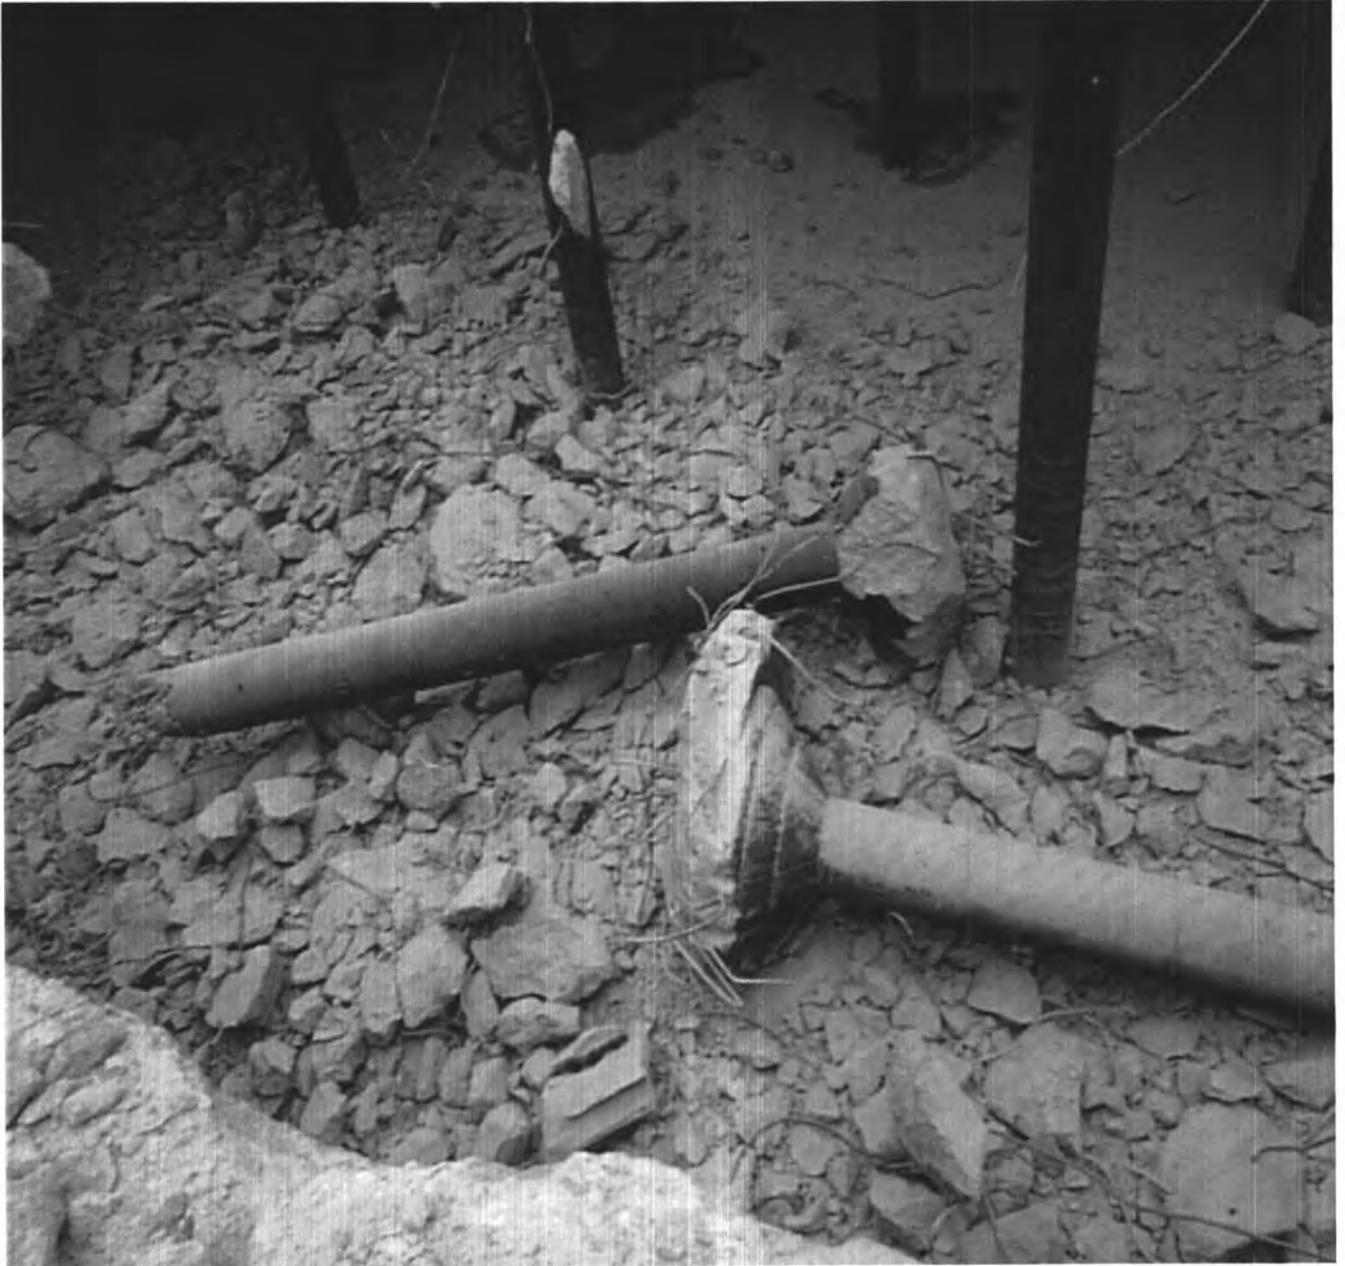
7.6 COLUMNS TAKEN DOWN

The concrete columns were completely taken down and crushed into small size concrete rubble. The rebar was recycled as scrap.

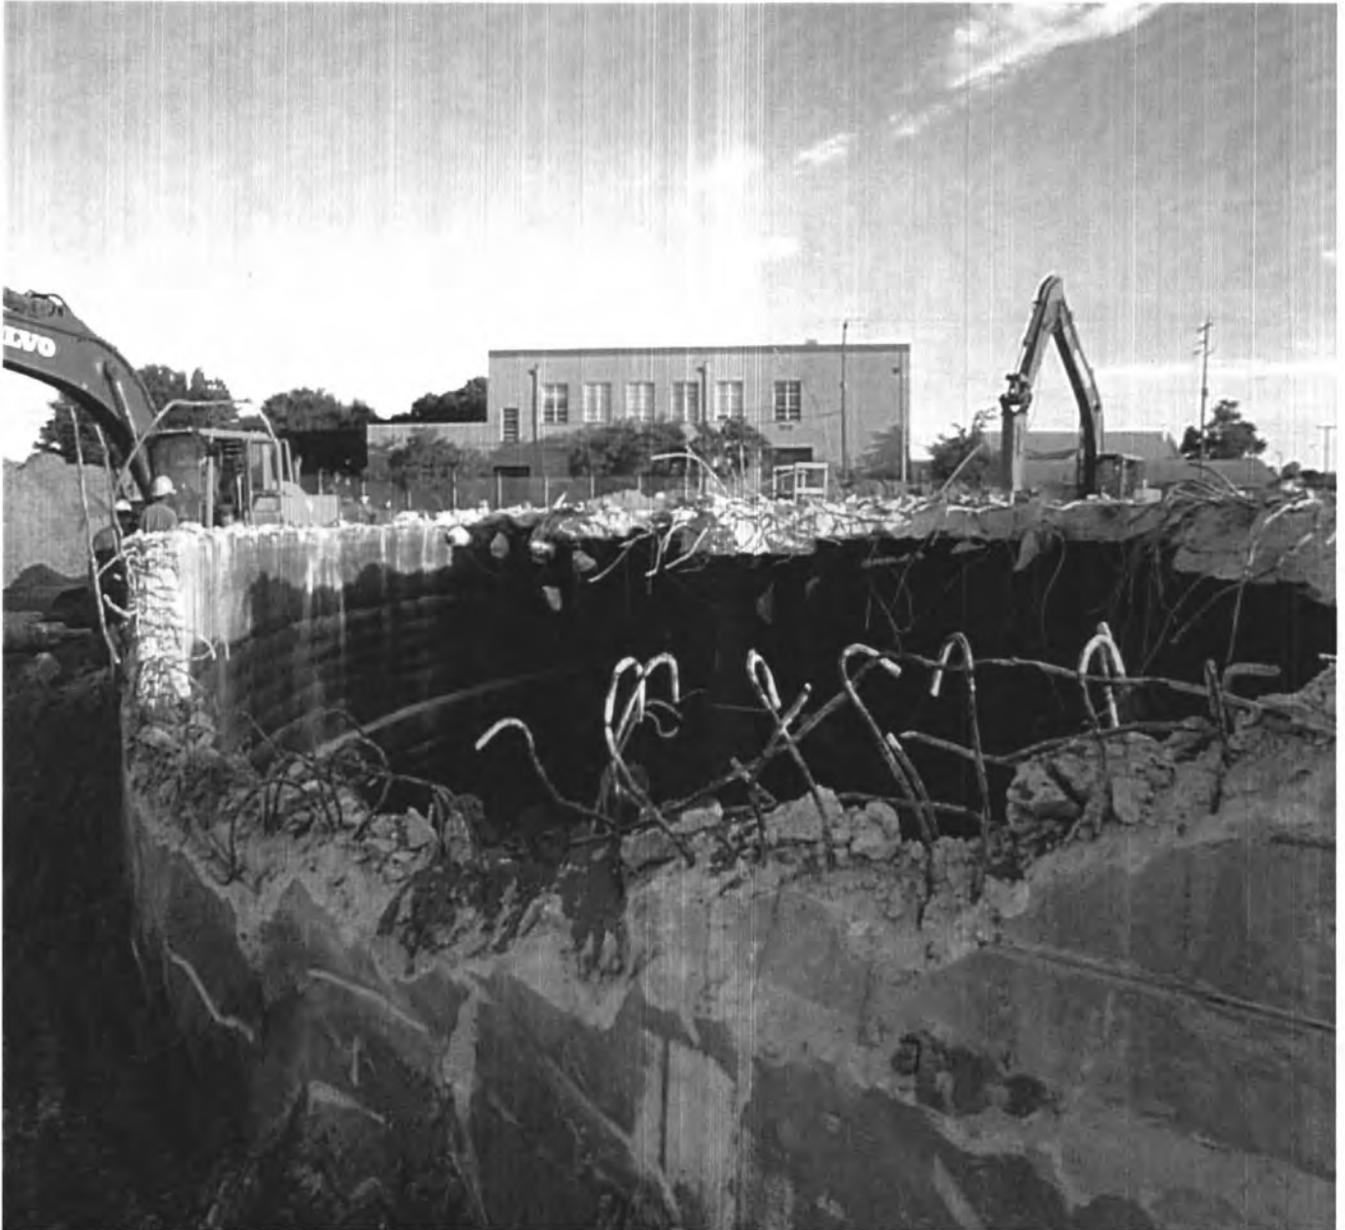
7.7 TANK TOP CRUSHED

The tank top and the wall were demolished with the hydraulic concrete crusher and the hydraulic jack hammer.

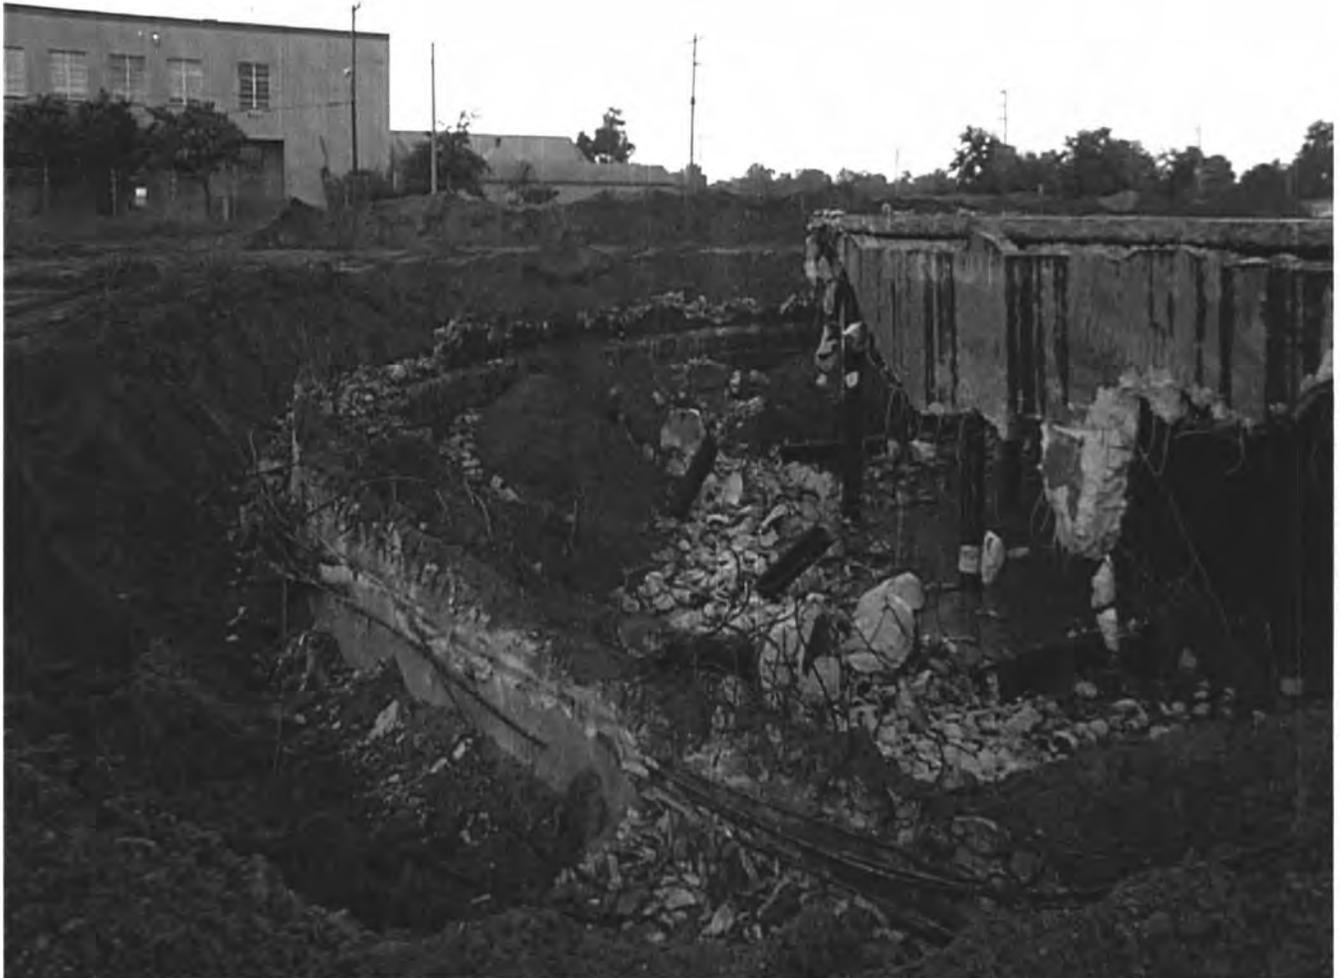
7.8 WALL CRUSHED

The excavation around the tank and pump room wall continued as the wall sections were demolished. The tank walls were taken down to approximately 7.5 feet above mean sea level. The excavation around the tank and pump room walls stopped just above the existing french drain system which was designed to drain ground water away from the tank.

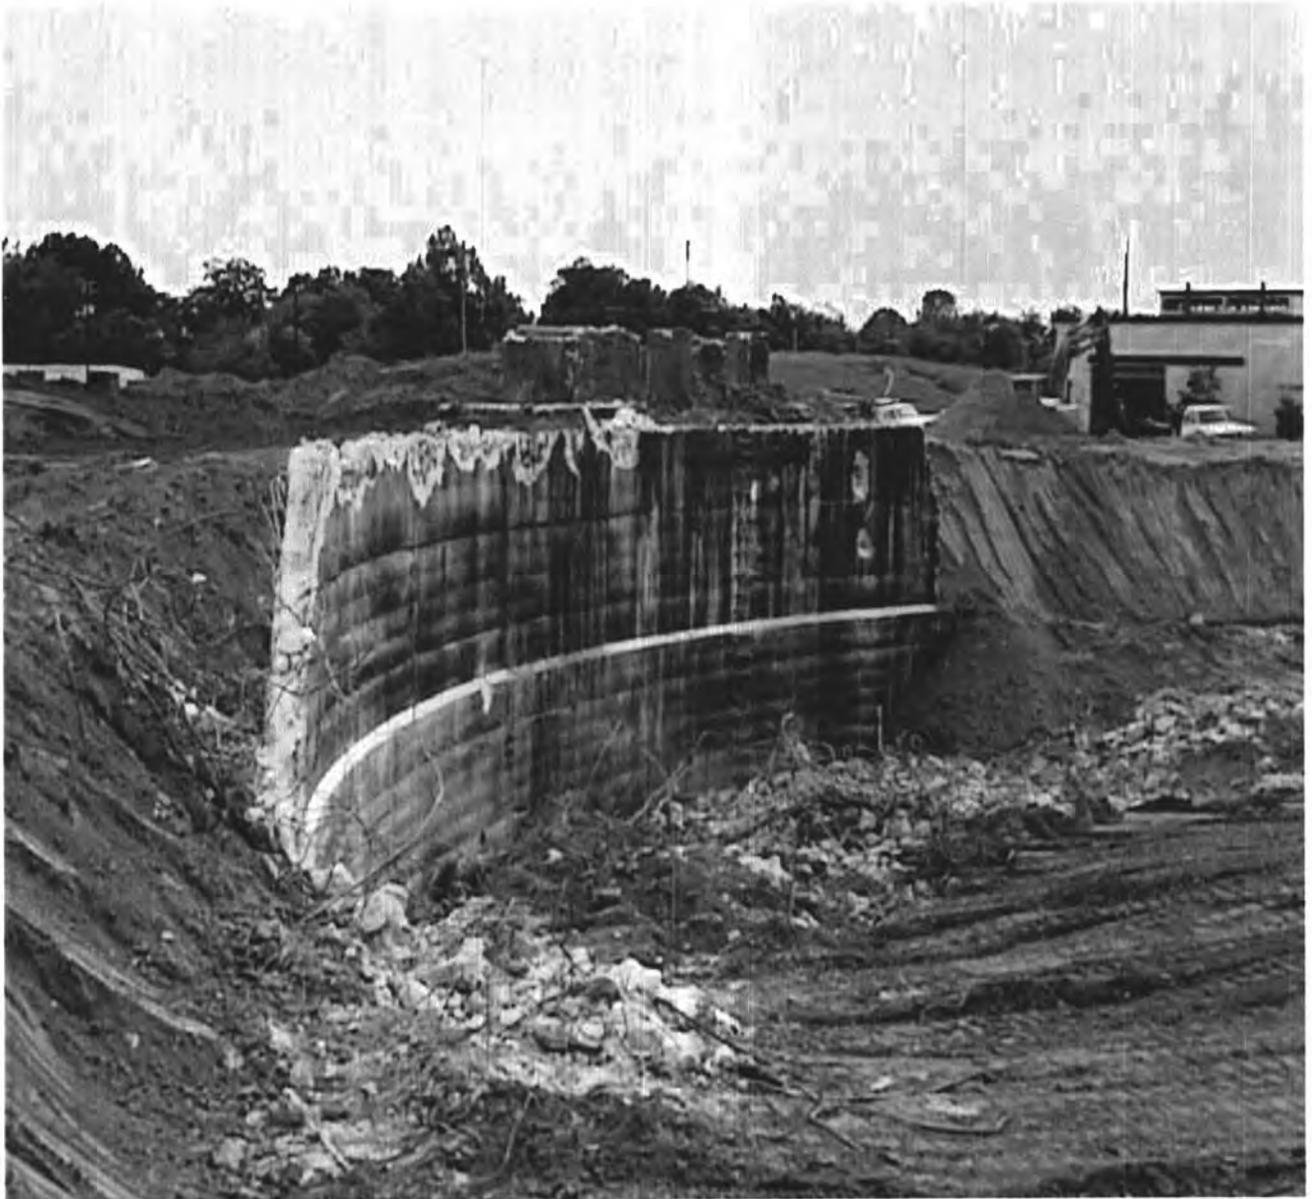
7.9 PUMP ROOM WALL

Approximately 12 feet of the tank wall was demolished. The step in the wall shown in the picture occurred 10 feet down when the thickness changed from 16 inches to 22 inches of concrete. The wall was removed for the tank and pump room approximately two feet below that step. The wall height is approximately 7.5 feet above mean sea level.

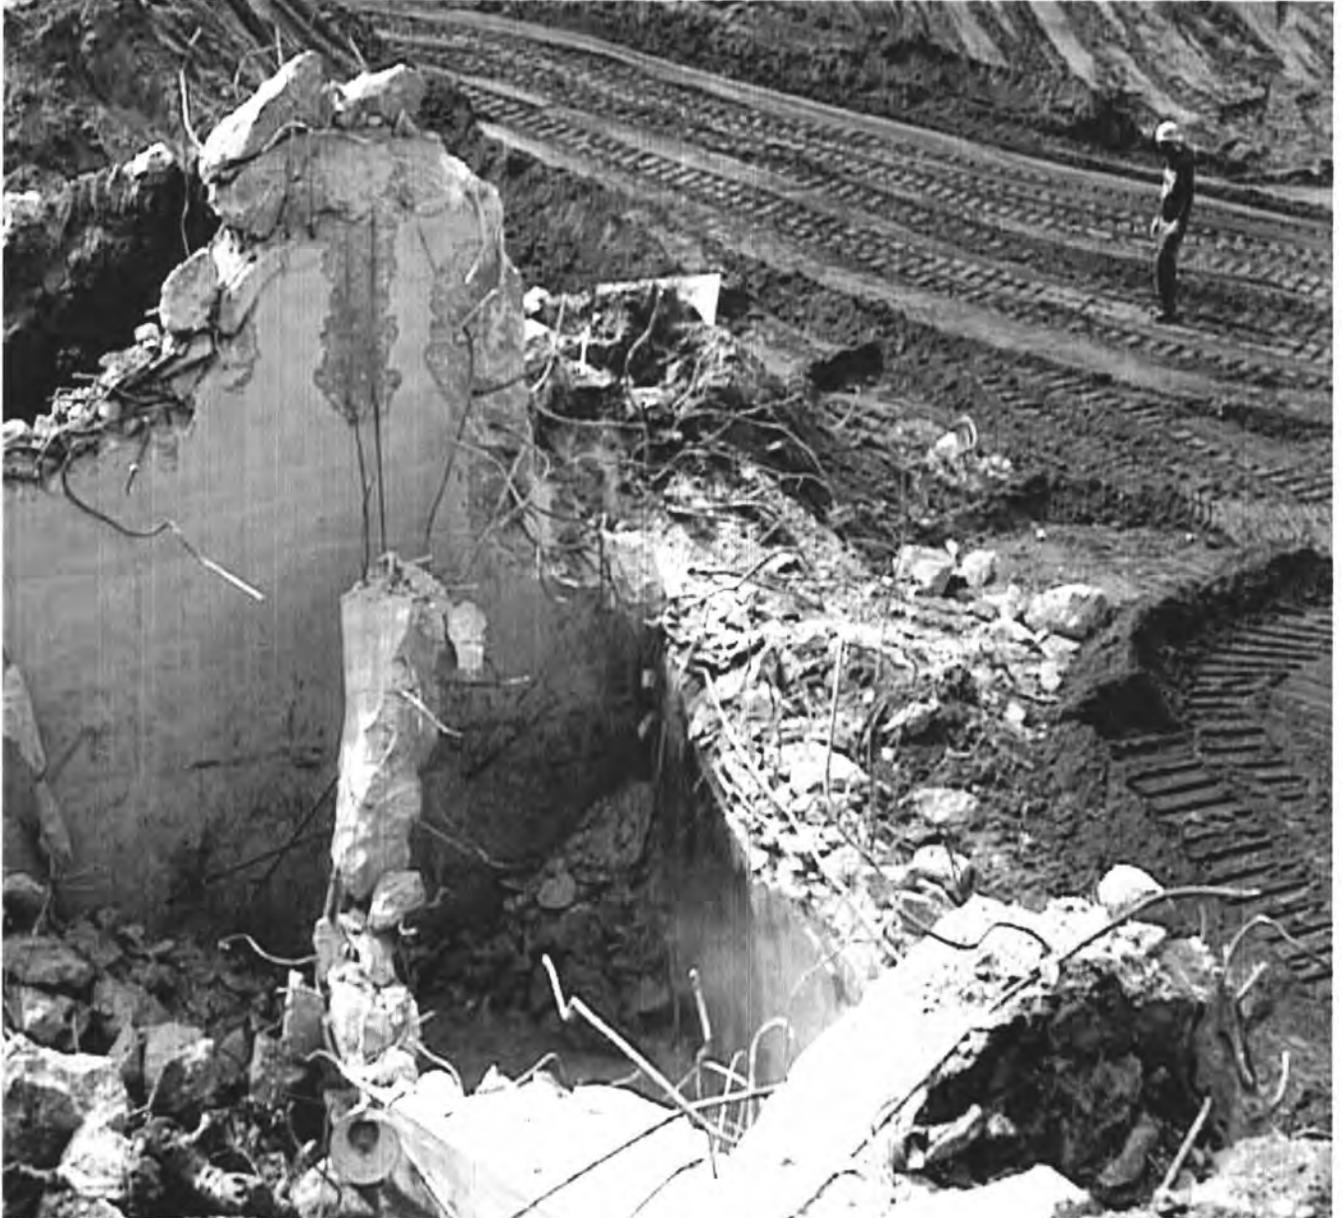
7.10 PUMP ROOM CRUSHED

The pump room was constructed from 24 inch thick rebar reinforced concrete. The pump room walls were crushed down to approximately 7.5 feet above mean sea level. The crushed concrete was placed in the remaining wall and bottom of the pump room and was backfilled with soil to eliminate the voids.

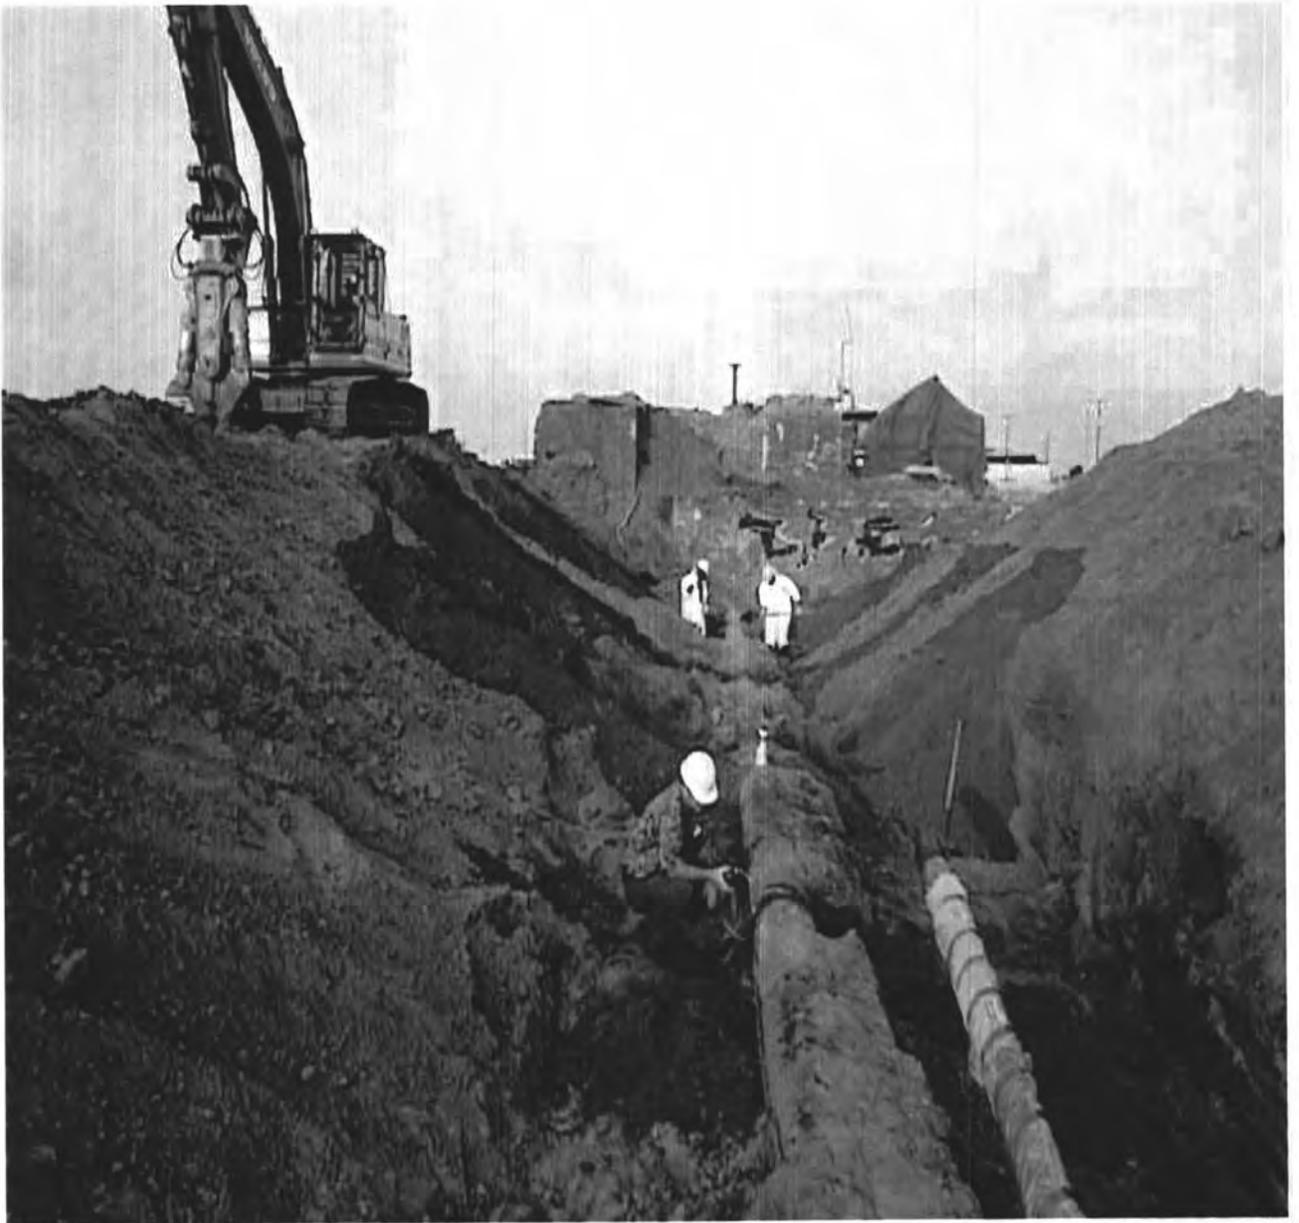
7.11 PIPING ISOLATED

The 16 inch fill/suction piping and the 6 inch sludge piping was removed 45 feet away from the pump room.

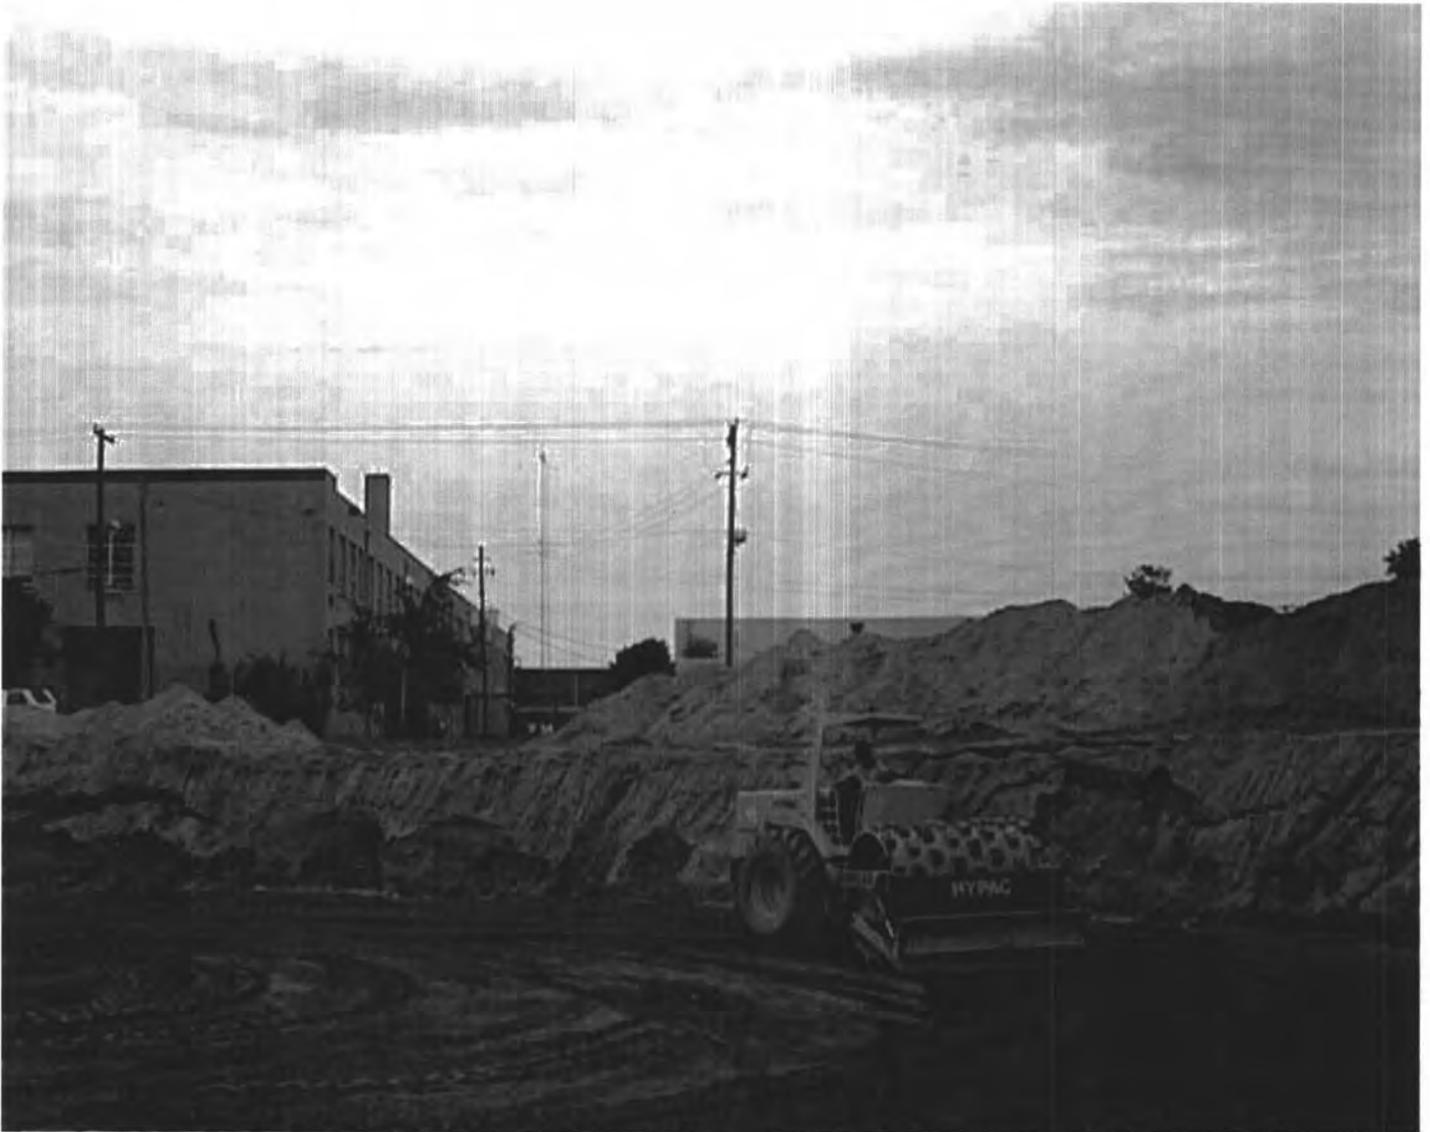
7.12 BACKFILL COMPACTED

The remaining (3 – 4 feet deep) portion of the tank/pump room was backfilled with soil and vibratory compacted during application. This was backfilled to the top of the remaining wall sections.

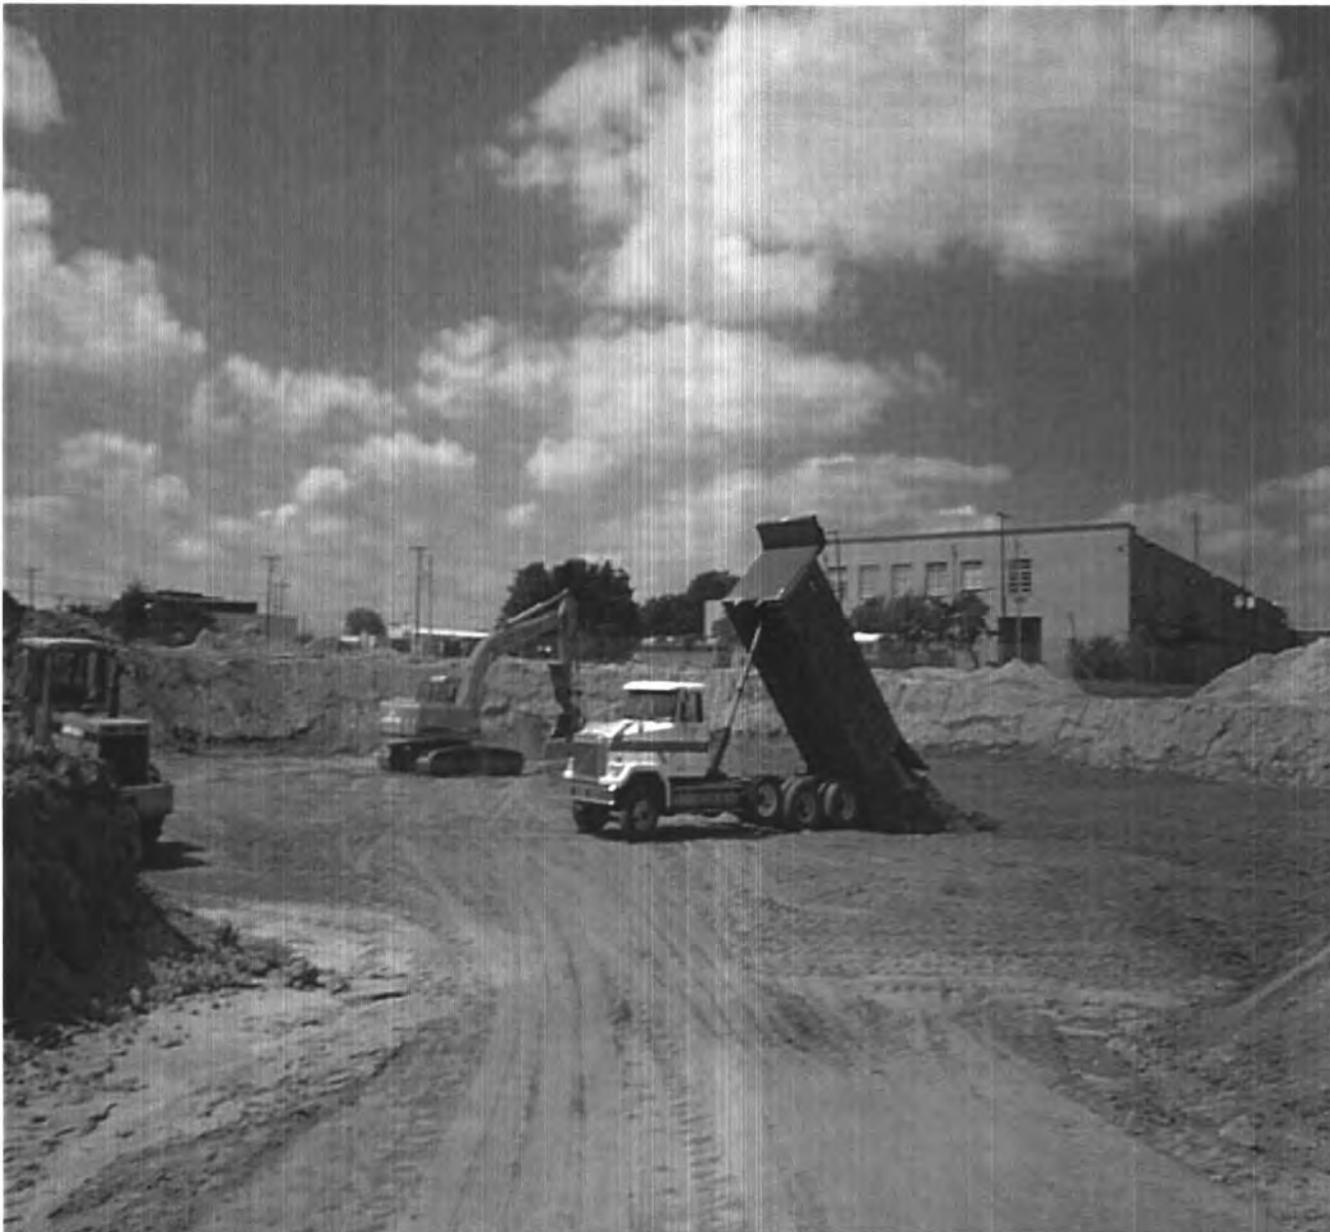
7.13 CLAY CAP

Clay material was dumped on the contoured and sloped backfilled site. The clay was spread out with the trackhoe and wheel loader. The clay cap was applied a minimum of five feet past the top of the remaining walls. The clay cap was compacted and tested to ensure that water infiltration into the remaining tank bottom would be insignificant.

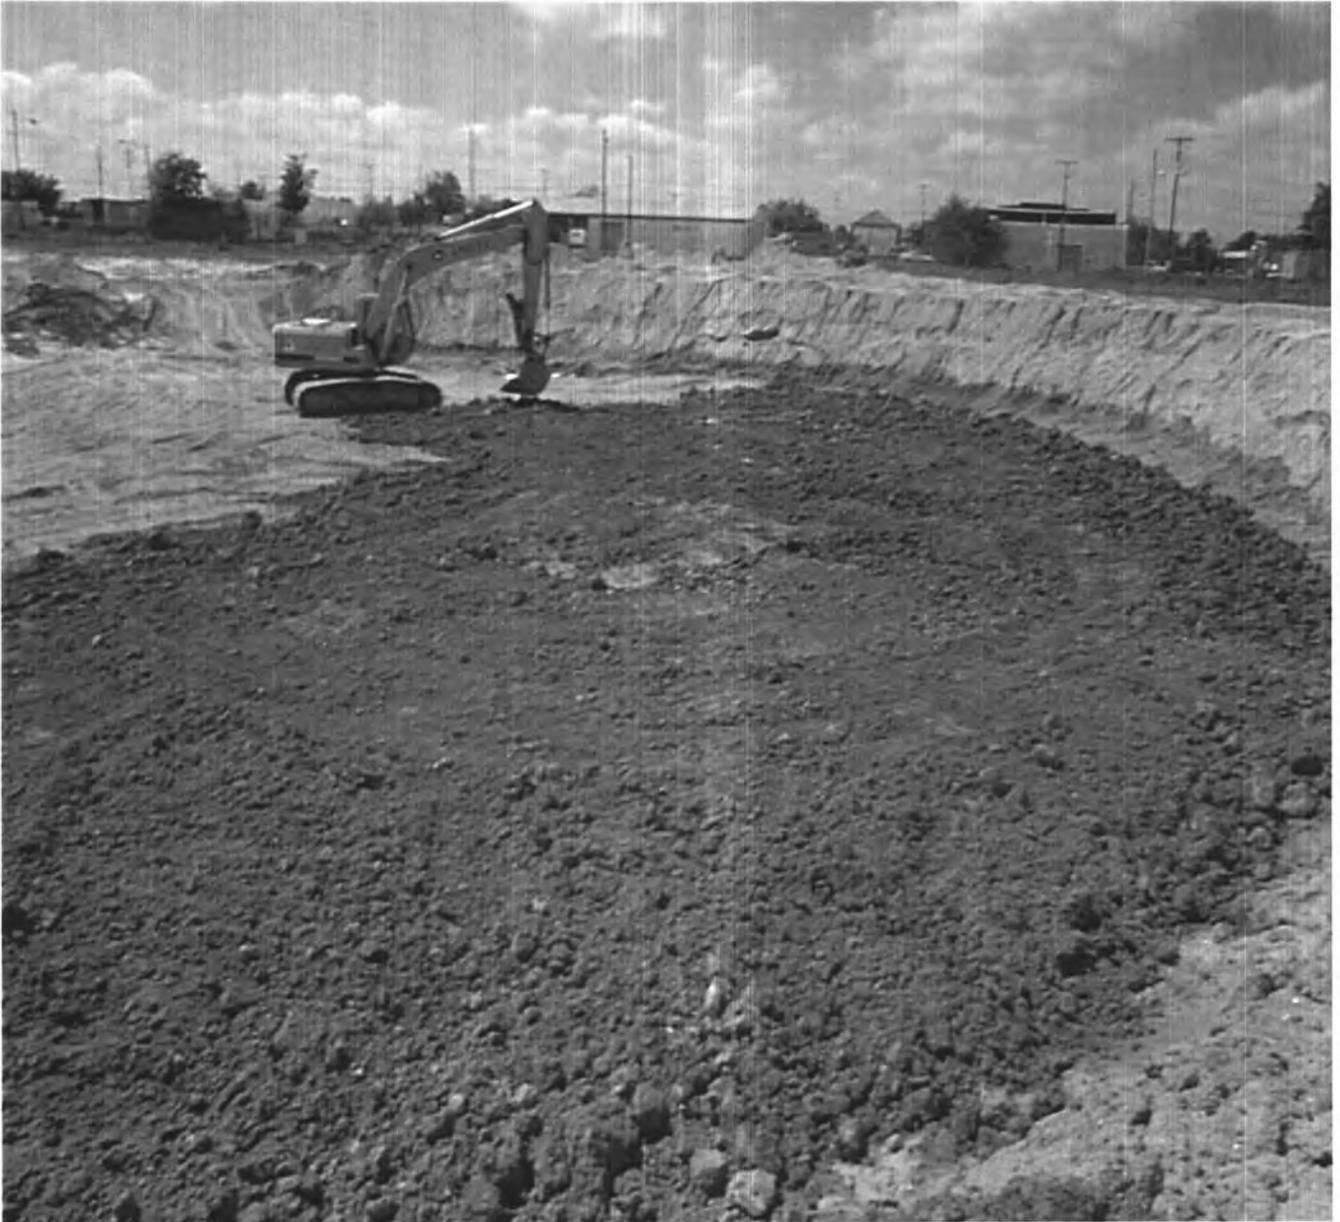
Clay cap material was applied in two separate lifts approximately eight inches thick.

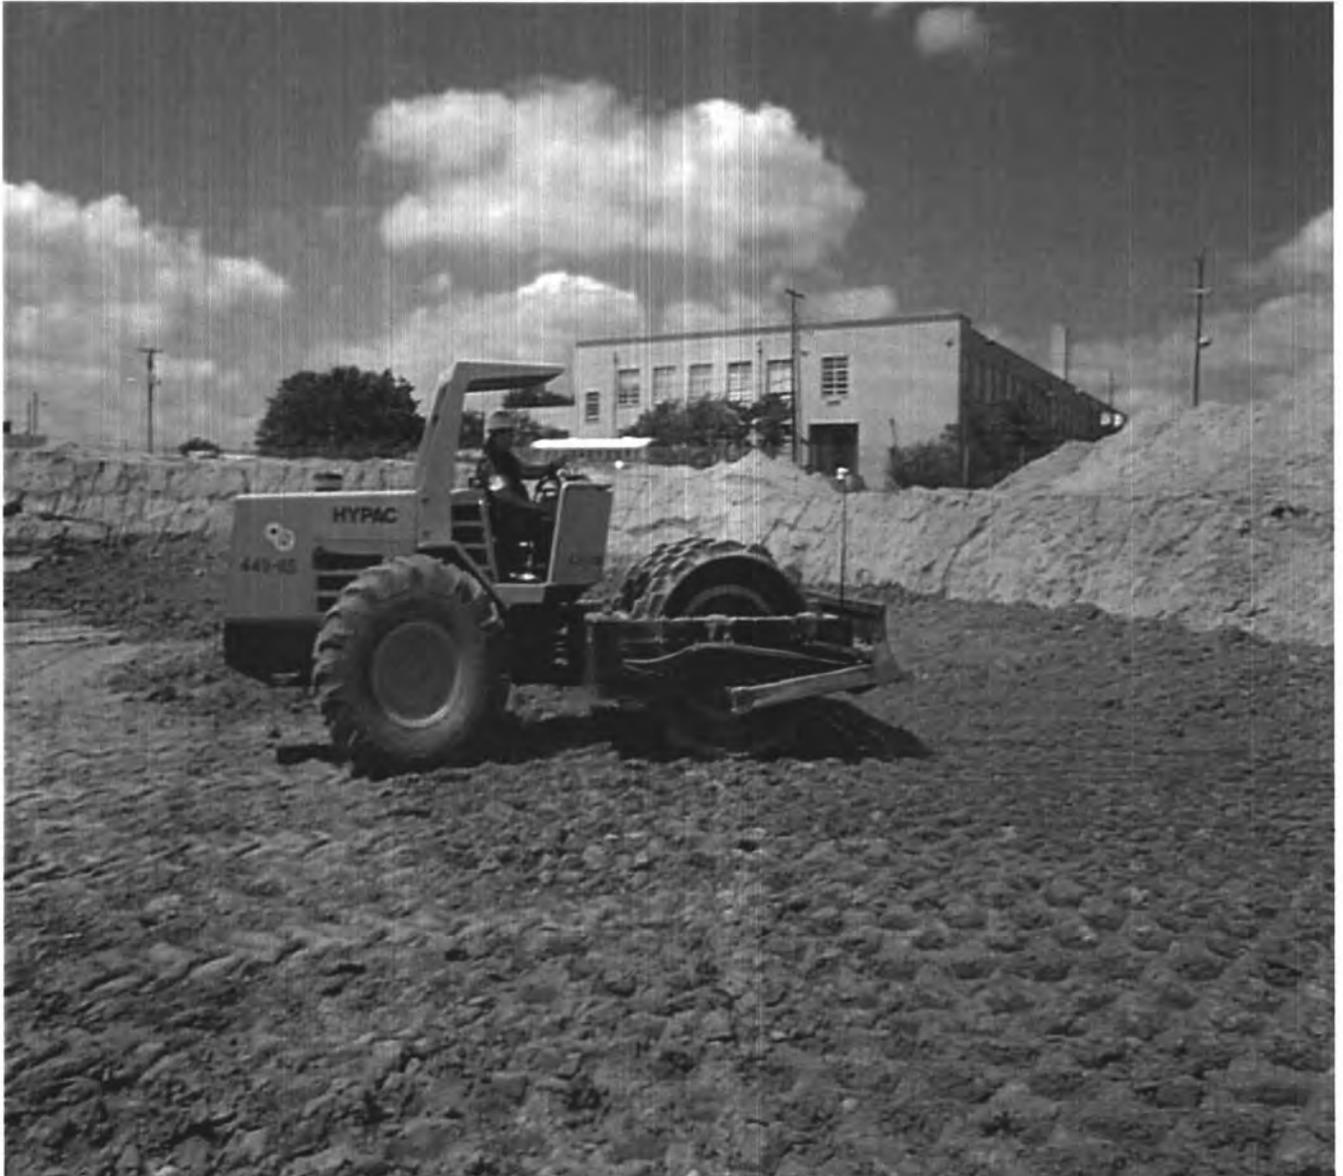
Each lift was vibratory compacted with the smooth drum roller and the sheepfoot compactors. The hydraulic conductivity and Proctor density was tested for each lift (the results are provided in Appendix B).
