COMPLETION REPORT FOR TANK P AND PUMP ROOM AT CHICORA TANK FARM CNC
CHARLESTON SC
04/16/1999
ENVIRONMENTAL DETACHMENT CHARLESTON

**COMPLETION REPORT FOR TANK P
AND PUMP ROOM AT
CHICORA TANK FARM IN
NORTH CHARLESTON, S.C.**

ENVIRONMENTAL DETACHMENT
CHARLESTON
1899 NORTH HOBSON AVE.
NORTH CHARLESTON, S.C. 29405-2106

April 1999

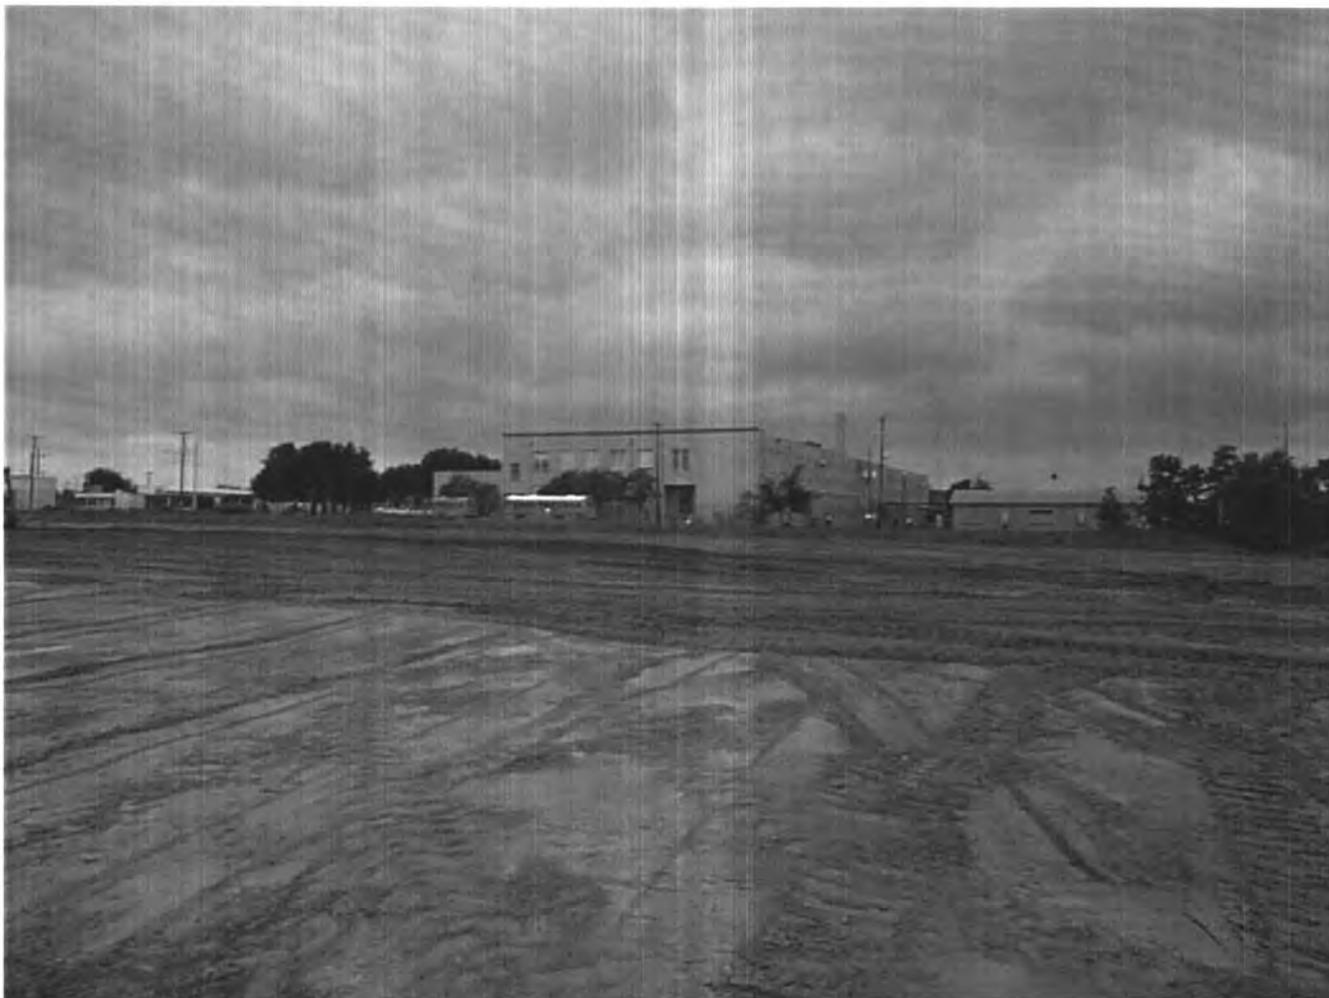
7.14 FINISHED CONTOURED SITE

The site was backfilled, vibratory compacted, graded, and sloped. The finished grade has an elevation of 15-16 feet which slopes down from west to east to 12.5 feet above mean sea level. The remaining tank floor is 13-15 feet below the finished grade level. The ex-tank site has layers of different material. The layer on the tank bottom is approximately 4 feet of concrete rubble compacted with backfill. On top of the rubble is approximately 3-4 feet of backfill soil filled to the top of the remaining wall. Next is one foot of impervious clay material that is covered with approximately 5-6 feet of backfill soil.

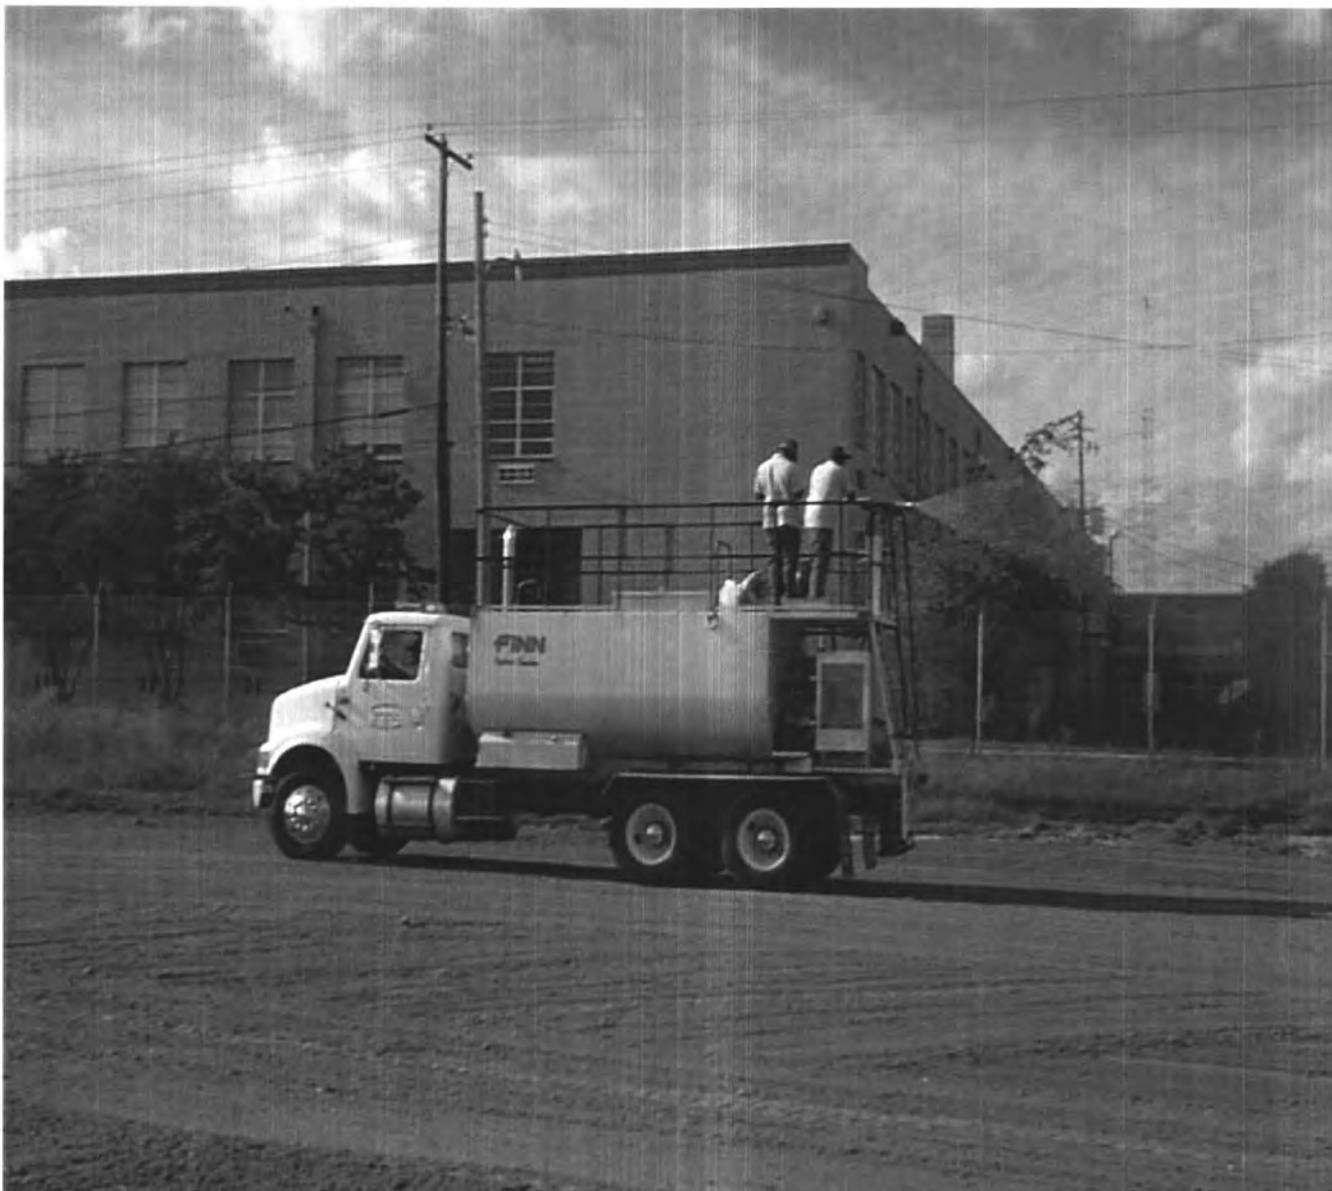
7.15 HYDROSEEDING

The seedbed was prepared and the site was hydroseeded with winter rye and Bermuda grass seed to stabilize the soil and reduce erosion.
