GROUNDWATER SAMPLING REPORT FORMER LIQUID WASTE DISPOSAL AREA SITES 1  
AND 3 NAS CORPUS CHRISTI TX  
6/1/1992  
ENSAFE

**NAVAL AIR STATION  
CORPUS CHRISTI, TEXAS  
GROUNDWATER SAMPLING REPORT**

**JUNE 1992**

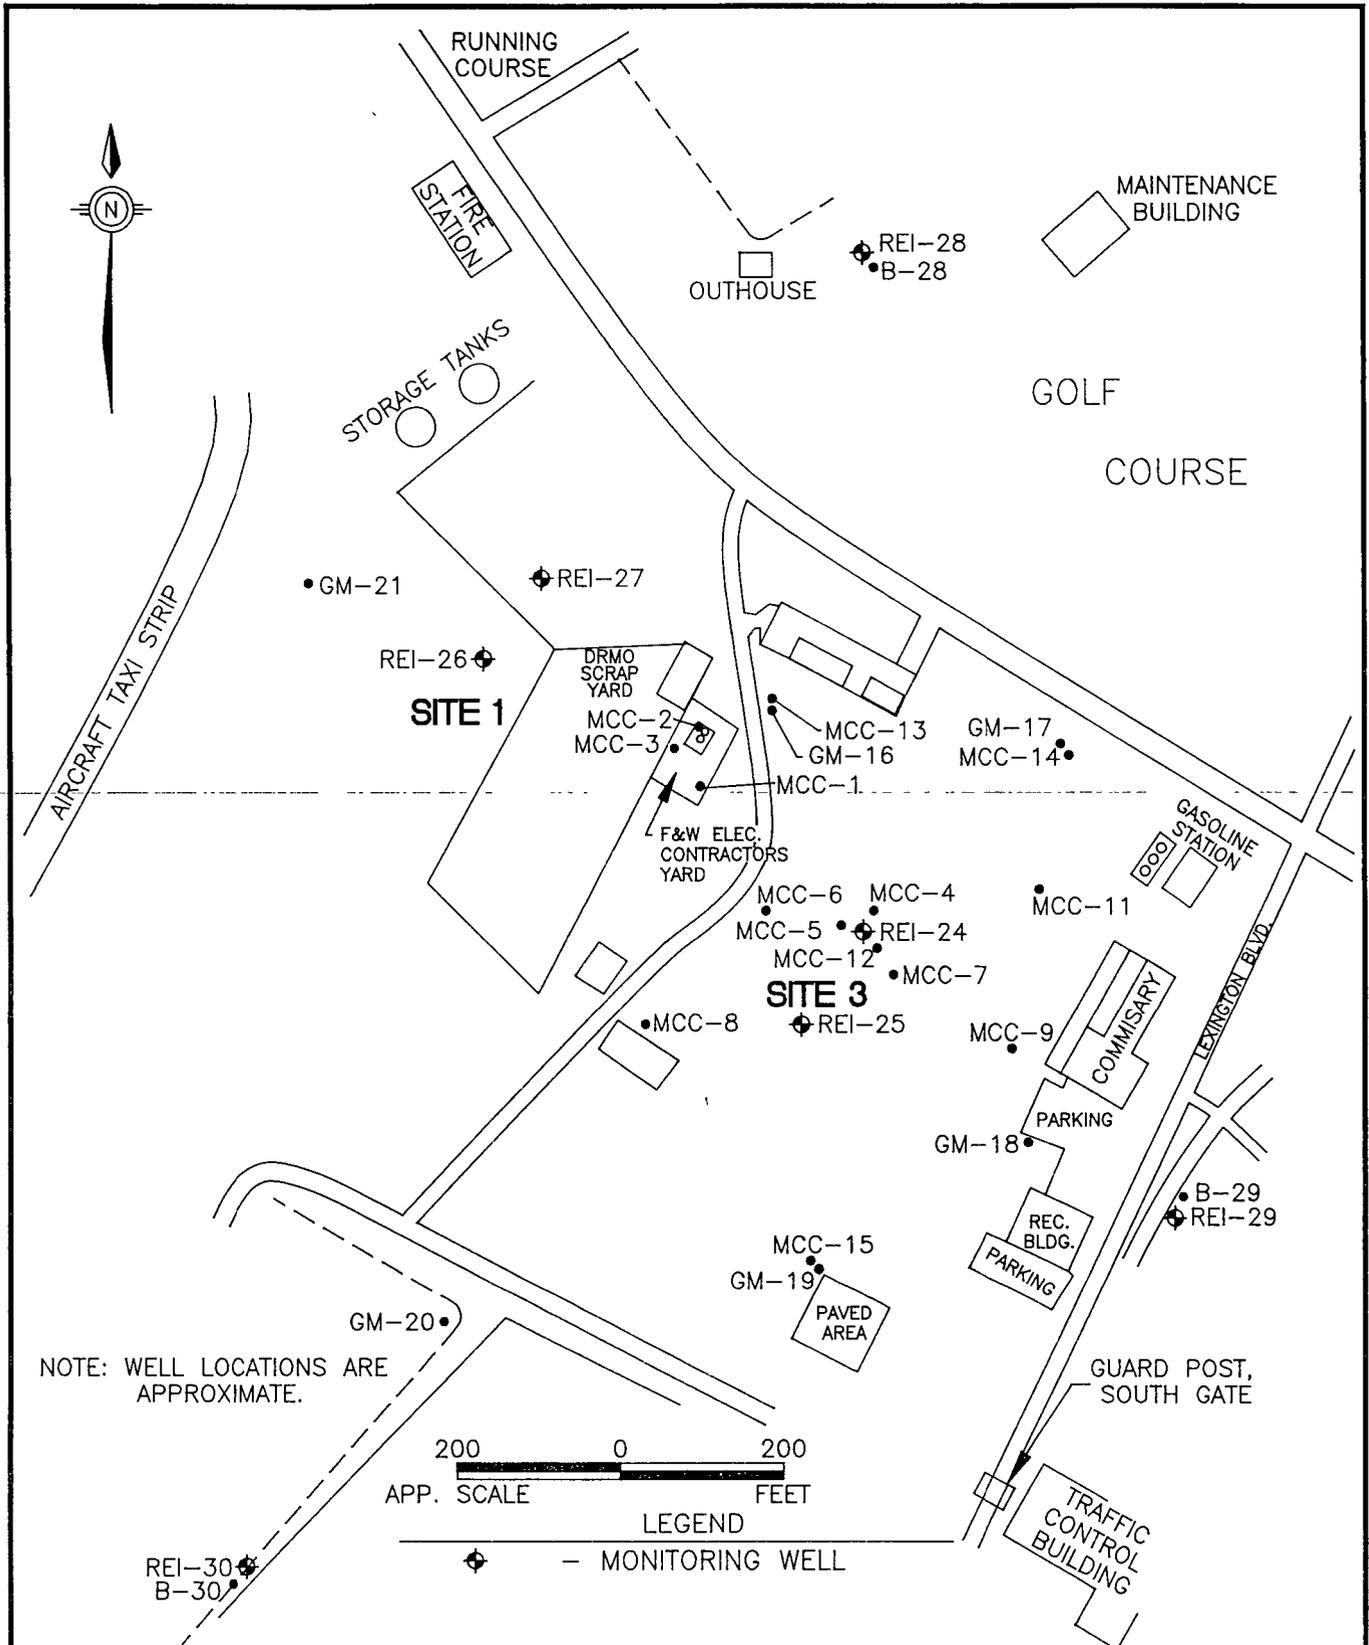
FIGURE 2  
SITES 1 AND 3  
MONITORING WELL LOCATIONS  
CORPUS CHRISTI N.A.S.

The former waste units of this study are located approximately 1000 to 2500 feet northwest of the south gate of the NAS (Figure 1). Locations of groundwater monitoring wells associated with these two units are shown in Figure 2.

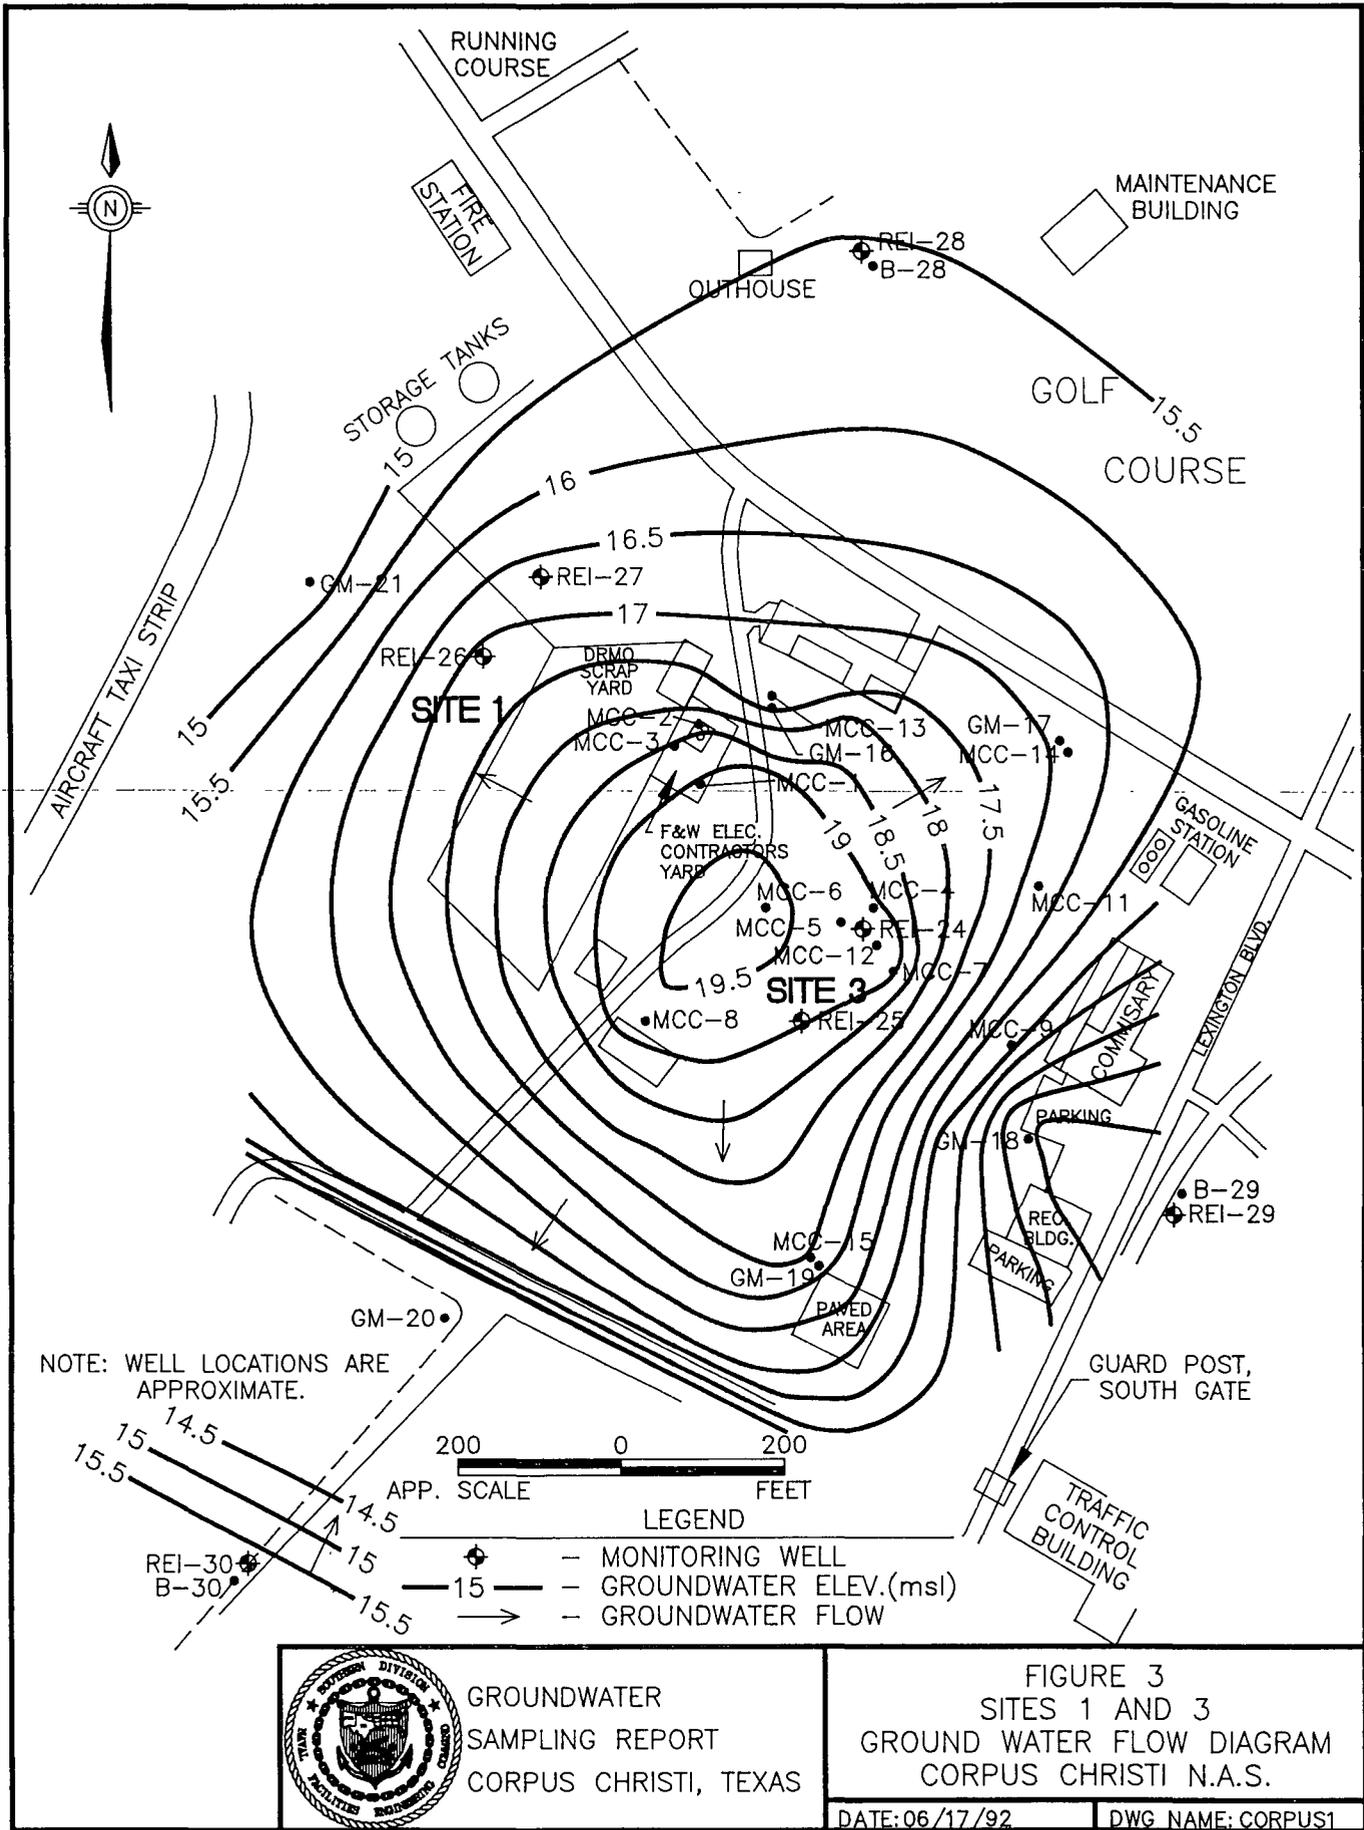
The groundwater flow diagram (Figure 3) indicates that mounding conditions exist in the Site 3 area. The groundwater mound is centered around MCC-6 with flow radiating outward across the Site 1 area in a northwesterly direction. A groundwater trough exists in the area between GM-20 and REI-30 in southwestern portion of the study area. The cause of these conditions is unknown at this time.
