**Construction Completion Report
French Drain and Groundwater Treatment System Installations
(SWMU's 1, 2, and 4)**

**Naval Air Station
Corpus Christi, Texas**

July 2004

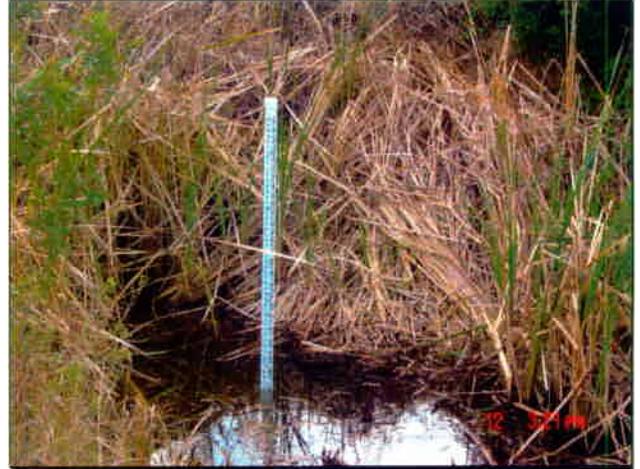
Photo A-7 (General)
Typical flowing sands in excavations

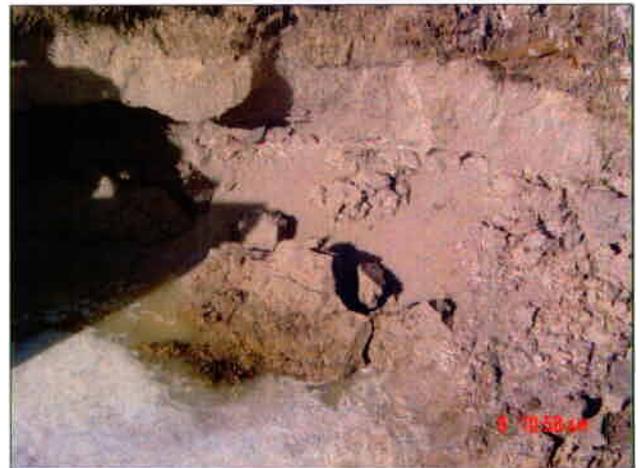
Photo A-8 (General)
Typical flowing sands in excavations

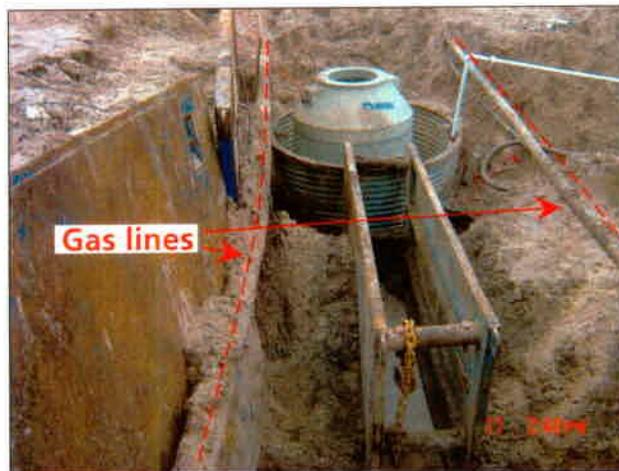
Photo A-23 (Trench 3)
Installation of sump and French drain in Trench Section No. 3. Subsurface natural gas lines running parallel to the trench are exposed on the left and right sides of the trench

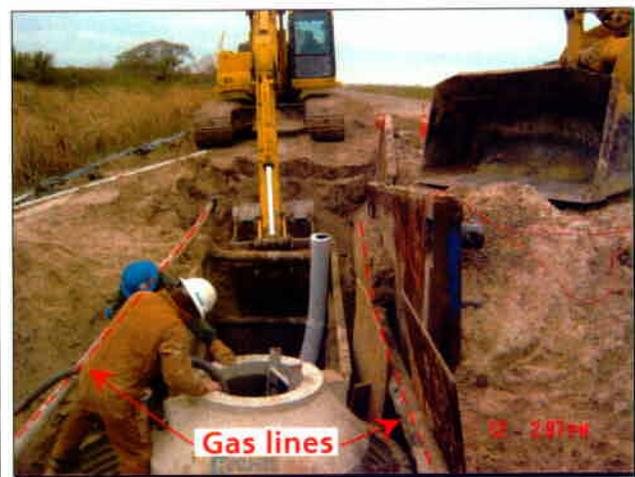
Photo A-24 (Trench 3)
Installation of sump and French drain in Trench Section No. 3. Subsurface natural gas lines running parallel to the trench are exposed on the left and right sides of the trench

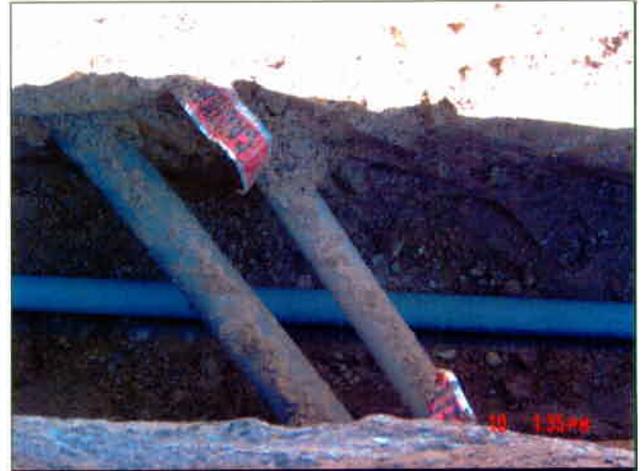
Photo A-34 (Electrical)

Existing utility lines crossing the electrical line/conduit trench adjacent to the DRMO scrap yard

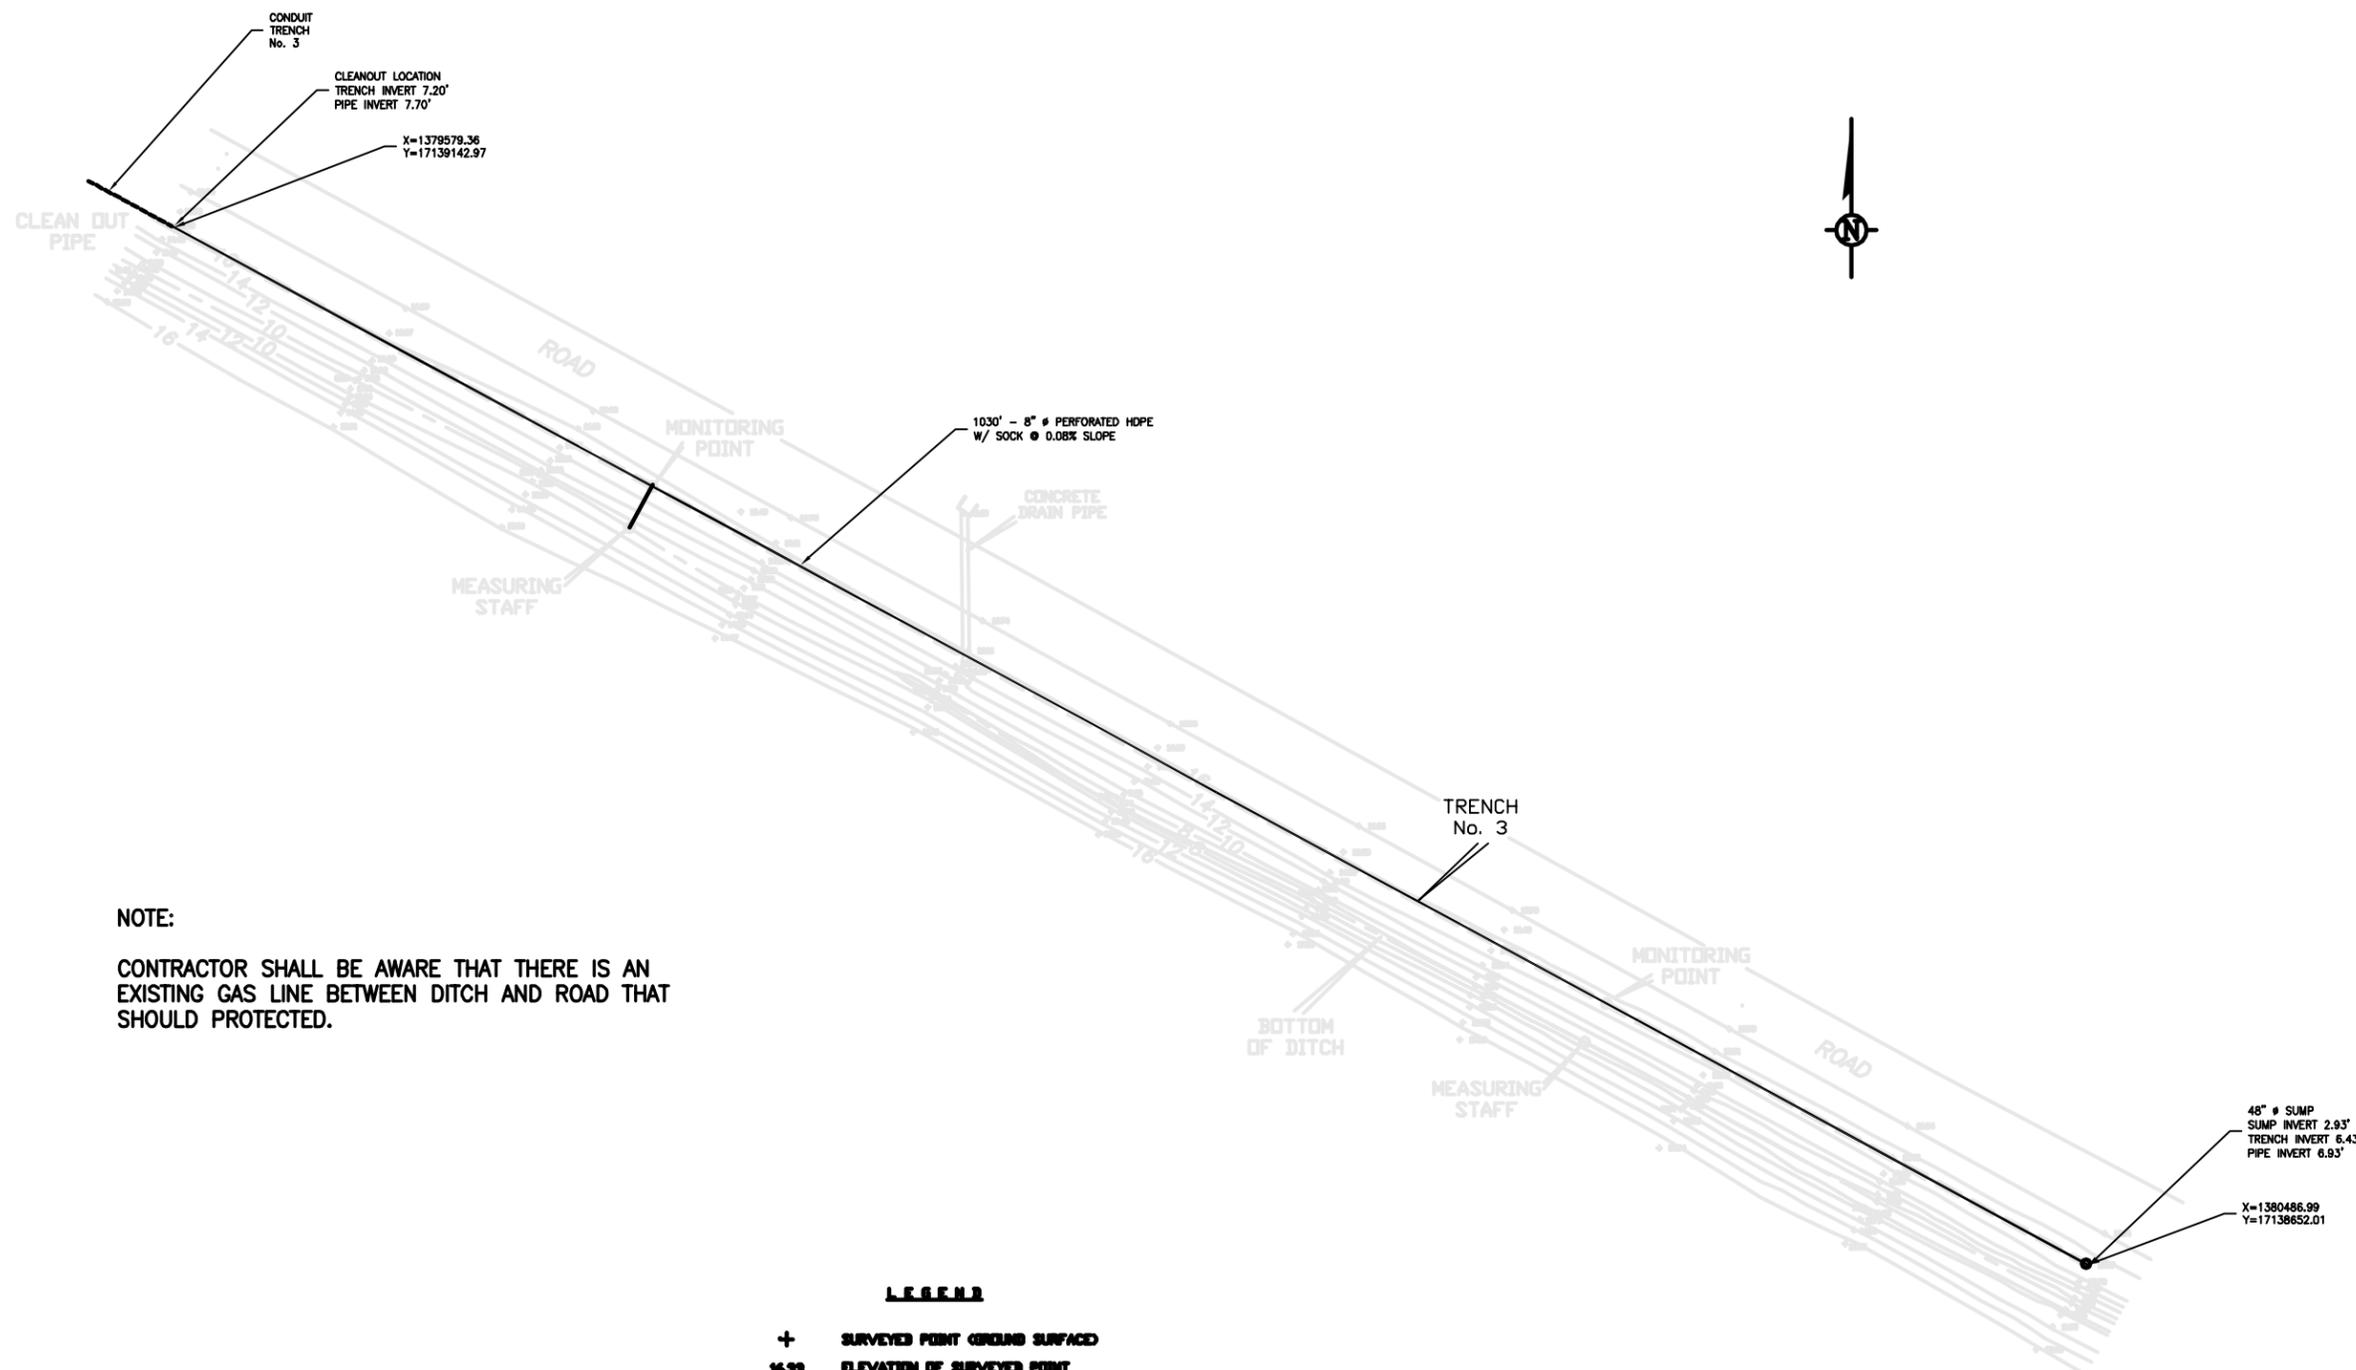
CONTRACTOR SHALL BE AWARE THAT THERE IS AN EXISTING GAS LINE BETWEEN DITCH AND ROAD THAT SHOULD PROTECTED.
