LEAD AND ASBESTOS SURVEY OF COMMISSARY STORE BUILDINGS G-1, G-677 AND G-  
678 NAS KEY WEST FL  
5/22/1995  
NAVY PUBLIC WORKS CENTER

**LEAD AND ASBESTOS SURVEY  
OF  
COMMISSARY STORE  
(G-1, G-677, G-678)  
NVSTA KEY WEST, FLORIDA**

**INSPECTION PERFORMED BY  
NAVY PUBLIC WORKS CENTER  
PENSACOLA, FLORIDA**

**MAY 22, 1995**

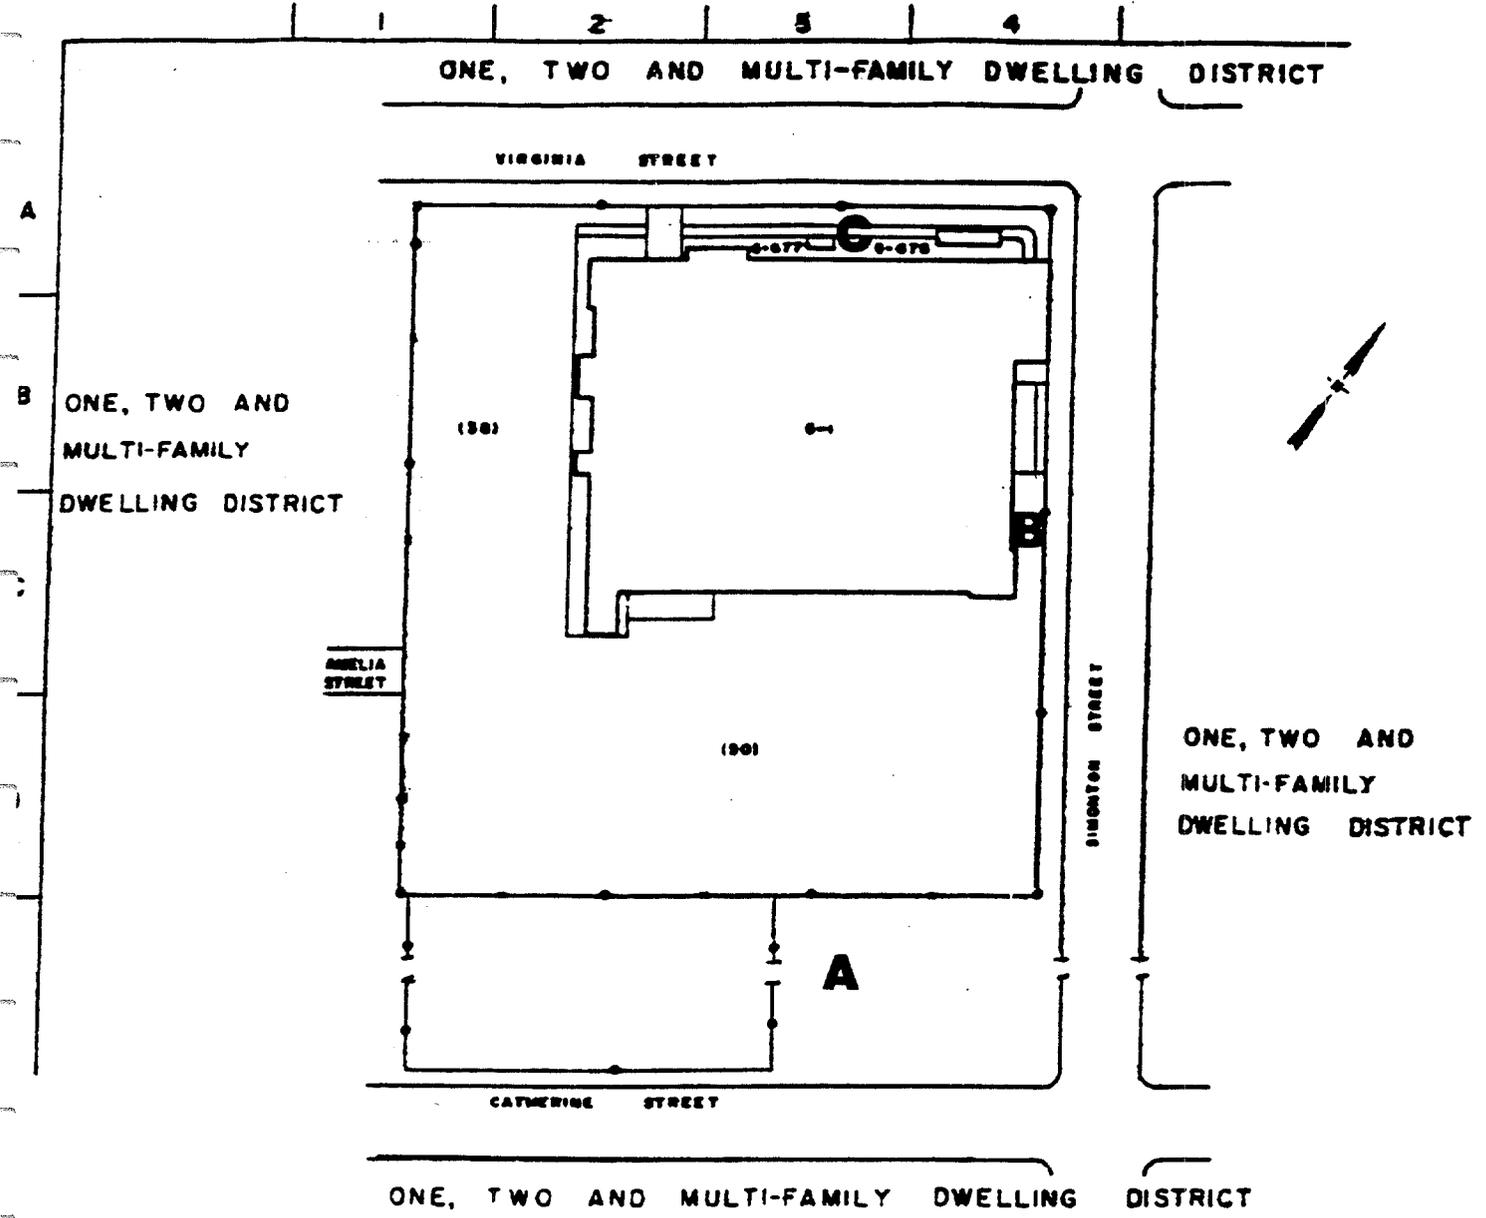
COMMISSARY STORE SOIL RESULTS

<u>SAMPLE #</u>	<u>SOIL EXPOSED(%)</u>	<u>RESULTS (ppm)</u>
A. KW045	90%	390 mg/kg (ppm)
B. KW046	90%	190 mg/kg (ppm)
C. KW047	90%	190 mg/kg (ppm)
