REPORT OF ASBESTOS SURVEY U S DEPARTMENT OF AGRICULTURE ANIMAL AND  
PLANT HEALTH INSPECTION SERVICE FACILITY NAS KEY WEST FL  
6/25/1999  
LAW ENGINEERING AND ENVIRONMENTAL SERVICES

**REPORT OF ASBESTOS SURVEY**

**USDA APHIS FACILITY  
KEY WEST, FLORIDA**

June 25, 1999

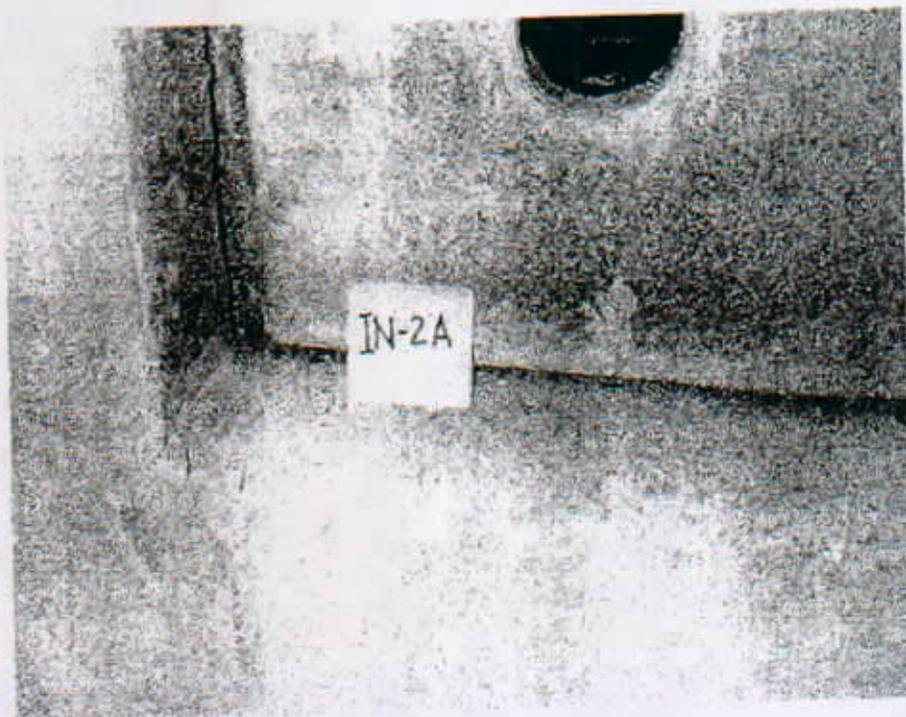
Photo No.2 Center incinerator interior surfacing.

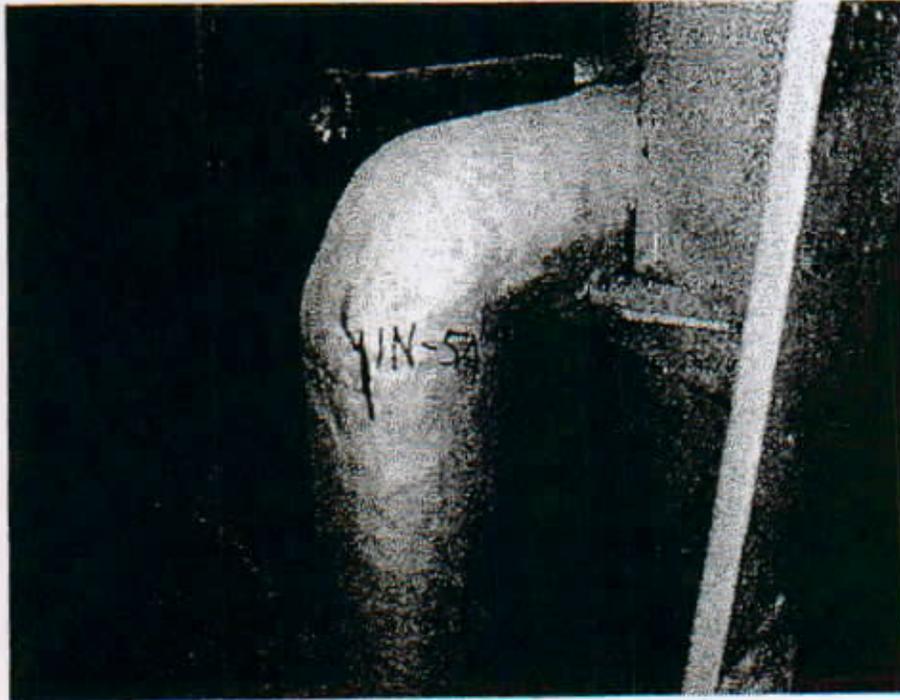
Photo No.5 3-inch & 5-inch diameter fabric-covered pipe insulation.

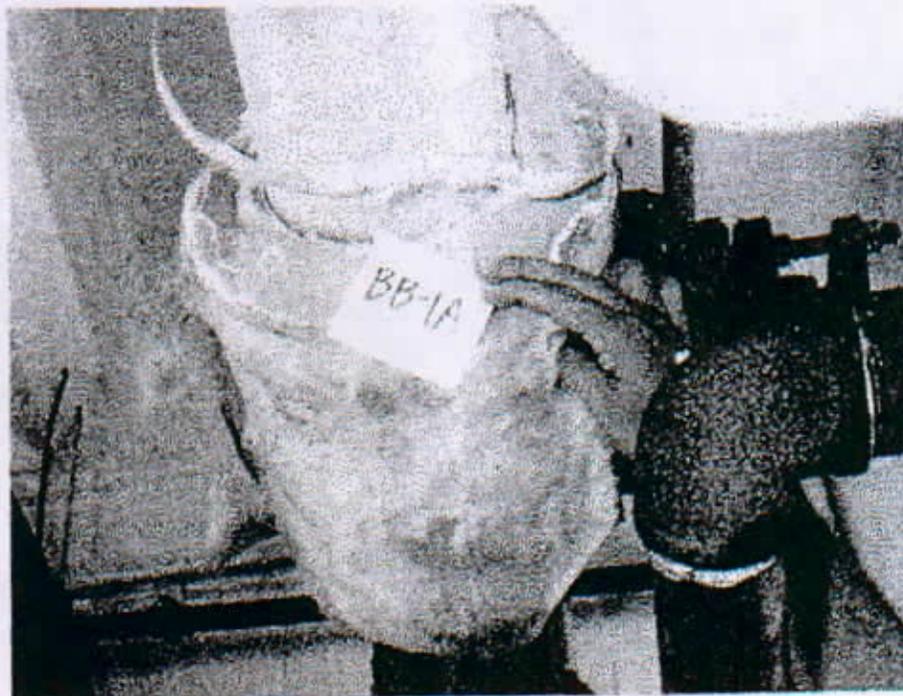
Photo No.9 Pipe insulation gasket, 10-inch diameter.

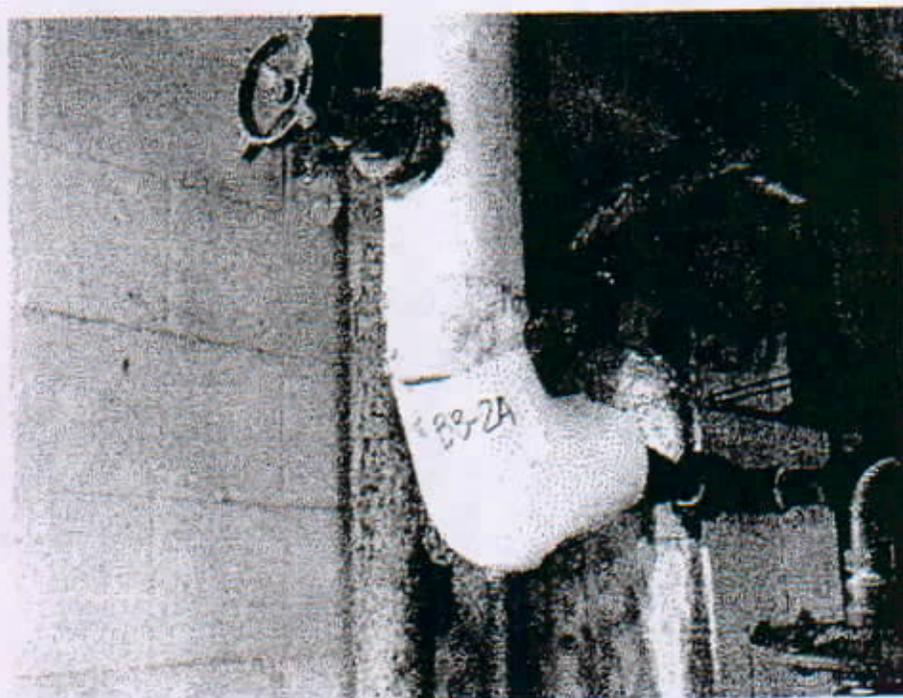
Photo No.10 Pipe insulation, 5-inch diameter.

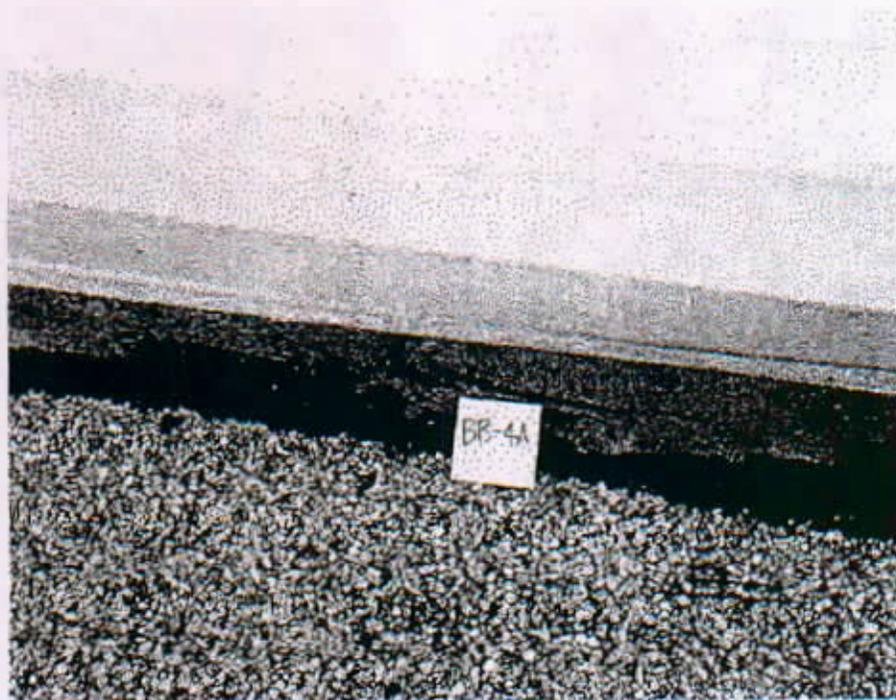
- **Main Building, Roof** - Samples of the built-up roof and the base flashings were found to contain asbestos.
- **Main Building, Barn Area** - Samples of the joint sealant for the exterior wall panels were found to contain asbestos.

Photo No.12 Asbestos-containing base flashing.

The identified Category I non-friable building materials were in good condition at the time of the survey. Prior to future renovation activities that would disturb these materials, we recommend that these asbestos-containing materials be removed by a State of Florida licensed Asbestos Removal Contractor in accordance with plans and specifications prepared by a licensed Florida Asbestos Consultant. Additionally, while these materials remain within the facility, we recommend that they be maintained in an asbestos Operations and Maintenance (O&M) Program.

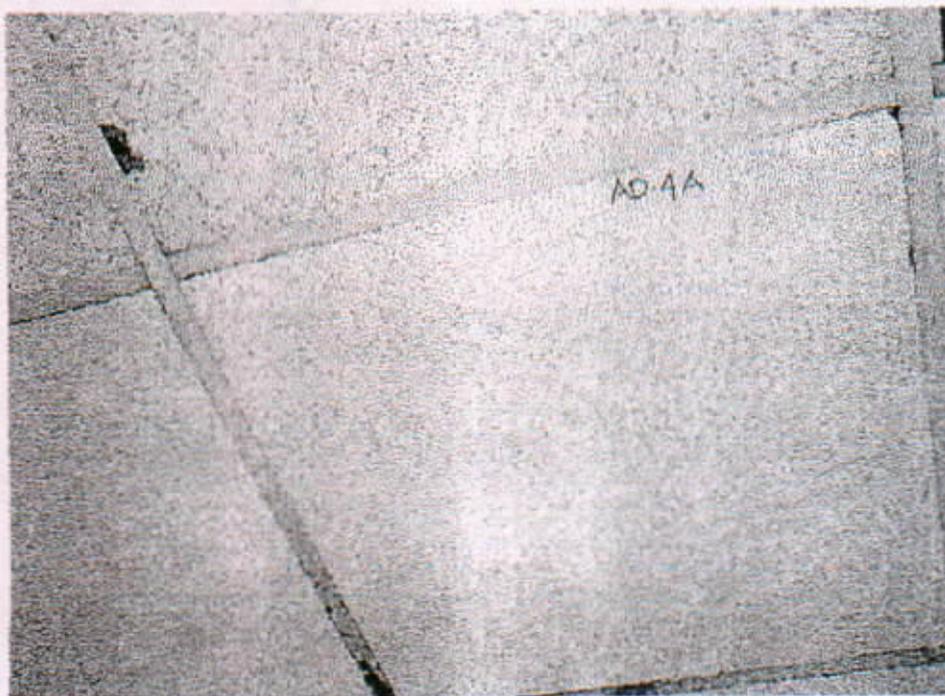
- **Main Building, Administration Area** – A total of 33 samples were collected from this area of the Main Building. Samples of the following materials were found to contain asbestos: 12-inch square brown floor tile/mastic, 12-inch square tan floor tile/mastic, 12-inch square white floor tile/mastic, 12-inch square blue floor tile/mastic, 12-inch square red floor tile/mastic, and sheet floor covering. These materials are defined as Category I non-friable ACM and were observed to be in good condition.

Photo No.16 Asbestos-containing 12" x 12" tan floor tile/mastic.

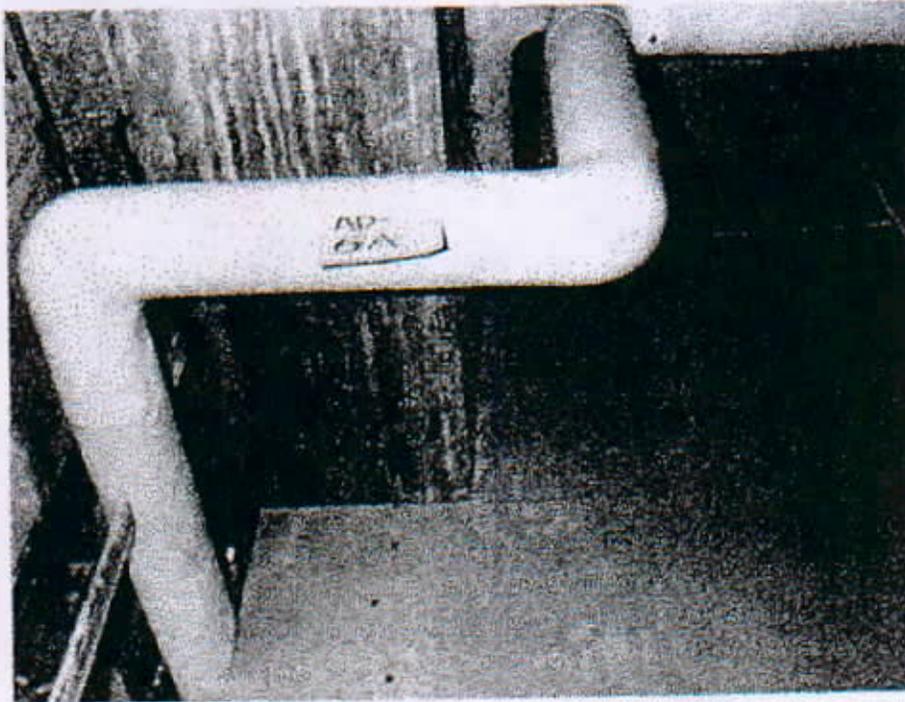
Photo No.17 3-inch and 5-inch diameter pipe insulation.

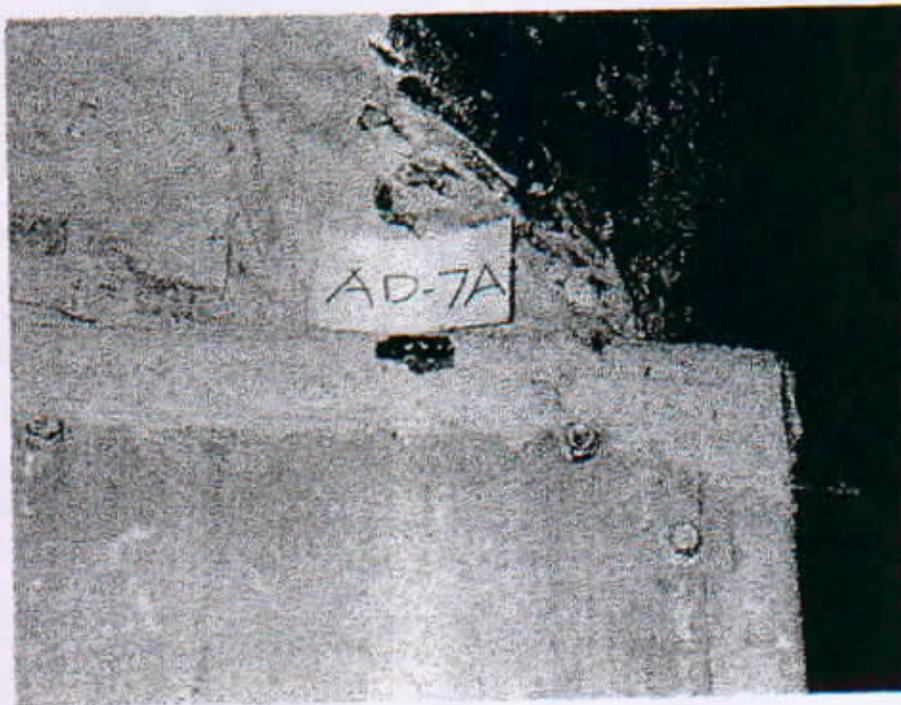
Photo No.18 White mastic on air handler.

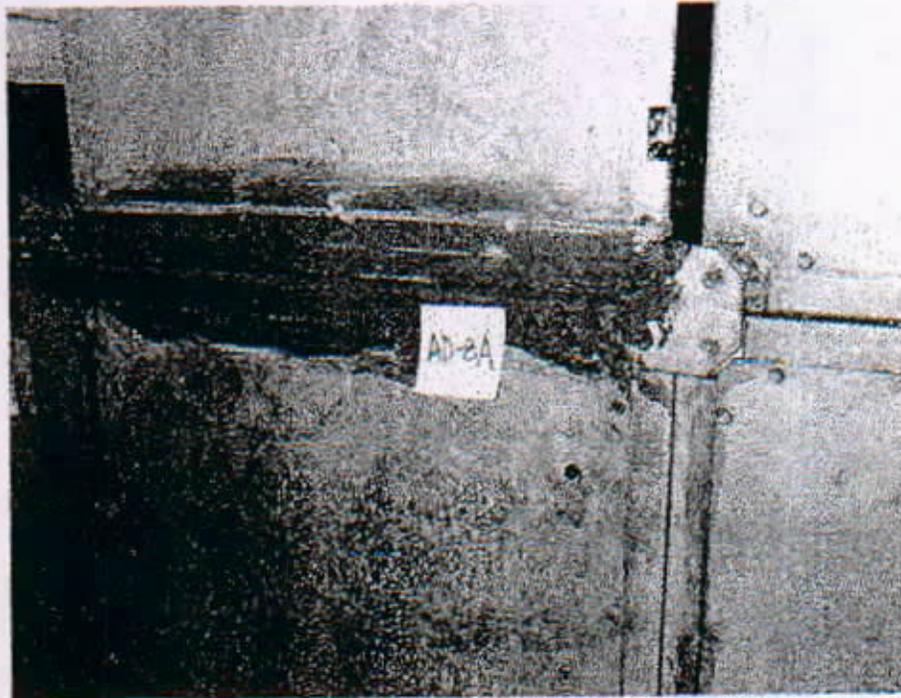
Photo No.19 Gray mastic on air handler.

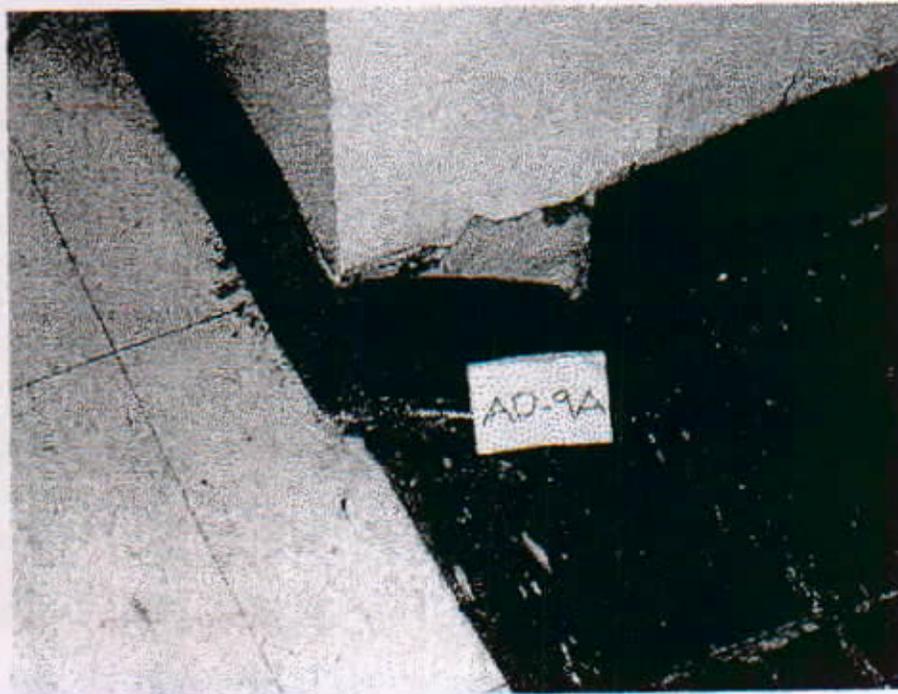
Photo No.20 Brown wall base trim/mastic.

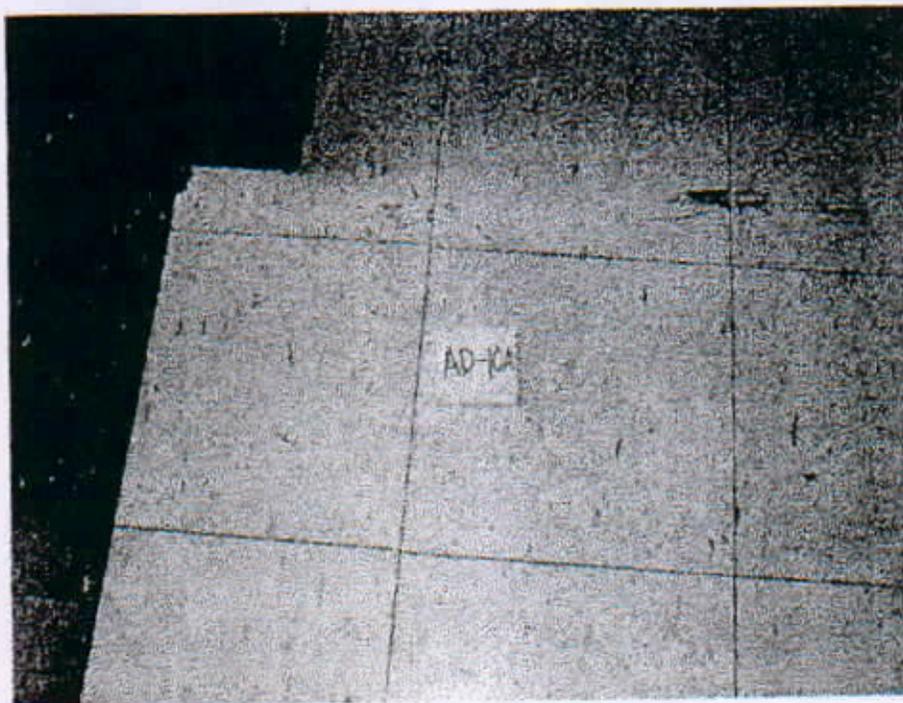
Photo No.21 Asbestos-containing 12" x 12" white floor tile/mastic.

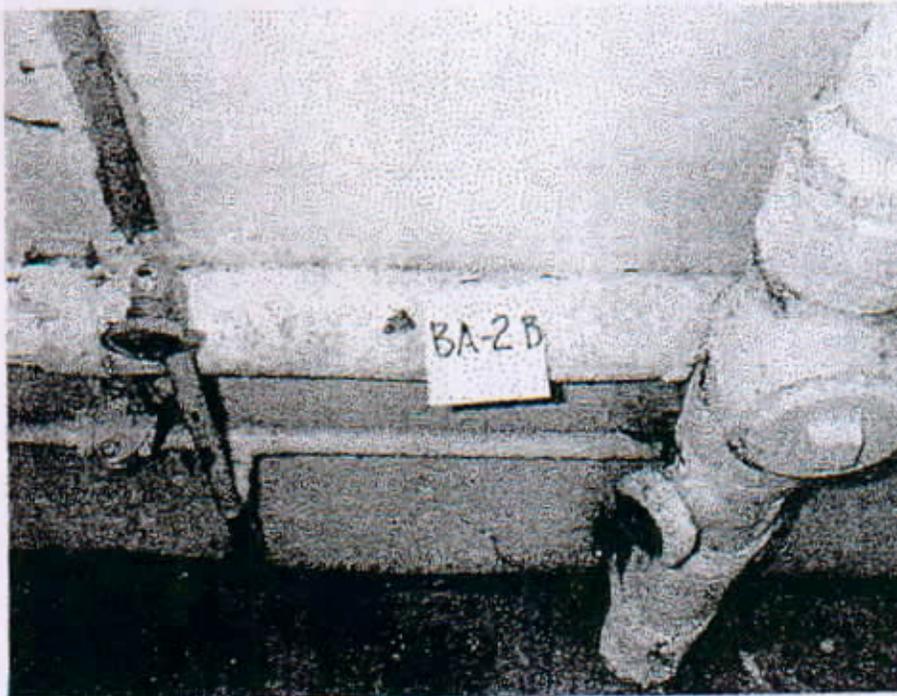
Photo No.26 Four-inch diameter pipe insulation.

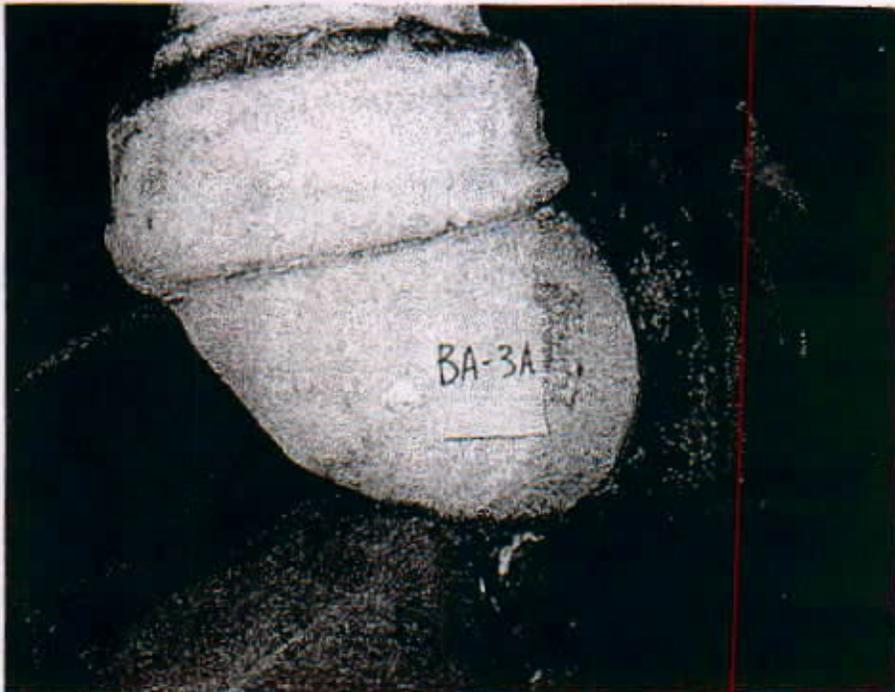
- Photo No.27 Muffler pipe elbow.

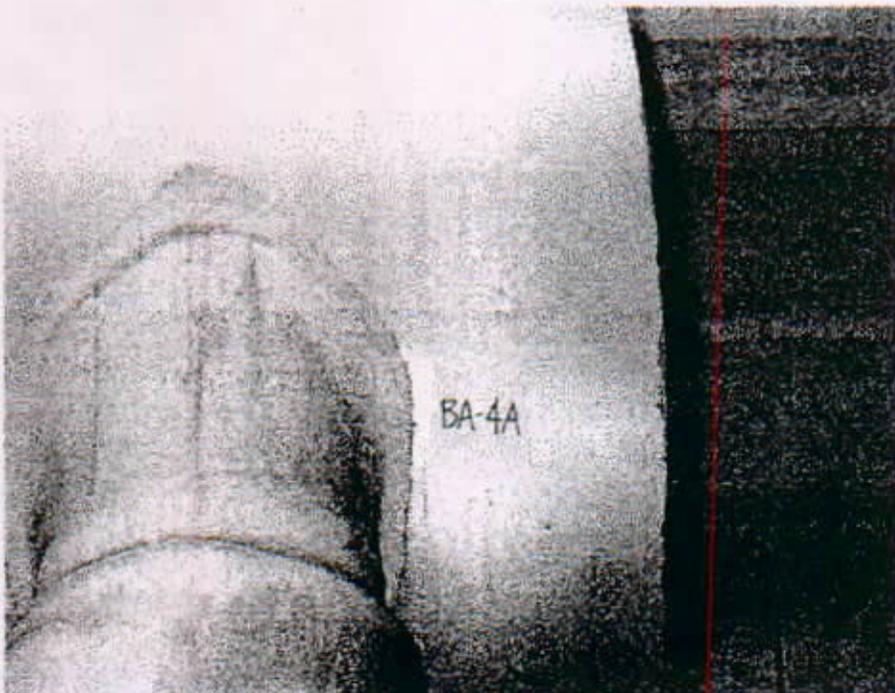
Photo No.28 Muffler tank insulation.

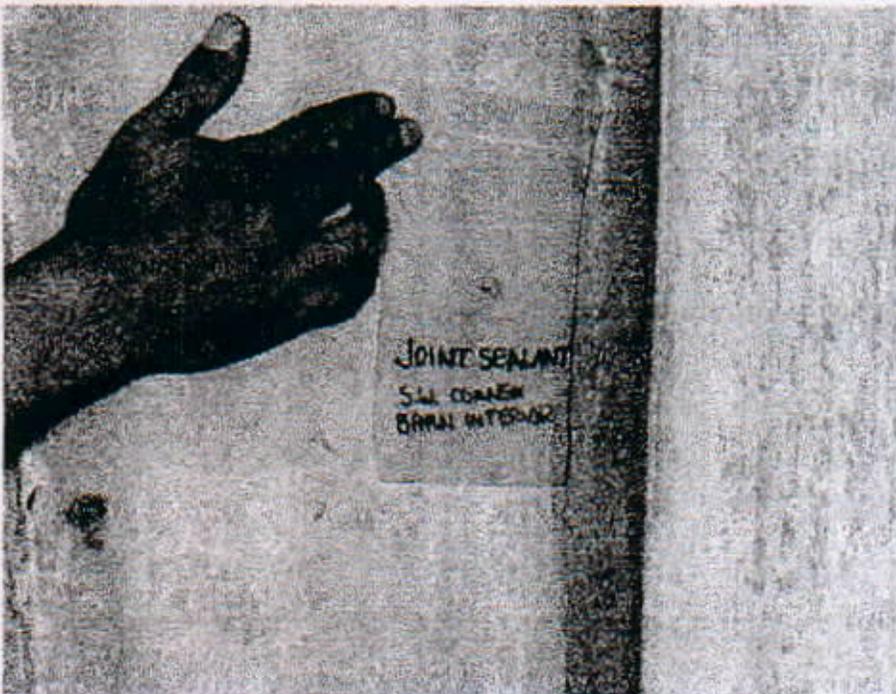
Photo No.32 Exterior wall panel joint sealant.

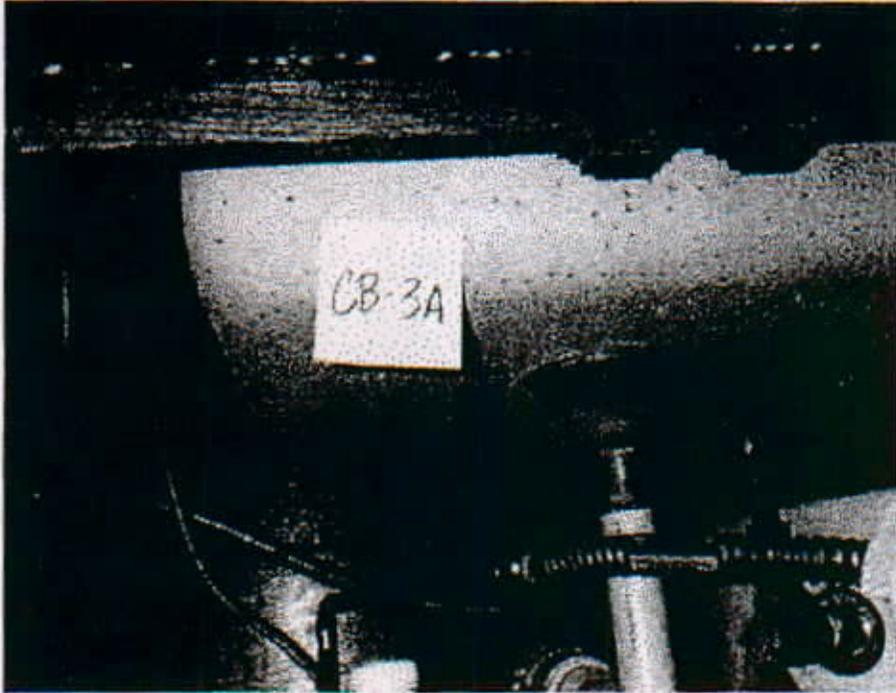
- **Control Building** – A total of 29 samples were obtained from this building (including the exterior surfacing of the Boiler Building and Wastewater Treatment Structure). Samples of the following materials were found to contain asbestos: sink undercoating, 12-inch square red floor tile/mastic, 12-inch square blue floor tile/mastic, built-up roof and base flashings. These materials are defined as Category I non-friable ACM and were observed to be in good condition.

Photo No.35 Asbestos-containing sink undercoating.

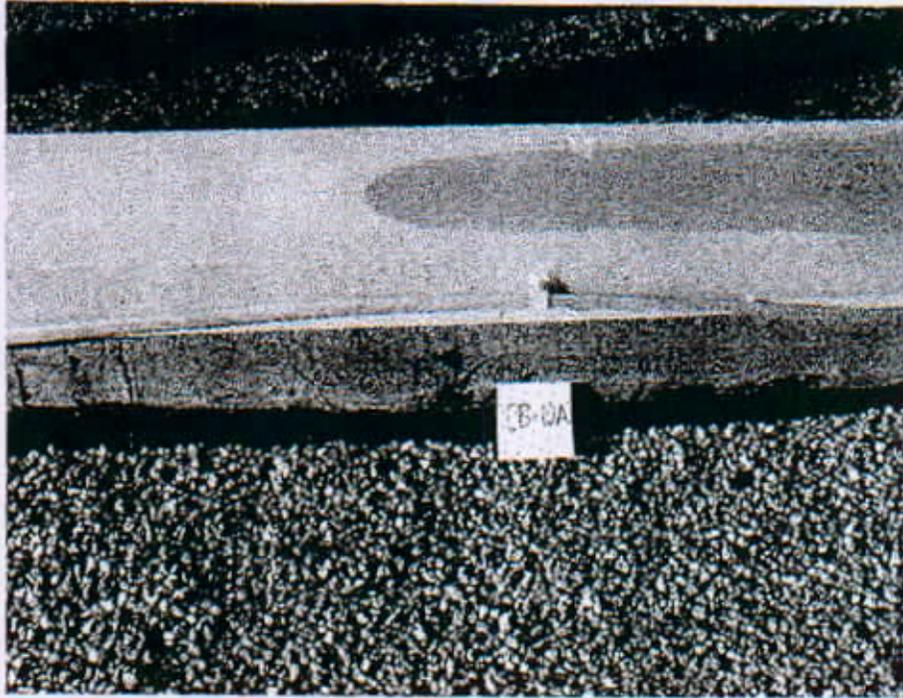
Photo No.41 Asbestos-containing base flashing.
