TRANSMITTAL LETTER FOR INSPECTION REPORT AND REPAIR OF GASOLINE
UNDERGROUND STORAGE TANKS AT SIGSBEE NEX NAS KEY WEST FL
06/13/2006
AUSTIN BROCKENBROUGH & ASSOCIATES, L.L.P.

Re: Inspection and Repair of USTs at Sigsbee NEX, Key West Naval Air Station, Key West, Florida; A&E Contract No. N62467-03-D-0160; SOW No. 22; AB&A Job No. 06-046; **Gasoline Storage Tanks - Inspection Report Letter.**

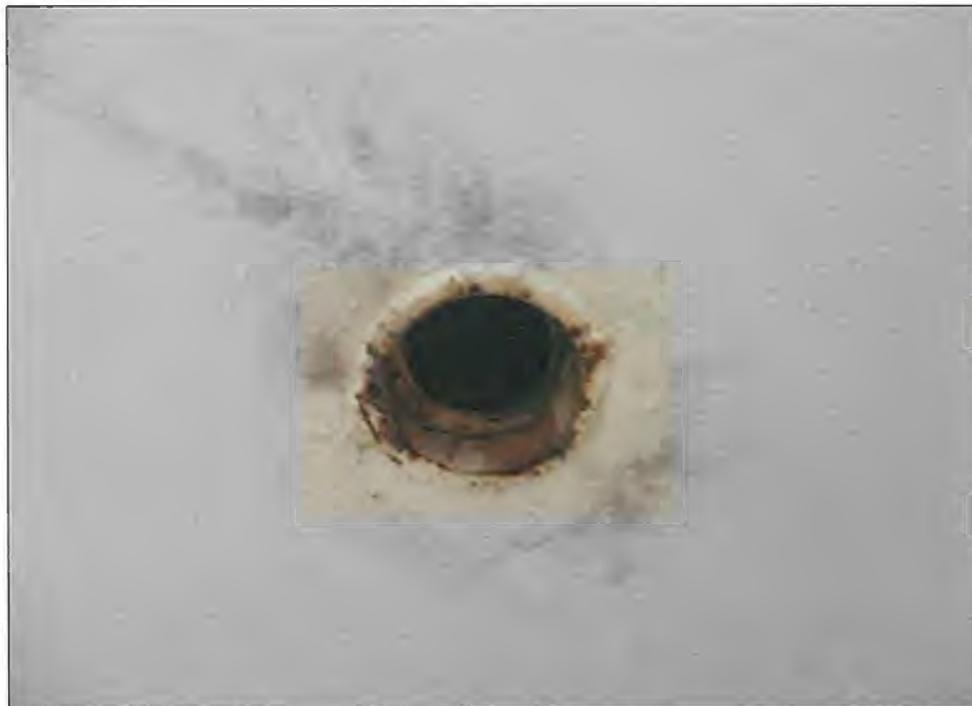
Photograph 1 – Threaded Vapor Recovery Nozzle and Riser Pipe
The vapory recovery nozzle threaded connection may not be vapor tight.
The irregularities in the interior coating shown here are coating blisters.

The interior coating of the premium gasoline tank is blistered as may be seen in Photograph 1. While no recommendations for replacing the coating are made at this time, the situation should be closely monitored as it could become a contamination problem if the coating starts to disintegrate.

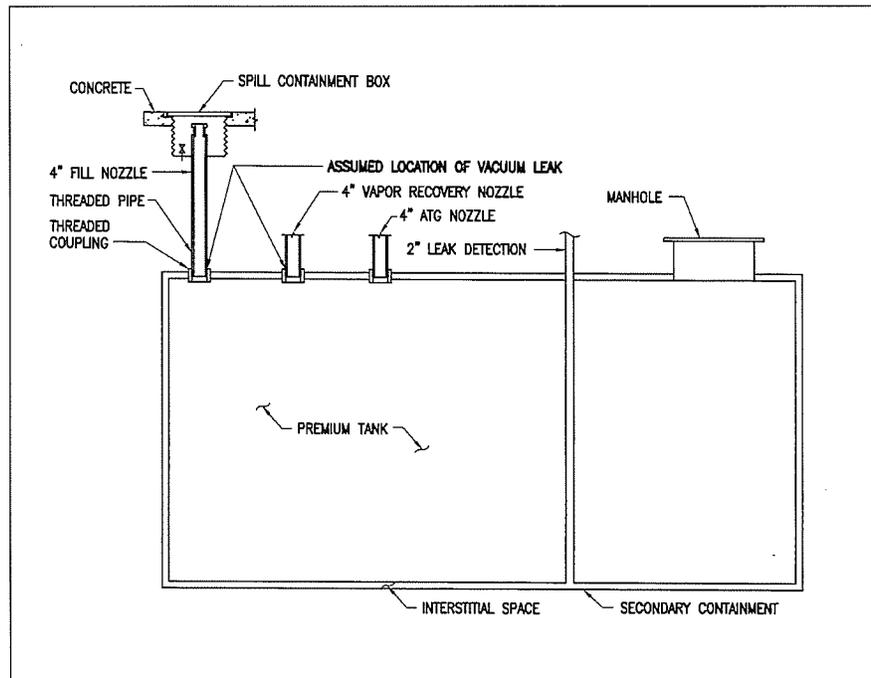
Figure 1 – Believed Location of Vacuum Leak

Acoustic equipment detected the sound of a leak in the vicinity of the vapor recovery and fill nozzle.

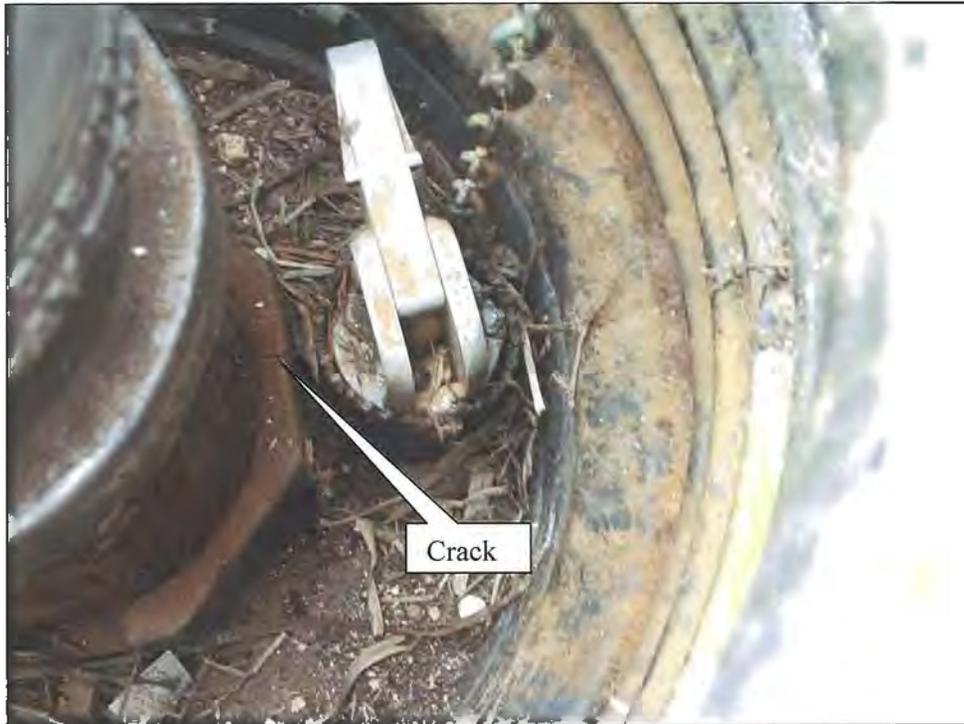
Photograph 2 – Vapor Recovery Spill Containment Box

The fill and vapor nozzle spill containment boxes of the regular gasoline tank appear to be located at a low elevation, relative to the adjacent concrete, which could cause rainwater to run off the concrete and into the boxes. Delivery truck drivers may also be contributing to the problem by opening the fill and/or vapor recovery caps when the spill containment boxes are full of water. It was also determined that the drain valve, located in the vapor recovery spill containment box, was stuck in the open position, and the bottom of the box is cracked at the threaded connection to the 4-inch riser pipe extension as shown in Photograph 2. The crack could allow water to pass unrestricted from the box into the riser pipe.

The cracked vapor recovery spill containment box bottom connection may allow rain water to enter the riser pipe.

1. Provide new fill and vapor recovery piping, and spill containment boxes at an elevation above the adjacent concrete.
2. Around the fill and vapor recovery spill containment boxes, re-install the concrete crown up and at an elevation equal to the adjacent concrete.
