INSPECTION AND REPAIR REPORT OF UNDERGROUND STORAGE TANKS AT SIGSBEE
NEX NAS KEY WEST FL
06/13/2006
AUSTIN BROCKENBROUGH & ASSOCIATES, L.L.P.

INSPECTION AND REPAIR OF USTS AT SIGSBEE NEX

Key West Naval Air Station
Key West, Florida
Contract No. N62467-03-D-0160
Delivery Order No. 22

13 June 2006

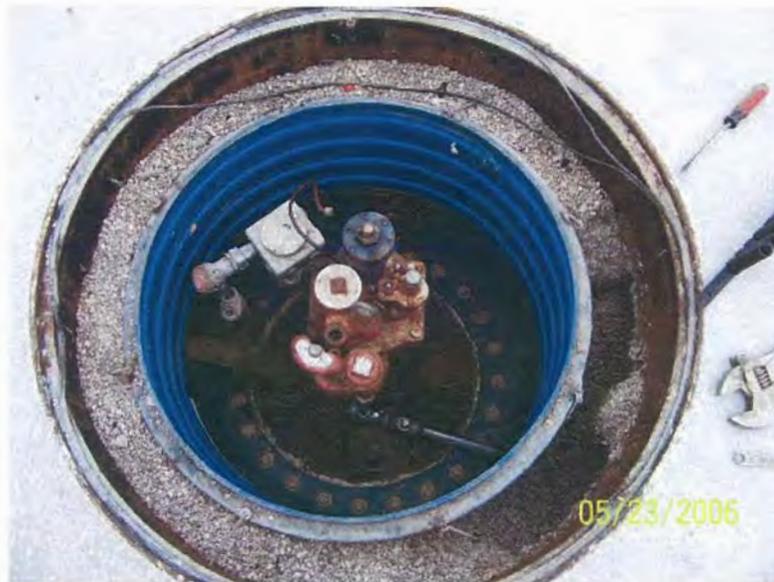
Picture 1 shows the tank sump after removing the manhole cover.

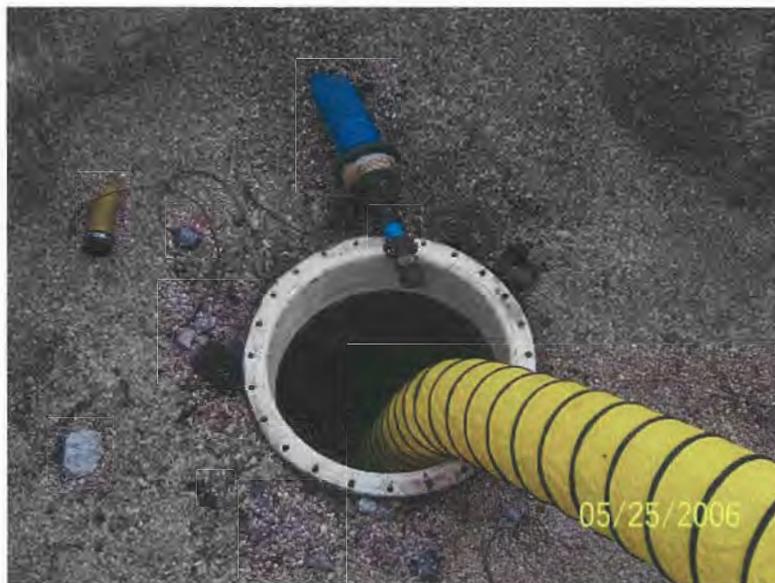
Picture 2 shows the ventilation of the premium tank.

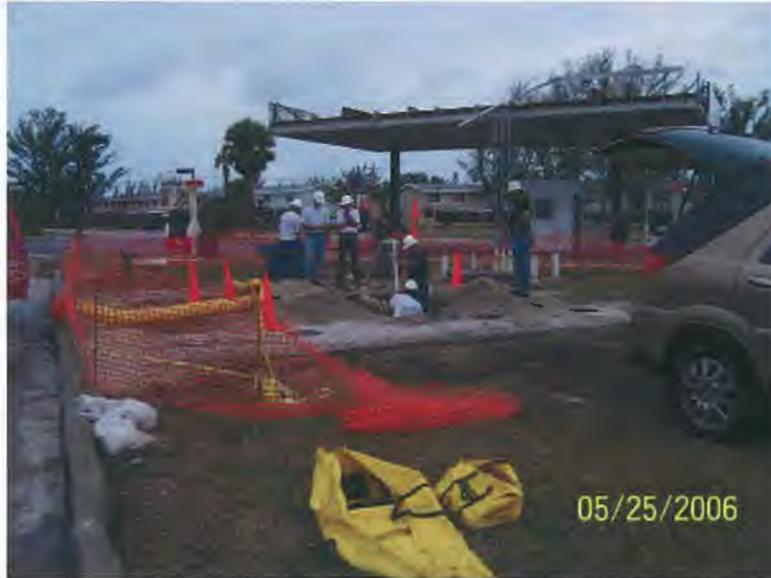
Picture 3 shows the set up of the tripod along with the safety equipment.

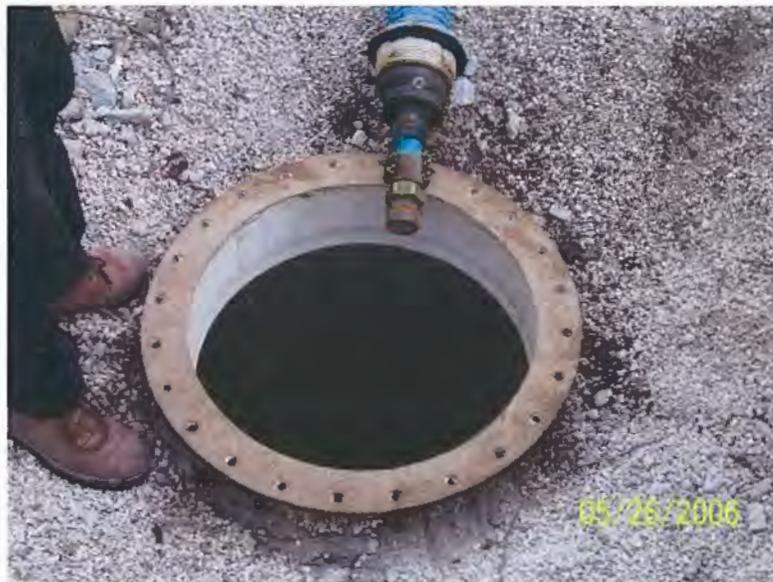
Picture 4 shows the inside of the premium tank after the equipment has been removed from the top of the tank.

HI recommends that the riser pipes be replaced on the premium tank as soon as possible. A Certified Tightness Test should be performed after these repairs. Please be advised an Incident Notification Form should be filed with the Health Department (HRS) explaining when and how the repairs should be completed.

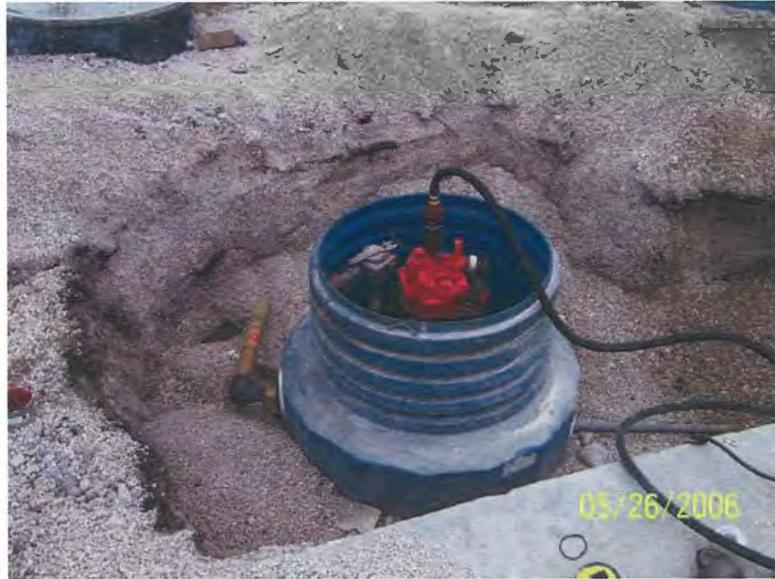
Picture 5 shows the removal of the fuel from the premium tank.

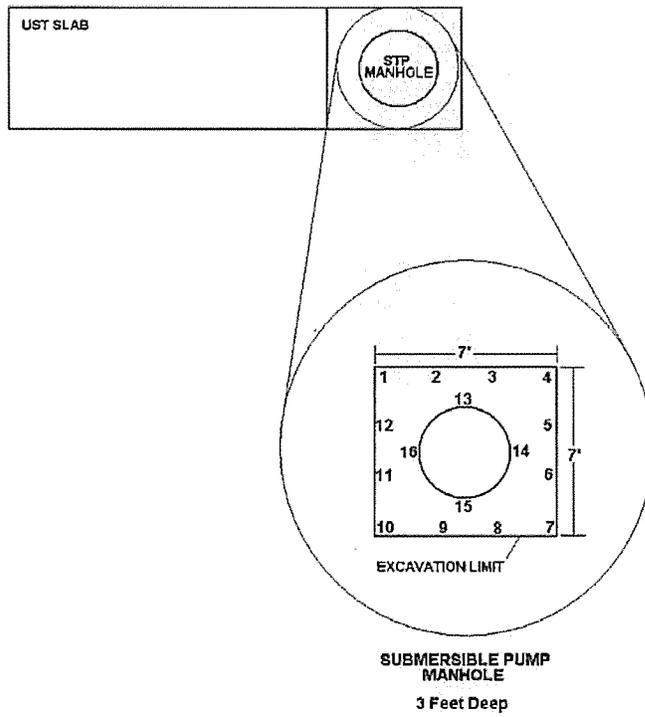
**NEXCOM FACILITY
BUILDING 4085 SIGSBEE ROAD
NAVAL AIR STATION
KEY WEST, FLORIDA**
Not to Scale

Soil samples for field OVA screening were obtained at representative areas of the excavation resulting from the removal of the above referenced component. The total depth of the excavations was approximately 3.0 feet below land surface (BLS). Please see Site Plan.

Positive OVA field screening results were not obtained. Visible staining was not observed. All areas yielded OVA field screening results of <10 ppm. The complete OVA results are appended.
