ENVIRONMENTAL BASELINE SURVEY PUBLIC/PRIVATE VENTURE HOUSING
PRIVATIZATION NAS MAYPORT FL
08/01/2004
NAVFAC SOUTHERN

**Environmental Baseline Survey
Public / Private Venture Housing Privatization
Naval Station Mayport
Mayport, Florida**

August 2004

**Southern Division
Naval Facilities Engineering Command
North Charleston, South Carolina**

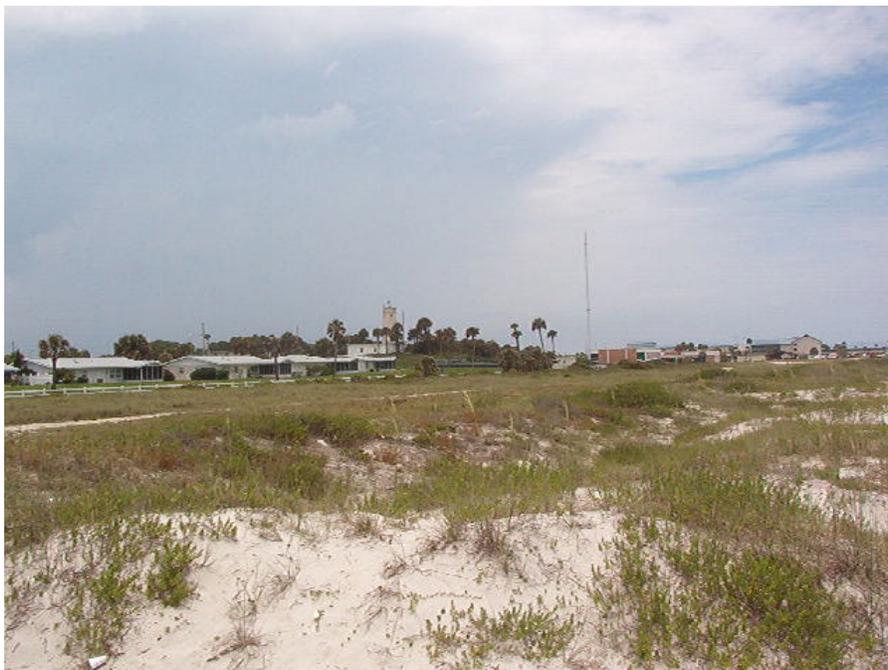
Based on a review of the 1996 Phase I Historic Resources Survey of the Main Cantonment Dune Line, there is an area, the dune line, on the subject property that is reportedly considered a significant cultural resource. The dune line is considered a high potential landform for archaeological studies because of its elevated nature. This site consists of a scatter of prehistoric Swift Creek ceramics.

Main Cantonment Dune Line, portion of subject property at Bennett Shores housing area

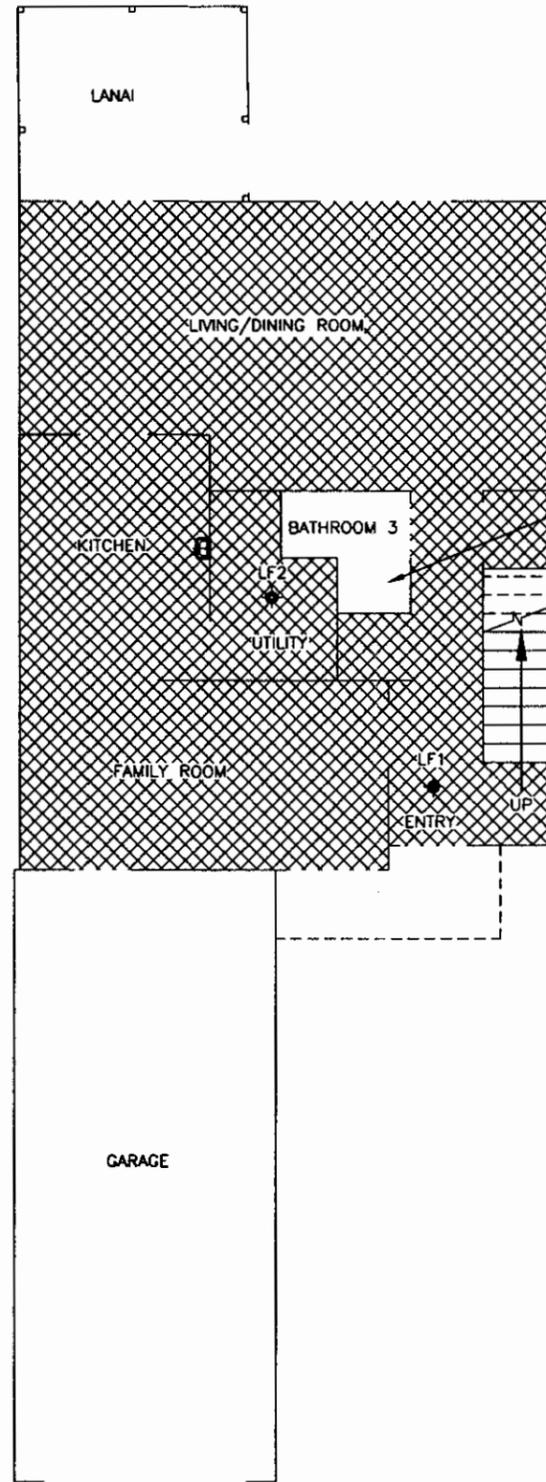
LEAD WAS IDENTIFIED IN THE CERAMIC TILE BASECOVE IN UNIT 1002F (BATHROOM 3).

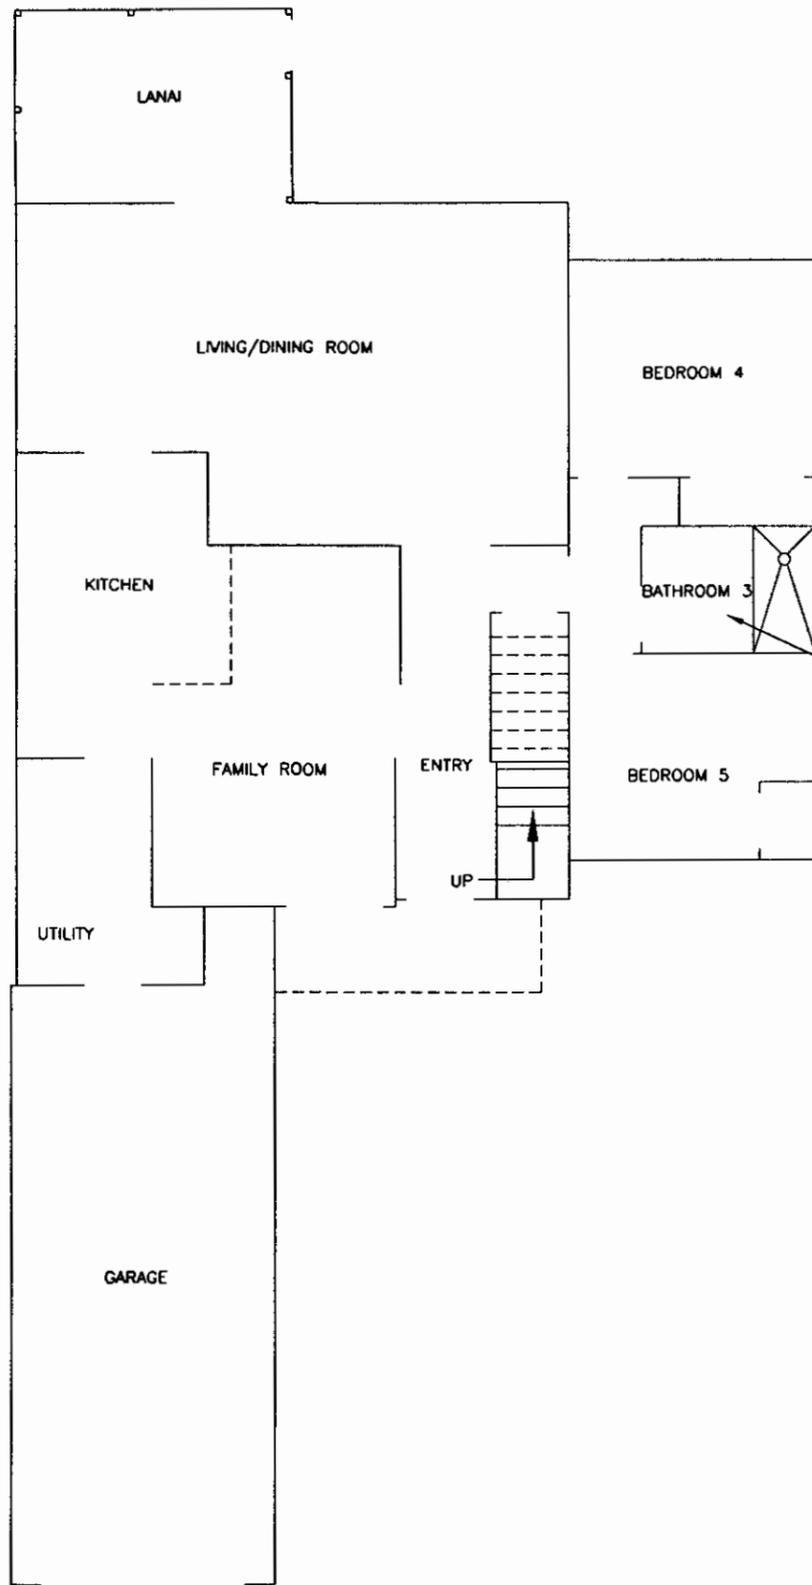
UNIT 1002F HAS CERAMIC TILE BASECOVE GLAZING THAT IS CONSIDERED LBP. CERAMIC TILE BASECOVE MAY CONTAIN LEAD IN UNITS NOT TESTED.
