FINAL 2013 WELL INSPECTION AND MAINTENANCE RECORD MILLINGTON SUPPACT TN
(PUBLIC DOCUMENT)
3/14/2014
RESOLUTION CONSULTANTS

2013 WELL INSPECTION AND MAINTENANCE RECORD

NAVAL SUPPORT ACTIVITY MID-SOUTH
MILLINGTON, TENNESSEE

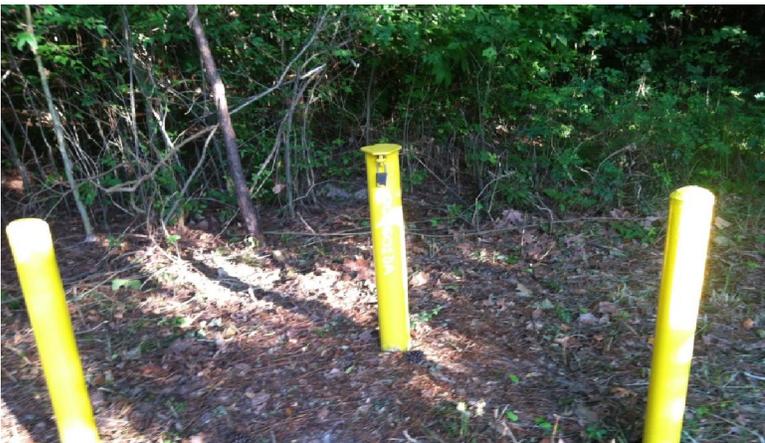
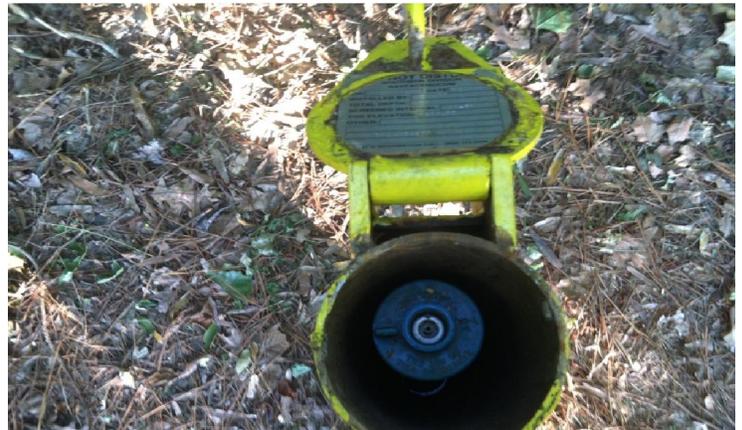
Observations: The monitoring well is in good shape and operational.

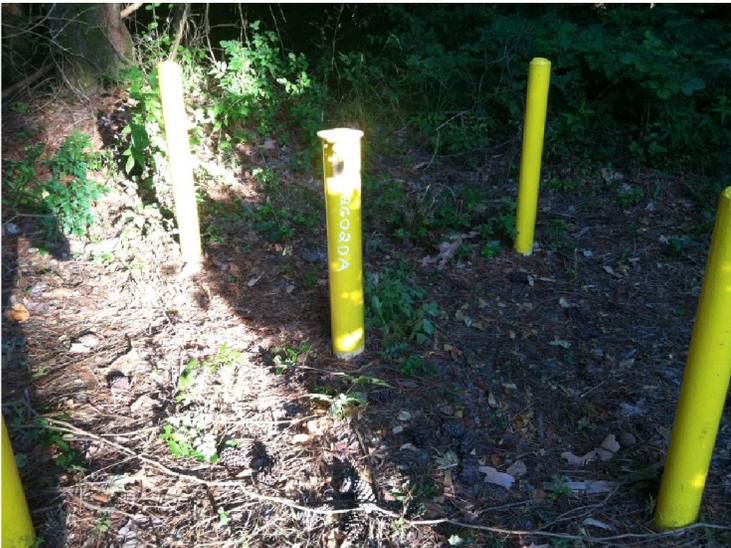
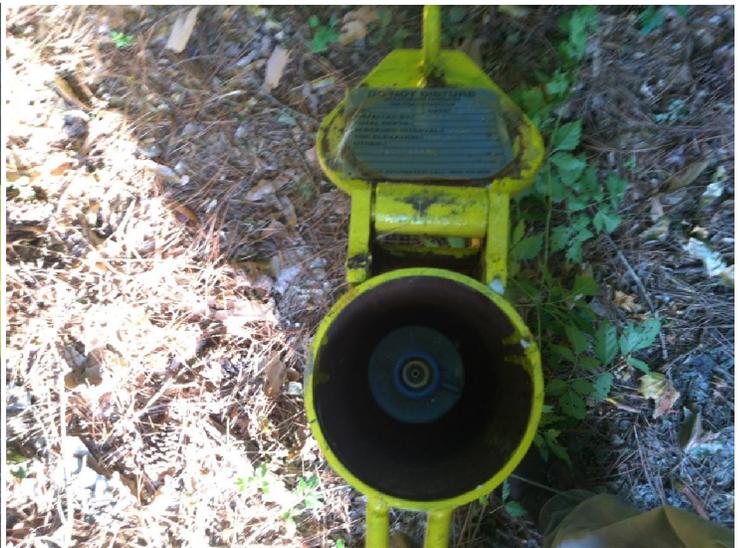
Date: 7/16/2013
 Well ID: 002G02DA Picture No.: _____ Location: SWMU 2
 Completion: _____ Above-ground: Yes

Observations: The monitoring well is in good shape and operational.

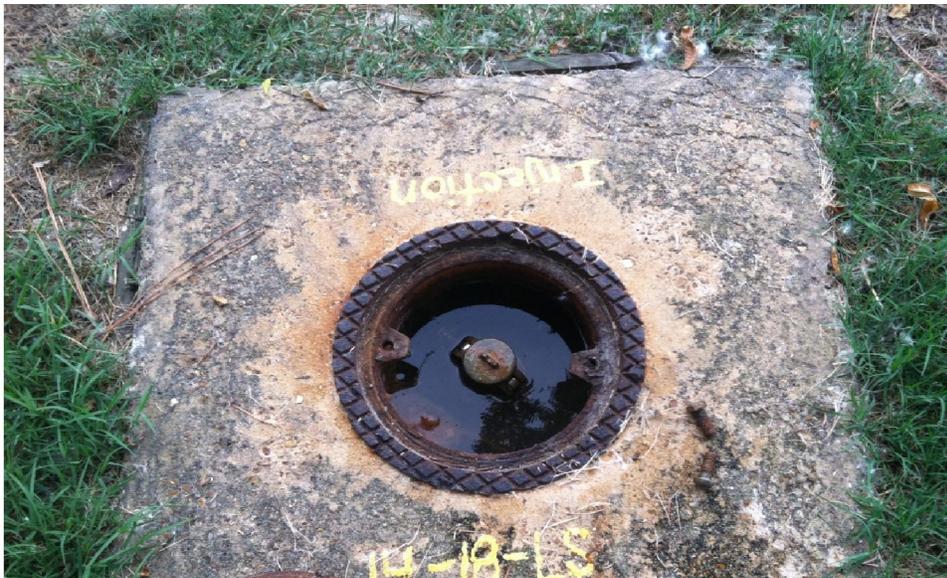
Observations: The injection well is in good shape and operational. Slight water surface water intrusion in well manhole.
