ENVIRONMENTAL CONDITIONS REPORT REMEDIATION OF SOLID WASTE
MANAGEMENT UNIT 39 (SWMU 39) TCE PLUME MILLINGTON SUPPACT TN
10/01/2011
LEE & RYAN

ENVIRONMENTAL CONDITIONS REPORT

Remediation of SWMU 39 TCE Plume
NSA Mid-South
Millington, TN 38054

October 2011

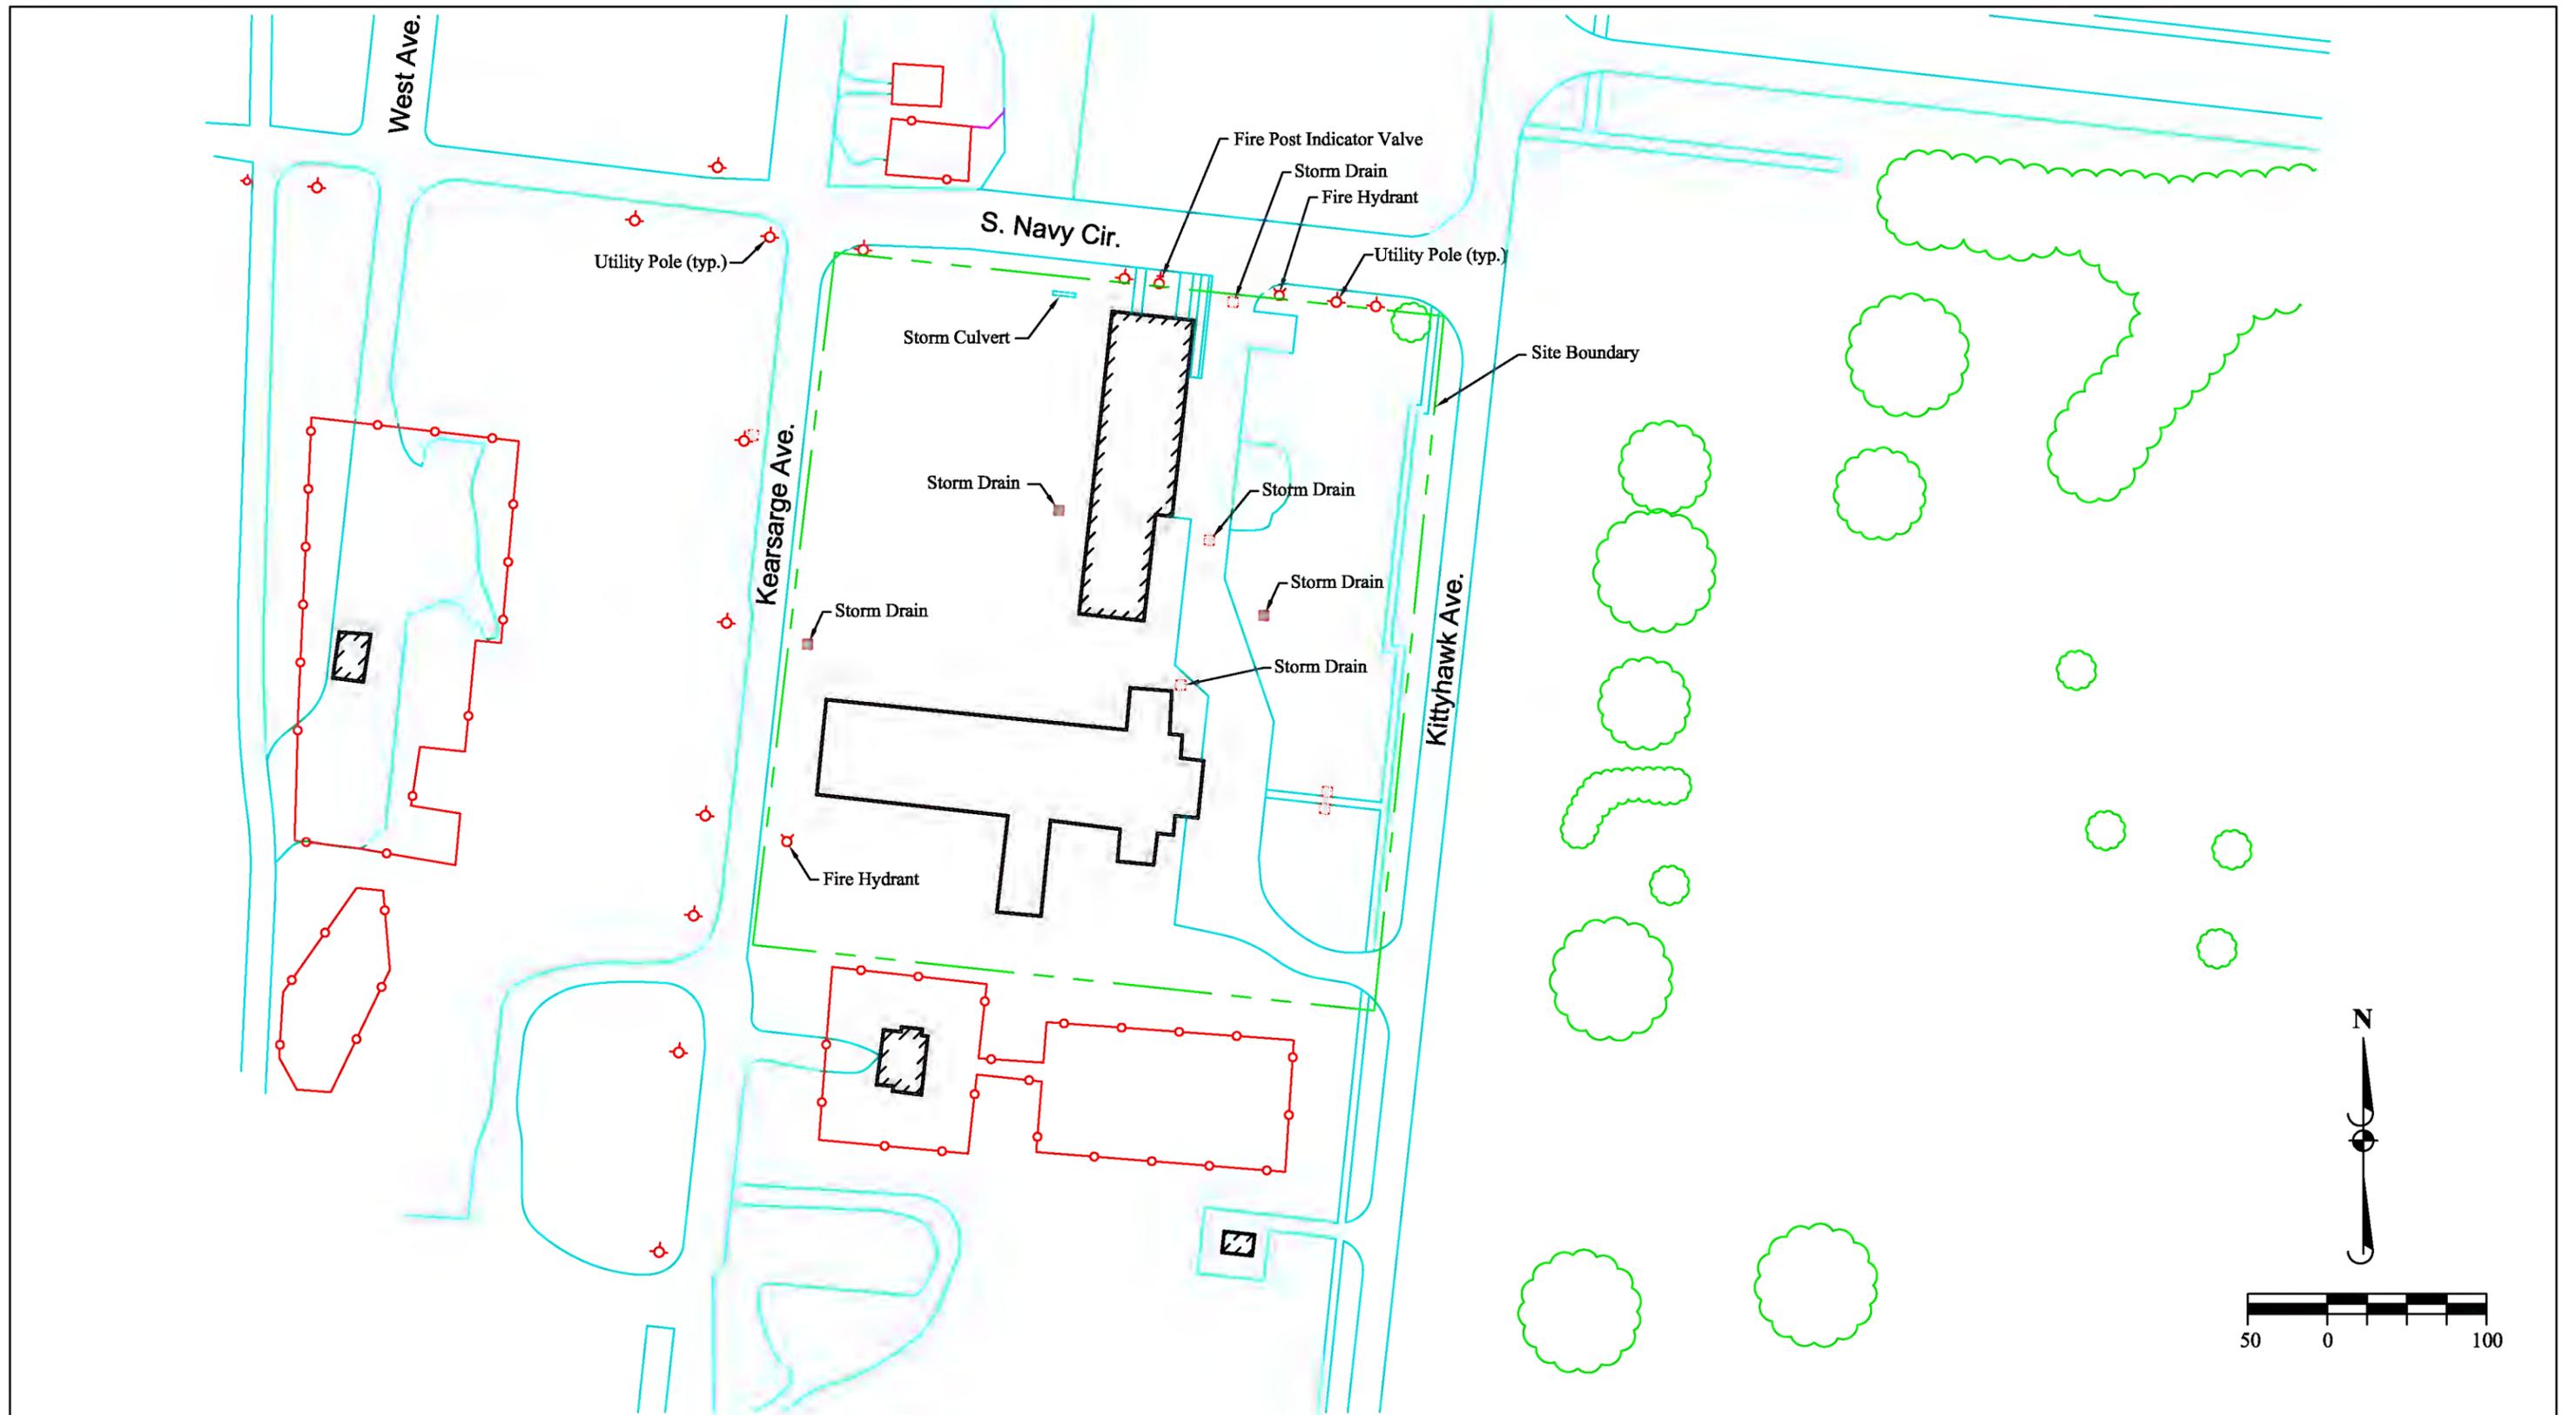
SWMU 39
Site Layout Map

The subject property, SWMU 39, is approximately 3.90 acres in size and is bordered by Kearsarge Avenue to the west, South Navy Circle to the north, Kittyhawk Avenue to the east, and a working dog training facility to the south (Building S-212). The property in the immediate vicinity of SWMU 39 appeared to be industrial, and a park exists east of Kittyhawk Avenue (see **Figure 3**).

Lee & Ryan observed five stormwater drains on-site and are shown on **Figure 3**. A warning sign was observed immediately adjacent to the stormwater inlet located near the northeast corner of the concrete pad. The warning sign stated "No Dumping Drains to Creek".

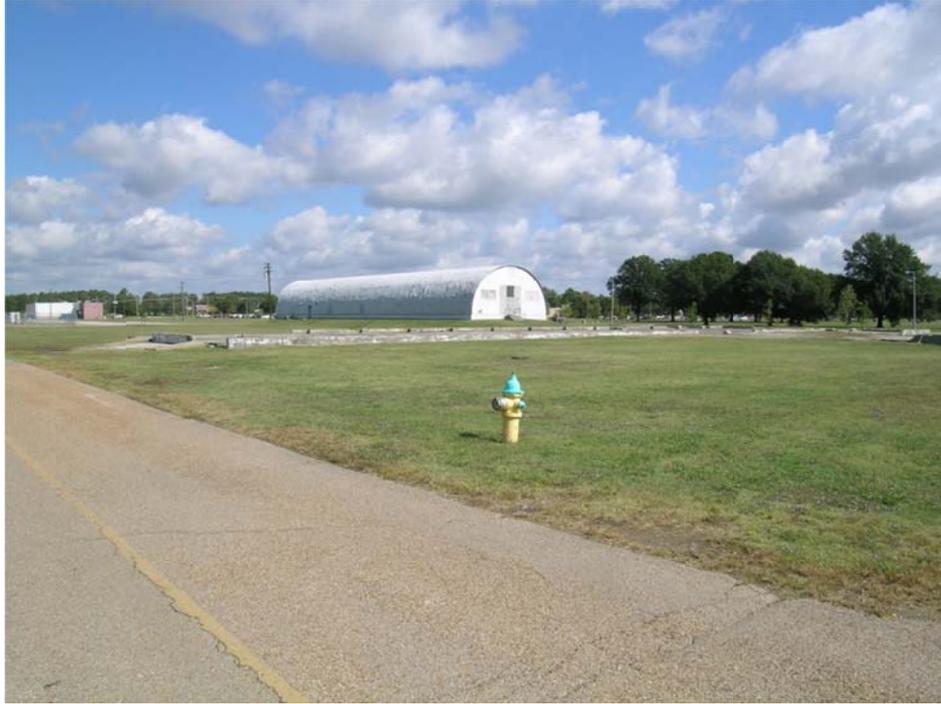
Figure 1:

Photo of north and west side of SWMU 39 looking northeast along Kearsarge Avenue. Note the concrete pad in the foreground.

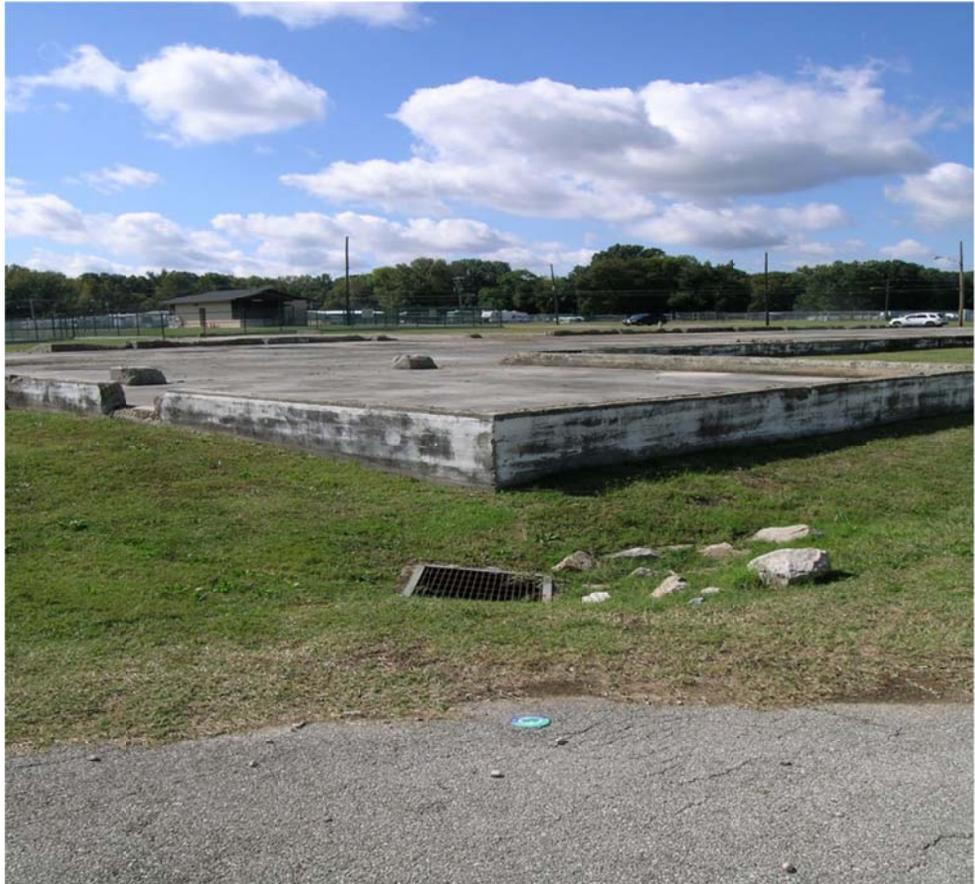
Figure 2:

Photo of the concrete pad with a stormwater drain in the foreground looking southwest. Note blue circular sign on asphalt.

Lee & Ryan and TolTest will cover the stormwater drains during drilling, potassium permanganate (KMnO₄) injection, and during demolition activities. Furthermore, as outlined in the Erosion Control Plan to be included in the Work Plan, the potential for sediment run-off during drilling, injection, demolition, and excavation will be minimized by the use of straw bales, coir logs, silt fencing, and/or other means necessary.

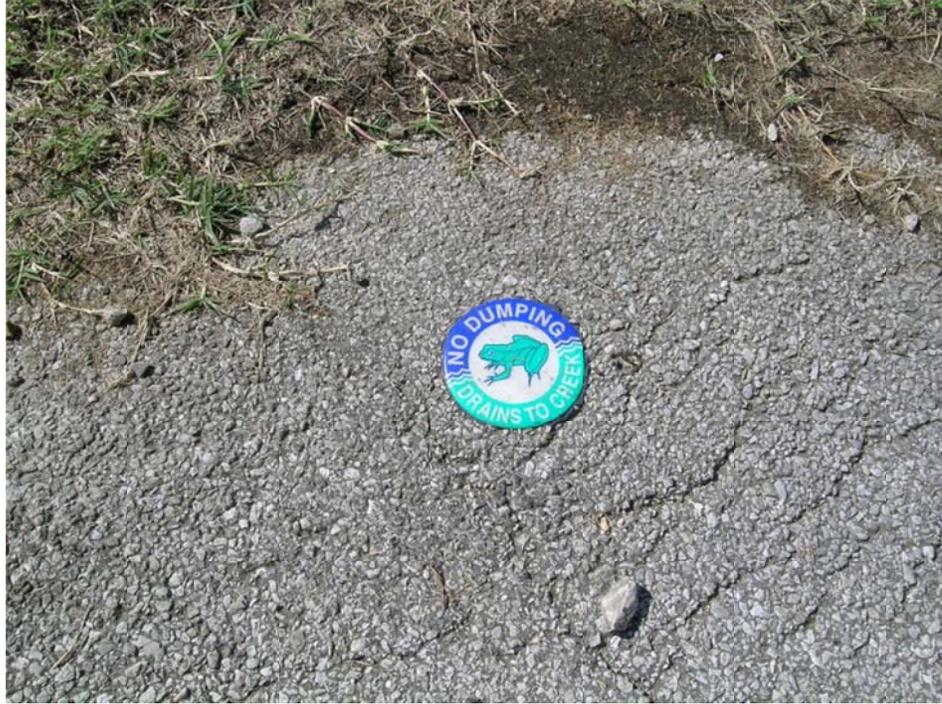
Figure 3:

The blue sign indicates that stormwater inlet drains to creek.

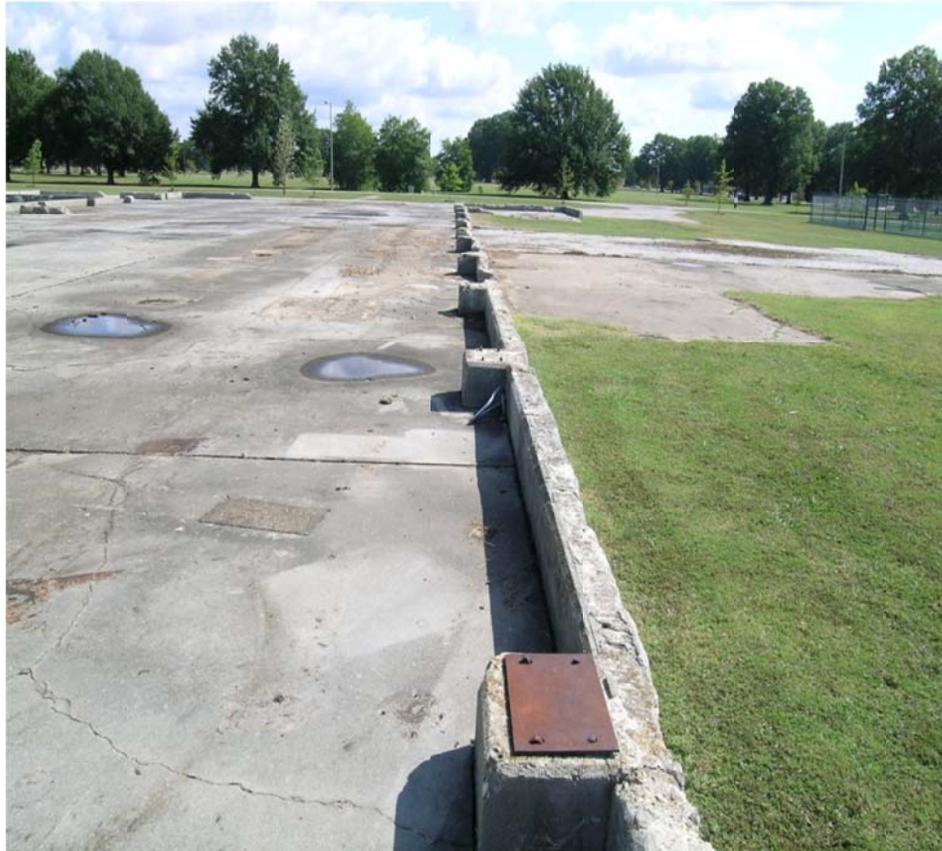
Figure 4:

View of concrete pad looking east. Note the park area across Kittyhawk Avenue.

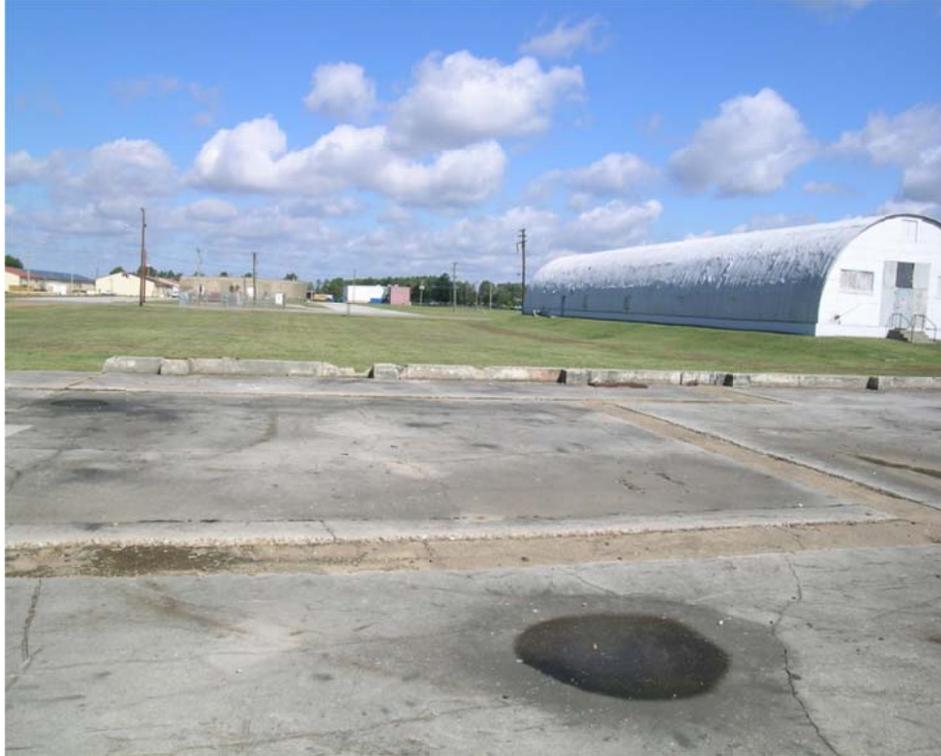
The concrete pad is approximately 16,426 square feet in size with the perimeter being approximately 778 feet. The concrete pad is approximately 2.0 feet thick with steel supports for steel beams. As part of this Contract Task Order, the pad will be demolished and disposed off-site at a NAVFAC approved sanitary waste landfill.

Figure 5:
View of concrete pad looking north.

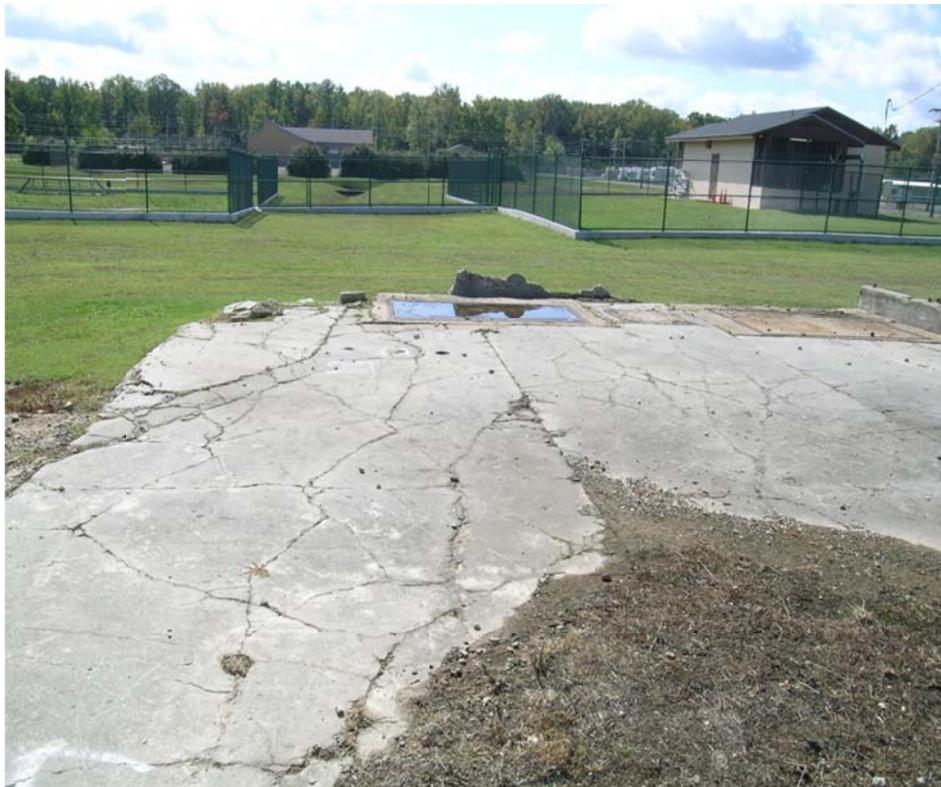
Figure 6:
View of adjacent dog training facility looking south from the west side of the concrete pad.

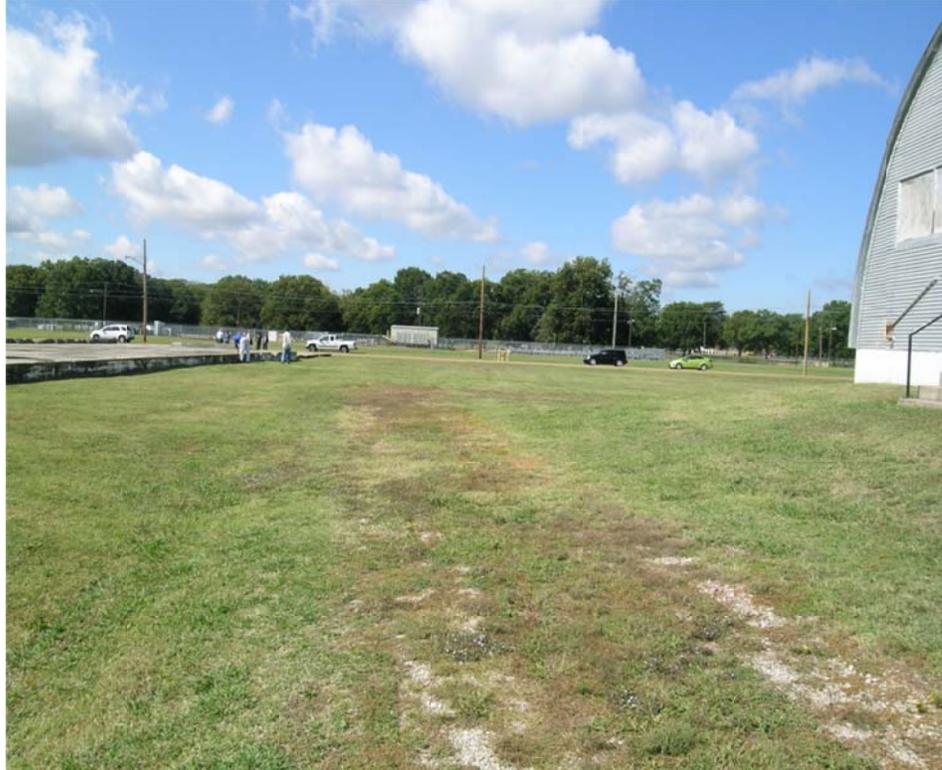
Figure 7:

The subject property and surrounding area was characterized as relatively level with low relief. An apparent swale exists between Building S-203 and the concrete pad. The surface water drainage appears to be south and west to a north-south trending drainage ditch which flows into Big Creek Drainage Canal.

View of grassy area between the east side of the concrete pad and building the right. Note the swale on the left.

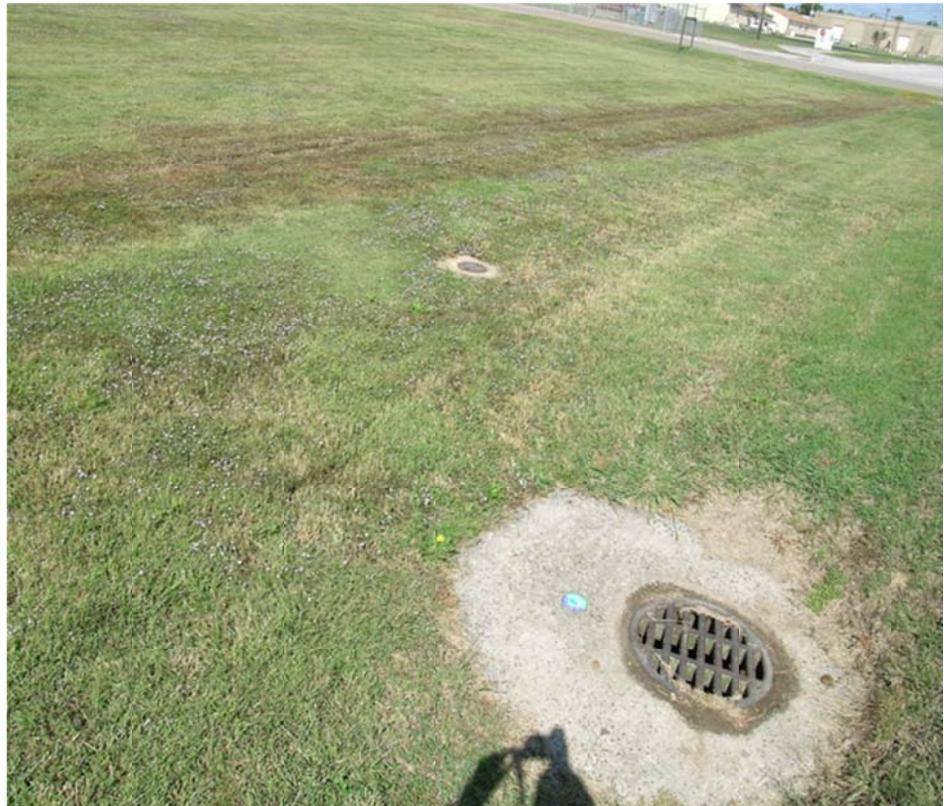
Figure 8:

View of stormwater drain and injection well located immediately north of the building looking northwest.

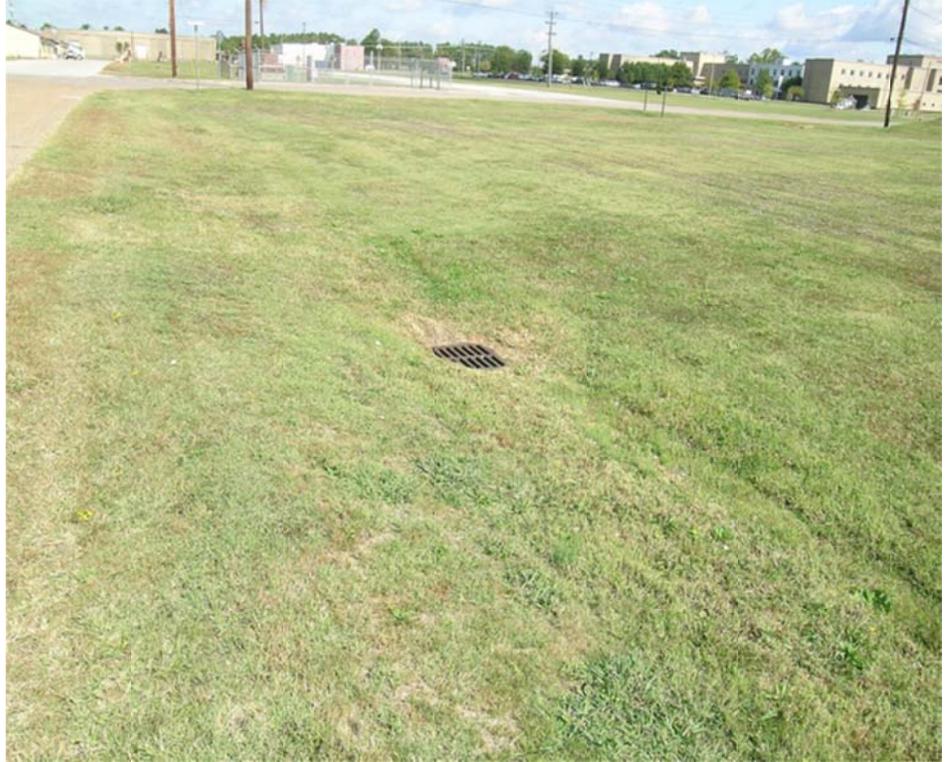
Figure 9:

View of stormwater drain looking north along Kearsarge Road that forms the western property boundary.

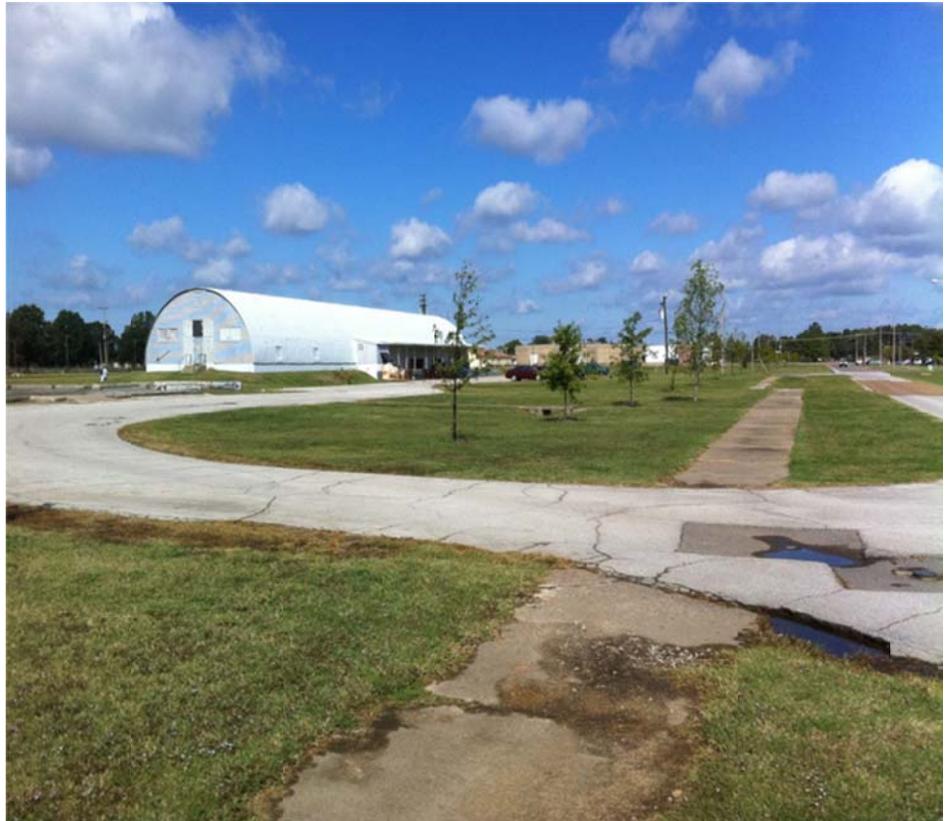
Figure 10:

View of the Building S-203 and adjoining parking lot that will be the lay down area, looking north.

The vehicular traffic and on-site work activities will be conducted in a way to minimize the potential for adverse environmental impacts to occur including damage to Building S-203 and the adjoining parking area, the trees located adjacent to Kittyhawk Avenue, to other vehicular traffic coming into and out of the parking area, and the physical features on-site during mobilization such as the stormwater culvert, stormwater drains, the fire hydrant, and injection and monitoring wells.

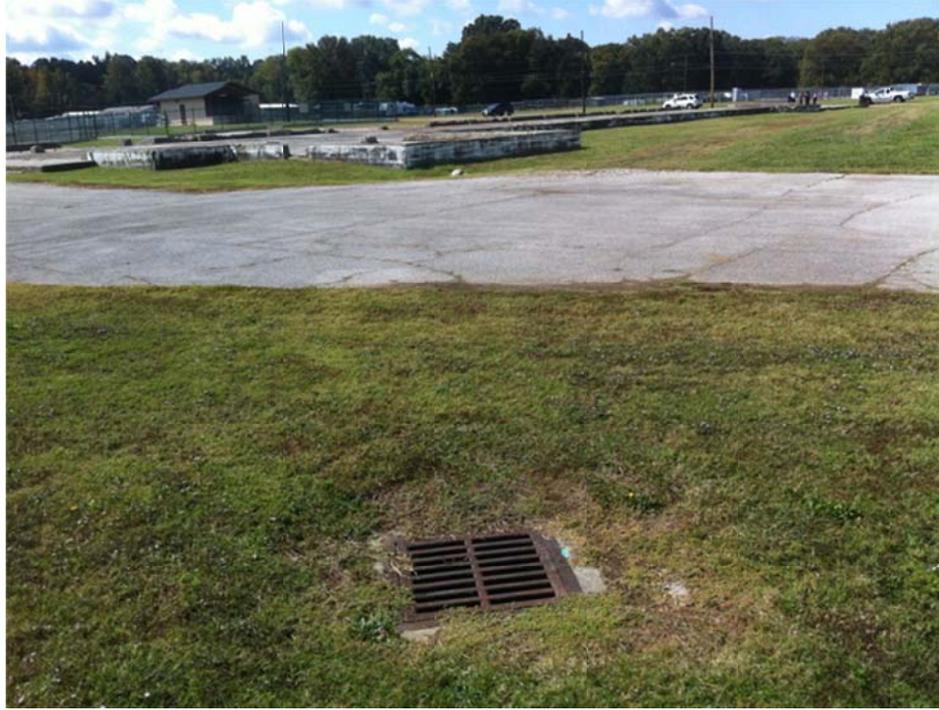
Figure 11:

View of stormwater drain located on the east side of the building parking lot looking southwest.

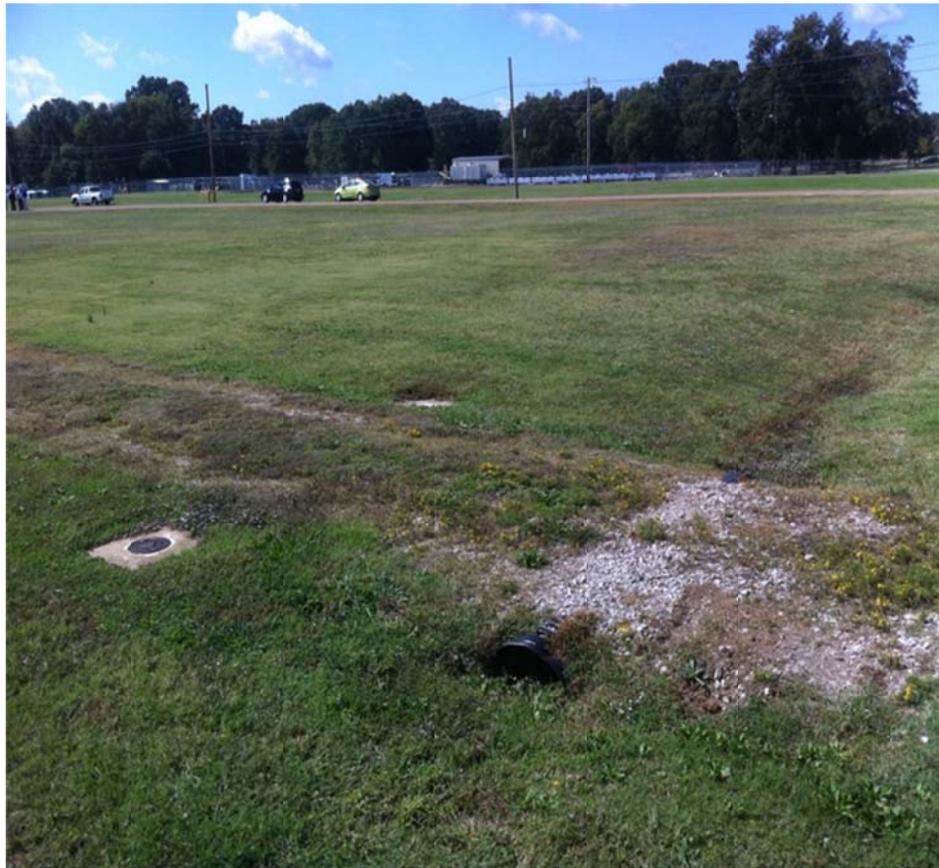
Figure 12:

View of a monitoring and injection well located on the north side of the property looking southwest. Note the stormwater culvert to the right.

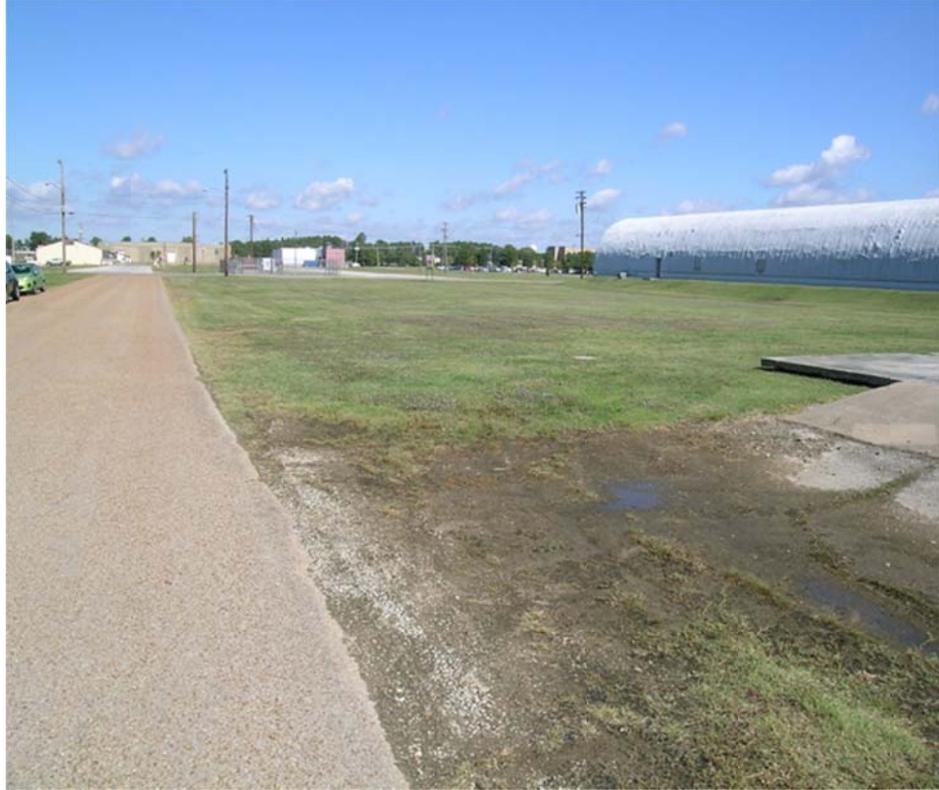
Figure 13:

View of west side of property looking north along Kearsarge Avenue. Note the entrance ramp to the concrete foundation on the right.

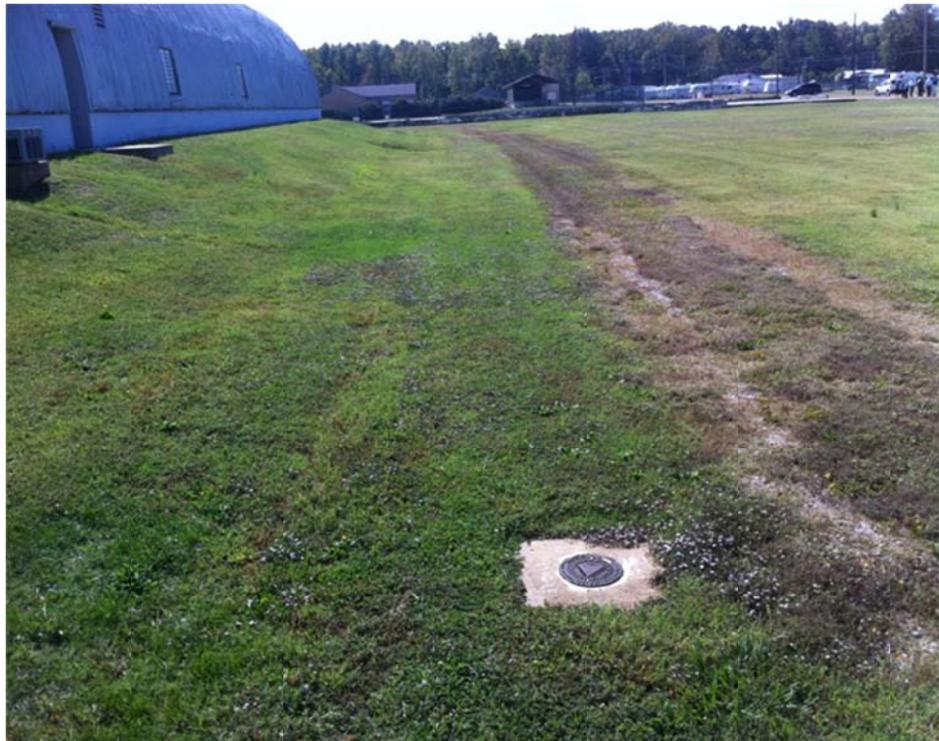
Figure 14:

View of an injection well located on the north side of the property looking south. The well is a circular concrete structure in the foreground, with a dirt path leading away from it. In the background, there is a large blue building and other structures under a clear sky.
