June 1983

INITIAL ASSESSMENT STUDY OF NAVAL AIR STATION, PENSACOLA PENSACOLA, FLORIDA

NEESA 13-015

NAVAL ENERGY AND ENVIRONMENTAL
SUPPORT ACTIVITY

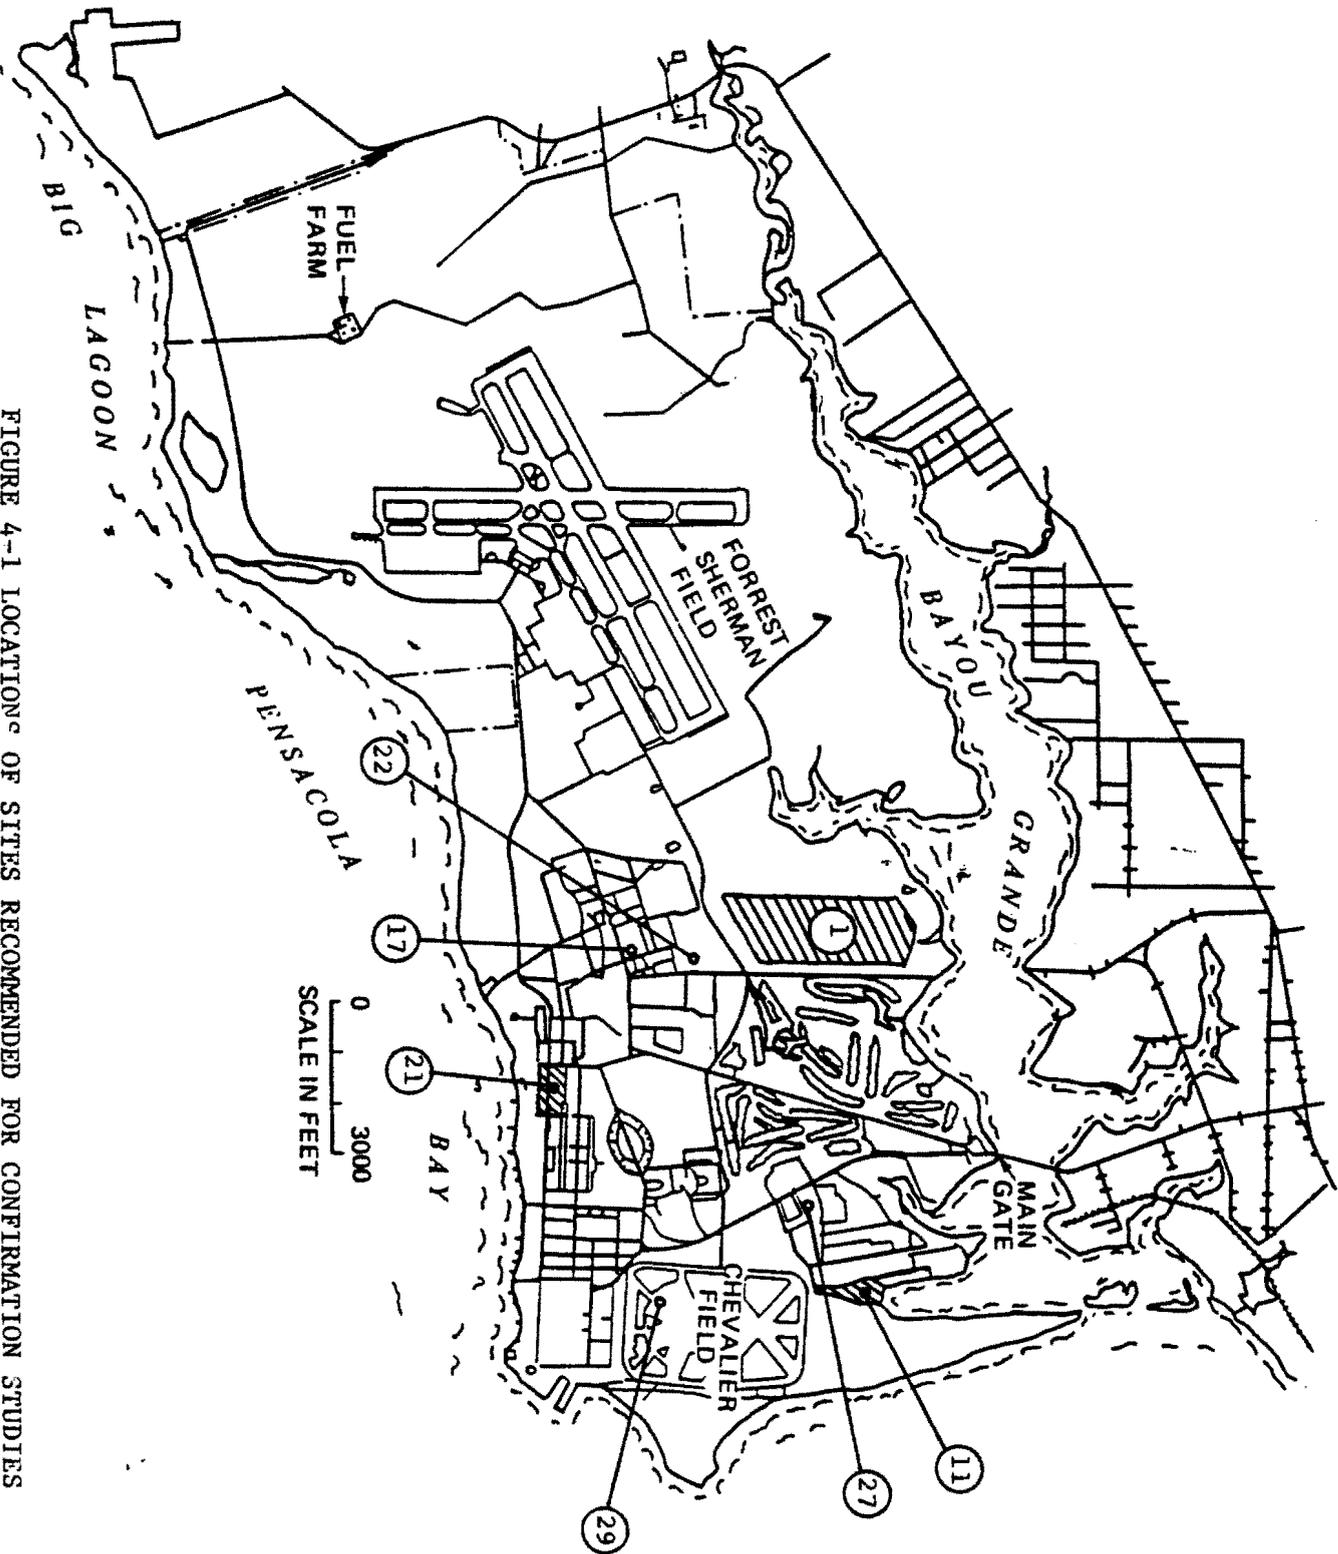
FIGURE 4-1 LOCATIONS OF SITES RECOMMENDED FOR CONFIRMATION STUDIES

4.4 CONFIRMATION STUDY. The areas that warrant further investigation under a confirmation study include: the Sanitary Landfill (Site 1); North Chevalier Field Disposal Site (Site 11); the Transformer Storage Yard (Site 17); Sludge Disposal at Fuel Tank Area (Site 21); the Refueler Repair Shop Fuel Disposal Site (Site 22); the Radium Dial Shop Sanitary Sewer (Site 27); and the soil South of Building 3460 (Site 29). Figure 4-1 shows the locations of the seven sites identified for confirmation studies. Table 4-1 summarizes a recommended environmental monitoring program for the seven sites. Prior to the selection of sampling points, personnel from the Environmental Branch of the Public Works Center should be consulted regarding the location of contaminant sources.

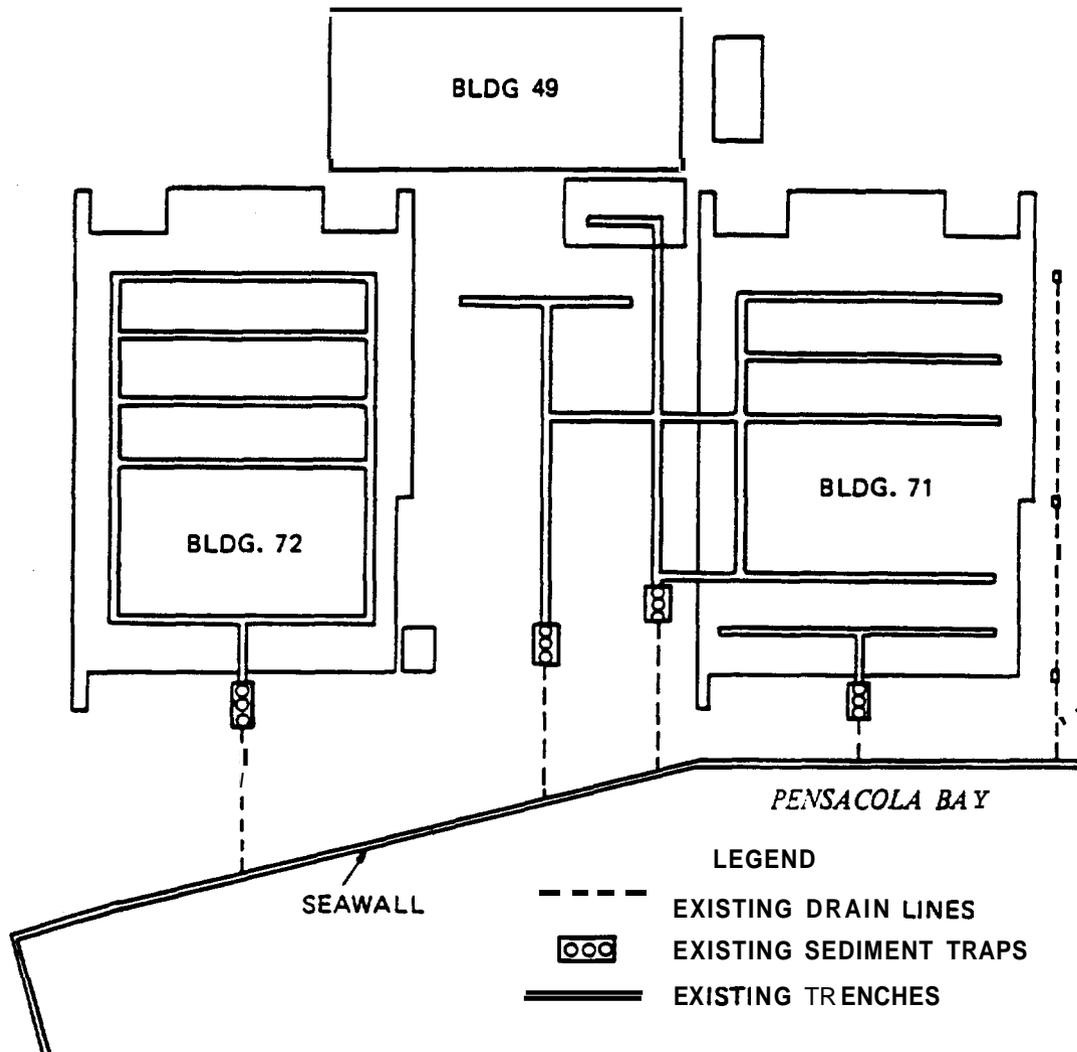
FIGURE 6-3 OUTFALL TRENCHES DISCHARGED WASTE FROM PAINT STRIPPING OPERATIONS INTO PENSACOLA BAY PRIOR TO 1973

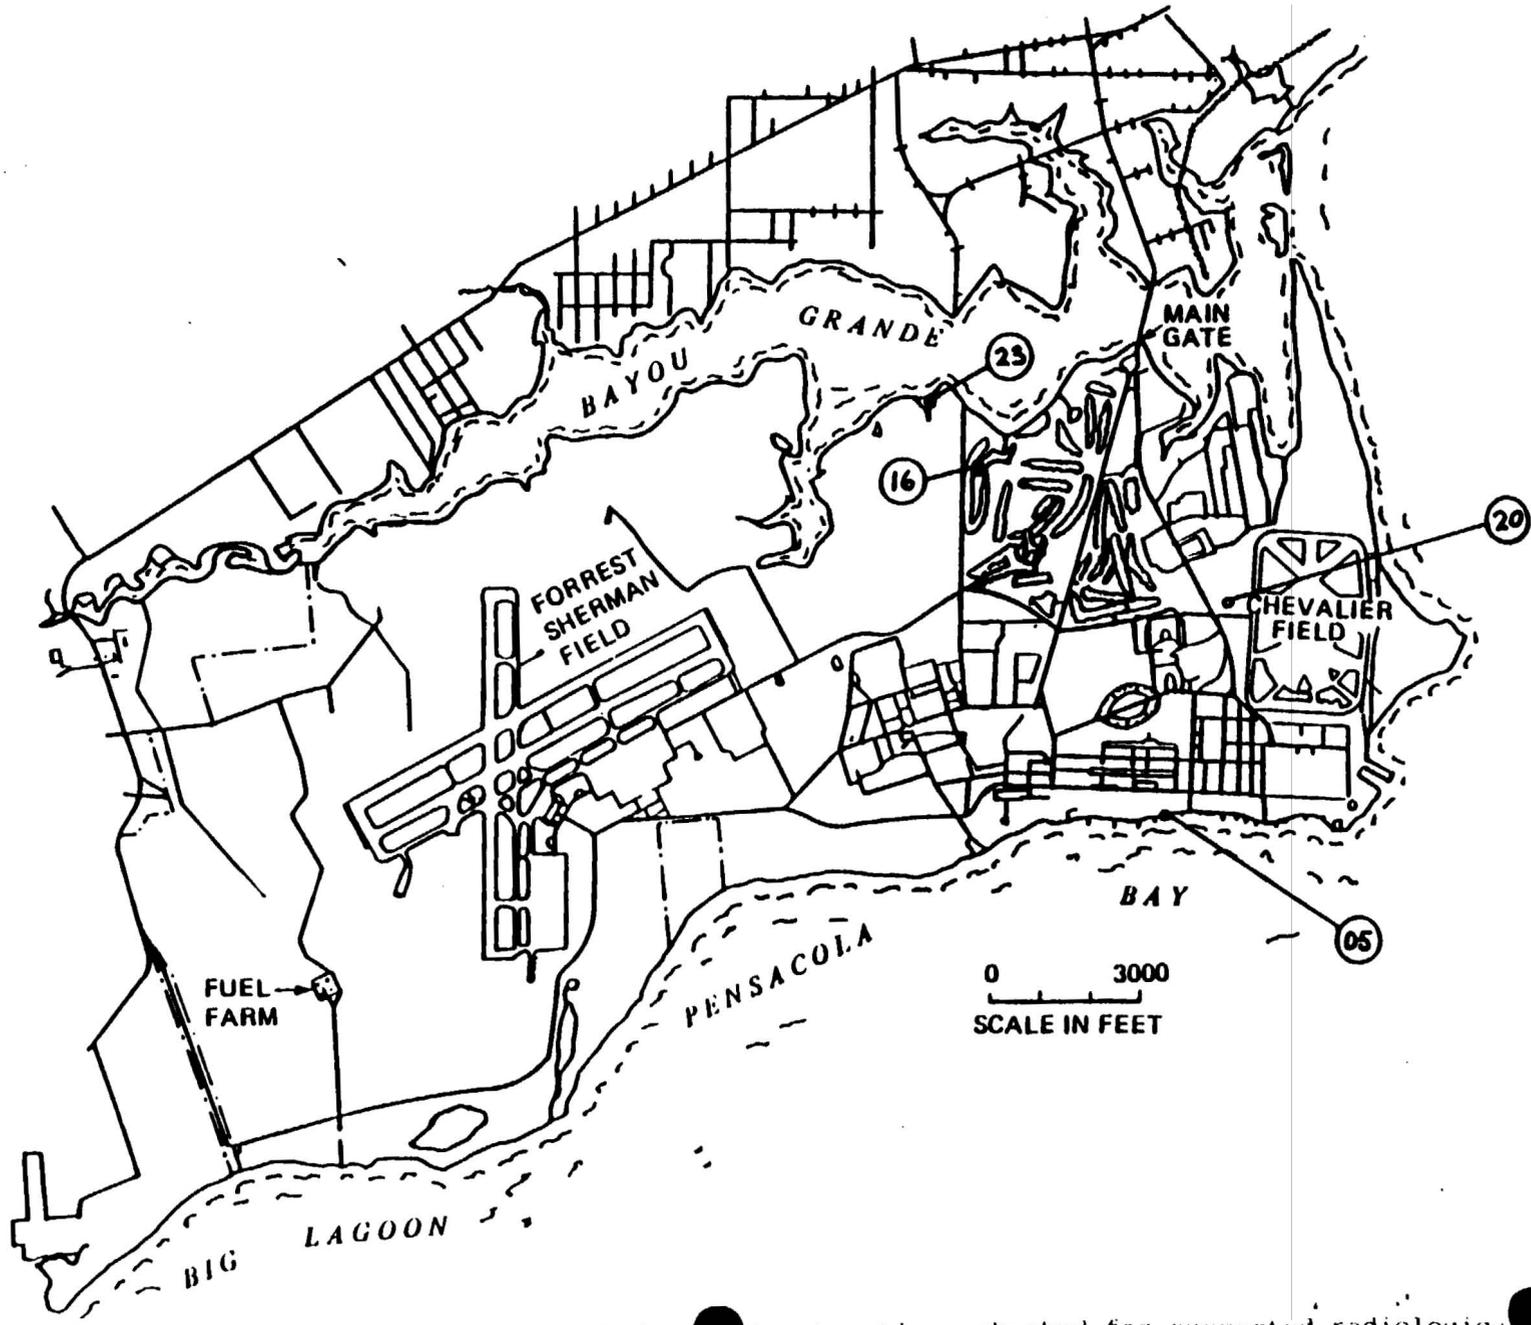
FIGURE 4 Locations checked for suspected radiological contamination. Contamination was not found.

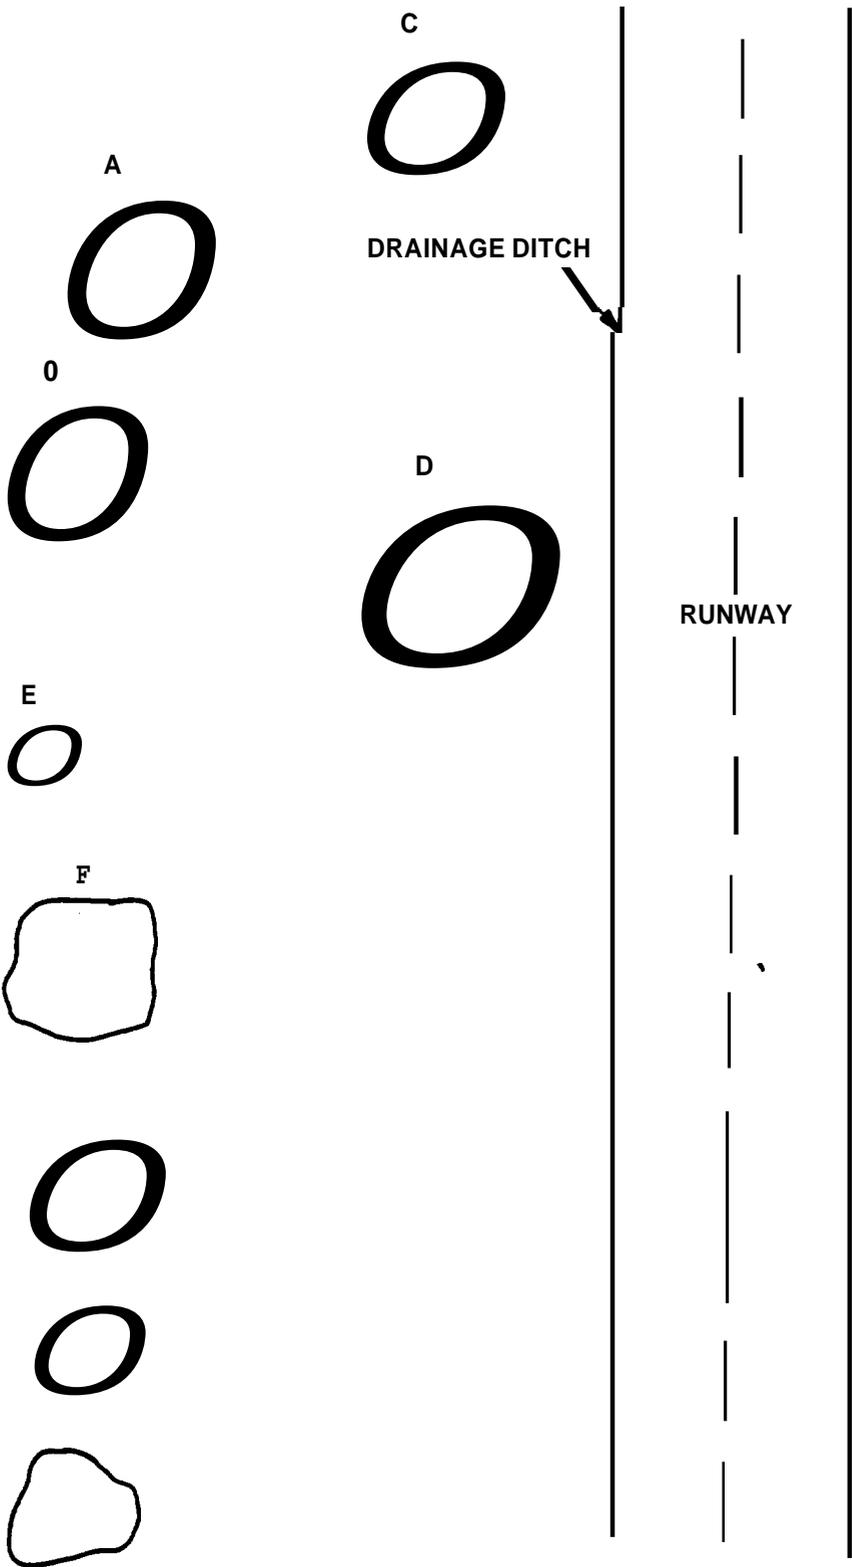
fuel was burned in 30 to 50-gallon batches. About five fires per day were set using as much as 250 gallons of fuel per day. The major part of the fuel must have been burned off, but it can be assumed that some of the fuel soaked into the soil under the unlined pits. It is estimated that about 200 gallons per week was disposed of here. This site is located near the southwestern portion of Forrest Sherman Field at coordinates L-8 through M-8 on the general development map. The dimensions of the site are approximately 1,300 feet by 2,600 feet. The materials disposed of here included JP-4, JP-5, AVGAS, and lube oil.

FIGURE 6-8 Locations of the crash crew training area fire pits.

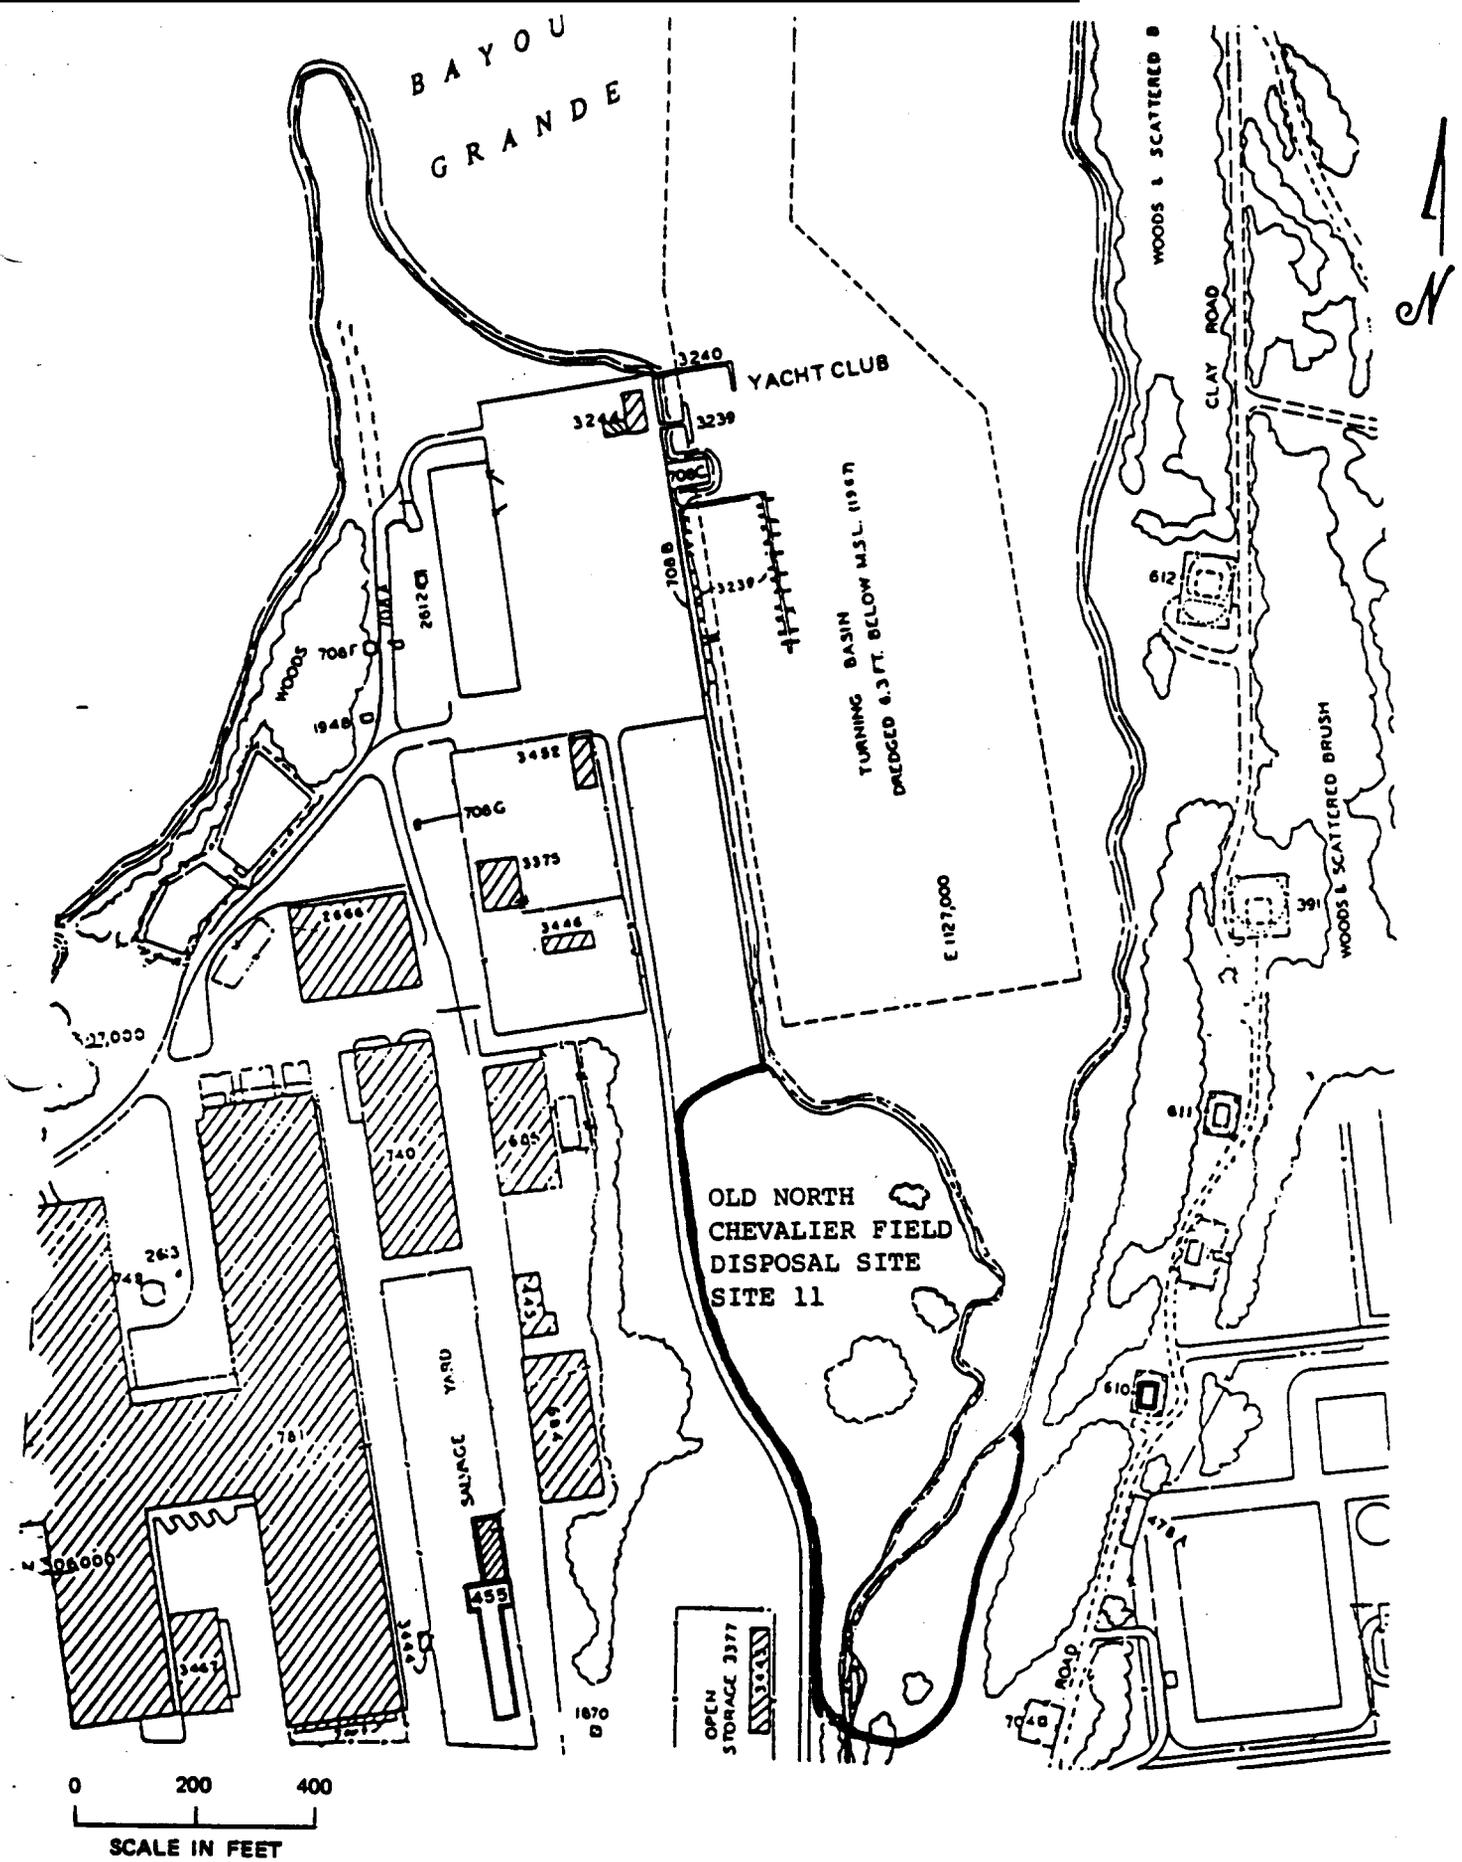
6.6.11 North Chevalier Field Disposal Site (Site 11). Located at the end of a branch of Bayou Grande, this disposal site was used from the early 1930s to the mid-1940s for burning refuse. Wastes from aircraft engine overhauls, other waste oils, lumber, and other burnables were disposed of at this site. Approximately 24 cubic yards per day of such items were disposed of there. An unknown number of 55-gallon drums were also found at this site during its operation. From the time of the site's operation until the early 1950s, oil slicks were noted in the Bayou branch during heavy rains. In 1981, a well was sunk into this old disposal site. The well showed that there was still oil

FIGURE 6-12 APPROXIMATE LOCATION OF OLD NORTH CHEVALIER FIELD DISPOSAL SITE

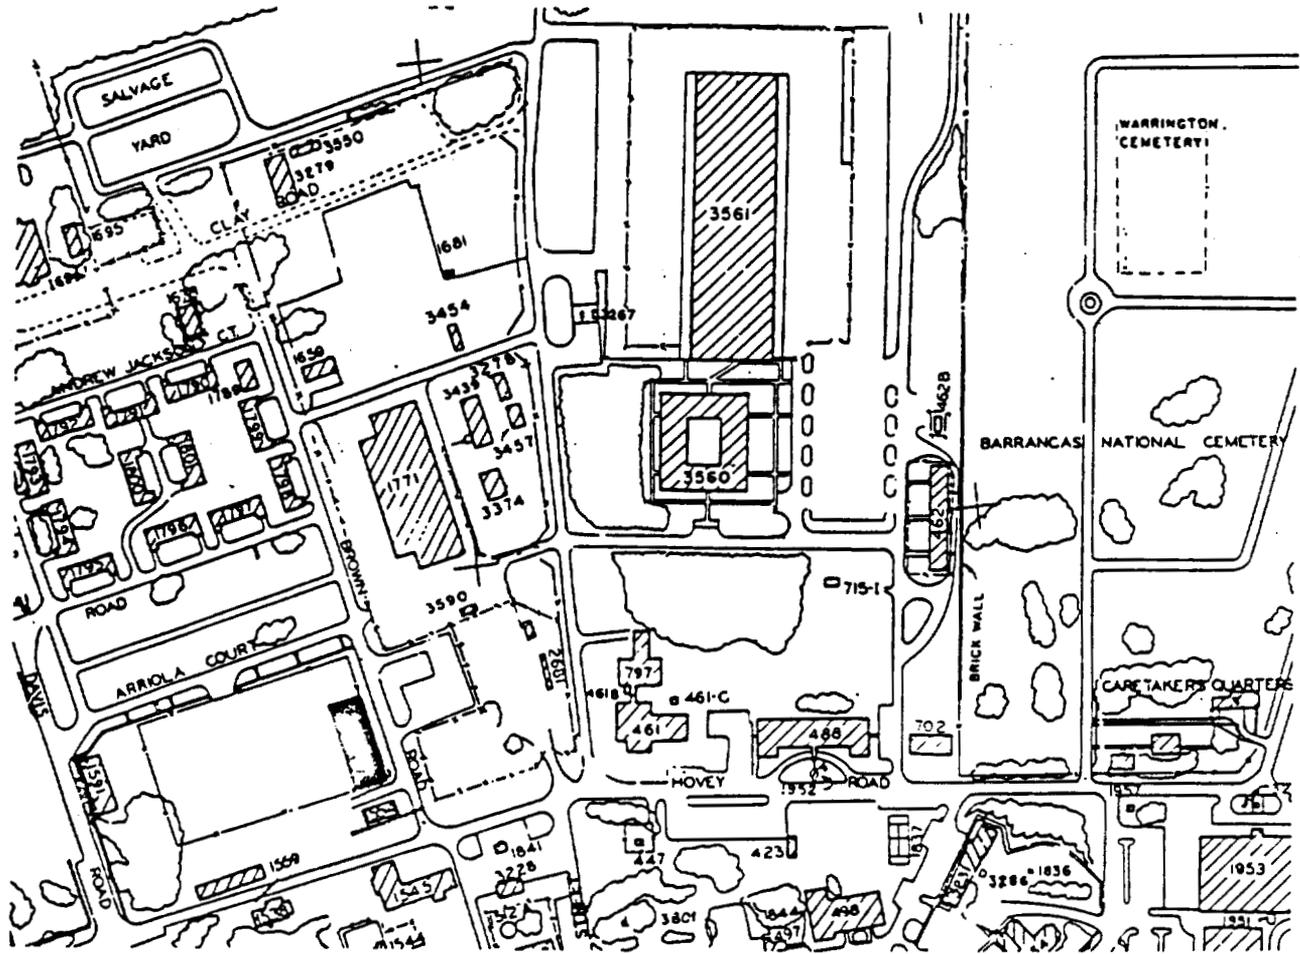
FIGURE 6-15 Transformer Storage Yard. Transformers were stored here when not in use, or when awaiting disposal.

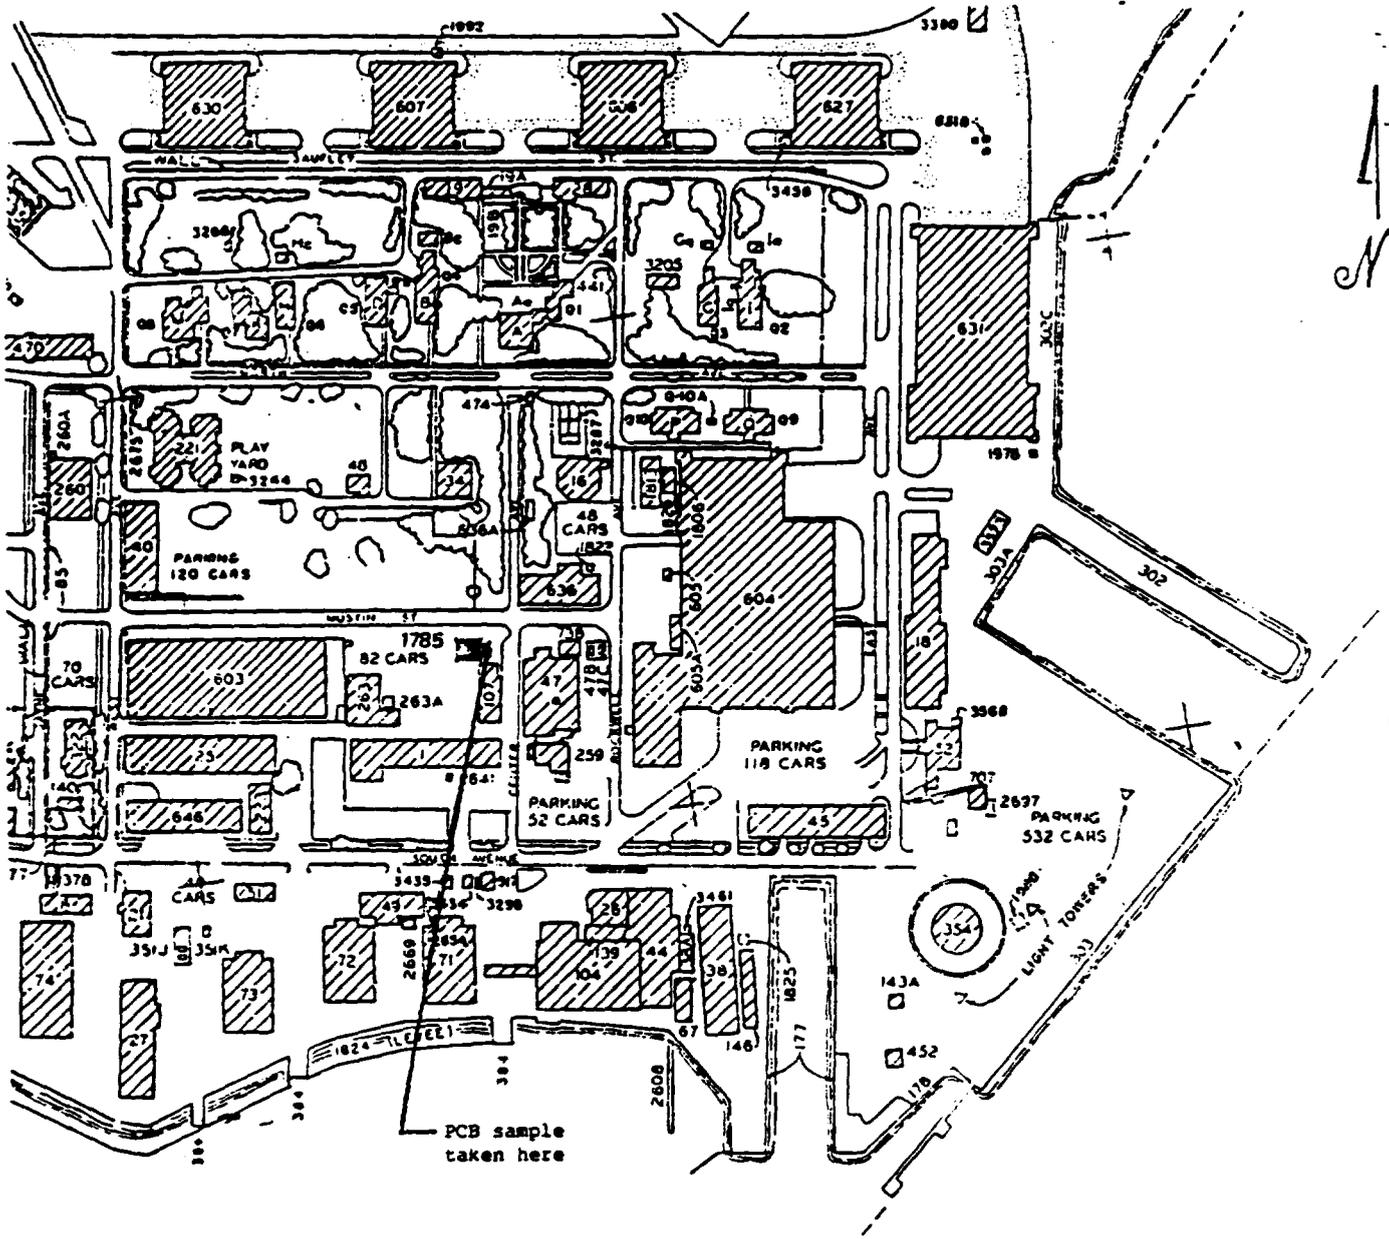
FIGURE 6-16 Transformer Oil Spill Site at Substation A. About 50 gallons of oil containing PCB's was spilled in 1966 or 1967.

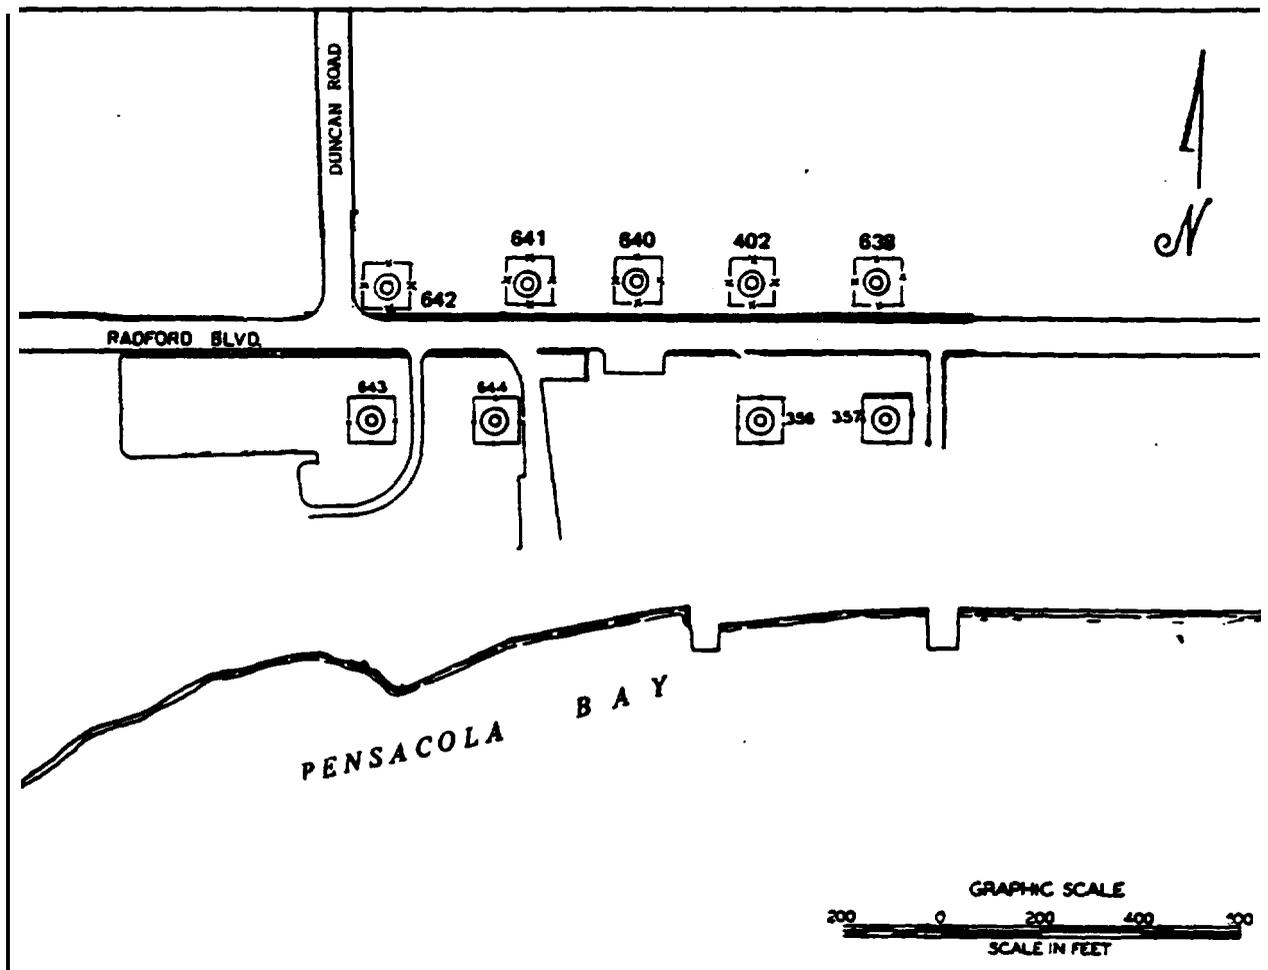
FIGURE 6-17 LOCATIONS OF NINE AVIATION GASOLINE STORAGE TANKS. SLUDGE WAS REMOVED FROM THE TANKS AND DISPOSED OF AROUND THE PERIMETER OF EACH TANK SITE. THE SLUDGE MAY CONTAIN LEAD CONTAMINATION. THE FIVE TANKS NORTH OF RADFORD BOULEVARD ARE NO LONGER STANDING. THESE NINE TANK SITES ARE CONSIDERED COLLECTIVELY AS SITE 21.

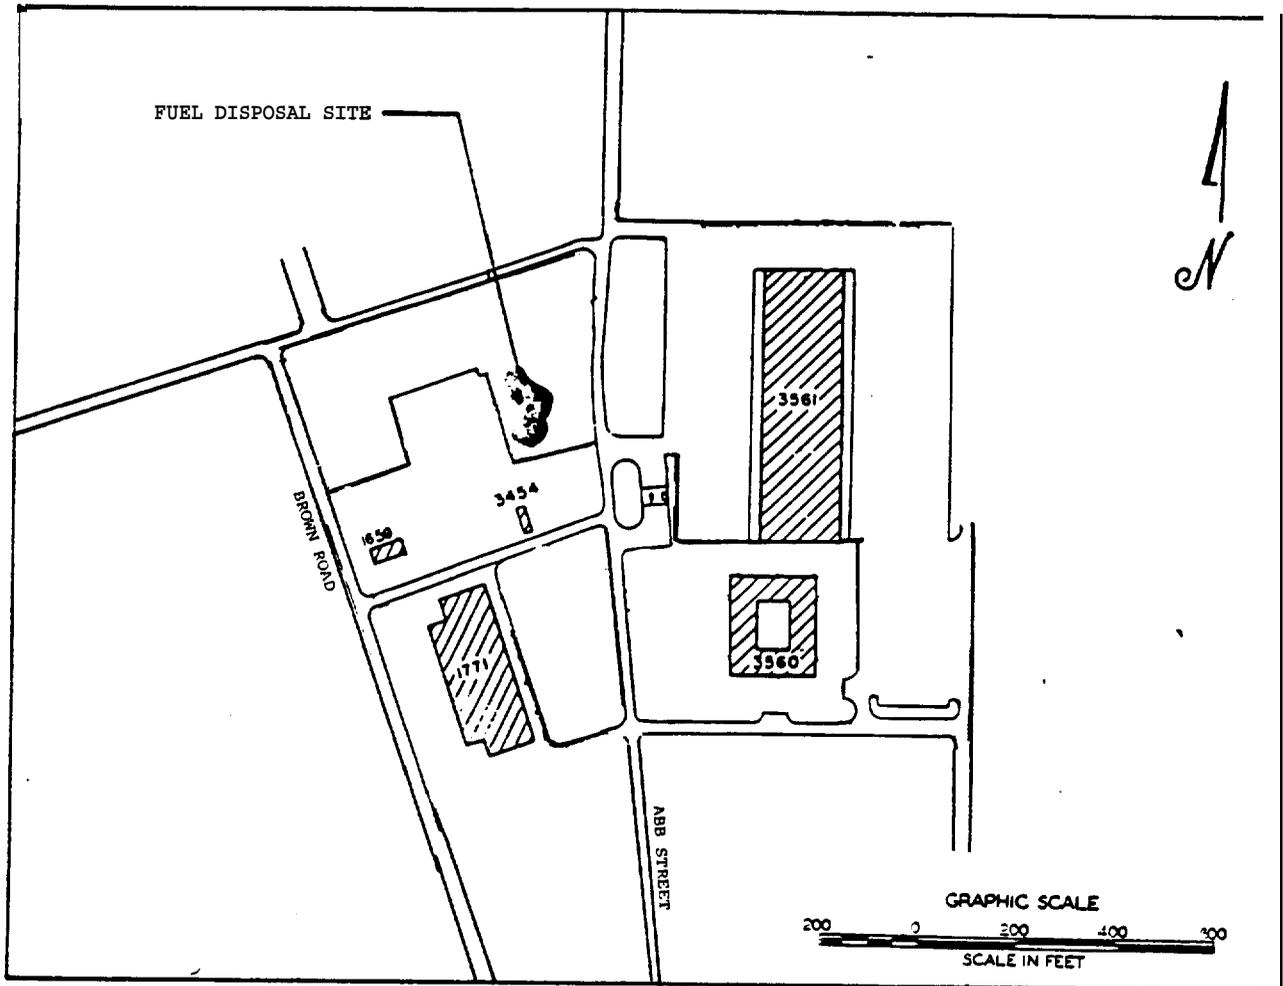
FIGURE 6-18 REFUELER REPAIR SHOP FUEL DISPOSAL SITE (SITE 21). RESIDUAL AVIATION GASOLINE WAS DISPOSED OF HERE. THE AVIATION GASOLINE CONTAINS A LEAD COMPOUND.

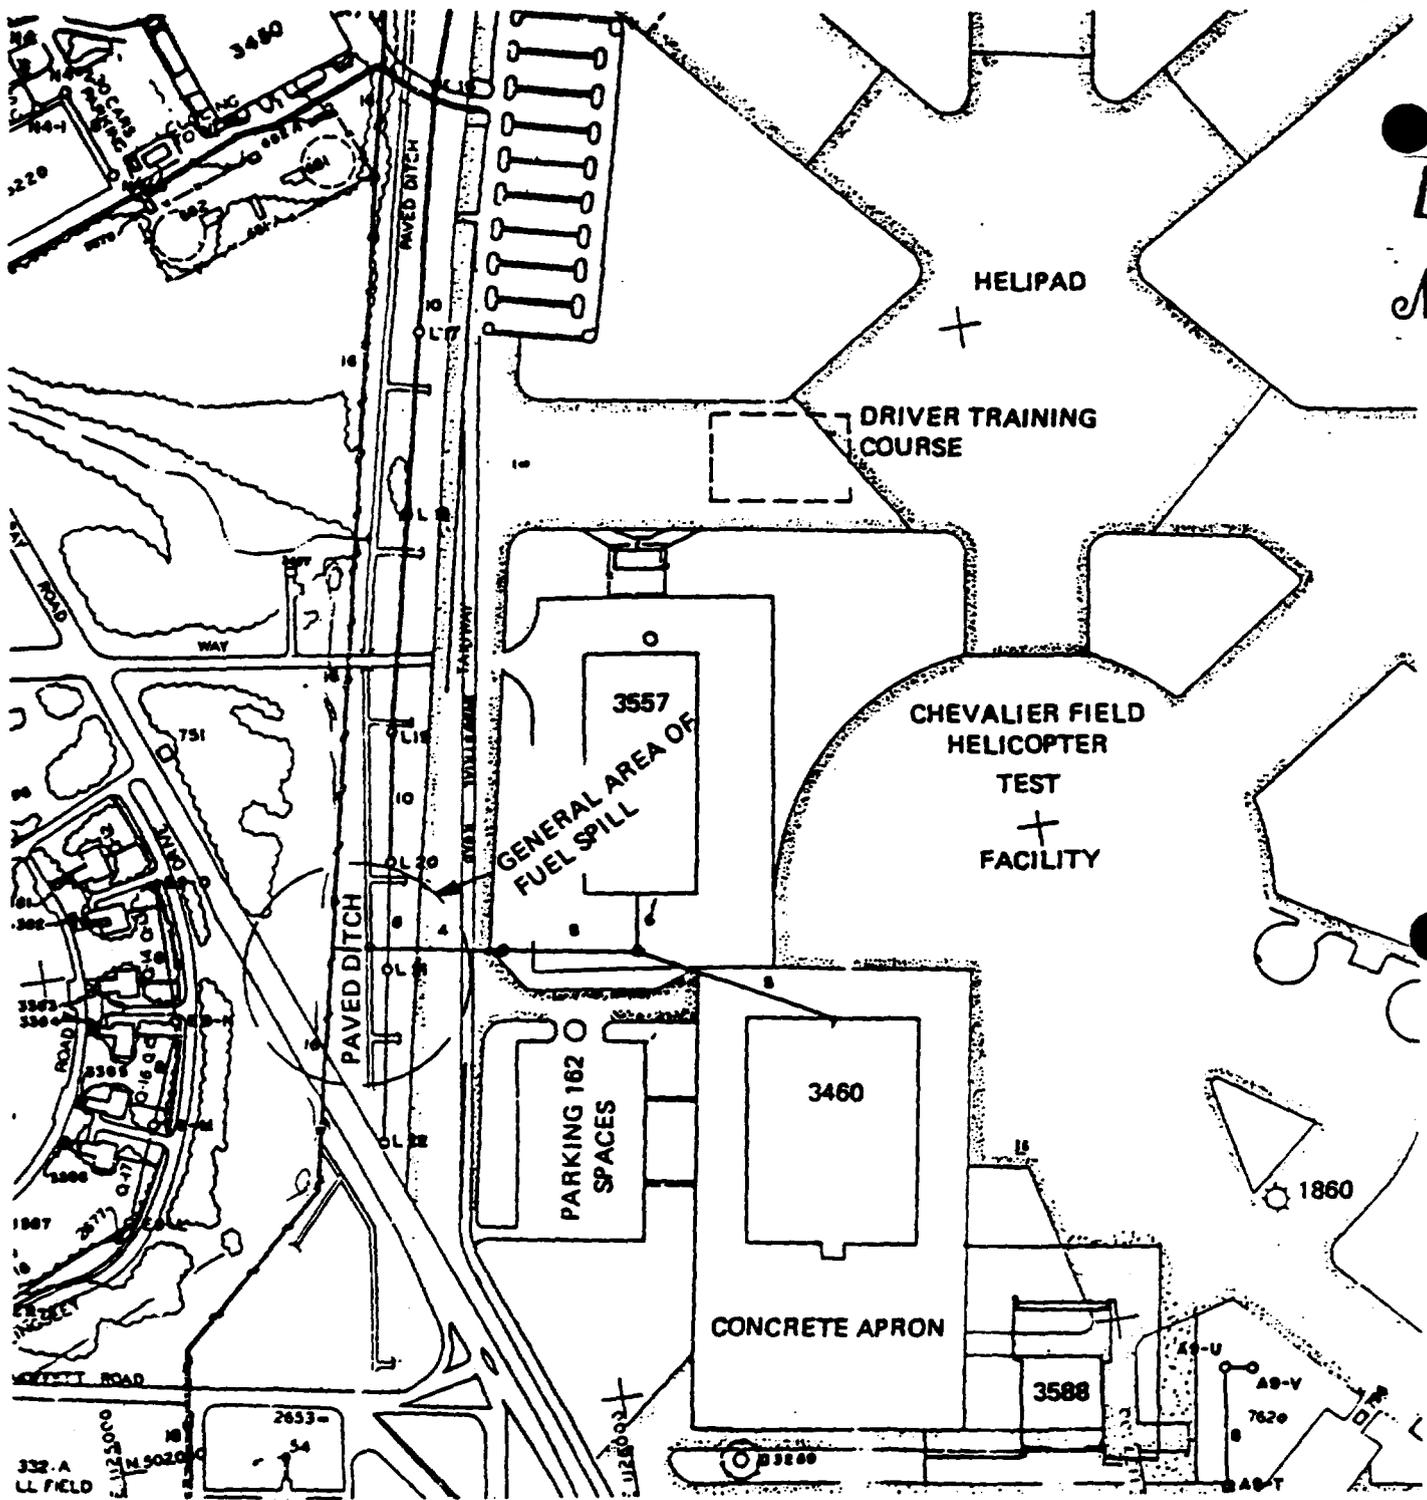
FIGURE 6-19 LOCATION OF CHEVALIER FIELD FUEL SPILL. (SITE 23)

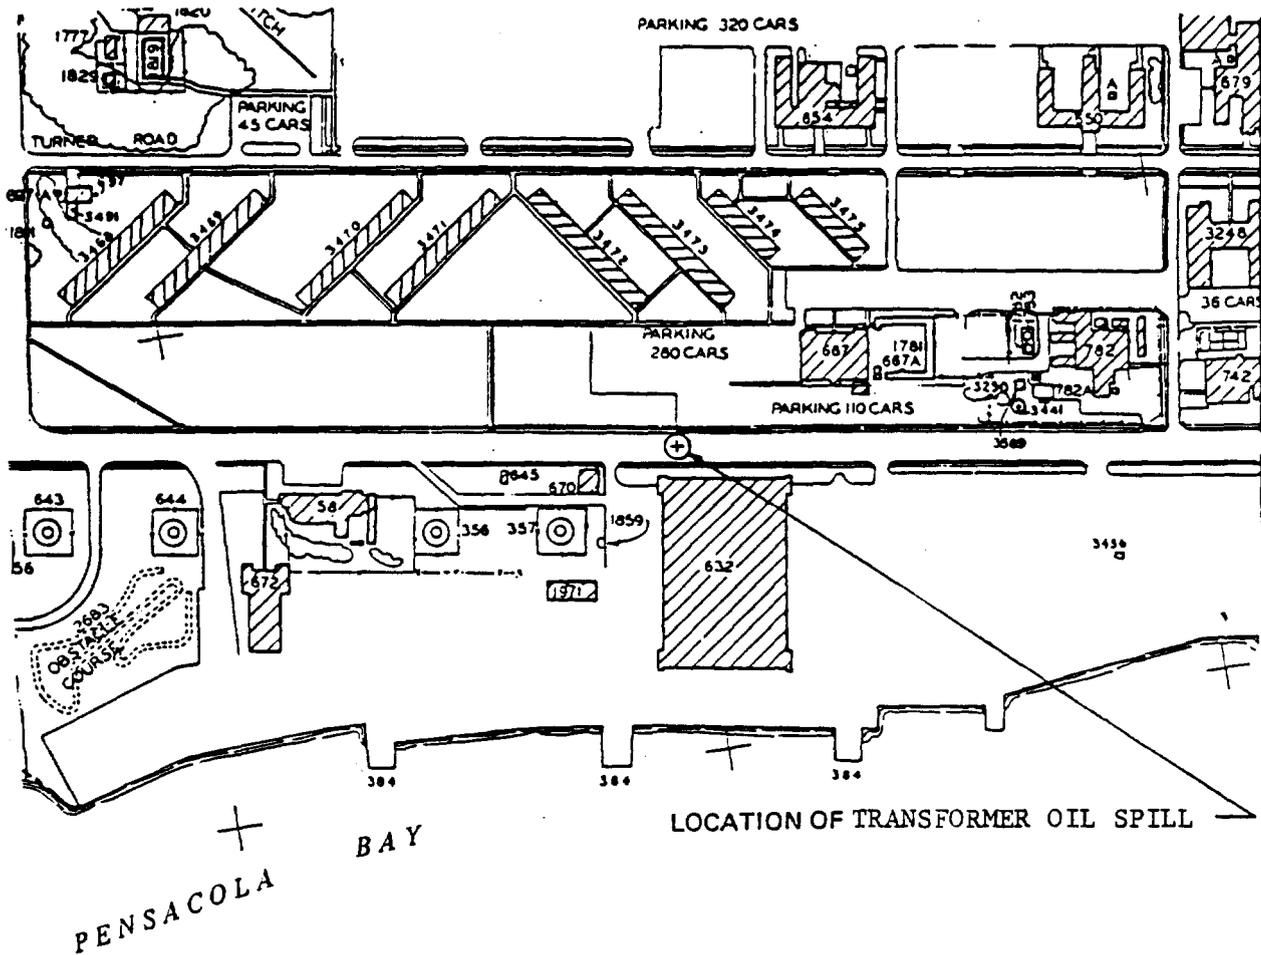
FIGURE 6-21 LOCATION OF TRANSFORMER OIL SPILL. (SITE 28). A TRANSFORMER FELL ONTO THE ROADWAY, AND BROKE OPEN. THE OIL SPILLED IS SUSPECTED TO CONTAIN PCB COMPOUNDS.
