RE: Data Evaluation Summaries and Proposed Samples Location Changes,
Phase I Site Groups A through E, Contamination
Assessment/Remedial Activities Investigations, Naval Air Station
(NAS) Pensacola, Florida, Contract No. N2467-88-C-0200,
Modification No. 7.

FIELD TASKS/ DATA EVALUATION SUMMARY
NAS PWSACOLA - SITE 12

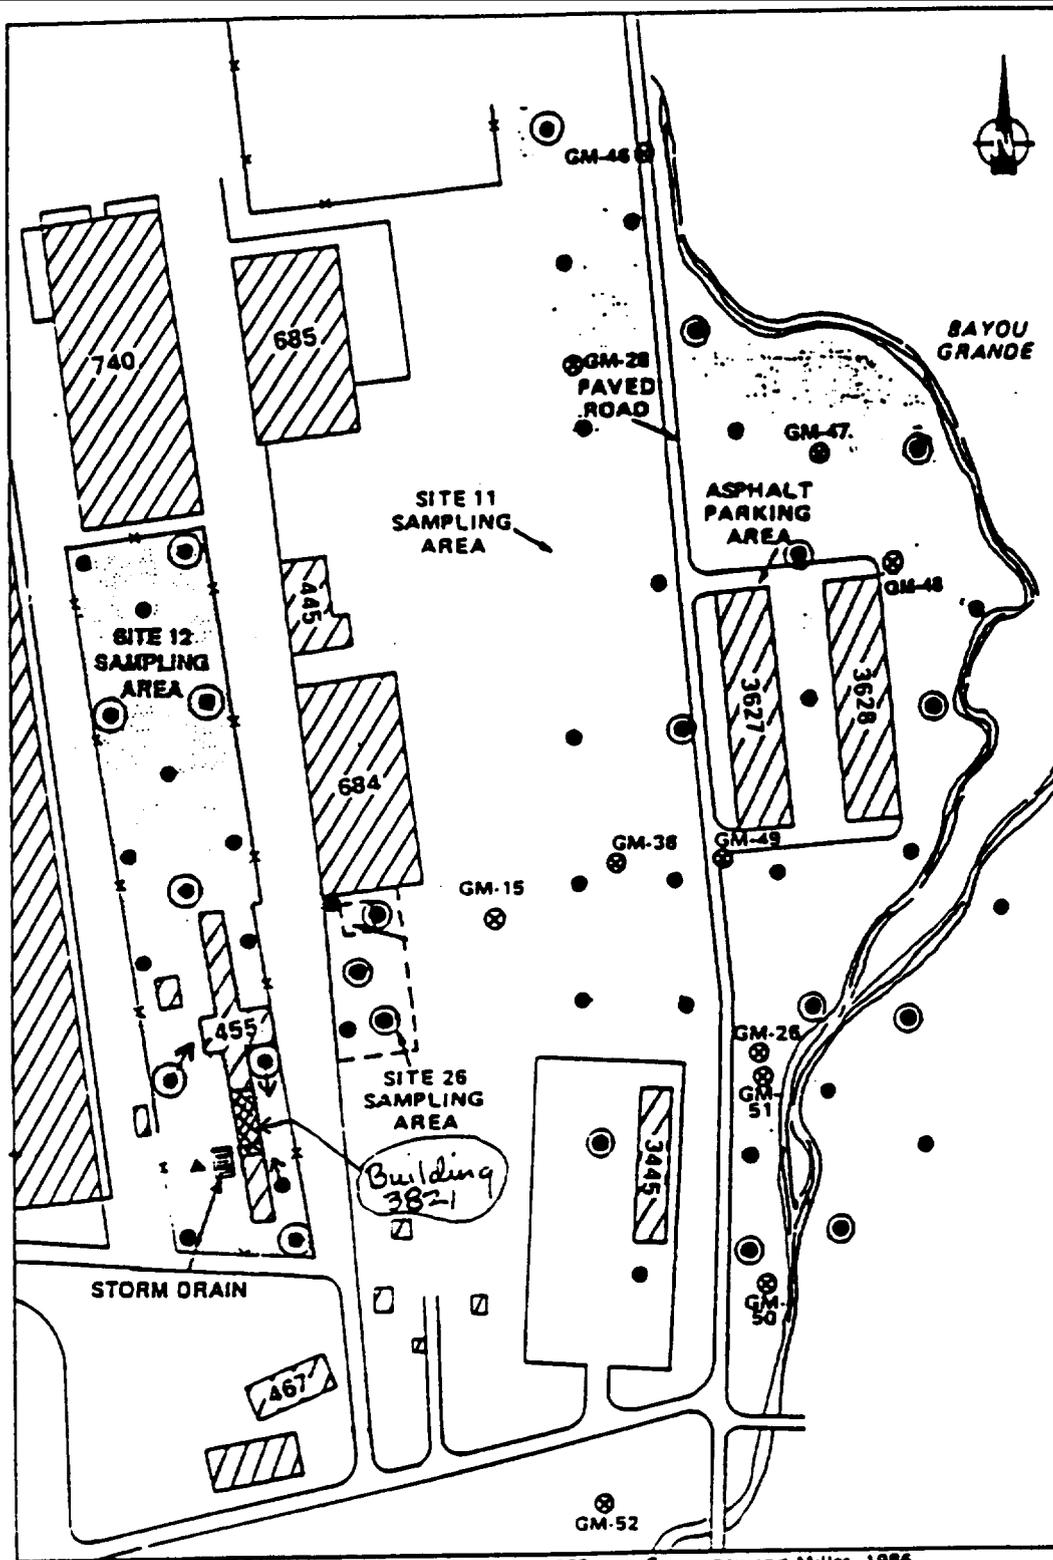
14-4 Site 12 Sample Location Changes

An HNu and an OVA were used to monitor surface emissions at Site 12. Slightly elevated readings from 4 to 7 parts per million (ppm) above background were noted around drums stored outside the southeast corner of Building 3821 (see attached figure) and also at 9 ppm above background inside Building 3821 in the northeast corner of the building.

A radiation survey of the site revealed that elevated readings were noted on the west side of Building 455 at 3 to 7 micro Roentgens per hour ($\mu\text{R}/\text{h}$) above background. Of greater significance, readings obtained between the northeast corner of Building 3821 and the fence, which is located at the east boundary of the site, were 30 to 35 $\mu\text{R}/\text{h}$ above background.

The results of the field tasks conducted to date indicate that a few sampling locations should be moved to areas where elevated OVA and radiation readings were noted in the southeast portion of the site (see attached figure). One soil boring and temporary monitoring well should be moved to just west of Building 455 and one soil boring and temporary well southeast of Building 455 should be moved approximately 50 feet to the south, near the northeast corner of Building 3821, near the location of elevated OVA and radiation readings. In addition, one soil boring should be moved to near the southeast corner of Building 3821 where an elevated OVA reading occurred. E & E believes that the proposed amendments in the sampling locations will be more useful in locating possible contaminated areas at this site. All other sampling locations presented in the work plan for Site 12 appear to be in locations suitable for the Phase I assessment.

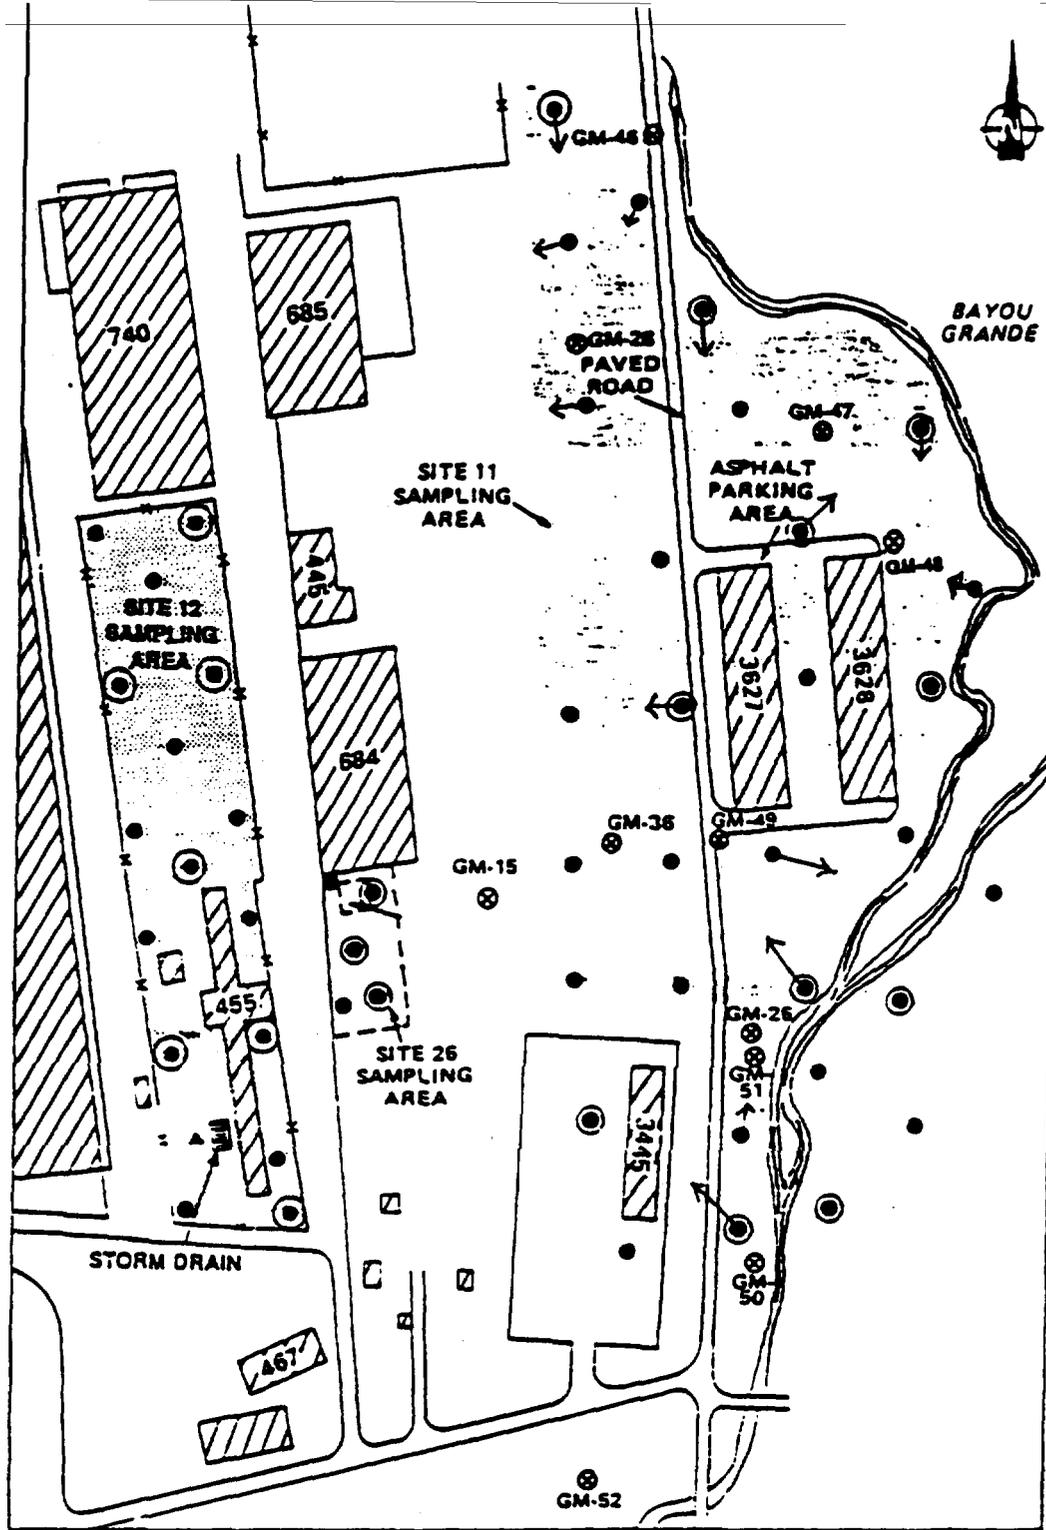
Site 11 - Sample Location Changes

A radiation survey was performed over the site area. An elevated reading was observed 50 feet east of Building 3628 which was 35 to 45 micro Roentgens per hour ($\mu\text{R}/\text{h}$) above background. Slightly elevated readings above background were also observed south of this location and appear to coincide with the southeast boundary of the cleared area for Buildings 3627 and 3628. Slightly elevated readings above background were also noted along the abandoned road in the northwest portion of the site and along Pat Belinger Road in the south portion of the site. These readings can probably be attributed to road material used in the older road on the site.

The results of the survey indicate that high EM conductivity readings are occurring in the eastern portion of the site and include the area around Buildings 3627 and 3628. Shallow elevated conductivities could possibly be attributed to salt water intrusion in the surficial aquifer; however, it is also possible that these could be due to a leachate plume. A very significant deep conductivity anomaly located around the north end of Building 3628 may be related to the downward migrating portion of the plume. It is not clear at this time if magnetic anomalies in this same area are associated with the EM anomaly. Numerous magnetic anomalies were observed in the central and southern area of the site. Approximately one half of the magnetic

The results of the field tasks conducted to date indicate that some of the sampling locations should be adjusted (see attached figure). As shown in the figure, the changes to the original locations are relatively minor. The purpose of the relocations shown is to either avoid surface obstructions or other inaccessible areas, or to place the sample points in or down-gradient from areas having surface emissions, radiation or geophysical anomalies or near other areas identified on aerial photos or during the site reconnaissance as being potential sources of contamination. E & E believes that the proposed changes to the sampling locations will be more useful in locating possible contaminated areas at this site. All other sampling locations presented in the work plan for Site 11 appear to be in locations suitable for the Phase I assessment.

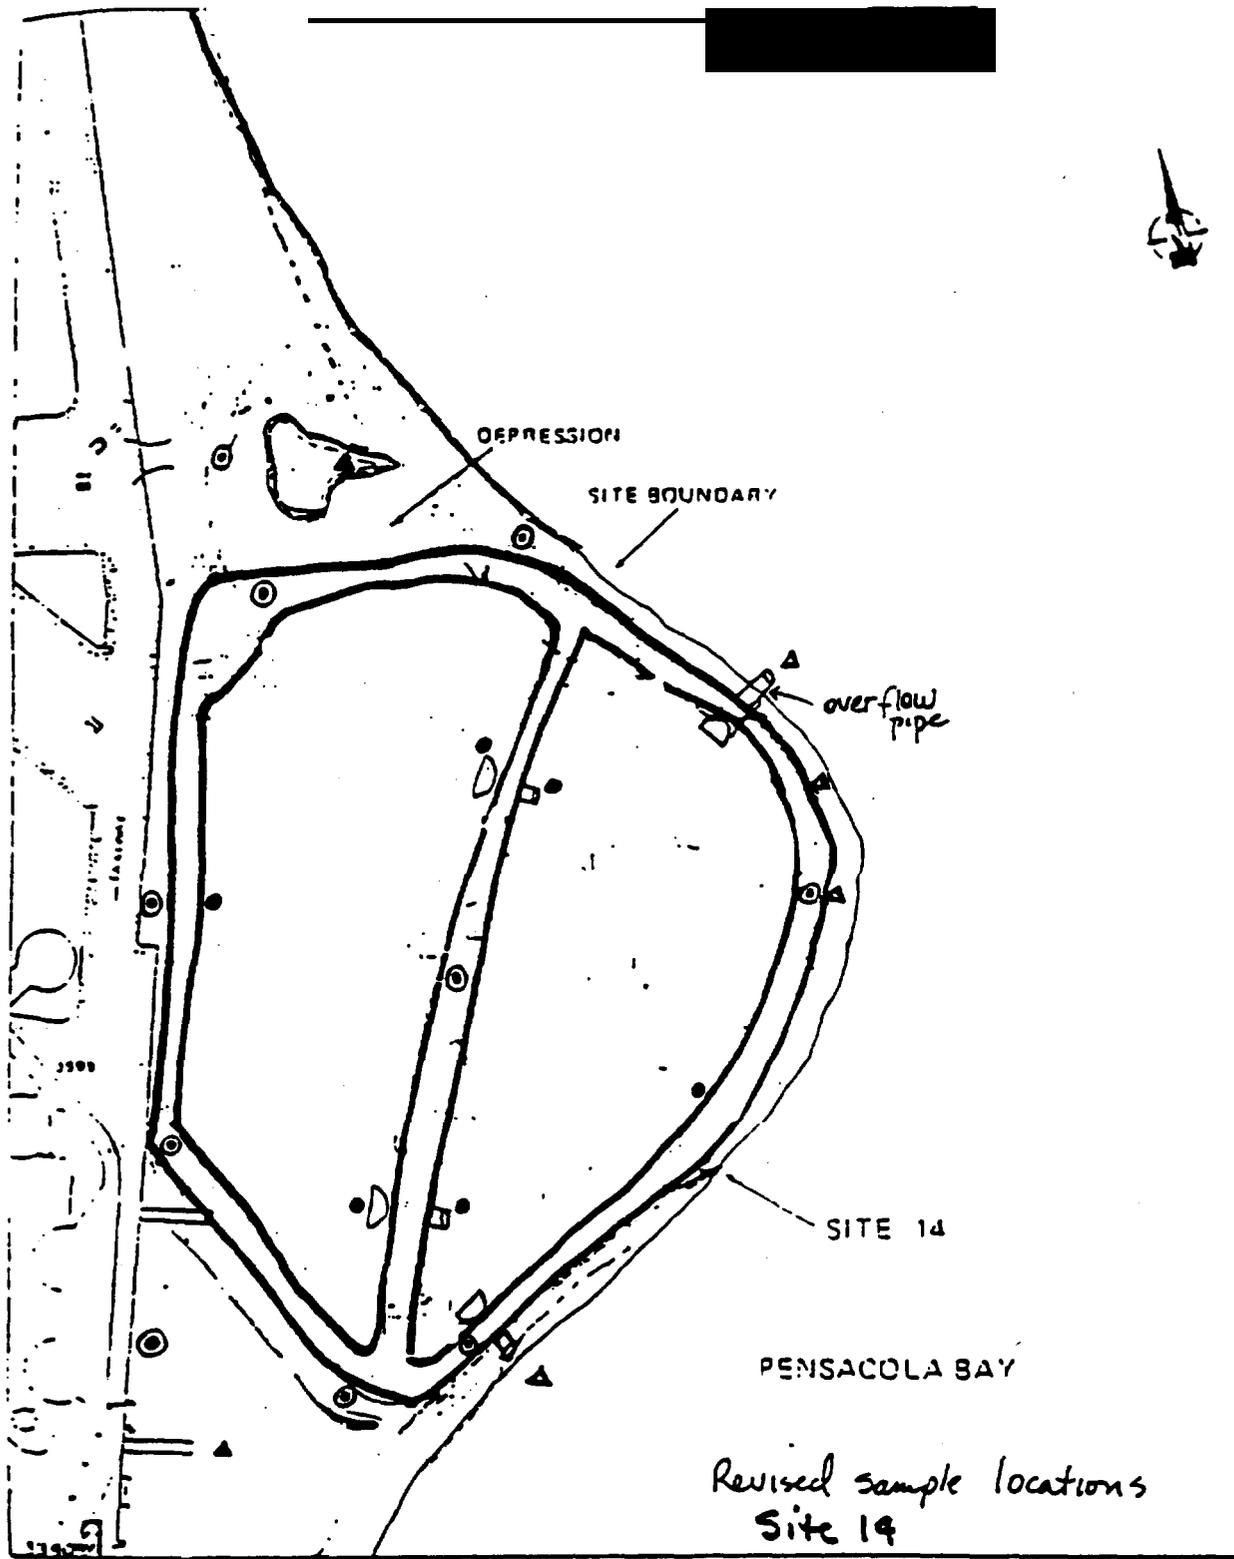
Site 14 -- A field reconnaissance was also conducted for Site 14. The overall physical appearance of Site 14 is significantly different than it appears in the work plan. The size of the site has decreased to approximately one-half the original width. The areas of depression have also changed. The site appears to be divided into two areas of depression surrounded by berms of sand approximately 20 to 30 feet high. This change in the physical appearance of Site 14 will significantly affect the sampling locations.

Site 14 -- Due to the change in the physical layout of Site 14, new sample locations are needed (See attached figure). A temporary monitoring well will be placed near the northern pond and a composite sediment sample will be collected in the pond. One monitoring well will be placed between Chevalier Field and the spoil pile and two wells will be placed near the marsh area south of the spoil pile. One of these wells will be placed between the spoil pile and the marsh and the other will be placed between a concrete runoff culvert from Chevalier Field and the marsh. A composite sediment sample will also be collected in the marsh area south of the dredge pile. An additional monitoring well will be drilled just north of the berm on the beach. The five remaining monitoring wells proposed in the work plan will be placed along the berm of the dredge spoil pile. Two wells will be placed on the western berm, one on the center berm, and two on the eastern berm. Three soil borings will be drilled inside the western depression and three will be drilled inside the eastern depression. Due to the unstable nature of the soil in these depressions, the borings will be drilled just inside of the berms. Four sediment samples are proposed to be collected east of the dredge pile. One of these will be collected at each of the two outfalls that go into the bay. The other two will be collected at the foot of the berm on the bayside. E & E believes that these modified sample locations will serve to identify the principal areas and primary contaminants of concern at the site.

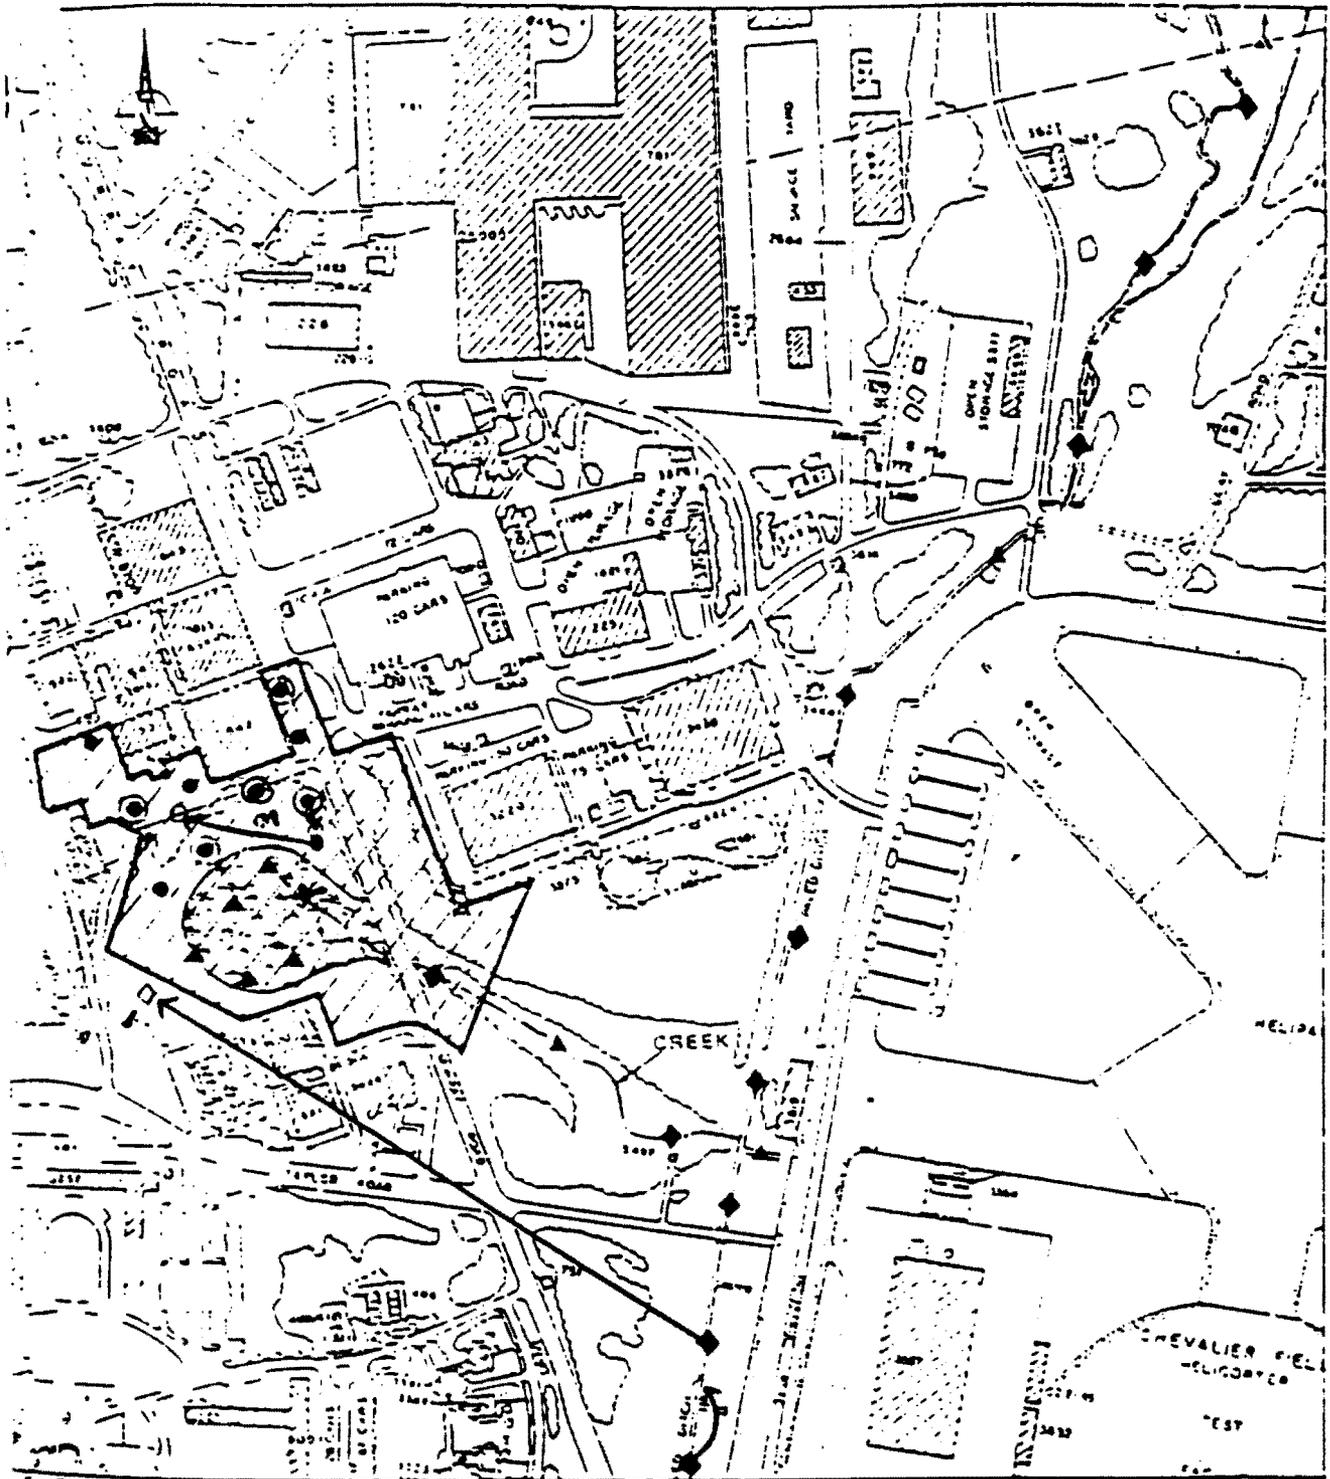
During the inspections were made in and around gs 649 and 755, in and around the swamp, and along the banks of the creek and paved . Several pipes which appear to be outfalls were located. One pipe located southwest of the swamp area, which appeared to be a er outfall, was discharging a small volume of water into a small creek which leads to the swamp. Another pipe, of PVC ti was noted downstream south of il 649 and was discharging water into the swamp at a rate of approximately 30 gallons per minute (gpm). The water emanating from this pipe is believed to be from the cooling system in l 649. A third pipe was noted near the l of the swamp. This was a ut metal pipe and appeared to be discharging water at a rate near 50 gpm. At least three other outfall pipes were noted along the paved ditch downstream of where the creek enters the ditch. S should be collected from each of these outfalls.

The results of the field tasks conducted to date indicate the need for some amendments to the sample locations presented in the Site 30 work plan. E & E recommends placing a sediment/surface water sample in the area southwest of the swamp where an outfall was noted and elevated surface emission OVA readings were detected (See figure). One of the sediment/surface water samples located in the ditch upstream from where the creek enters the ditch can be eliminated to compensate for the extra sample southwest of the swamp. E & E also recommends that the soil boring located just east of the swamp and just west of Hurray road be relocated to the northwest along the western end of the linear area of anomalies noted by the EH 31 during the geophysical survey. E & E believes that the proposed amendments in the sampling locations will be more useful in locating possible contaminated areas at this site. All other sampling locations presented in the work plan for Site 30 appear to be in locations suitable for the Phase I assessment.
