PROJECT COMPLETION REPORT
FOR
PETROLEUM-CONTAMINATED SOIL REMOVAL
UNDER DELIVERY ORDERS 0006 AND 0017
AT SITES 2662W AND PSC-36, CHEVALIER FIELD
NAVAL AIR STATION PENSACOLA, FLORIDA

DEPARTMENT OF THE NAVY
SOUTHERN DIVISION
NAVAL FACILITIES ENGINEERING COMMAND

BECHTEL ENVIRONMENTAL, INC.
OAK RIDGE, TENNESSEE

JANUARY 1996

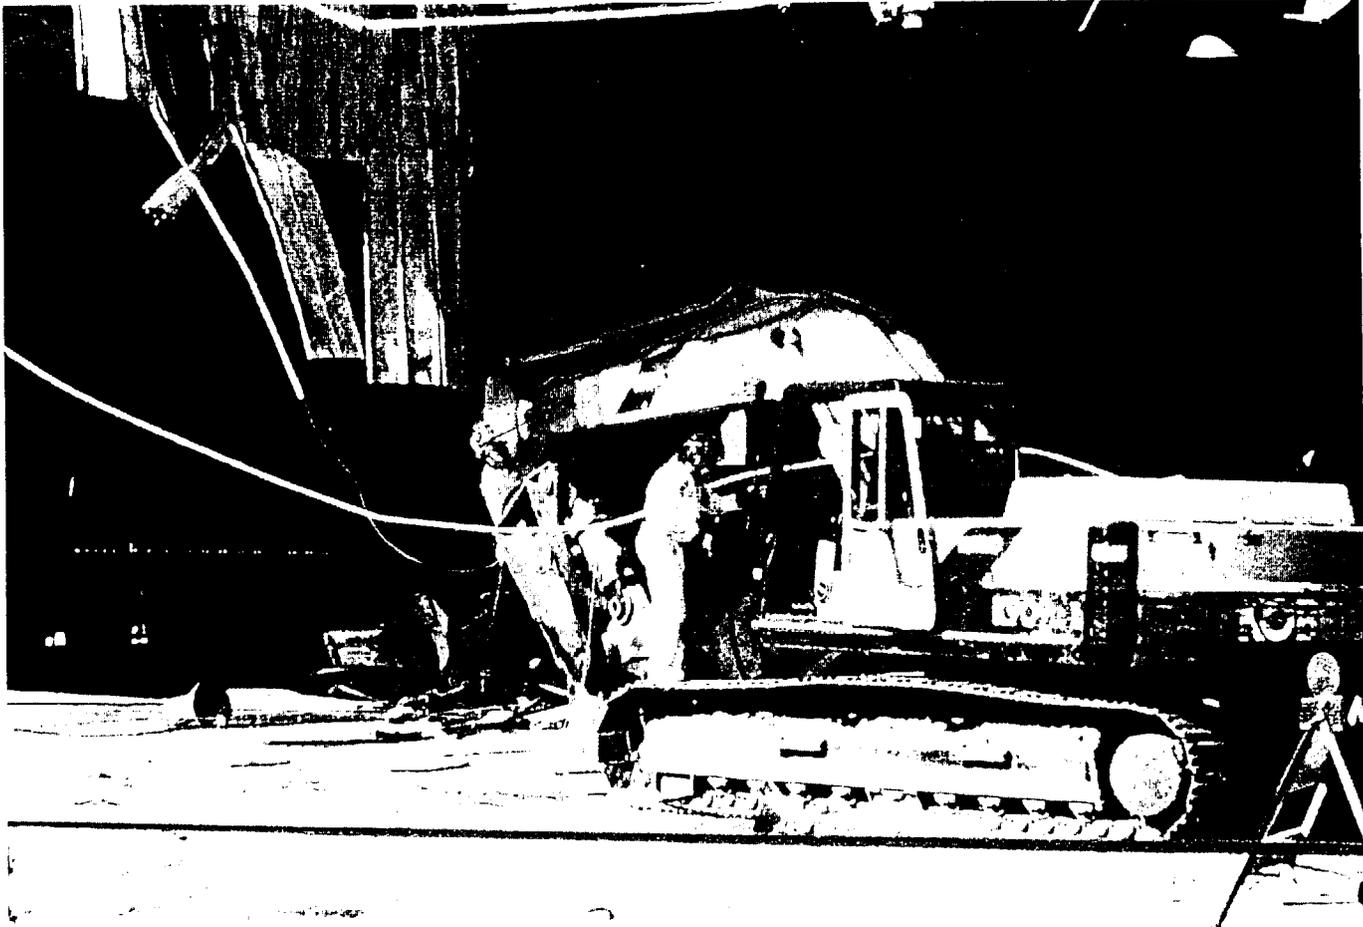
Figure 2

Shear ng Operation-Demolition Bldg 2662

Solution: A lead abatement plan was developed in the field, unit prices were negotiated with the demolition subcontractor for working under changed environmental working conditions, the potential extra costs were trended, and work was authorized to proceed using special equipment (track operated shear) and appropriate personal protective equipment (Appendix D, Photographs 2, 3, 4 and 5). No schedule delay resulted.

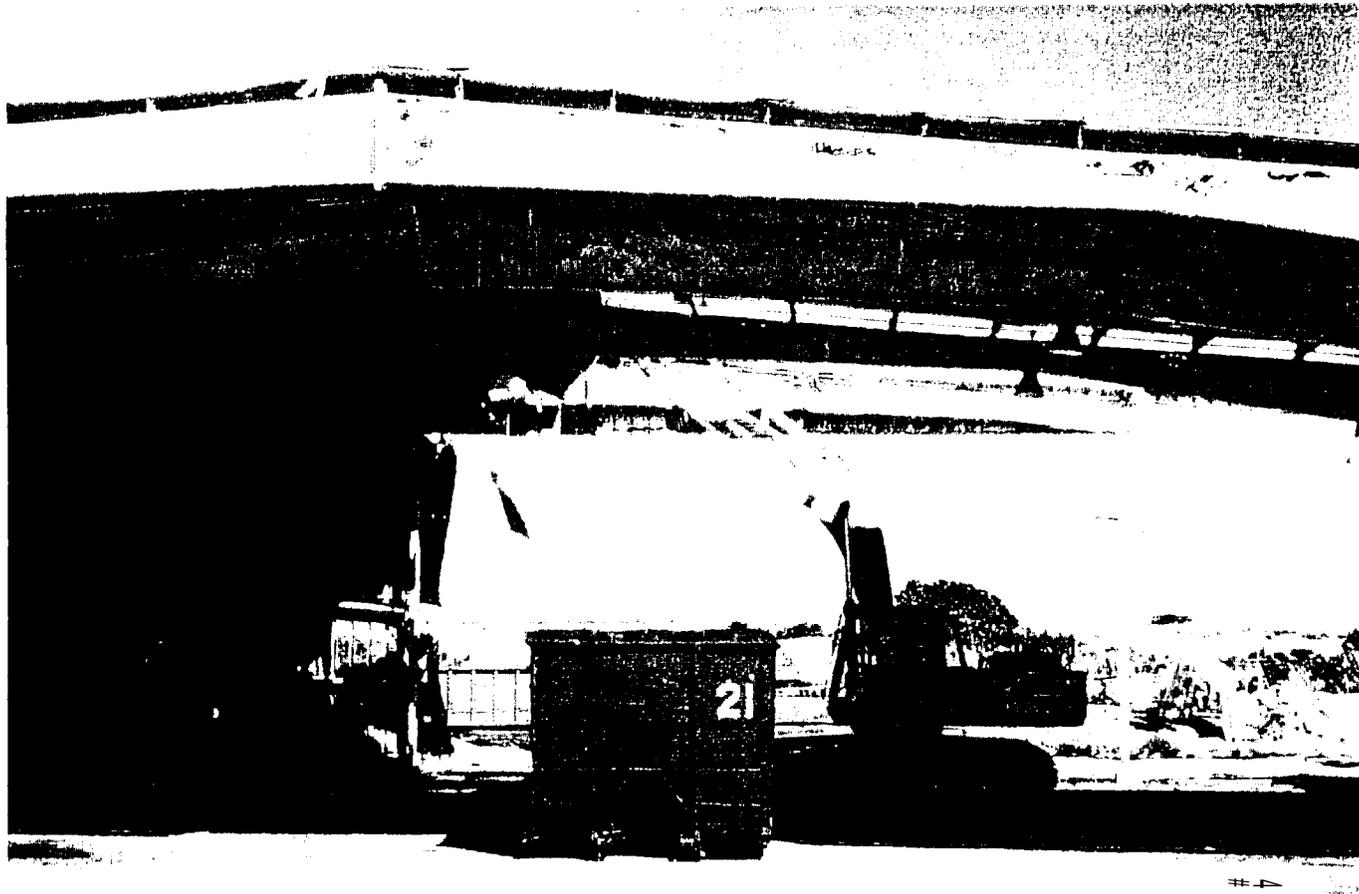
Figure 3

Looking Into Building 2662 as Demolition Takes Place

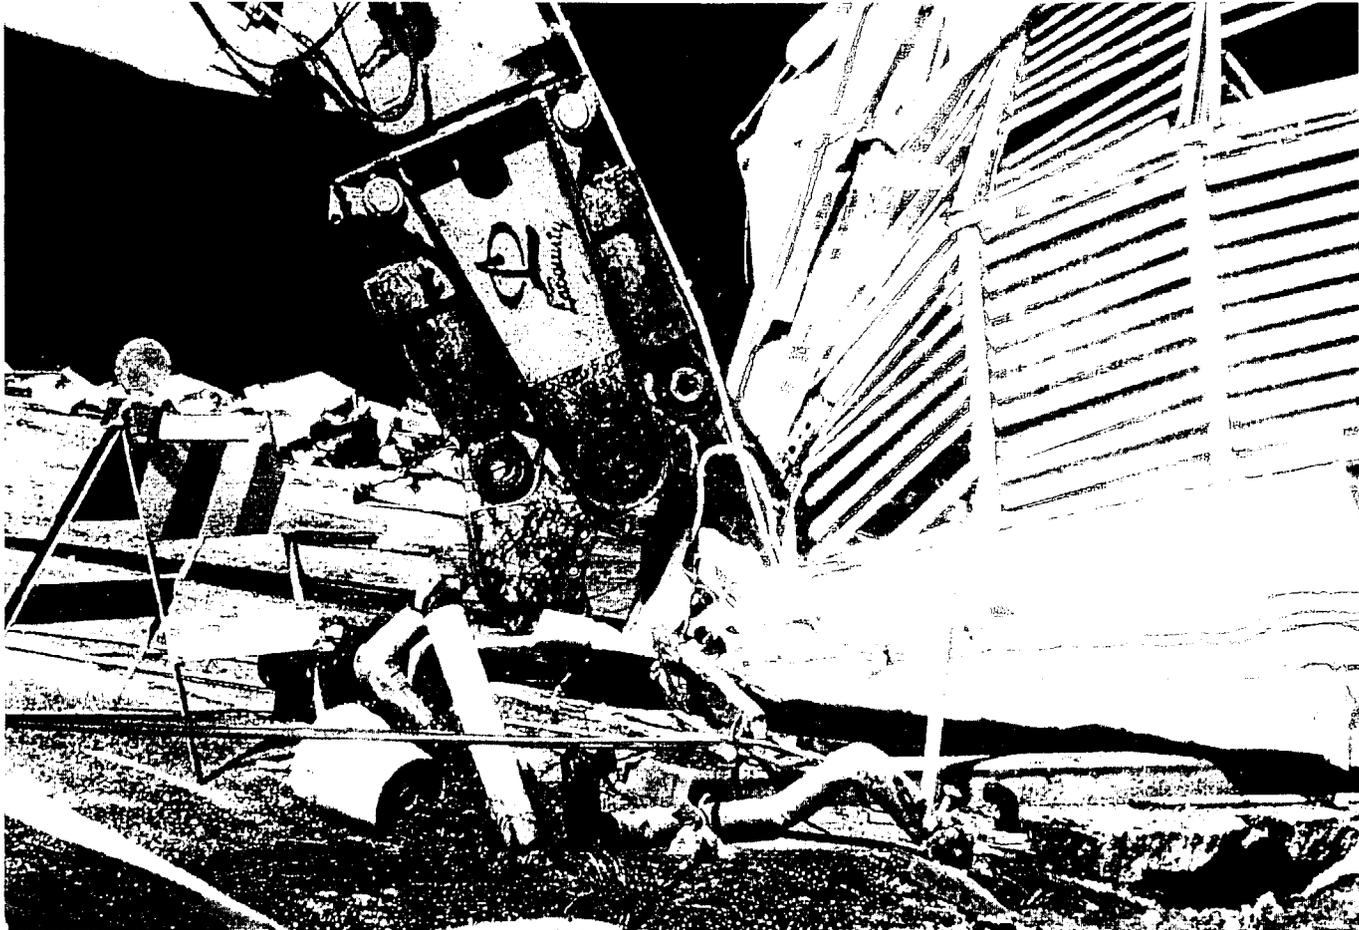
Figure 4

Looking N.W. Bldg 2662 with Partial Demolition

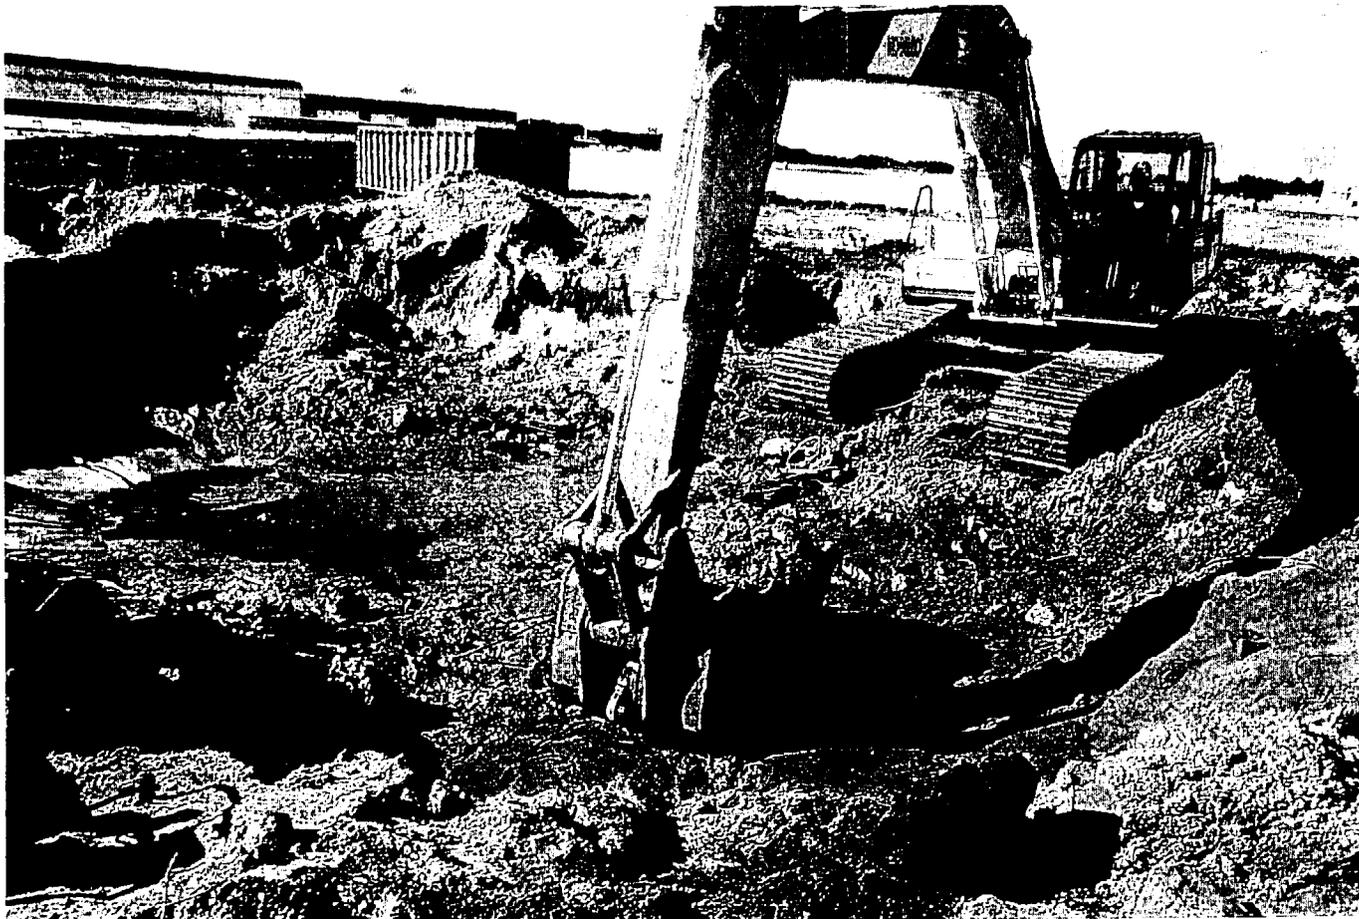
Figure 12

Looking into Oily Water Separator

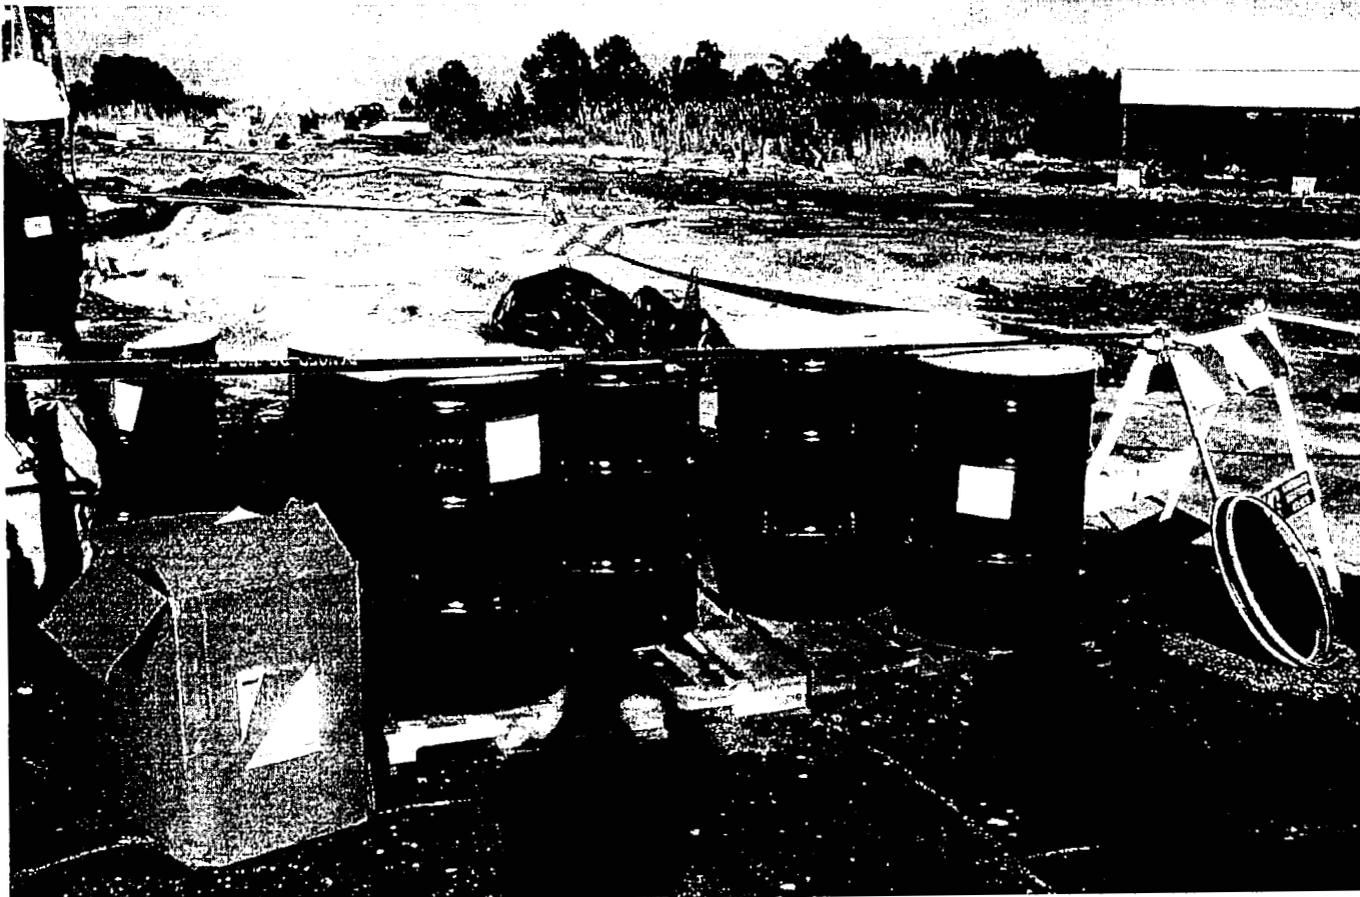
Figure 11

Looking at Drums of Floor Sweeping Waste from Bldg 2662

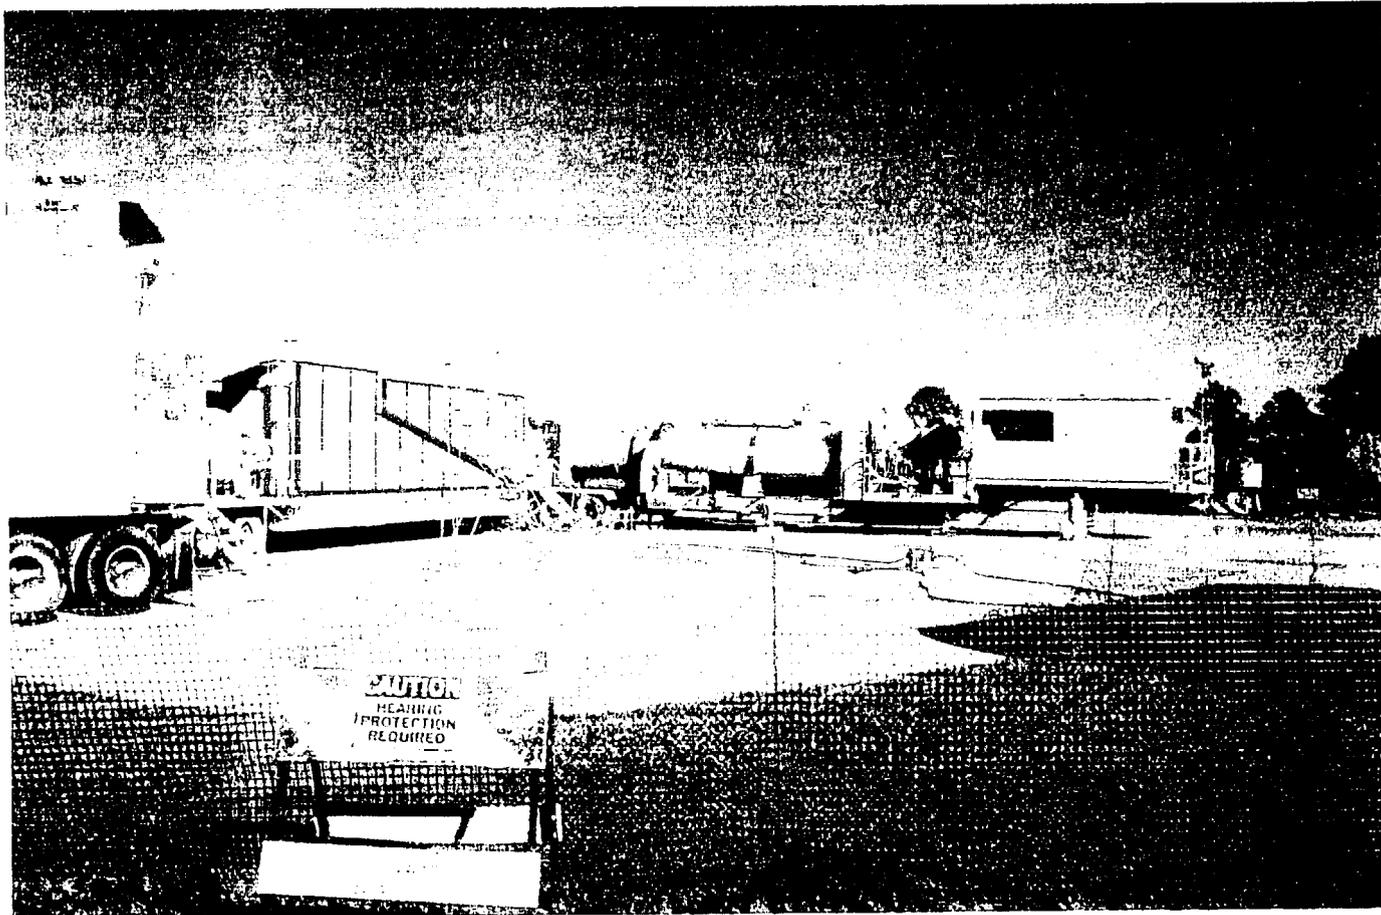
Figure 17

The thermal treatment subcontractor failed his FDEP-required stack test and shut down the unit before completing the treatment of the soil.

Looking East at Soil Thermal Treatment Unit

Solution: The contractor loaded and transported the soil offsite to his fixed soil treatment unit in Maxville, Florida, for disposal.

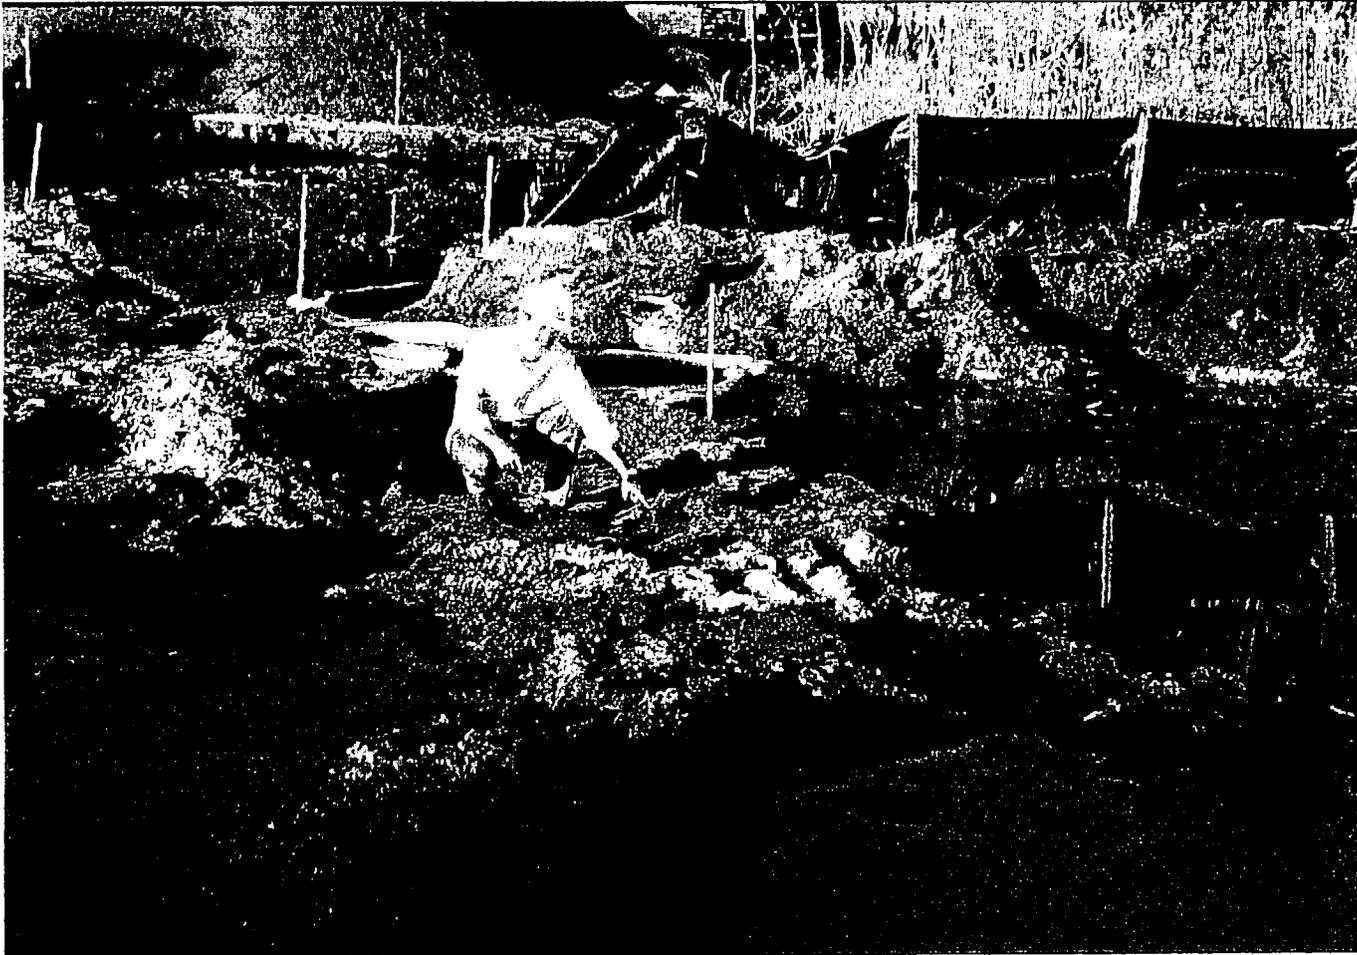
Figure 19

Active utilities in the remediation zone were permanently terminated **as** directed by the NTR. The bilge waste water line that intersected the excavation area on the east side was not removed. The line was temporarily supported to maintain its structural integrity during excavation and backfill work. **A 2-in,** threaded opening was discovered in the pipeline during excavation; the opening **was** reported immediately to the NTR and was repaired by Public **Works** personnel.

4 inch Opening in Bilgewater Pine in Solvent Plume
