**REPORT OF
PHASE I ENVIRONMENTAL SITE ASSESSMENT**

**A Portion of Outlying Landing Field (OLF) Bronson
Approximately 430-Acre Site
Naval Air Station Pensacola, Florida**

**October 20, 1997
LAW Project 50227-7-0052.01**

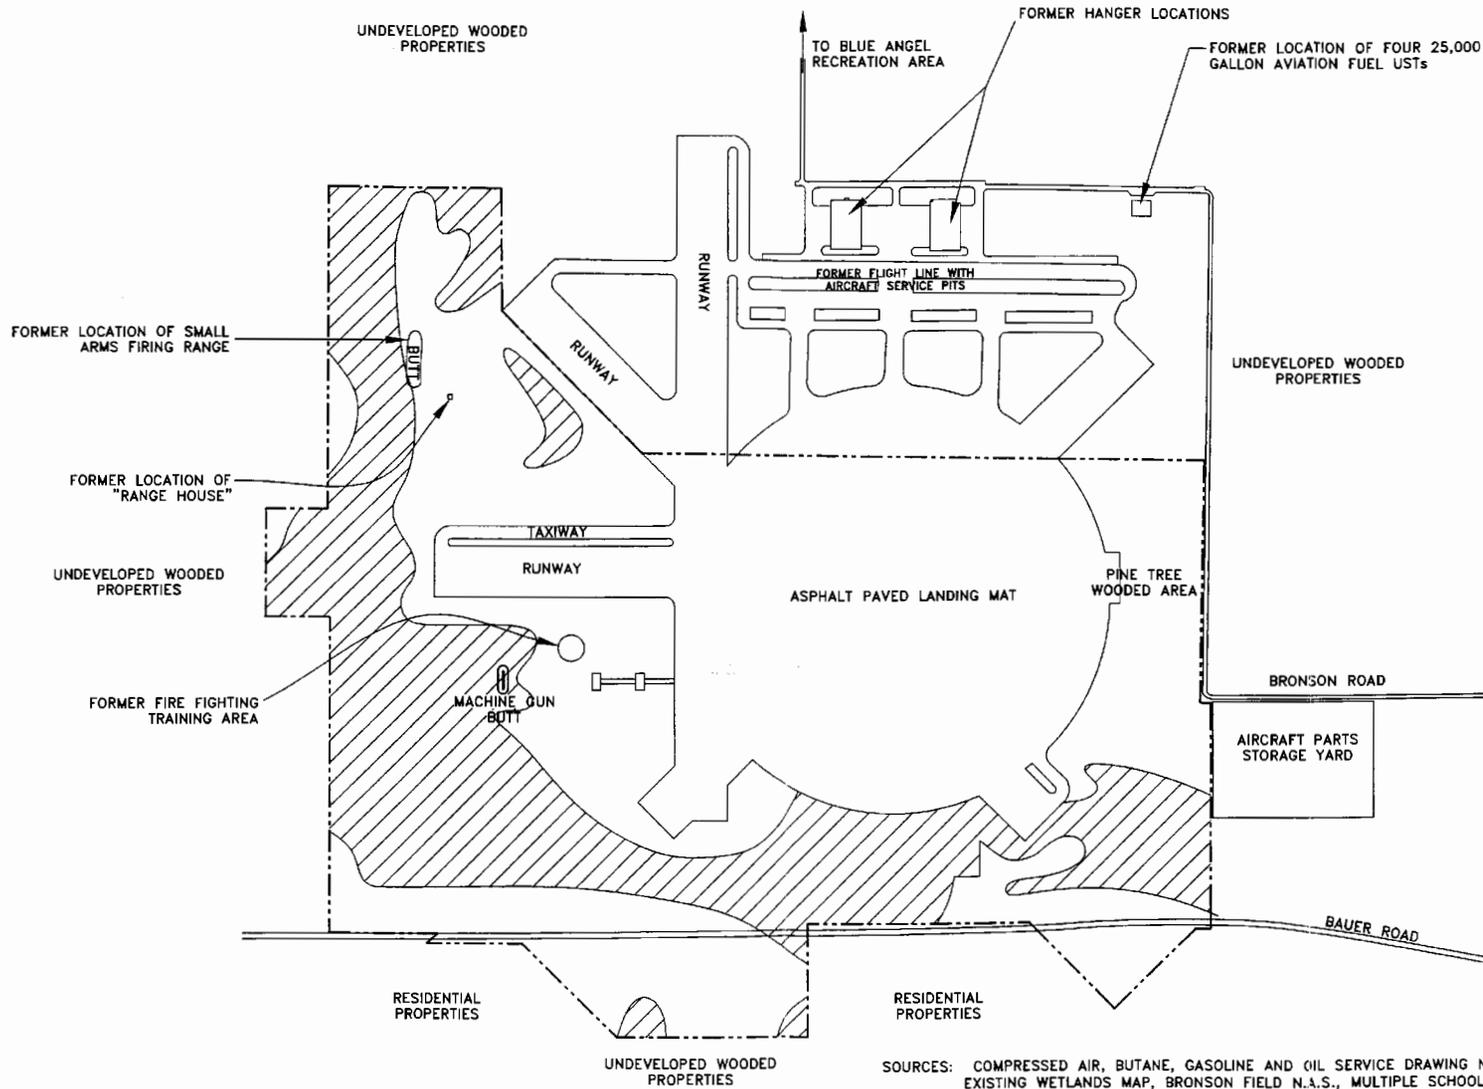
GENERALIZED SITE PLAN WITH
 SURROUNDED PROPERTIES NOTED
 PHASE I ENVIRONMENTAL SITE ASSESSMENT
 OLS BRONSON N.A.S.
 PENSACOLA, FLORIDA

The 1944 N.A.S. Drawing No. 23032 showed a "Machine Gun Butt" on the south-central portion of the subject site (see Figure 2). The presence of the Machine Gun Butt was observed in all the aerial photographs reviewed, and during our site reconnaissance. The Machine Gun Butt measures approximately 100 feet by 40 feet by 30 feet high. The 1992 Preliminary Assessment Report indicated that aircraft mechanics used the southeast section of OLF Bronson (south-central portion of the subject site) to calibrate 30-and-50 caliber aircraft machine guns. Bullets from aircraft guns were aimed at the Machine Gun Butt to test and align aircraft gun sites. We observed remnants of bullets embedded in the Machine Gun Butt during our reconnaissance. LAW's experience with firing ranges indicates that potential for soil and ground-water contamination due to the presence of lead and other heavy metals exists at firing ranges. Based on the presence of the former aircraft machine gun firing range, and the potential for contamination related to the former activities at the firing range, the former Machine Gun Butt is considered a recognized environmental condition.

The 1992 Preliminary Assessment Report indicated that a fire-fighting training area was located on the south-central portion of the subject site (see Figure 2). The fire-fighting training area was believed to be utilized during the time that OLF Bronson was active (1942-1958). The OLF Bronson Fire Department reportedly conducted practice burns at the training area. Details of the fire-fighting drills were not indicated in the report. The report did indicate that a typical fire-fighting drill consisted of filling a shallow pit with water then pouring flammable material on top of the water and igniting it. Typically, material burned during the training exercises would consist of readily available flammable products such as waste aviation gasoline. Other flammable liquids such as kerosene, chlorinated solvents, diesel fuel, hydraulic fluid, and automobile gas may have been burned. Due to the reported use of potential contaminants at the fire-fighting training area and their potential to come into direct contact with the ground surface, the former fire-fighting training area is considered a recognized environmental condition.

The assessment report identified the "Machine Gun Butt" on the south-central portion of the subject site as a potential environmental concern (see Figure 2). The Machine Gun Butt had been utilized during the active period of OLF Bronson as a backstop for aircraft machine gun targets. The report concluded that the metals which were fired into the Machine Gun Butt could have potential to impact local surface waters and a minimal impact on ground water. The assessment report recommended that soil sampling be conducted in the area of the Machine Gun Butt to evaluate whether potential metal contaminants are migrating from the earthen mound. LAW is not aware that this recommended soil sampling activity at the former Machine Gun Butt has been conducted.
