**DRAFT FINAL SUMMARY AND  
TECHNICAL EVALUATION REVIEW  
OF WORK PERFORMED AT 51  
SWMUs AND AOCs  
U.S. NAVAL STATION  
ROOSEVELT ROADS  
CEIBA, PUERTO RICO  
Work Assignment: R02031  
(Ref. No. 1-635-340)**

**Prepared for:  
U.S. Environmental Protection Agency**

DRAFT FINAL SUMMARY AND TECHNICAL EVALUATION REVIEW  
OF WORK PERFORMED AT 51  
SWMUs AND AOCs  
U.S. NAVAL STATION ROOSEVELT ROADS  
CEIBA, PUERTO RICO

Work Assignment No.:	R02031
EPA Region:	II
EPA Site/Facility I.D. No.:	PR2170027203
Contract No.:	68-W9-0003 (TES-6)
TRC Document No.:	NY-R31.RP4
TRC Project No.:	1-635-340-3-2000-0
TRC Project Manager:	Steven E. Panter
Telephone Number:	(908) 563-1100
Subcontract No.:	NA
Subcontractor Project Manager:	NA
Telephone No.:	NA
EPA Work Assignment Manager:	Timothy Gordon
Telephone No.:	(212) 264-9538
Date Prepared:	June 30, 1993

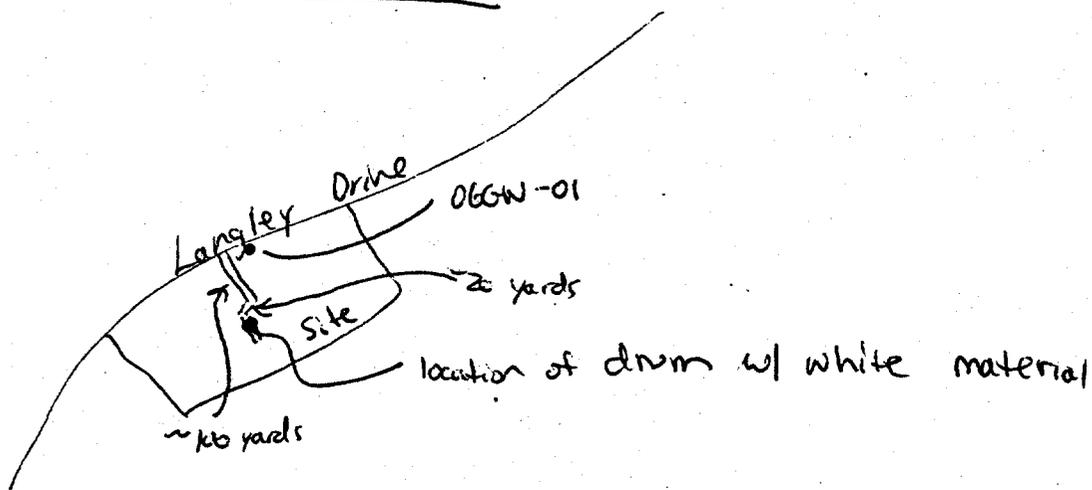
Sketch of Site:

2. The vegetative growth on the site is so thick that it is virtually impenetrable w/out the aid of a backhoe/bulldozer.
3. Other materials observed included rusted metal flexible pipe & concrete debris.
4. Baker's results should be in shortly obtain copy to make suggestions.

1. Sample the white material of the drum to determine if they are hazardous or not.

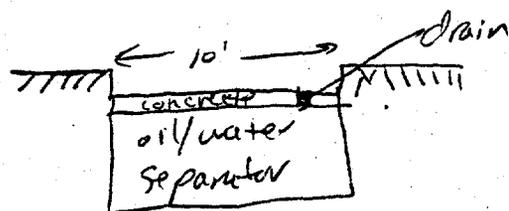
1. The oil/water separator consists of a grate (10' x 10') & 1' deep. There is a drain in the ~~sepa~~ pit that flows to the oil/water separator. The oil/water separator under lies the 1' catch basin & is not visible or accessible (see sketch): The only way to

determine if a release has occurred is to install HI borings on each side of the oil/water separator. However, there is no staining & no evidence of any release at this SWMU.

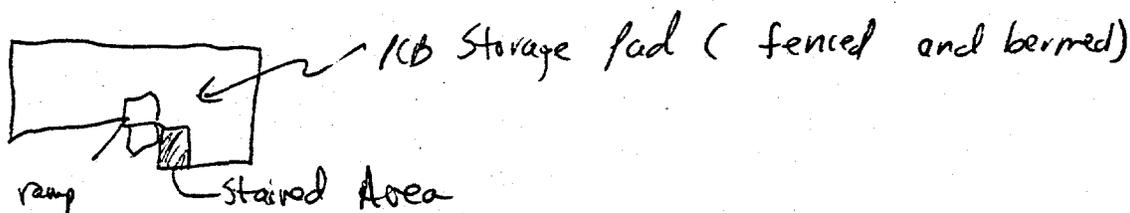
There is a stained area ~ 10' x 10' in area within the storage area (fenced and bermed). Within the storage area are numerous drums of PCB containing material as well as numerous transformers.

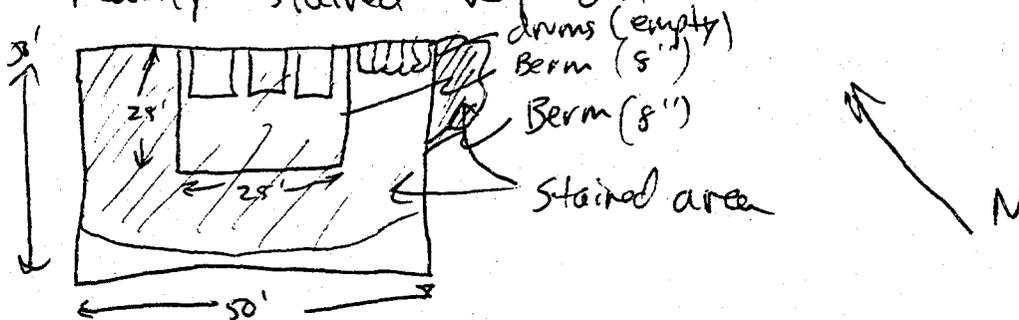
Yes. Most of the bermed (~8") pad is heavily stained w/ oil. Pad is ~50' x 50'

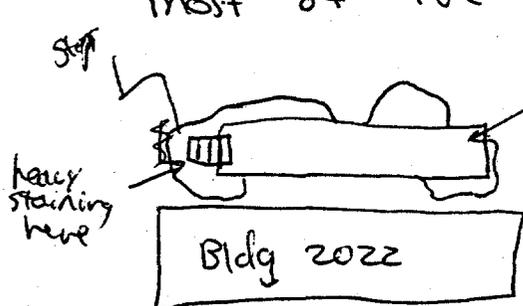
Yes. There is heavy oil staining surrounding most of the pad.

Bermed concrete pad. Berm is ~4" concrete is not cracked & it is in good condition.

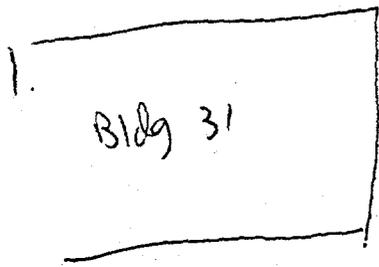
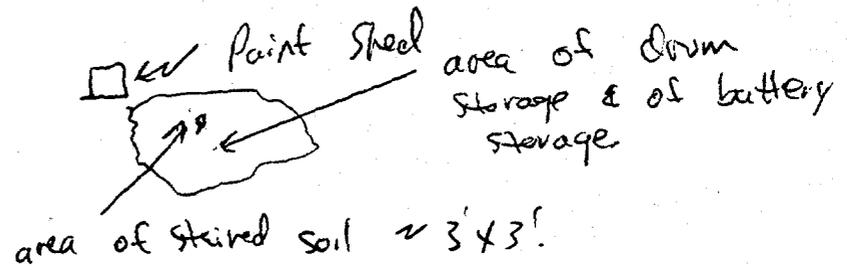
1. Drums should be kept on concrete piddled area
2. All drums were intact & not leaking
3. Area of stained soil was very small.
4. Paint Storage shed may be considered a separate SWMU.
- 5.

2. 4. Paint locker has at least 200 cans of various paints in various sized containers.
