Final
Asbestos Inspection Report
for

Naval Activity Puerto Rico
Ceiba, Puerto Rico

Volume 2 of 7

Buildings DN2-3 through 598

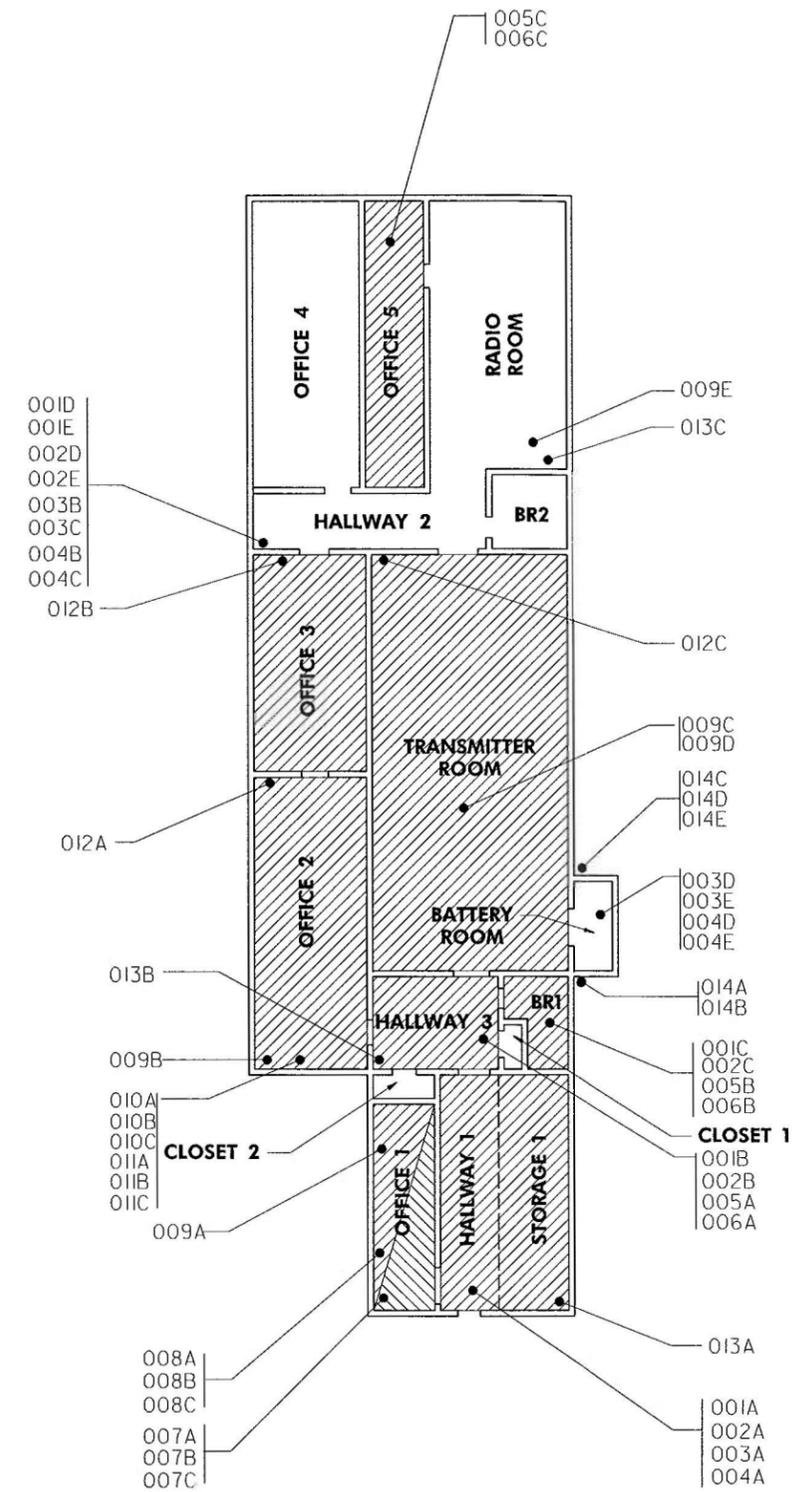
NOTE: ROOFING MATERIAL IS AN ACM.

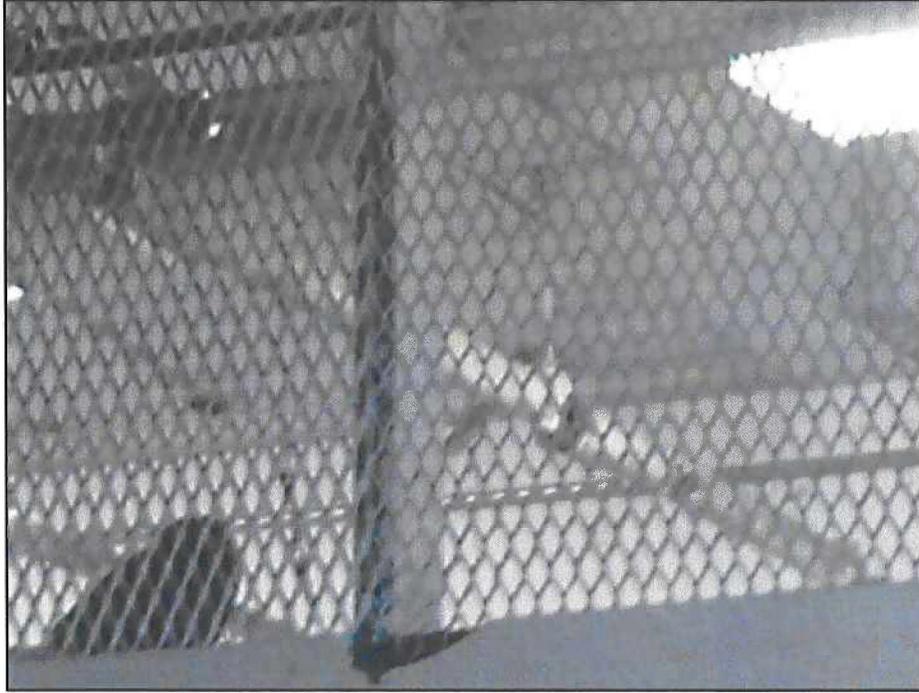
Building 31 is identified as “Public Works Department” and is approximately 120,640 square feet in size. Forty six suspect homogeneous materials were identified and sampled. Four of these materials, three types of floor adhesive (Materials #007, #018, and #021) and thermal pipe insulation (Material #045), were found to be ACM. Material #045 is friable, damaged, and accessible ACM.

Damaged area of corrugated paper thermal pipe insulation (Material #045)
in Storage 5

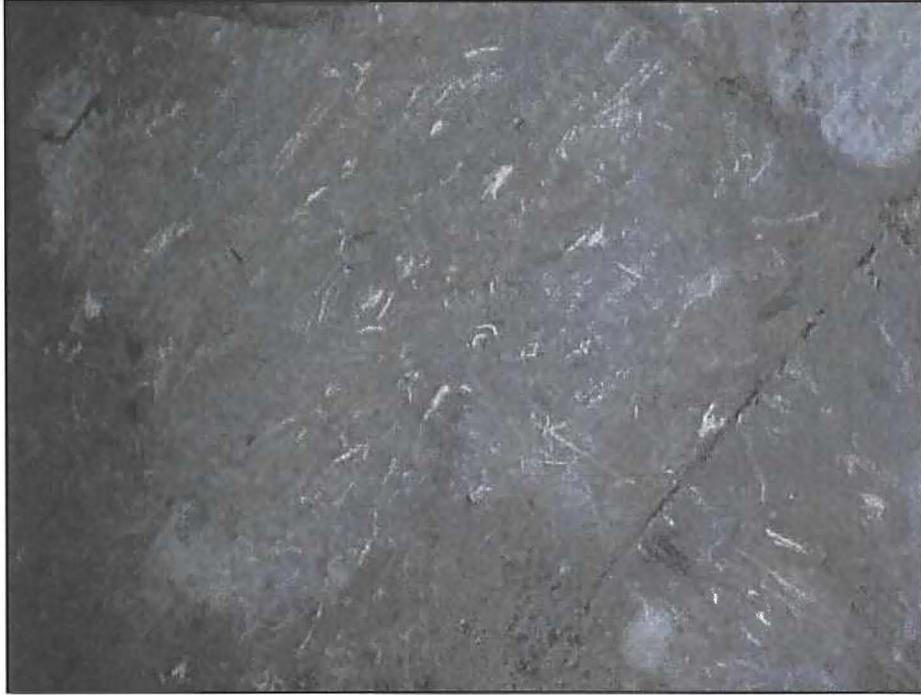
9" x 9" brown vinyl floor tile (Material # 010) over floor adhesive (Material #011)

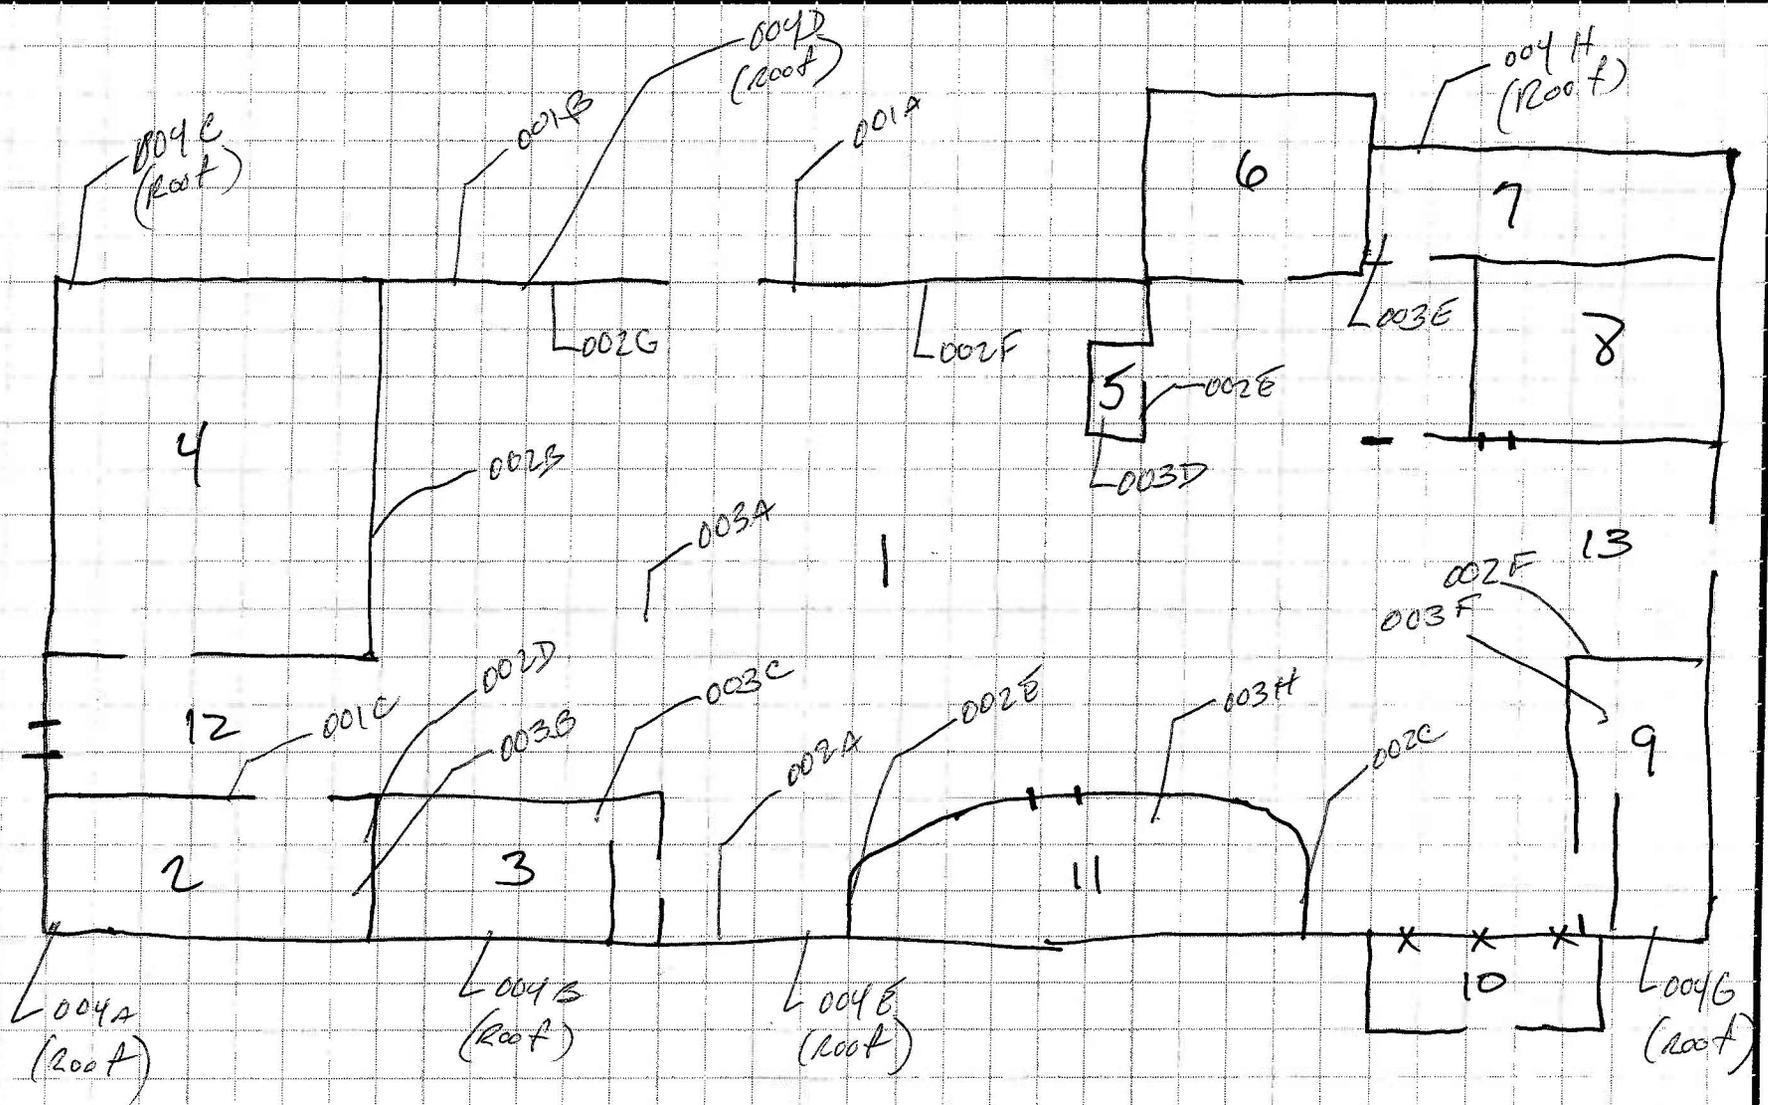
NOTE: ROOFING MATERIAL IS AN ACM.

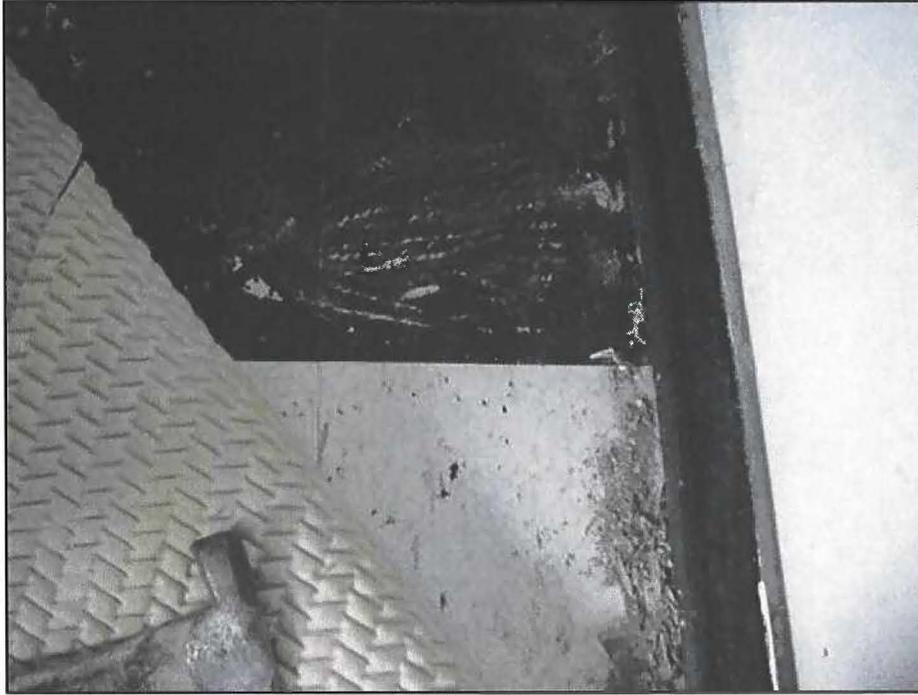
1'x1' white with black streaks vinyl floor tile (Material #001)

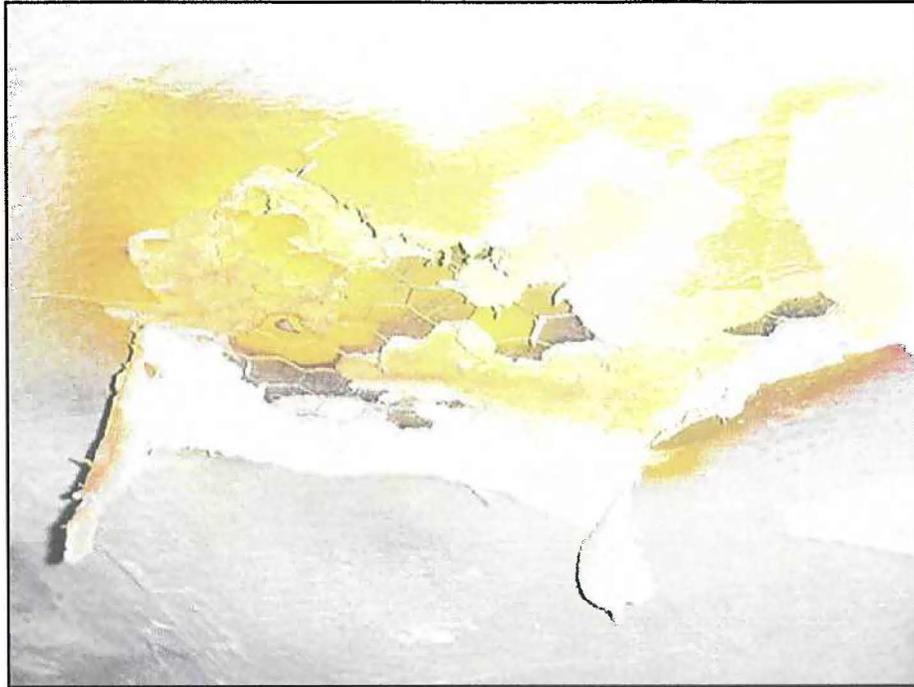
Building 426 is identified as “Oper Bldg-Control Tower” and is approximately 20,988 square feet in size. Twenty-five suspect homogeneous materials were identified and sampled. Ten materials were found to be an ACM, including six types of vinyl floor tile (Materials #003, #004, #011, #012, #018, and #023), floor adhesive (Material #005), duct insulation (Material #019), asphaltic roof sealer (Material #020), and roofing adhesive (Material#025). Material #019 was found to be friable, damaged, and accessible ACM.

Damaged and friable duct insulation (Material #019)

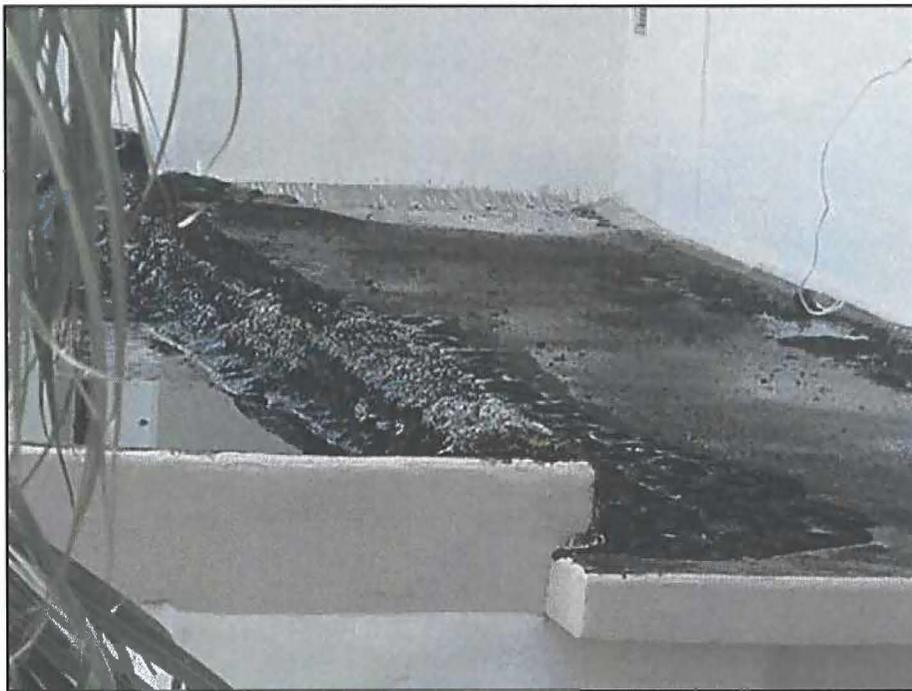
Asphaltic roofing sealer (Material #020)

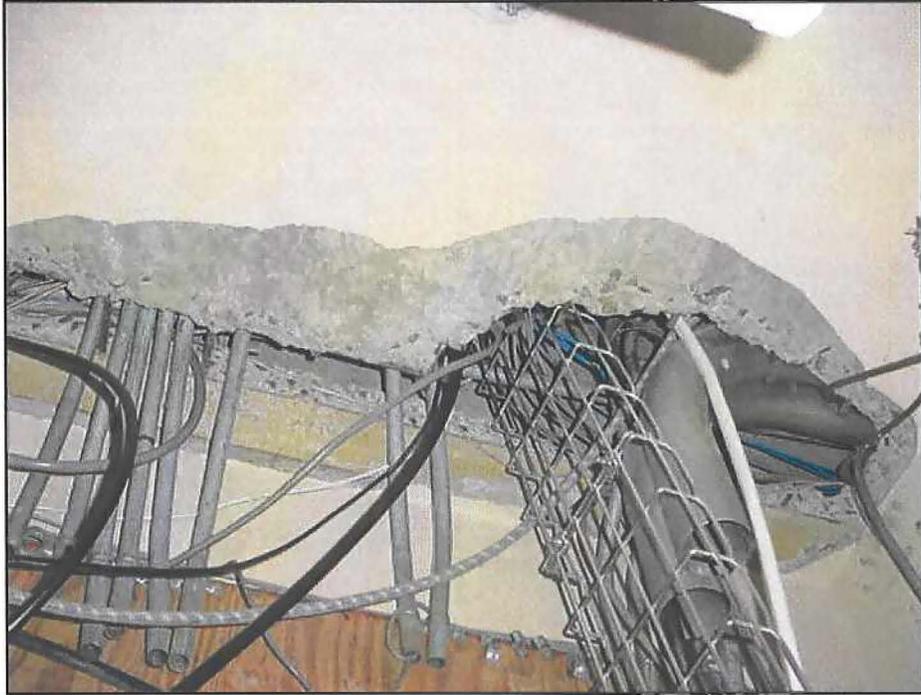
Building 598 is identified as “Navy Forces Region SOCOM” and is approximately 33,675 square feet in size. Forty suspect homogeneous materials were identified and sampled. Eight materials were found to be ACM, including: ceiling tile adhesive (Material #012), three types of vinyl floor tile (Materials #014, #020, and #026), plaster (Material #013), floor adhesive (Material #016), and two types of pipe insulation (Materials #023 and #024). The two pipe insulation materials are friable, damaged, and accessible ACM.

Damaged plaster (Material #013) on ceiling of Storage 7
