Final
Asbestos Inspection Report
for

Naval Activity Puerto Rico
Ceiba, Puerto Rico

Volume 6 of 7

Buildings 2342 through 2684

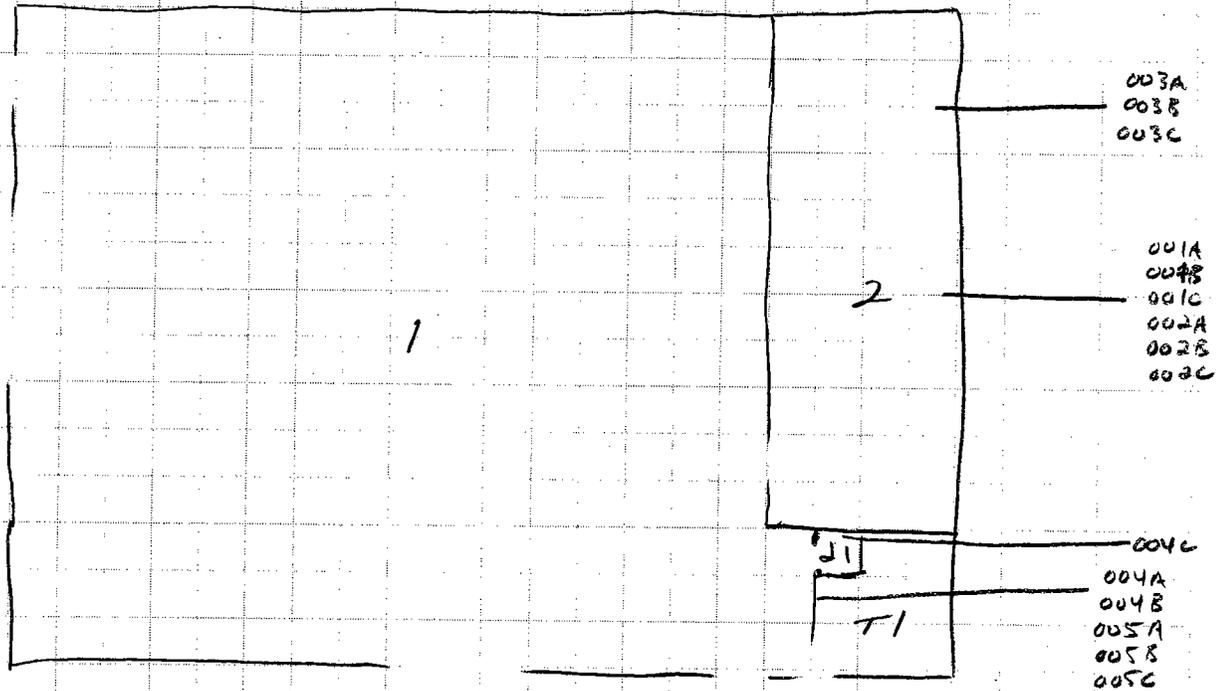
MATERIAL NUMBER	MATERIAL TYPE (MATERIAL DESCRIPTION)	ASBESTOS CONTENT	MATERIAL LOCATION(S)	FRIABLE	CONDITION	QUANTITY	COMMENTS
006	ASPHALTIC ROOFING MATERIALS (ROOFING, UNKNOWN DESCRIPTION)	ASSUMED ACM	EXTERIOR	No	UNDAMAGED	3,000 SF	THIS MATERIAL WAS INACCESSIBLE AND IS ASSUMED TO BE ACM.

NOTE: ROOFING MATERIAL IS AN ACM.

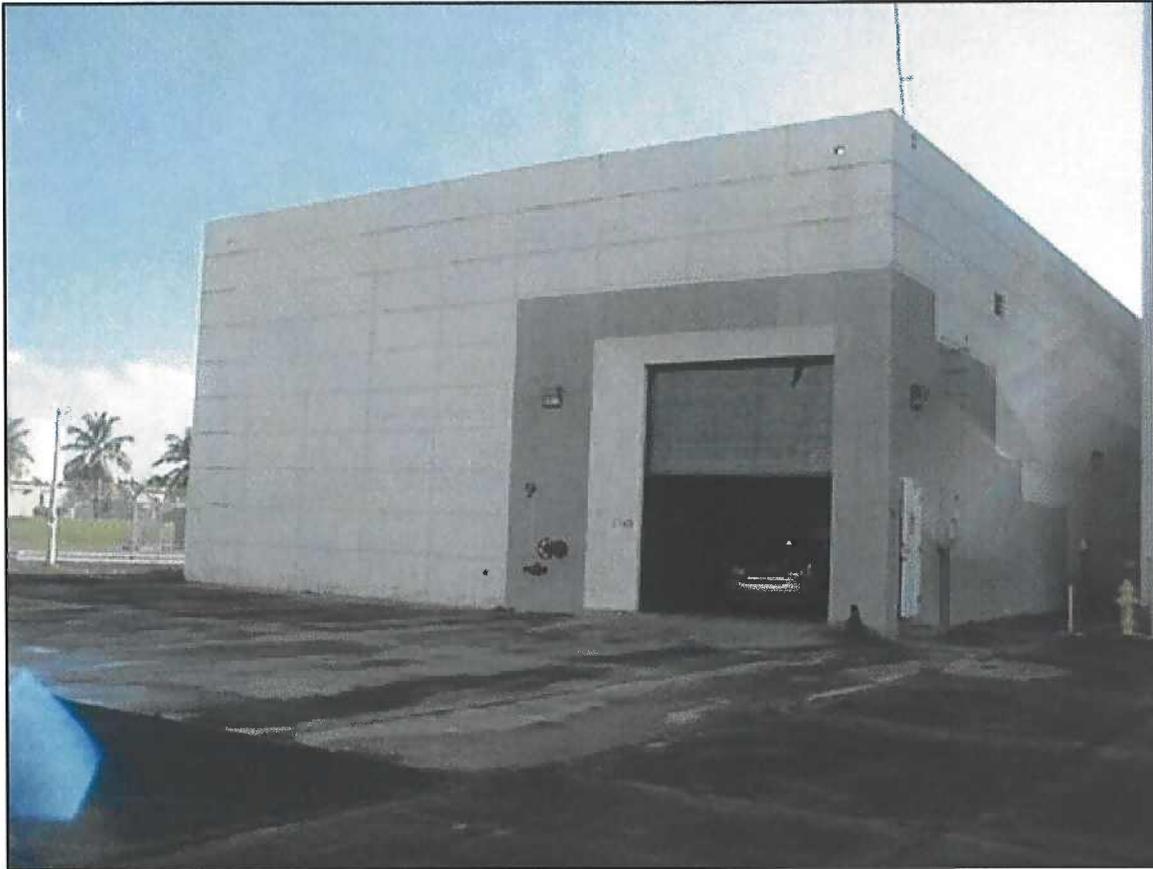
BUILDING 2343

Building 2343 is identified as “Aviation Suppt Div by B379” and is approximately 9,088 square feet in size. Five suspect homogeneous materials were identified and sampled. None of the materials were found to be ACM.

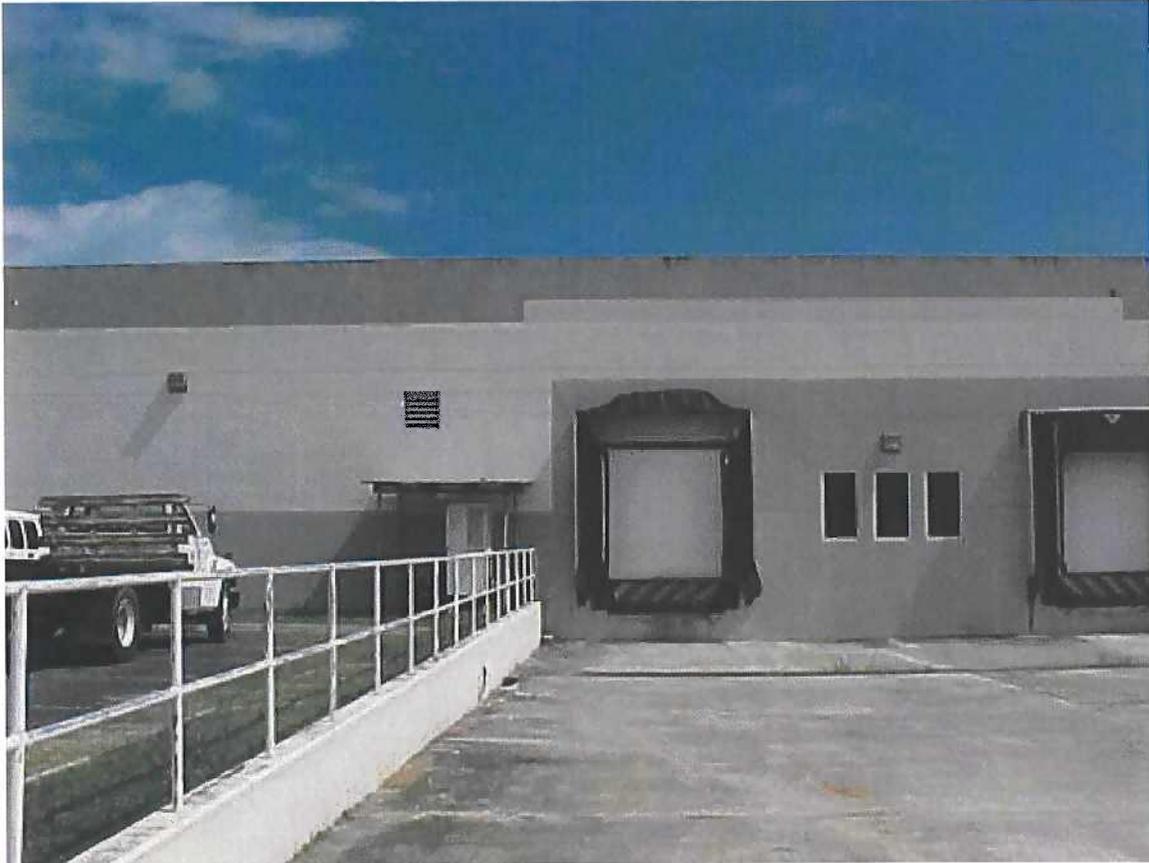
BUILDING 2344

Building 2344 is identified as “MWR Club Storage” and is approximately 9,700 square feet in size. Three suspect homogeneous materials were identified and sampled. None of the materials were found to be ACM.

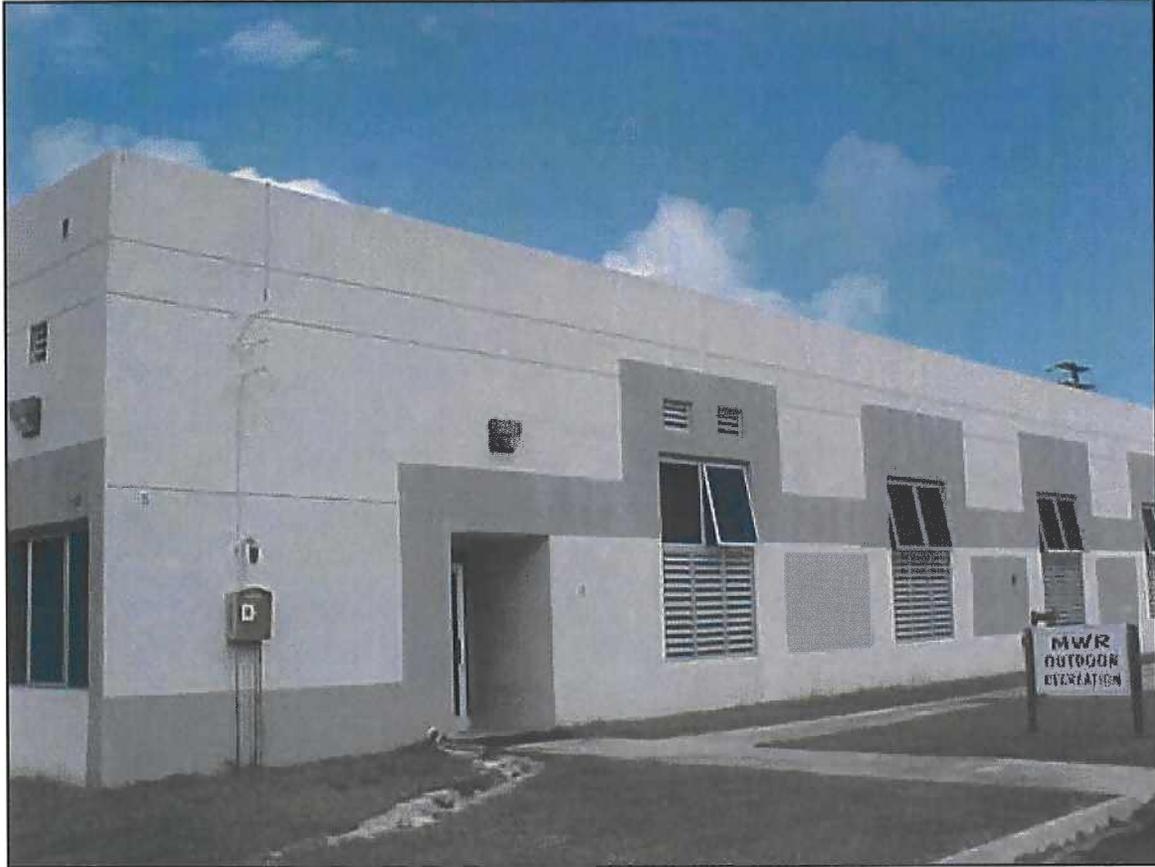
BUILDING 2345

Building 2345 is identified as “MWR Stge Bldg by Bldg 377” and is approximately 9,600 square feet in size. Three suspect homogeneous materials were identified and sampled. None of these materials were found to be ACM.

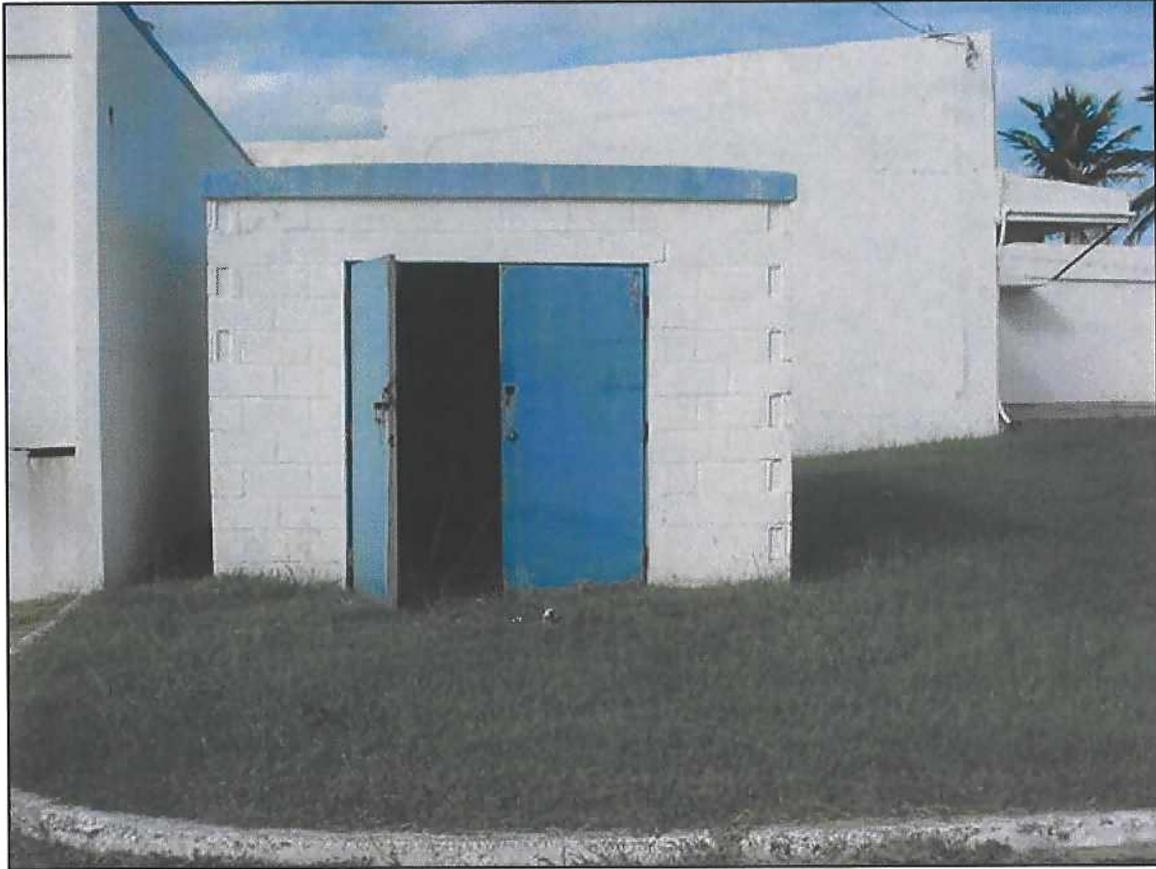
BUILDING 2347

Building 2347 is identified as “Stge Bldg by B#1685” and is approximately 168 square feet in size. No suspect materials were identified. Therefore, no sampling was conducted.

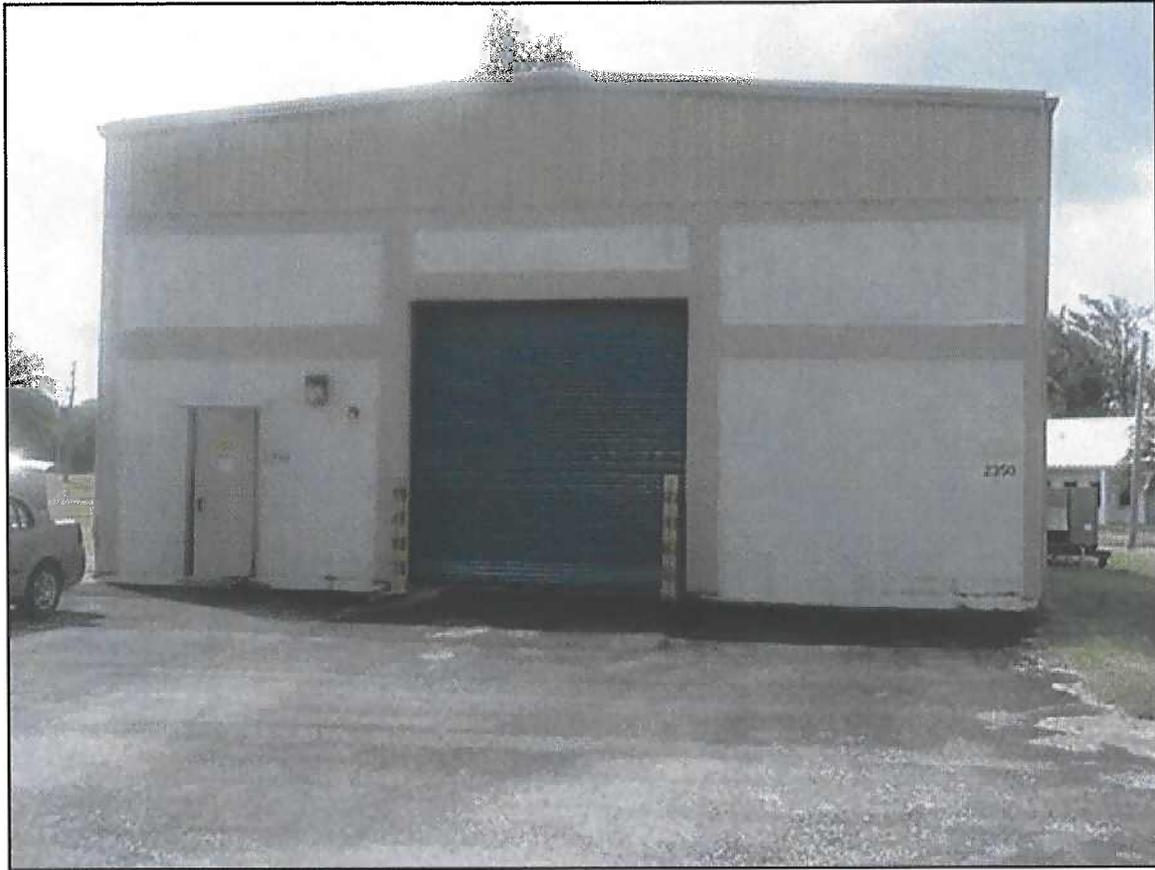
BUILDING 2350

Building 2350 is identified as “Supply Stge Bldg” and is approximately 4,000 square feet in size. Seven suspect homogeneous materials were identified and sampled. None of the materials were found to be ACM.

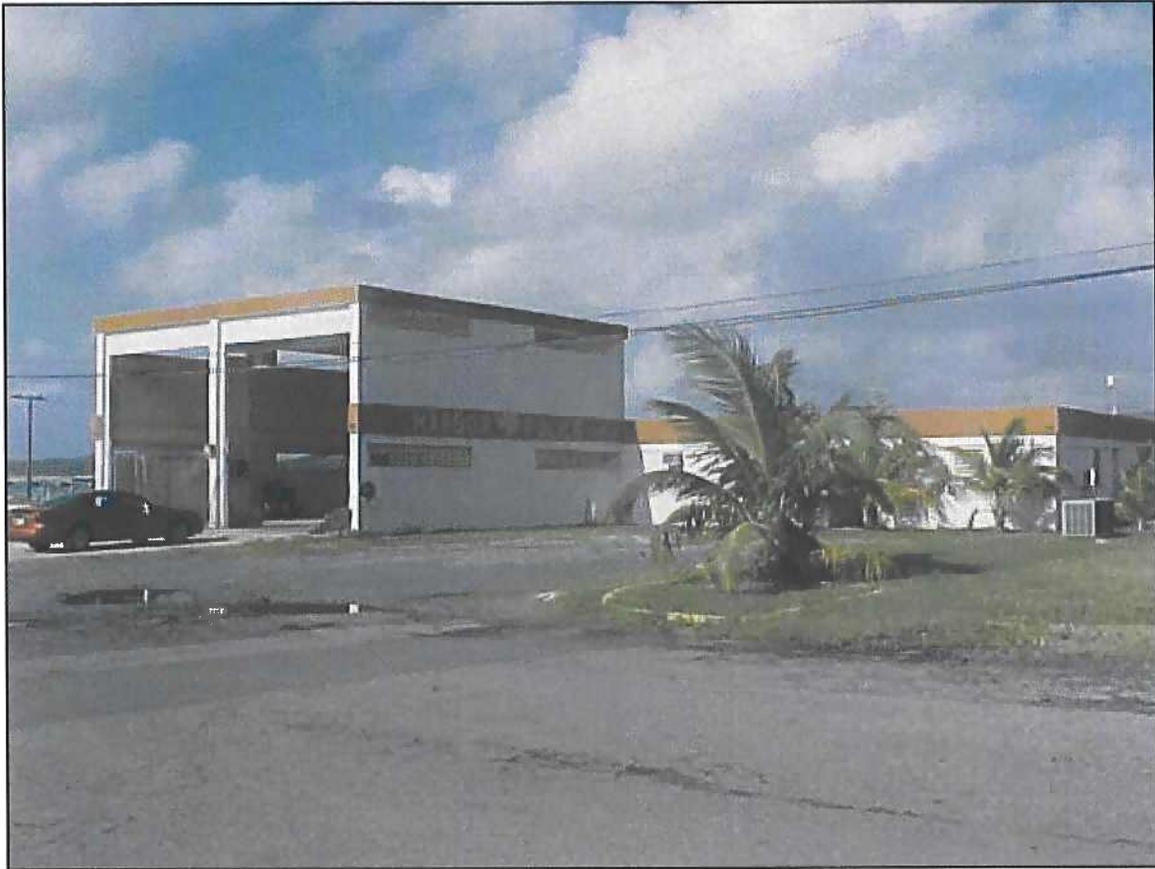
Building 2351 is identified as “Harbor Patrol” and is approximately 5,200 square feet in size. Four suspect homogeneous materials were identified and sampled. None of the materials were found to be ACM.

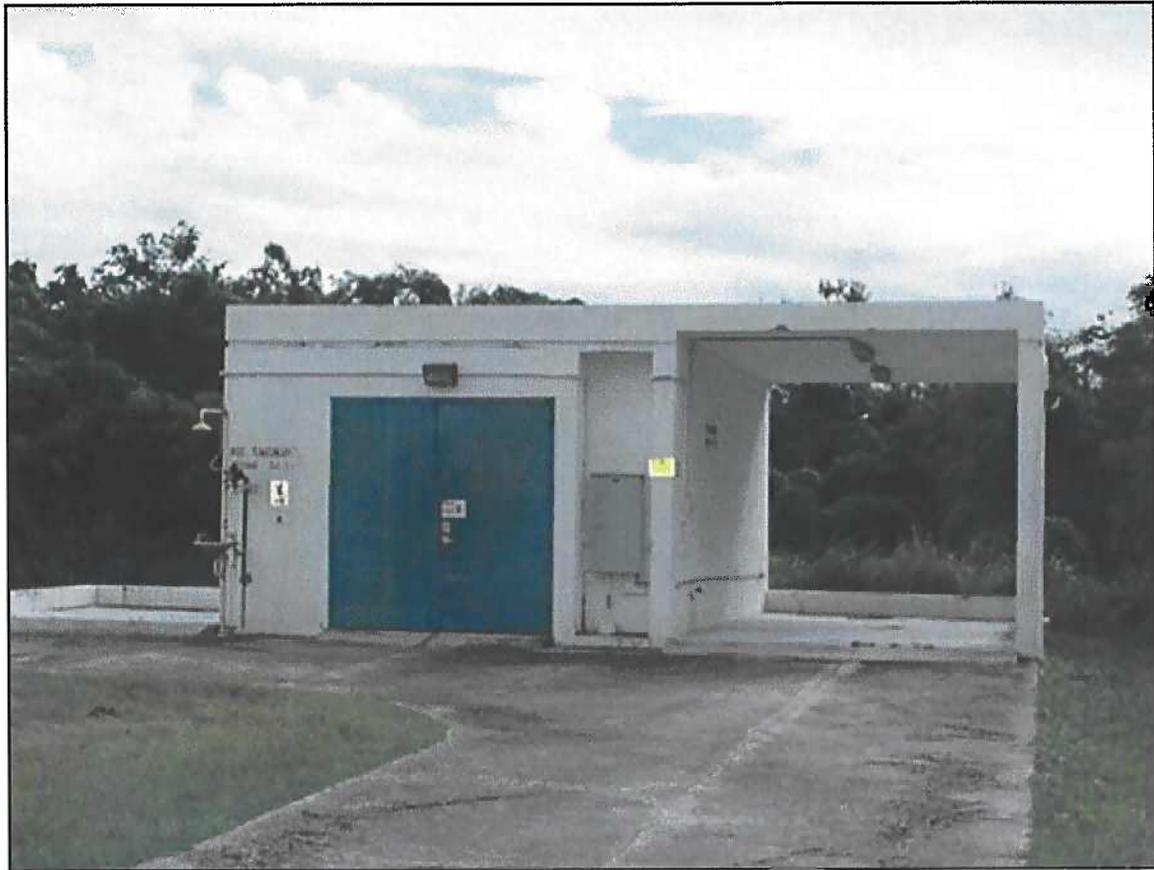
Building 2352 is identified as “Slat Suppt Maint Fac B-387” and is approximately 672 square feet in size. No suspect materials were identified. Therefore, no sampling was conducted.

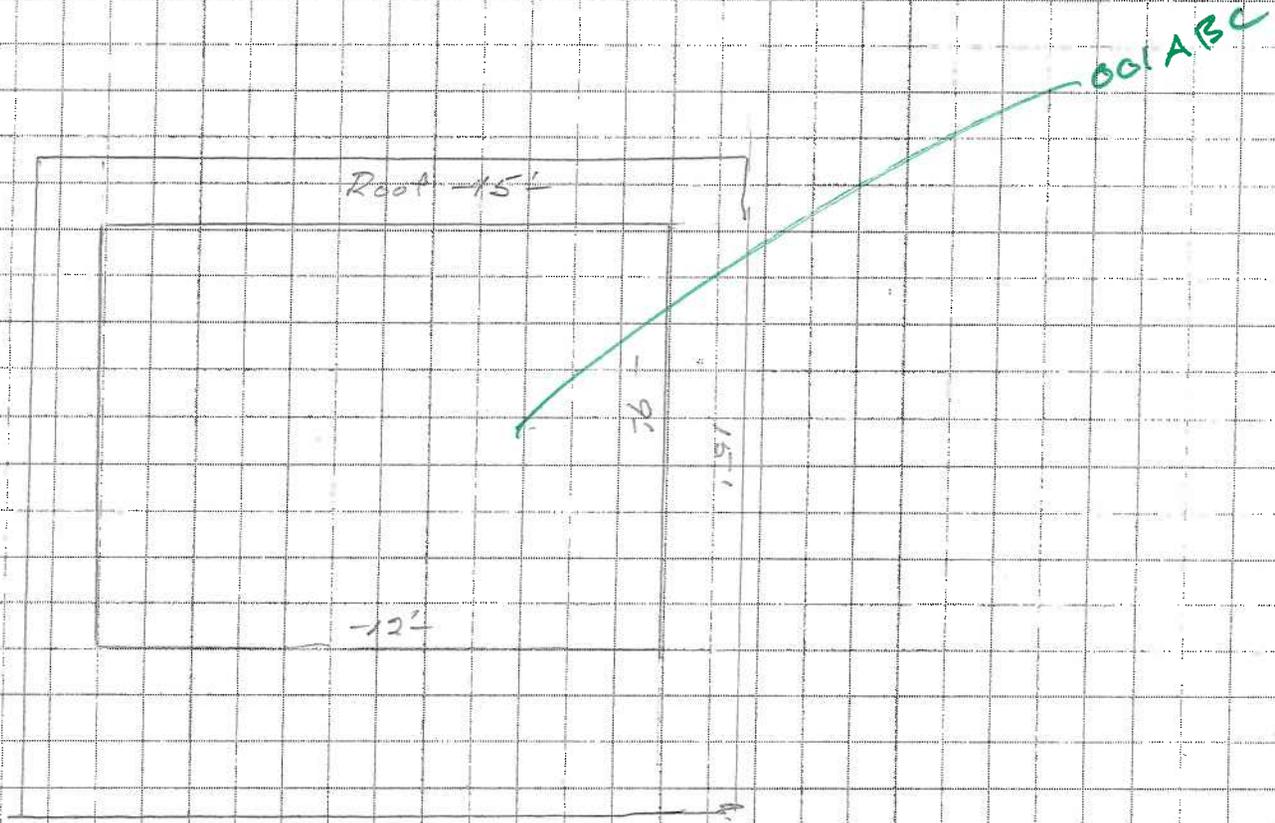
NOTE: ROOFING MATERIAL IS AN ACWT.
