Final
Asbestos Inspection Report
for

Naval Activity Puerto Rico
Ceiba, Puerto Rico

Volume 7 of 7

Buildings 3015 through 3195

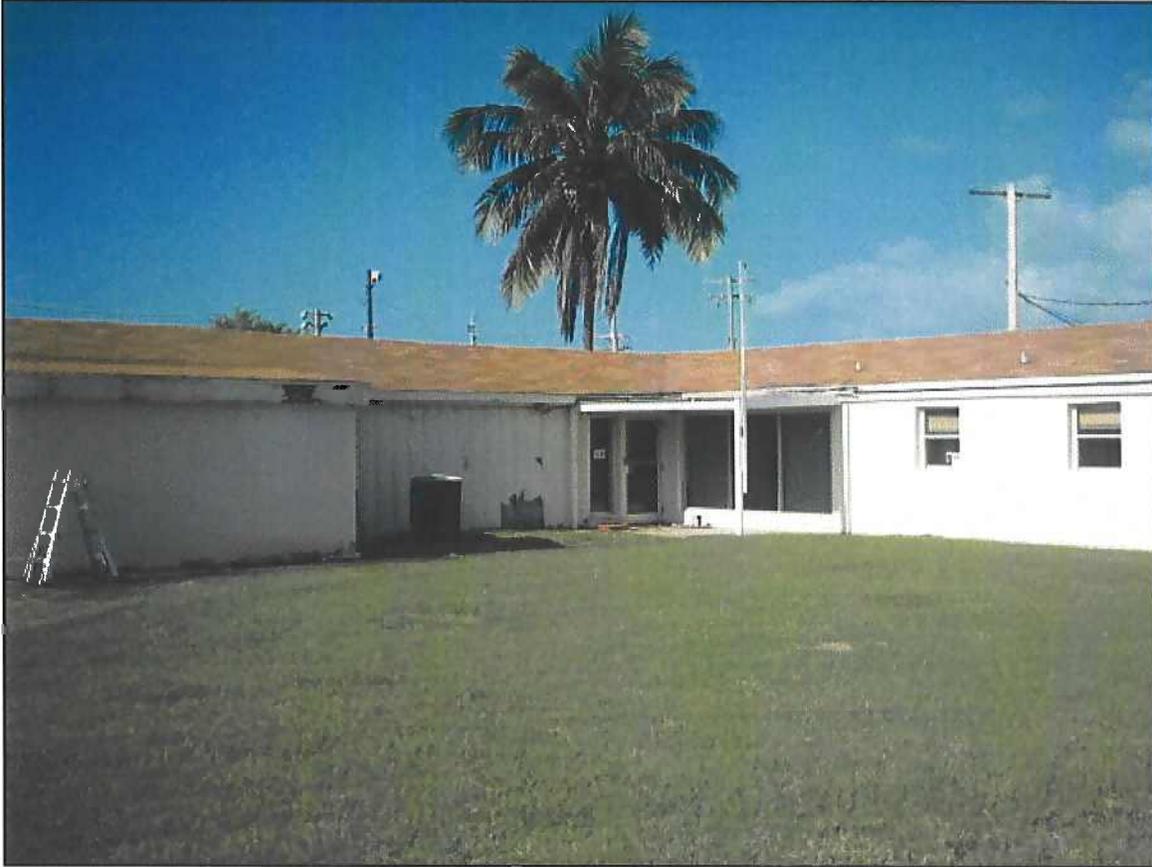
BUILDING 3015

Building 3015 is identified as “Dispensary/Dental” and is approximately 2,400 square feet in size. Ten suspect homogeneous materials were identified and sampled. Four materials were found to be ACM, including: vinyl floor sheeting (Material #002), floor leveling compound (Material #006), vinyl floor tile (Material #007) and its associated adhesive (Material #008). No friable, damaged, and accessible ACM was identified.

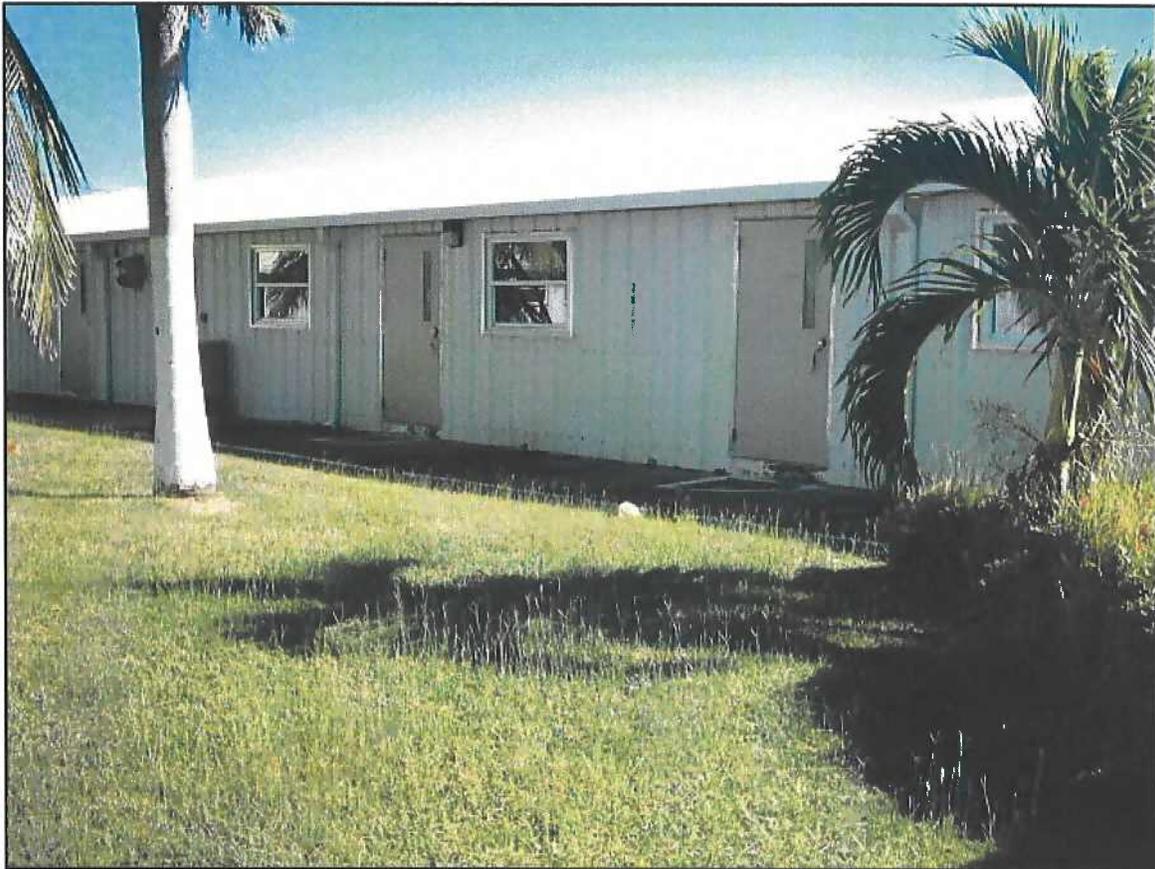
BUILDING 3016

Building 3016 is identified as “Operations/Engineering” and is approximately 1,920 square feet in size. Five suspect homogeneous materials were identified and sampled. One material, floor adhesive (Material #002), was found to be ACM. No friable, damaged, and accessible ACM was identified.

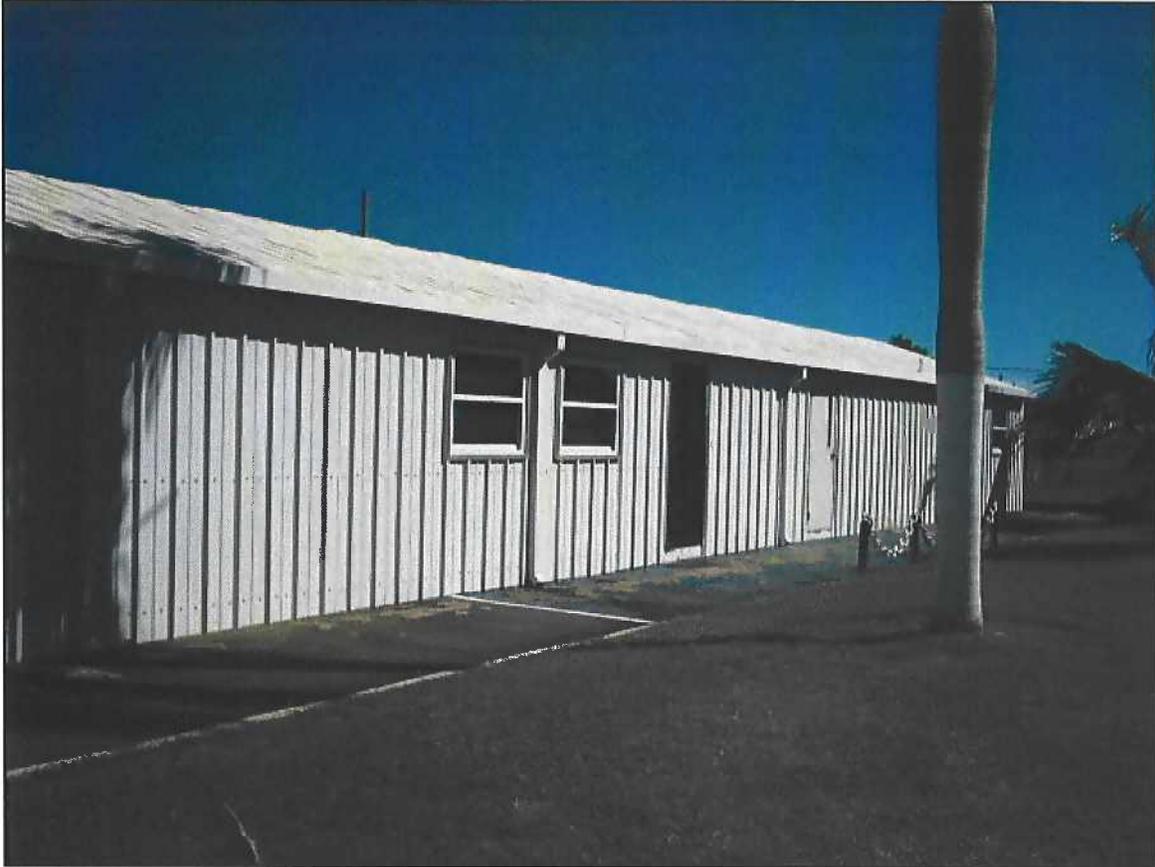
Building 3017 is identified as “Conf. Room / Mas. Chief / QC&P&E” and is approximately 1,920 square feet in size. Six suspect homogeneous materials were identified and sampled. One material, carpet adhesive (Material #003), was found to be ACM. No friable, damaged, and accessible ACM was identified.

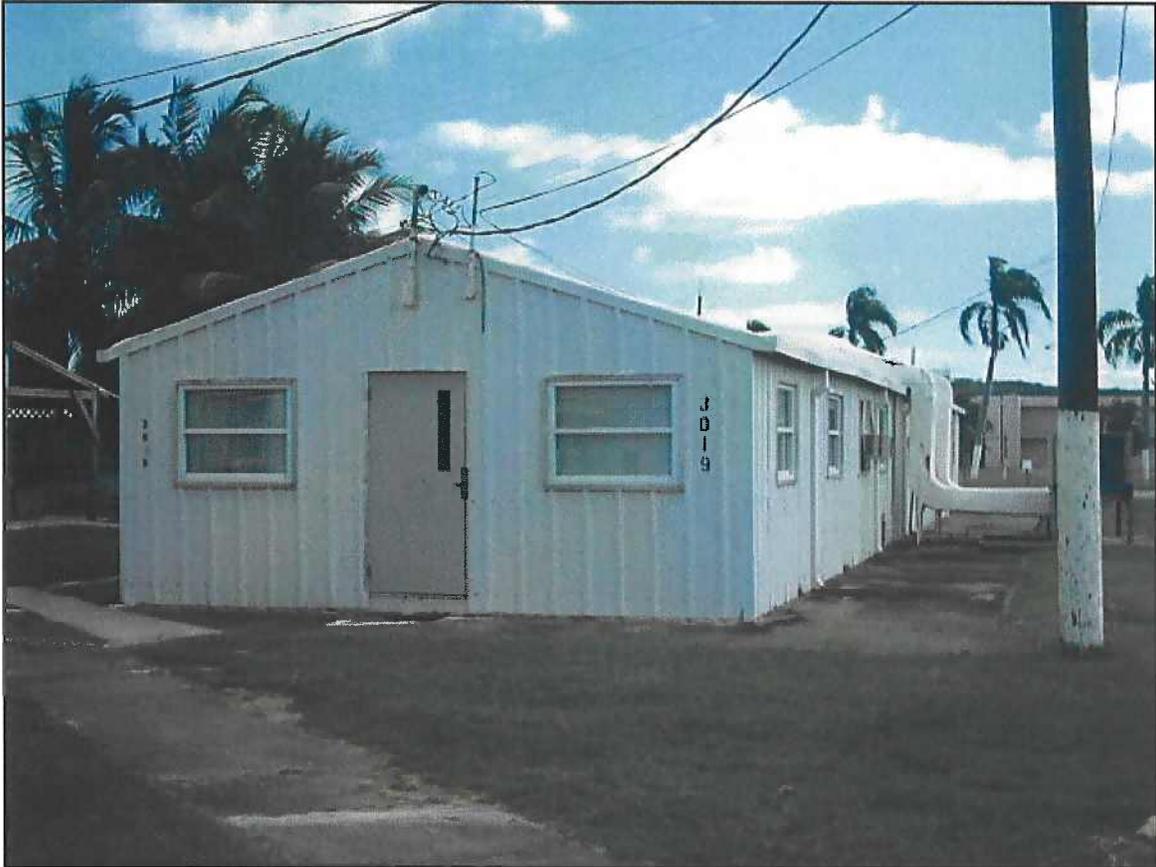
Building 3019 is identified as “Admin./Photo. Office” and is approximately 1,920 square feet in size. Six suspect homogeneous materials were identified and sampled. One material, floor adhesive (Material #002), was found to be an ACM. No friable, damaged, and accessible ACM was identified.

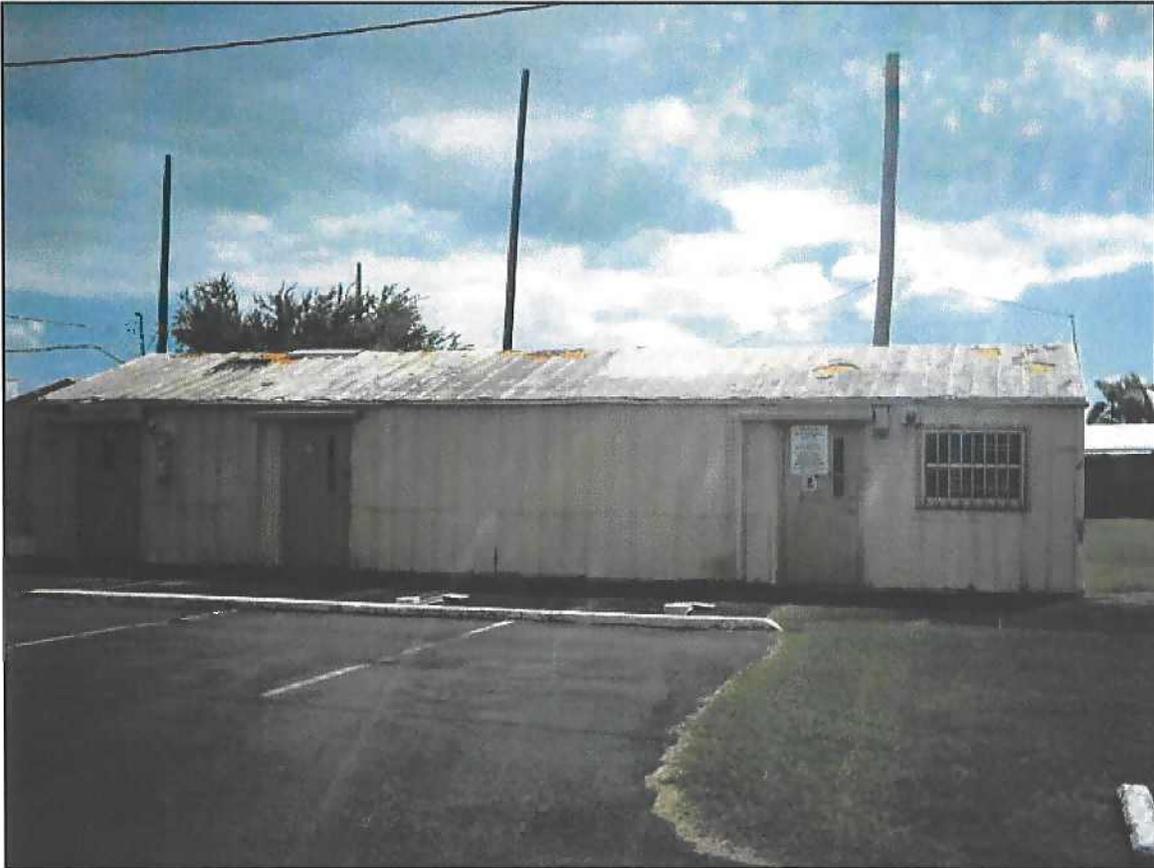
Building 3020 is identified as “Post Office/Barber Shop/Offi” and is approximately 960 square feet in size. Eight suspect homogeneous materials were identified and sampled. One material, floor adhesive (Material #002), was found to be an ACM. No friable, damaged, and accessible ACM was identified.

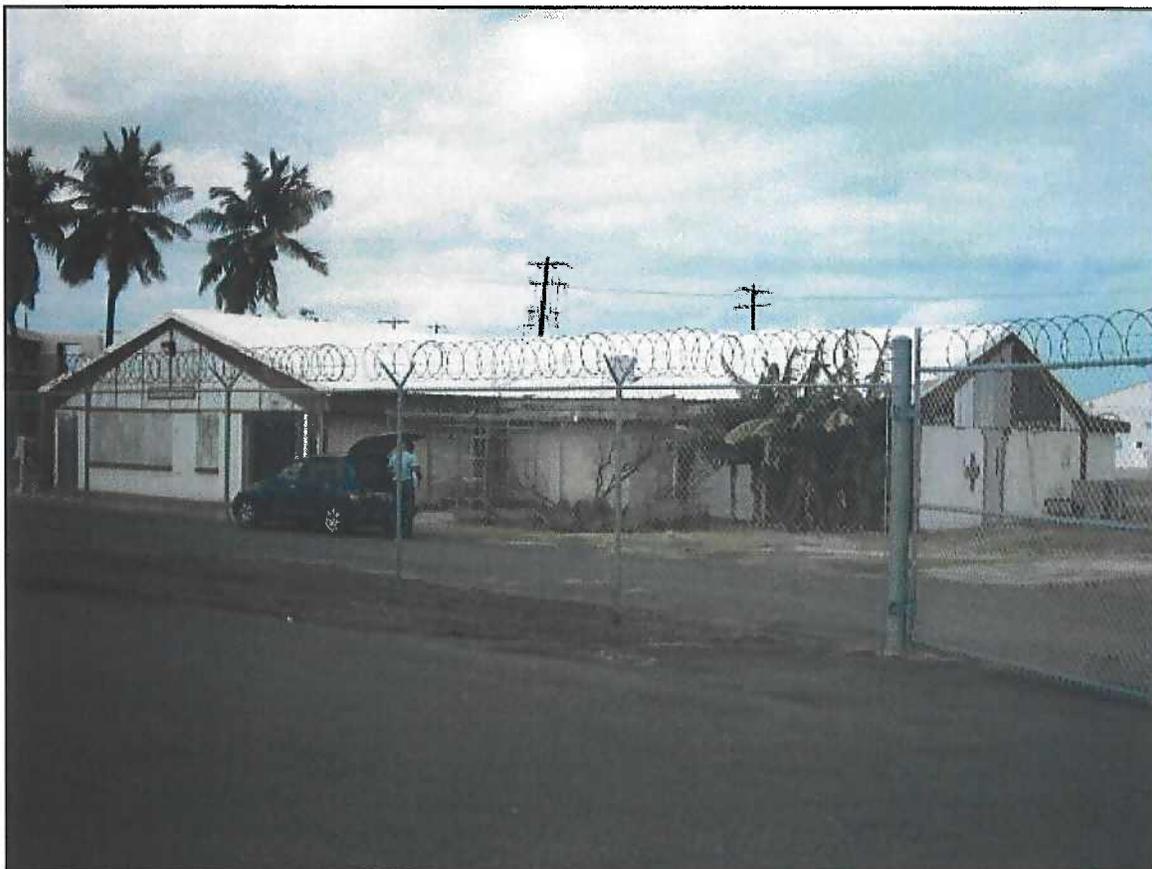
Building 3034 is identified as “Storage Bldg” and is approximately 6,275 square feet in size. Sixteen suspect homogeneous materials were identified and sampled. One material, vinyl floor tile (Material #005), was found to be an ACM. No friable, damaged, and accessible ACM was identified.

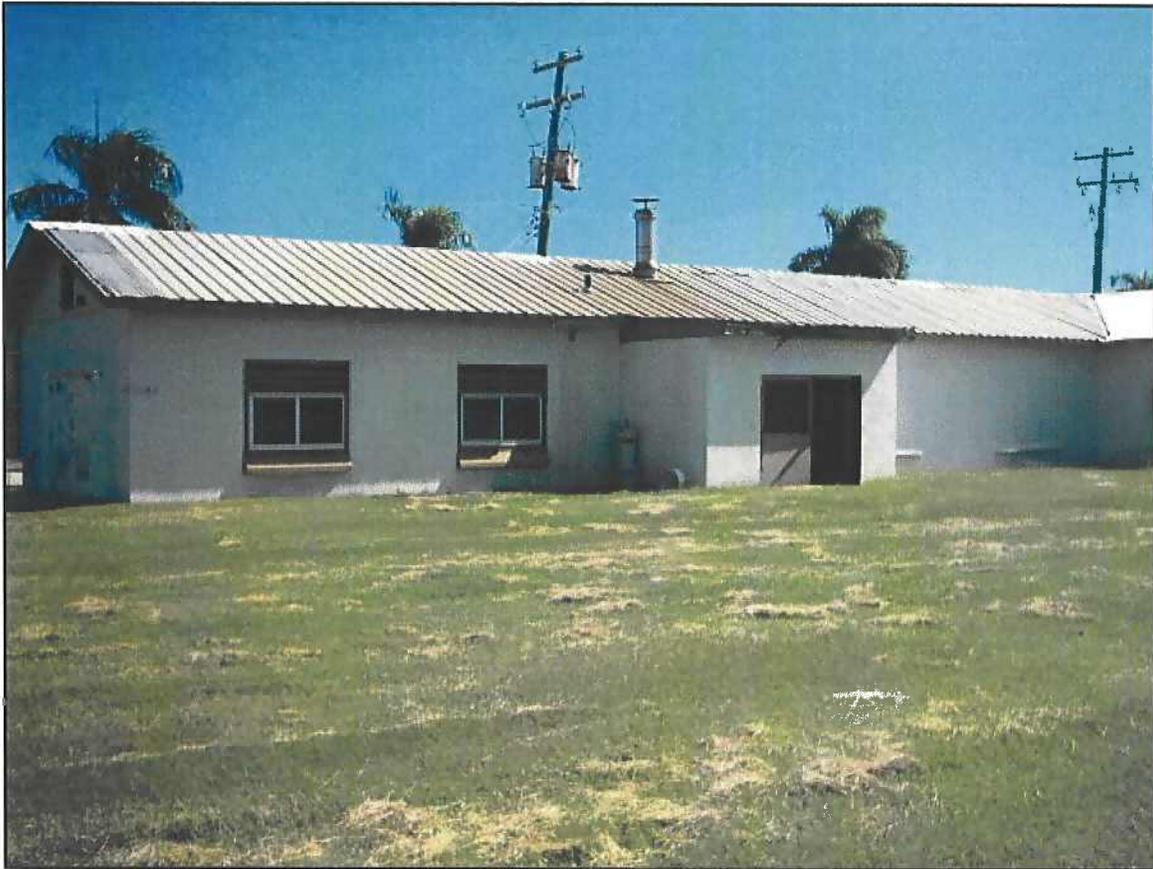
Building 3047 is identified as “Camp Laundry/Boiler Room” and is approximately 3,720 square feet in size. Seven suspect homogeneous materials were identified and sampled. One material, floor adhesive (Material #005), was found to be an ACM. No friable, damaged, and accessible ACM was identified.

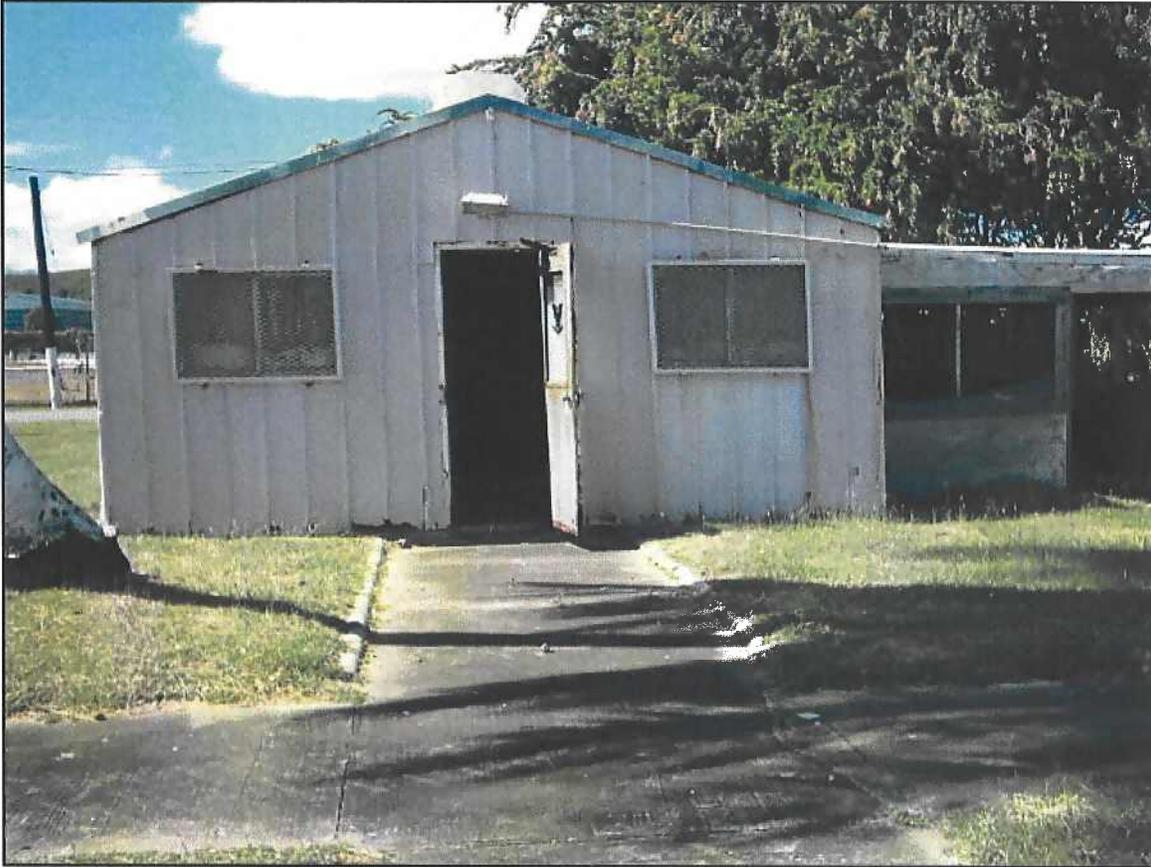
Building 3070 is identified as “1st Class Lounge” and is approximately 960 square feet in size. Five suspect homogeneous materials were identified and sampled. One material, floor adhesive (Material #003), was found to be an ACM. No friable, damaged, and accessible ACM was identified.

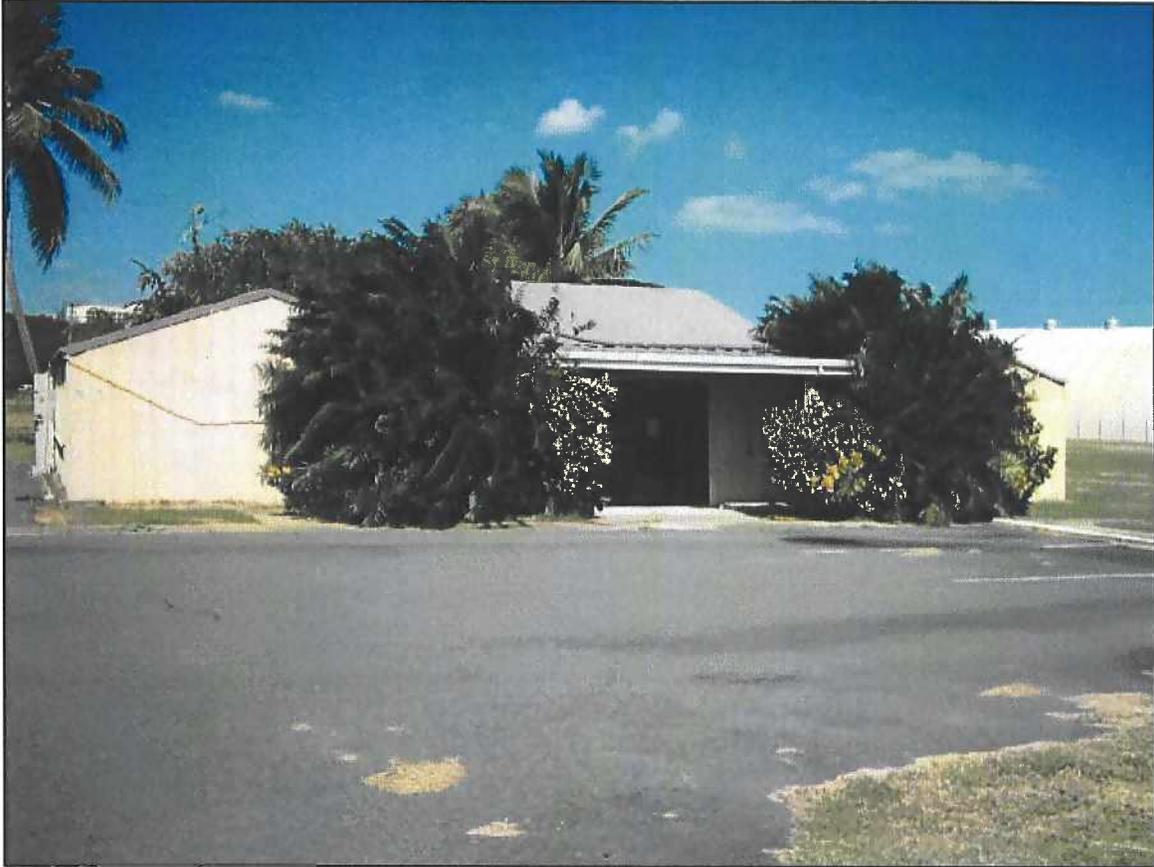
Building 3071 is identified as “Navy Exchange Facility” and is approximately 2,400 square feet in size. Six suspect homogeneous materials were identified and sampled. Three materials, two types of floor adhesive (Materials #002 and #004) and vinyl floor tile (Material #003), were found to be ACM. No friable, damaged, and accessible ACM was identified.

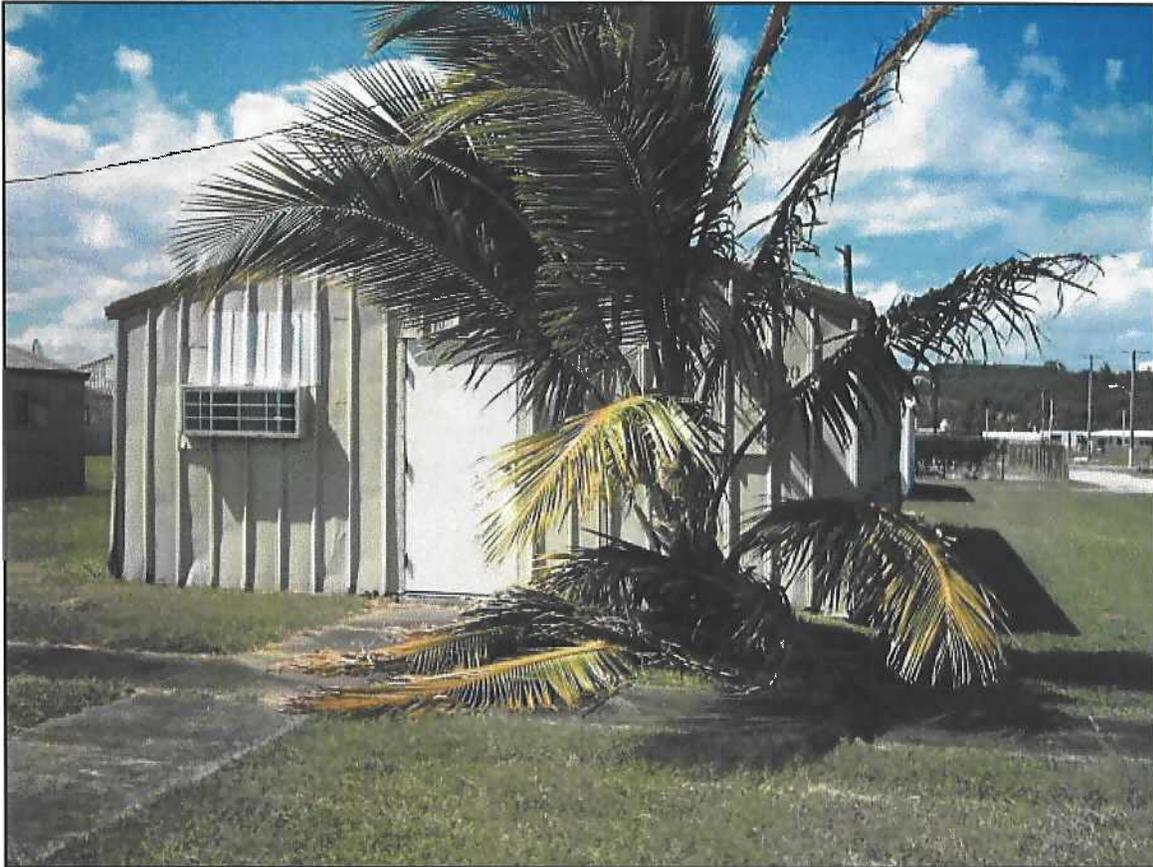
Building 3079 is identified as “Classroom” and is approximately 960 square feet in size. Seven suspect homogeneous materials were identified and sampled. Three materials, two types of vinyl floor tile (Materials #002 and #003) and floor adhesive (Material #004), were found to be ACM. No friable, damaged, and accessible ACM was identified.

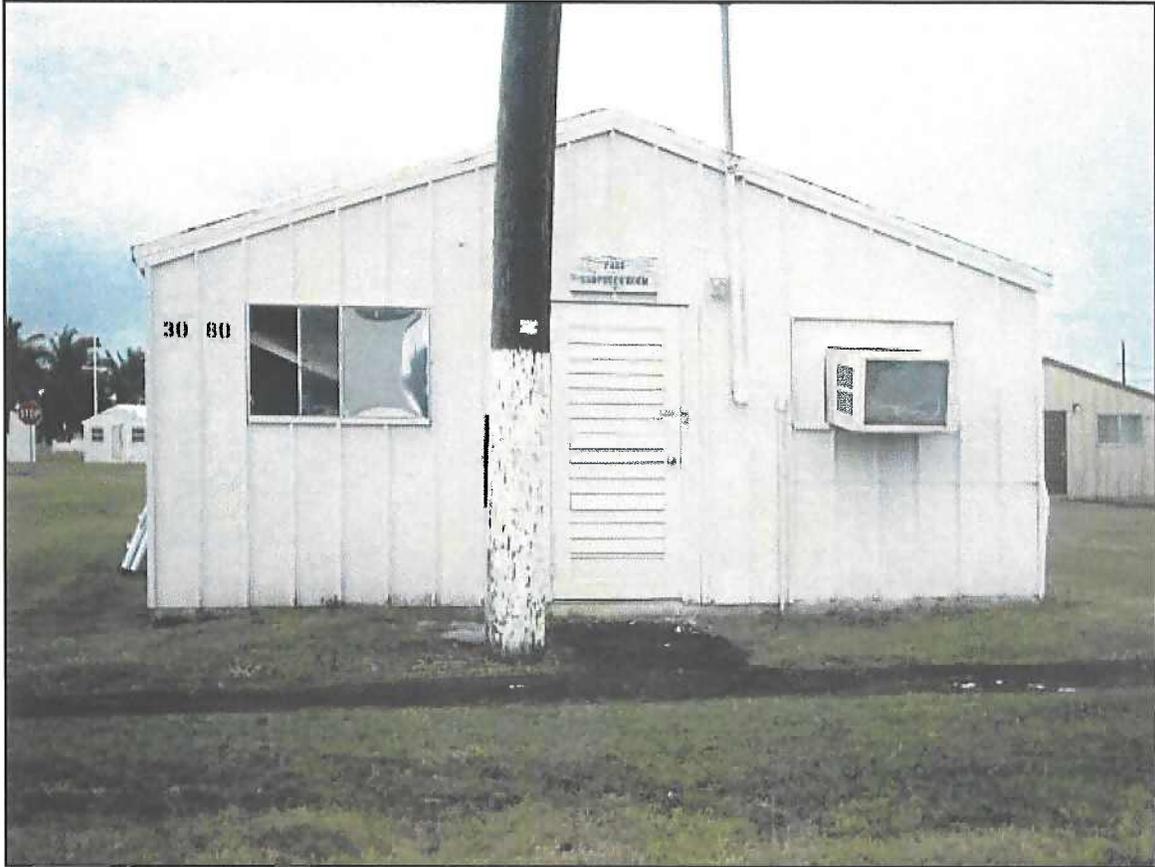
Building 3080 is identified as “Recreation Center” and is approximately 960 square feet in size. Five suspect homogeneous materials were identified and sampled. One material, an asphaltic patch on foam roofing material (Material # 005), was found to be an ACM. No friable, damaged, and accessible ACM was identified.

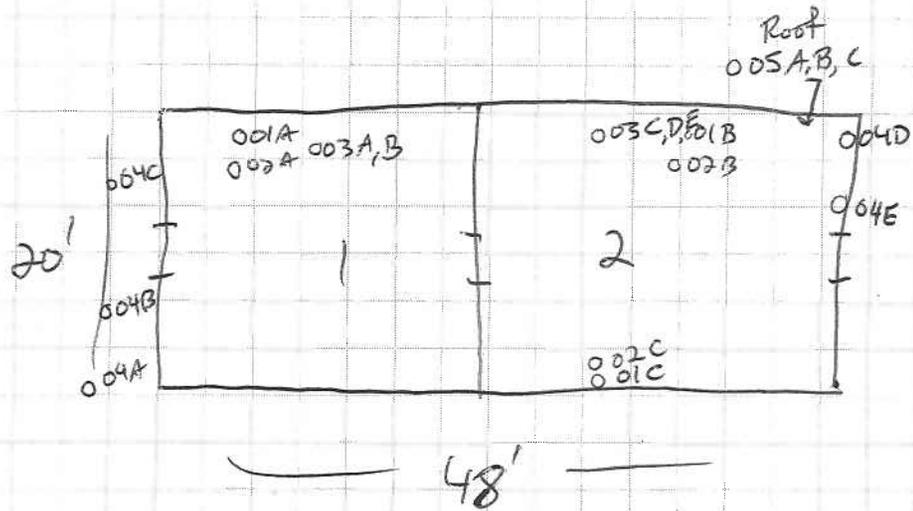
NOTE: PATCH ON ROOF (MATERIAL #005)
IS AN ACM

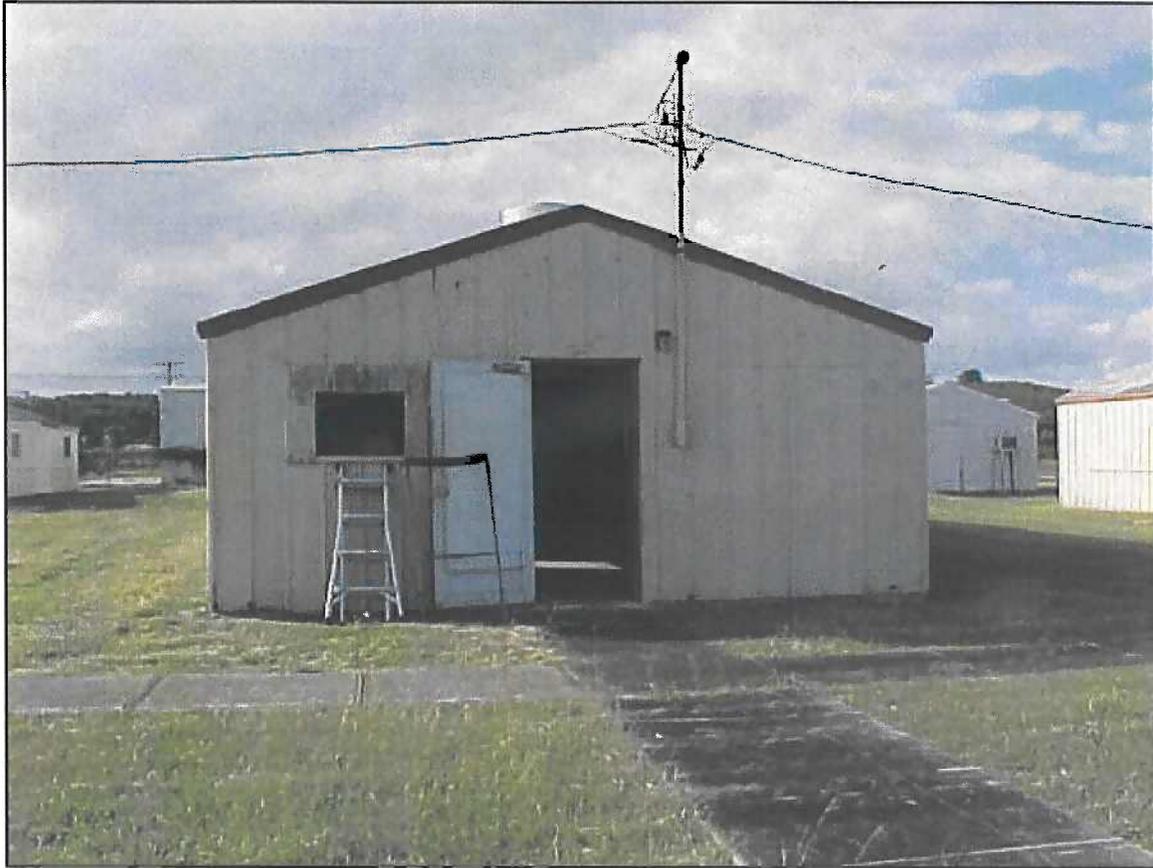
Building 3081 is identified as “E.M. Berthing” and is approximately 960 square feet in size. Three suspect homogeneous materials were identified and sampled. One material, floor adhesive (Material #002) was found to be an ACM. No friable, damaged, and accessible ACM was identified.

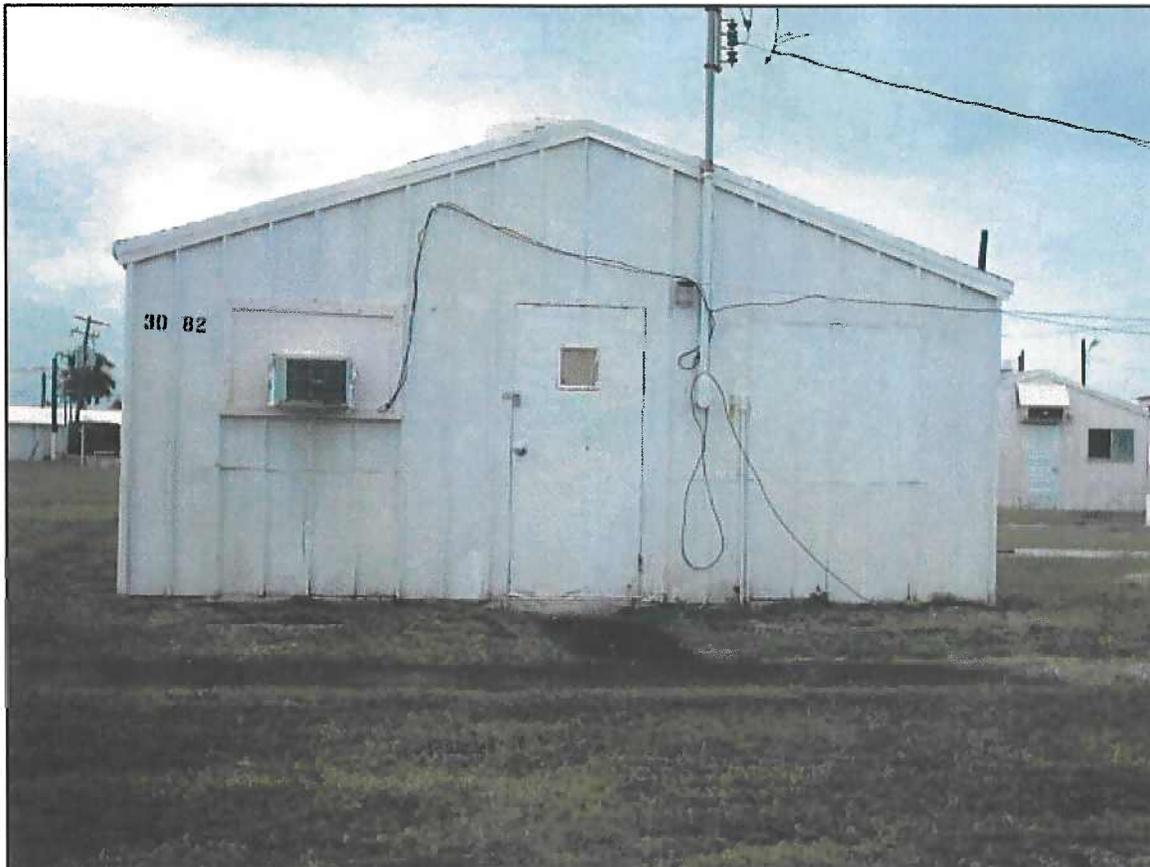
Building 3082 is identified as “E.M. Berthing” and is approximately 960 square feet in size. Six suspect homogeneous materials were identified and sampled. Two materials, floor adhesive (Material #002) and exterior window caulking on doors and windows (Material #006), were found to be ACM. No friable, damaged, and accessible ACM was identified.

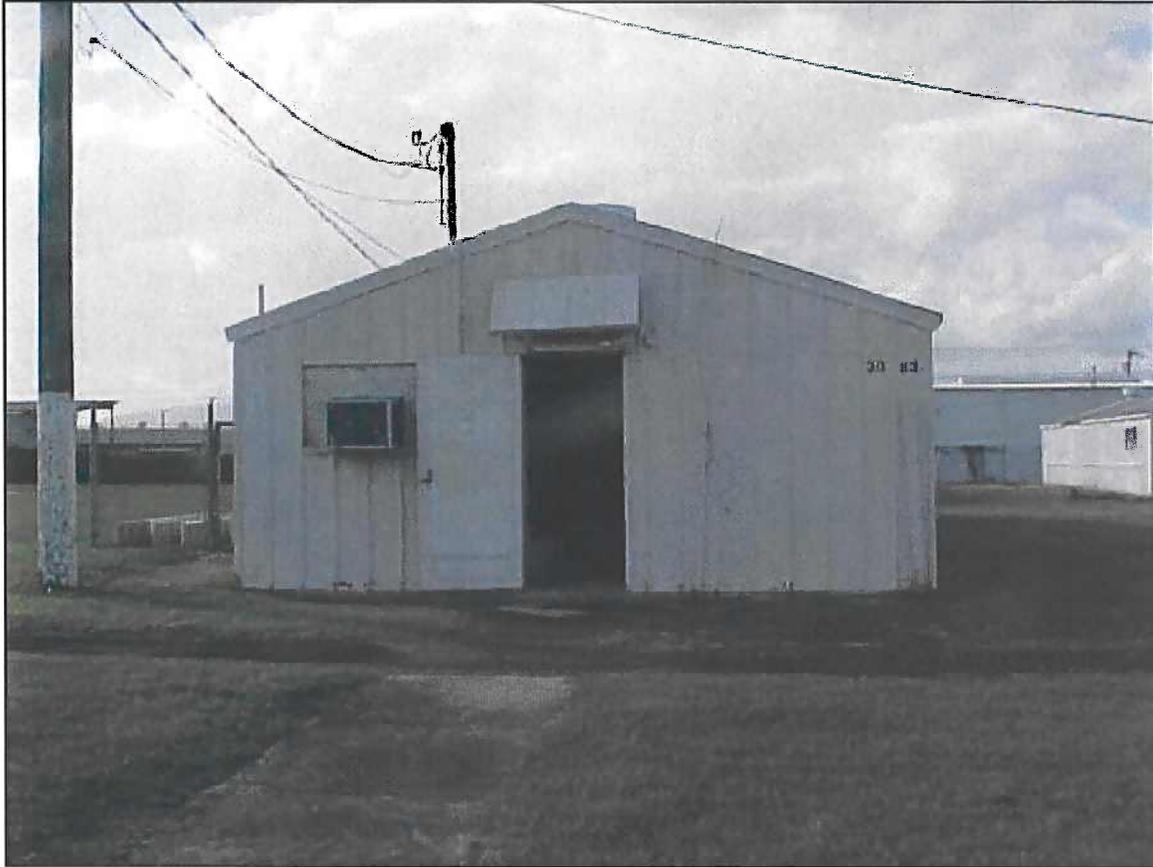
Building 3083 is identified as “CPO Galley” and is approximately 960 square feet in size. Four suspect homogeneous materials were identified and sampled. One material, floor adhesive (Material #002), was found to be an ACM. No friable, damaged, and accessible ACM was identified.

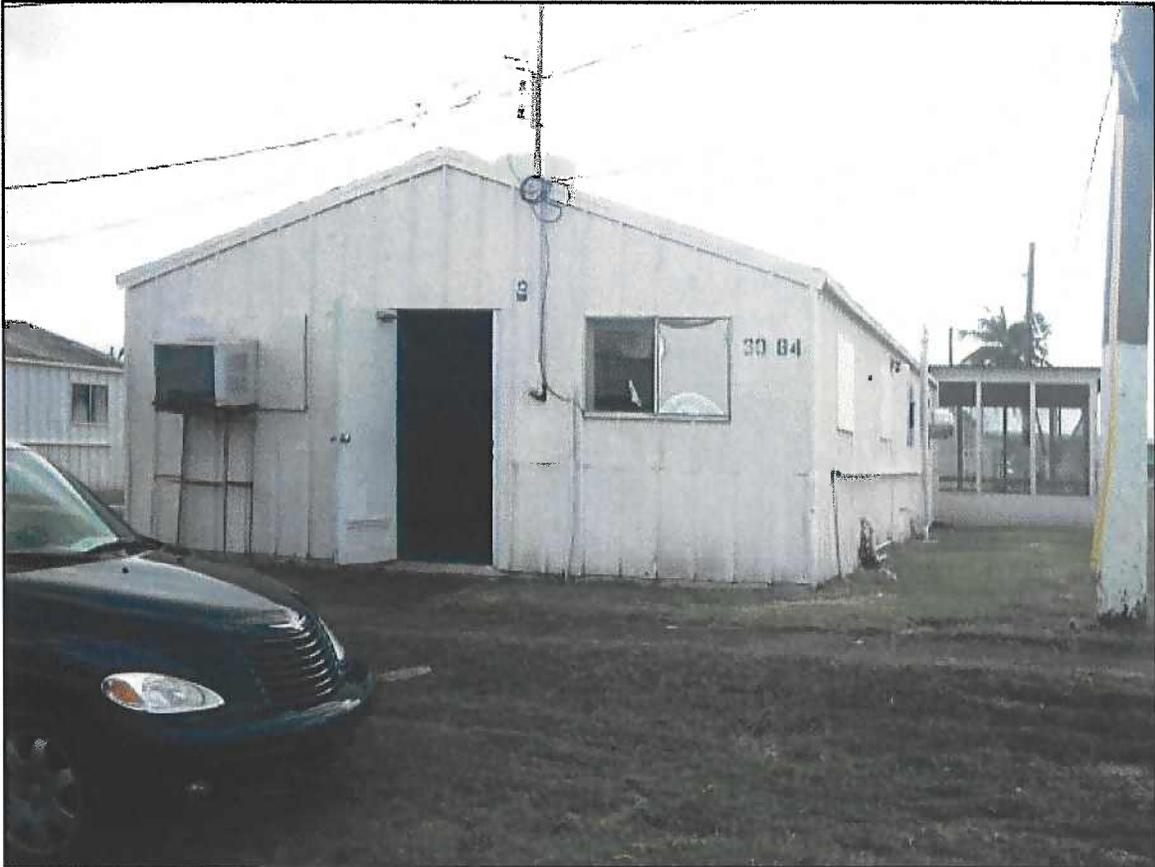
Building 3084 is identified as “CPO Lounge” and is approximately 960 square feet in size. Eleven suspect homogeneous materials were identified and sampled. Three materials, two types of vinyl floor tile (Materials #001 and #008) and floor adhesive (Material #002), were found to be ACM. No friable, damaged, and accessible ACM was identified.

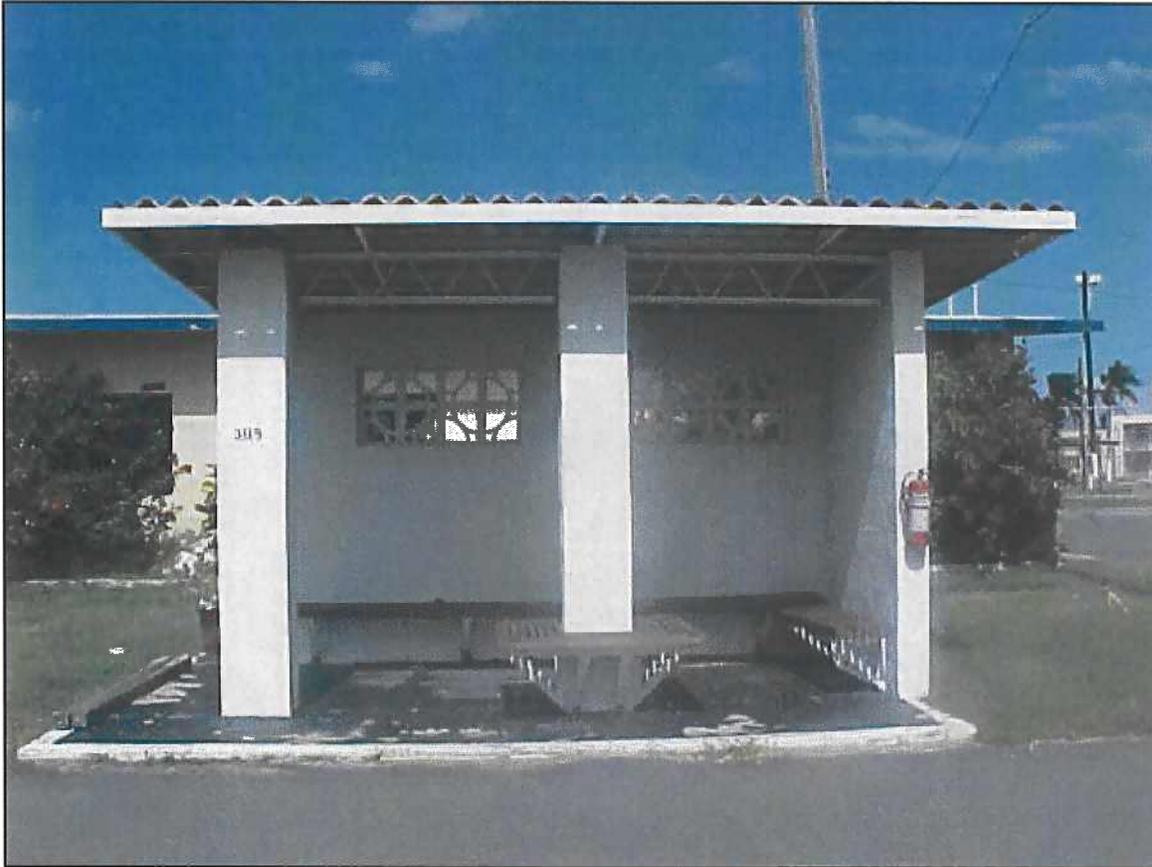
Building 3119 is identified as “Weather Shelter” and is approximately 112 square feet in size. One suspect homogeneous material was identified and sampled. This material, cement corrugated roof (Material # 001), was found to be an ACM. No friable, damaged, and accessible ACM was identified.

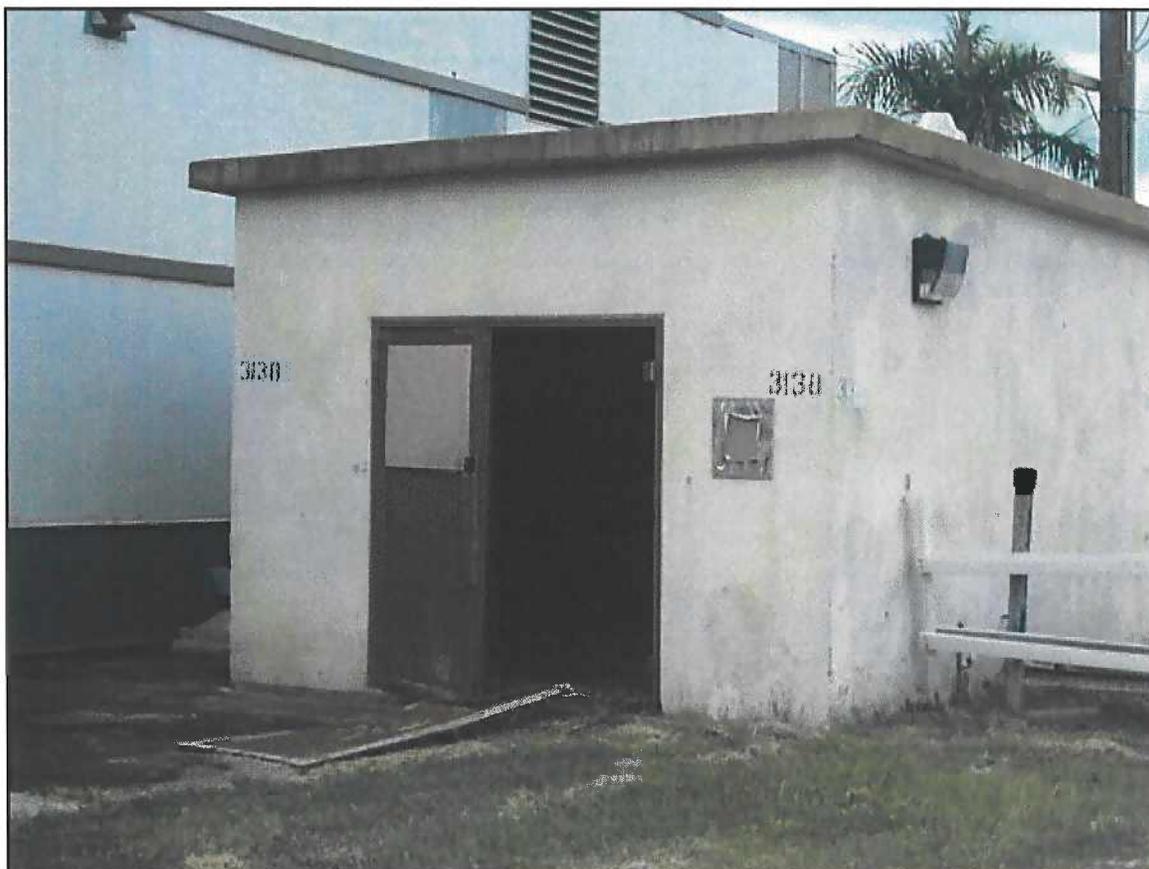
Building 3138 is identified as “EDF Emergency Generator Shed” and is approximately 480 square feet in size. One suspect homogeneous material was identified and sampled. The material, exterior stucco on concrete (Material #001), was found to be an ACM. No friable, damaged, and accessible ACM was identified.

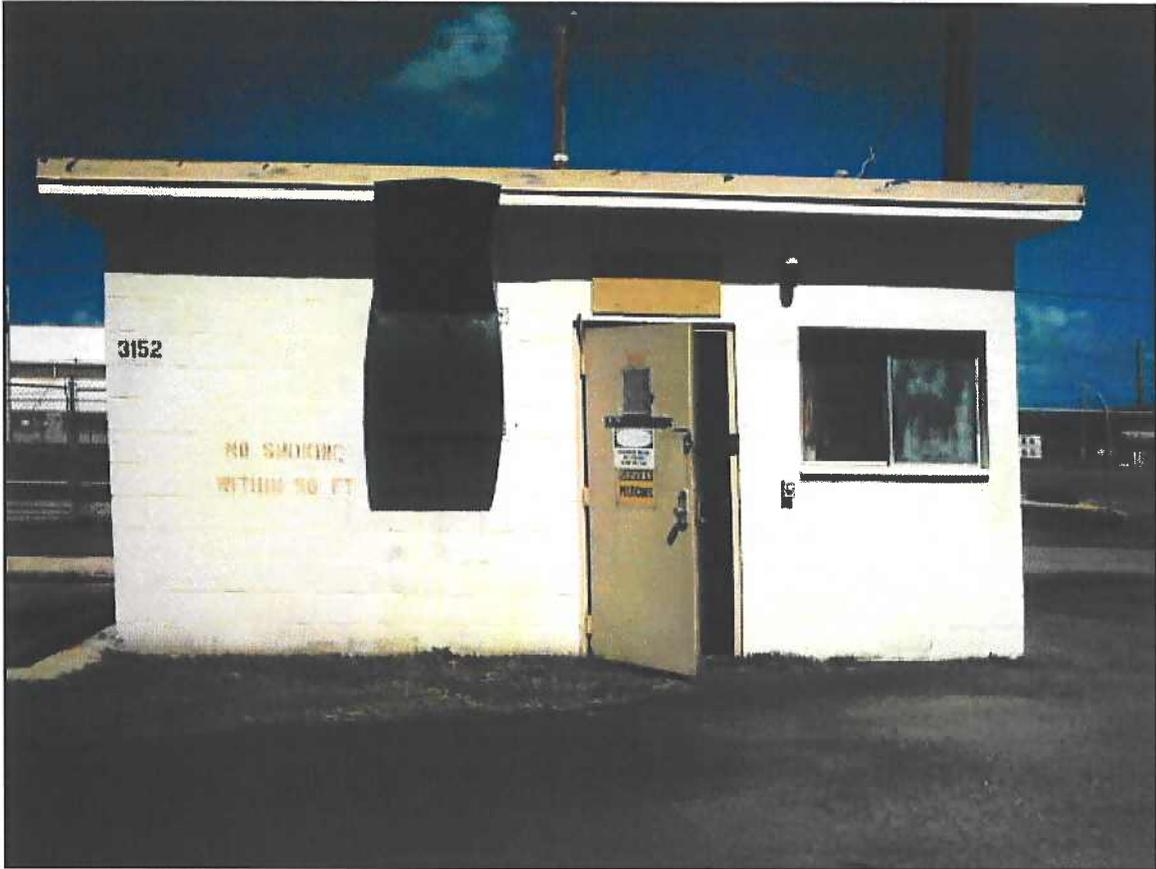
Building 3152 is identified as “Pest Control Building” and is approximately 324 square feet in size. Three suspect homogeneous materials were identified and sampled. One material, floor adhesive (Material #002), was found to be ACM. No friable, damaged, and accessible ACM was identified.

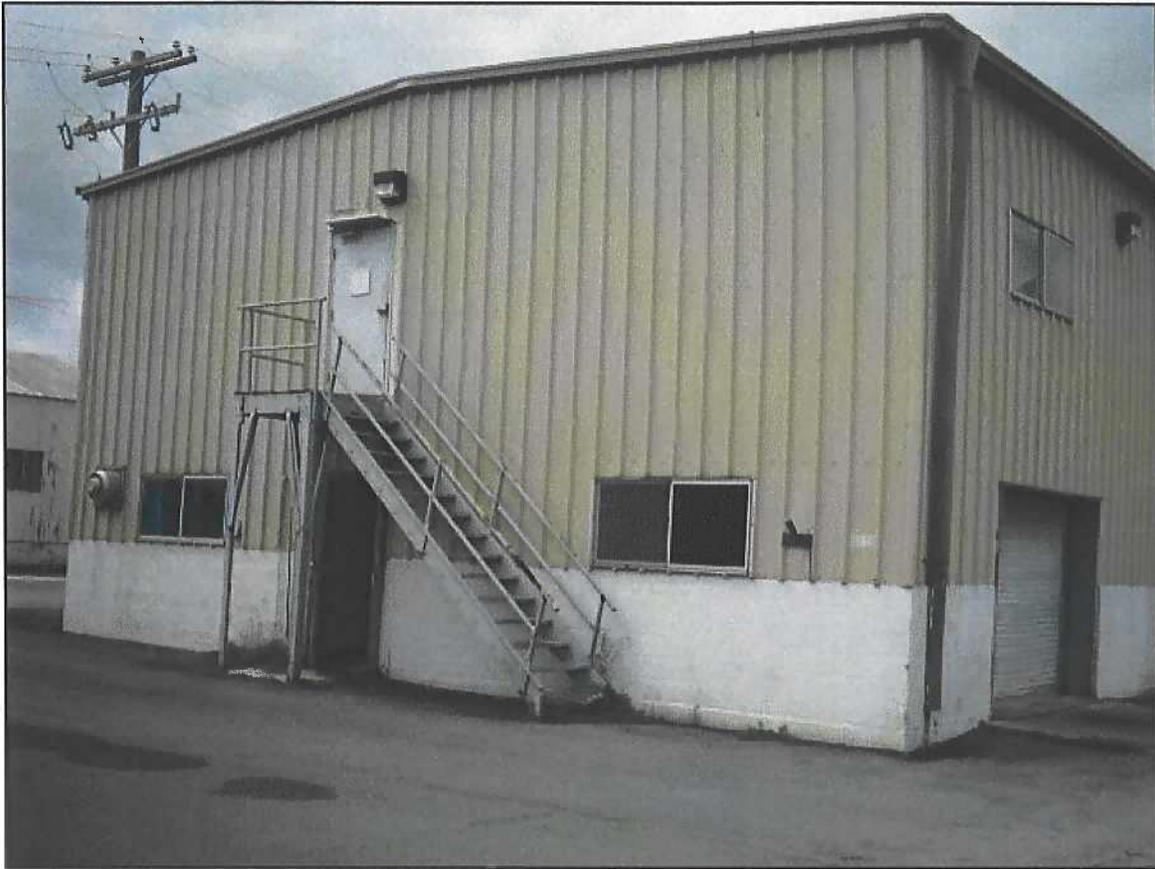
Building 3166 is identified as “Bravo Carpenter Shop” and is approximately 5,706 square feet in size. Seventeen suspect homogeneous materials were identified and sampled. One material, floor adhesive (Material #016), was found to be an ACM. No friable, damaged, and accessible ACM was identified.

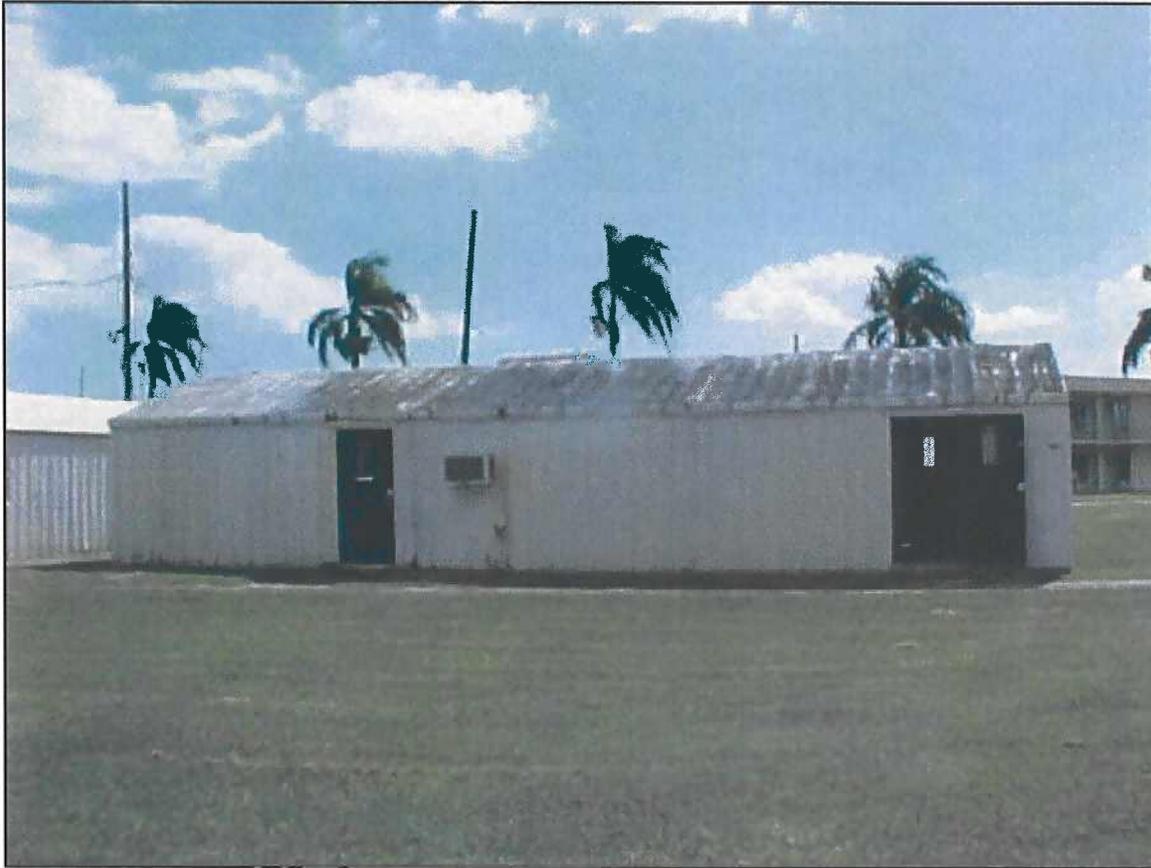
Building 3167 is identified as “SZ Training Facility” and is approximately 800 square feet in size. Eight suspect homogeneous materials were identified and sampled. Two materials, two types of floor adhesive (Materials #002 and #004), were found to be ACM. No friable, damaged, and accessible ACM was identified.
