Final
Asbestos Inspection Report
for

Naval Activity Puerto Rico
Ceiba, Puerto Rico

Volume 7 of 7

Buildings 3015 through 3195

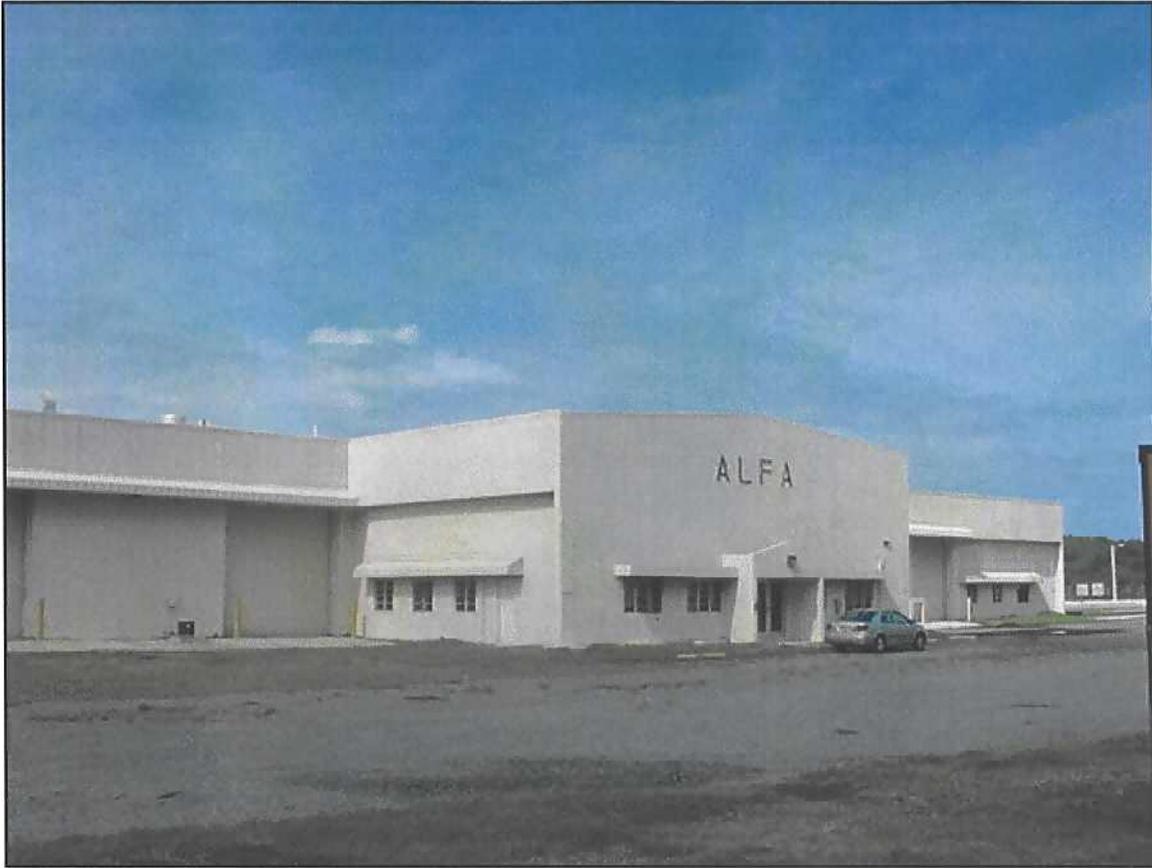
Building 3188 is identified as “Alfa Co Maint Bldg” and is approximately 35,721 square feet in size. Eleven suspect homogeneous materials were identified and sampled. One material, asphaltic roofing (roof flashing-Material #011), was found to be an ACM. No friable, damaged, and accessible ACM was identified.

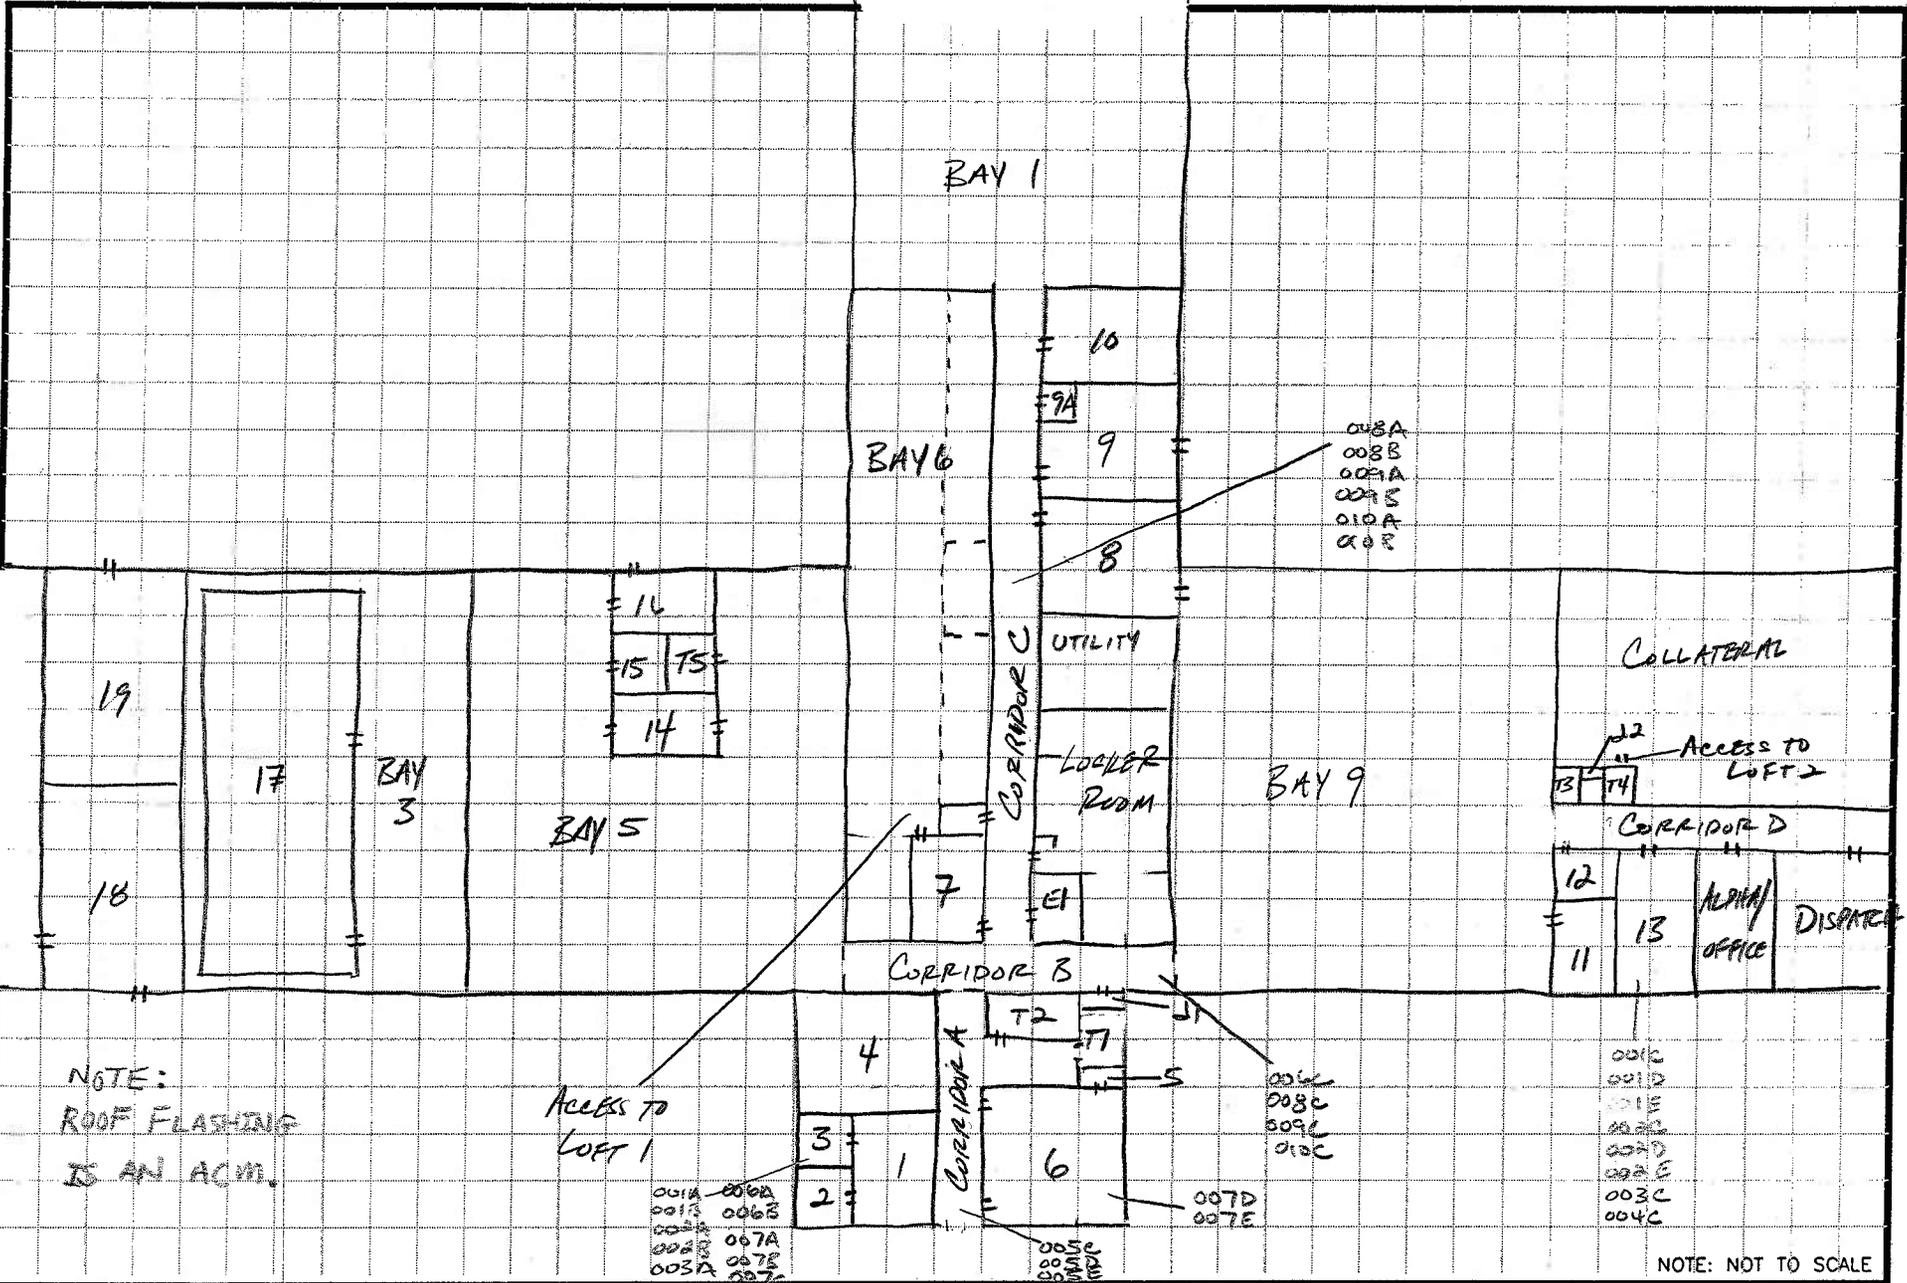
NOTE:
ROOF FLASHING
IS AN ACM.
