Final  
**Asbestos Inspection Report**  
for  
Military Family Housing  
Naval Activity Puerto Rico  
Ceiba, Puerto Rico

Contract N62472-01-D-1440 • Project Number 15 • June 2005

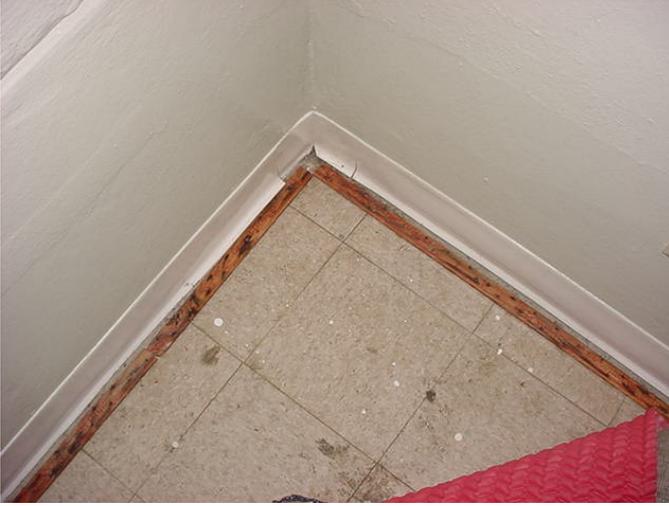
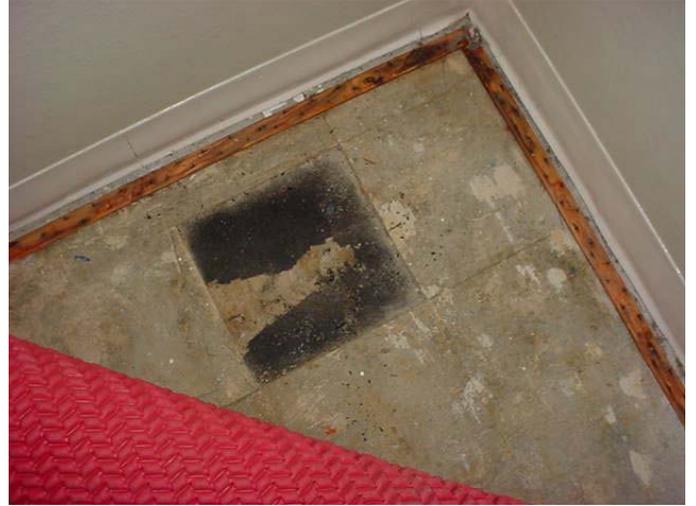
Unit	Material	Material No.	Comment	Condition
889C Algodones	Vinyl Floor Tile (9" X 9" Tan With Brown Streaks)	006	The Adhesive For This Material Is Material #007.	Undamaged
	Floor Adhesive (Black, Under 9" X 9" Tan With Brown Streaks Vinyl Floor Tile)	007	This Is The Adhesive For Material #006.	Undamaged
889G Algodones	See Initial Entry for Material #006	006	The Adhesive For This Material Is Material #007.	Undamaged
	See Initial Entry for Material #007	007	This Is The Adhesive For Material #006.	Undamaged
	Vinyl Floor Tile (9" X 9" Gray With Black Streaks)	010	The Adhesive For This Material Is Material #010. This Material Is Located Below The Existing Carpet.	Undamaged
	Floor Adhesive (Black, Under 9" X 9" Gray With Black Streaks Vinyl Floor Tile)	011	This Is The Adhesive For Material #010.	Undamaged
889H Algodones	See Initial Entry for Material #006	006	The Adhesive For This Material Is Material #007.	Undamaged

MATERIAL NUMBER	MATERIAL TYPE (MATERIAL DESCRIPTION)	ASBESTOS CONTENT	MATERIAL LOCATION(S)	FRIABLE	CONDITION	QUANTITY	COMMENTS
006	VINYL FLOOR TILE (9" X 9" TAN WITH BROWN STREAKS)	6% CH	889C ALGODONES 889G ALGODONES 889H ALGODONES 891D ALGODONES 893C ALGODONES 895C ALGODONES 897D ALGODONES 897G ALGODONES 897H ALGODONES	No	UNDAMAGED	5,054 SF	THE ADHESIVE FOR THIS MATERIAL IS MATERIAL #007.
007	FLOOR ADHESIVE (BLACK, UNDER 9" X 9" TAN WITH BROWN STREAKS VINYL FLOOR TILE)	8% CH	889C ALGODONES 889G ALGODONES 889H ALGODONES 891D ALGODONES 893C ALGODONES 895C ALGODONES 897D ALGODONES 897G ALGODONES 897H ALGODONES	No	UNDAMAGED	5,054 SF	THIS IS THE ADHESIVE FOR MATERIAL #006.
010	VINYL FLOOR TILE (9" X 9" GRAY WITH BLACK STREAKS)	5% CH	889G ALGODONES 889H ALGODONES 891D ALGODONES 893C ALGODONES 895C ALGODONES 897D ALGODONES 897G ALGODONES 897H ALGODONES	No	UNDAMAGED	1,180 SF	THE ADHESIVE FOR THIS MATERIAL IS MATERIAL #010. THIS MATERIAL IS LOCATED BELOW THE EXISTING CARPET.

Material Numbers 006 and 007  
9" x 9" Vinyl Floor Tile and Adhesive

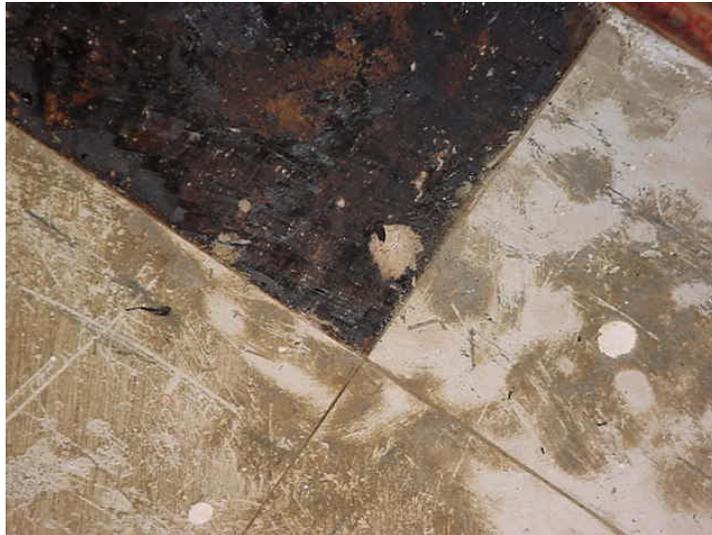
Material Numbers 010 and 011  
9" x 9" Vinyl Floor Tile and Adhesive

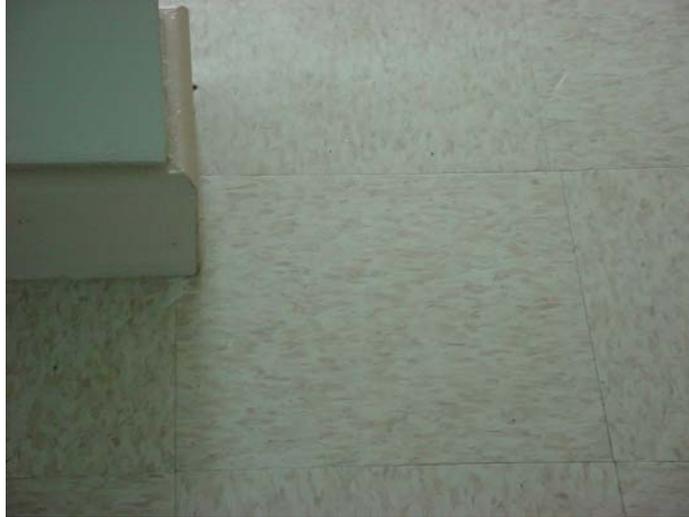
MATERIAL NUMBER	MATERIAL TYPE (MATERIAL DESCRIPTION)	ASBESTOS CONTENT	MATERIAL LOCATION(S)	FRIABLE	CONDITION	QUANTITY	COMMENTS
002	FLOOR ADHESIVE (TAN WITH BLACK RESIDUAL, UNDER 1' X1' TAN MOTTLED VINYL FLOOR TILE)	3% CH	11A AMERICAN CIRCLE 15A AMERICAN CIRCLE 1A AMERICAN CIRCLE 20A AMERICAN CIRCLE 25A AMERICAN CIRCLE 28A AMERICAN CIRCLE 35A AMERICAN CIRCLE 37A AMERICAN CIRCLE 47A AMERICAN CIRCLE 4B POINT CRUZ 92A SARATOGA ROAD	No	UNDAMAGED	10,209 SF	THIS IS THE ADHESIVE FOR MATERIAL #001.
008	FLOOR ADHESIVE (YELLOW WITH BLACK RESIDUAL, UNDER 1' X 1' GRAY MOTTLED VINYL FLOOR TILE)	4% CH	10D AMERICAN CIRCLE 16B AMERICAN CIRCLE 17C AMERICAN CIRCLE 1B POINT CRUZ 20B AMERICAN CIRCLE 21B AMERICAN CIRCLE 24C AMERICAN CIRCLE 2C AMERICAN CIRCLE 31B AMERICAN CIRCLE 34B AMERICAN CIRCLE 38B AMERICAN CIRCLE 39C AMERICAN CIRCLE 43B AMERICAN CIRCLE 5B AMERICAN CIRCLE 6B AMERICAN CIRCLE	No	UNDAMAGED	16,871 SF	THIS IS THE ADHESIVE FOR MATERIAL #007.

Material Number 002  
Floor Adhesive (002) under 1' x 1' Vinyl Floor Tile

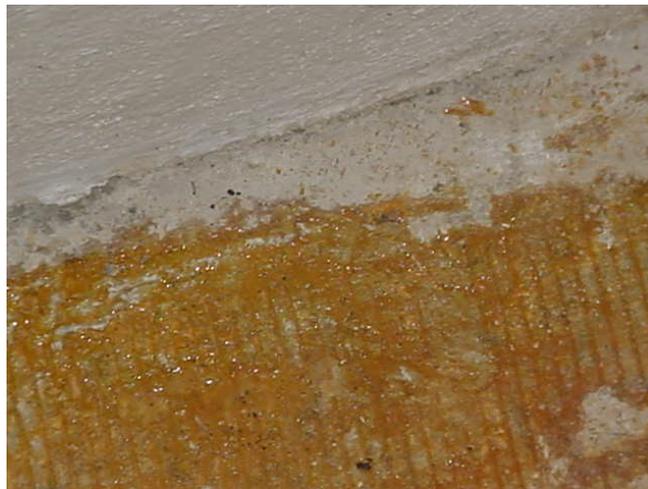
Unit	Material	Material No.	Comment	Condition
10D American Circle	Floor Adhesive (Yellow With Black Residual, Under 1' X 1' Gray Mottled Vinyl Floor Tile)	008	This Is The Adhesive For Material #007.	Undamaged
11A American Circle	Floor Adhesive (Tan With Black Residual, Under 1' X 1' Tan Mottled Vinyl Floor Tile)	002	This Is The Adhesive For Material #001.	Undamaged
15A American Circle	See Initial Entry for Material #002.	002	This Is The Adhesive For Material #001.	Undamaged
16B American Circle	See Initial Entry for Material #008.	008	This Is The Adhesive For Material #007.	Undamaged
17C American Circle	See Initial Entry for Material #008.	008	This Is The Adhesive For Material #007.	Undamaged
1A American Circle	See Initial Entry for Material #002.	002	This Is The Adhesive For Material #001.	Undamaged
1B Point Cruz	See Initial Entry for Material #008.	008	This Is The Adhesive For Material #007.	Undamaged

Material Number 008  
Floor Adhesive under 1' x 1' Vinyl Floor Tile

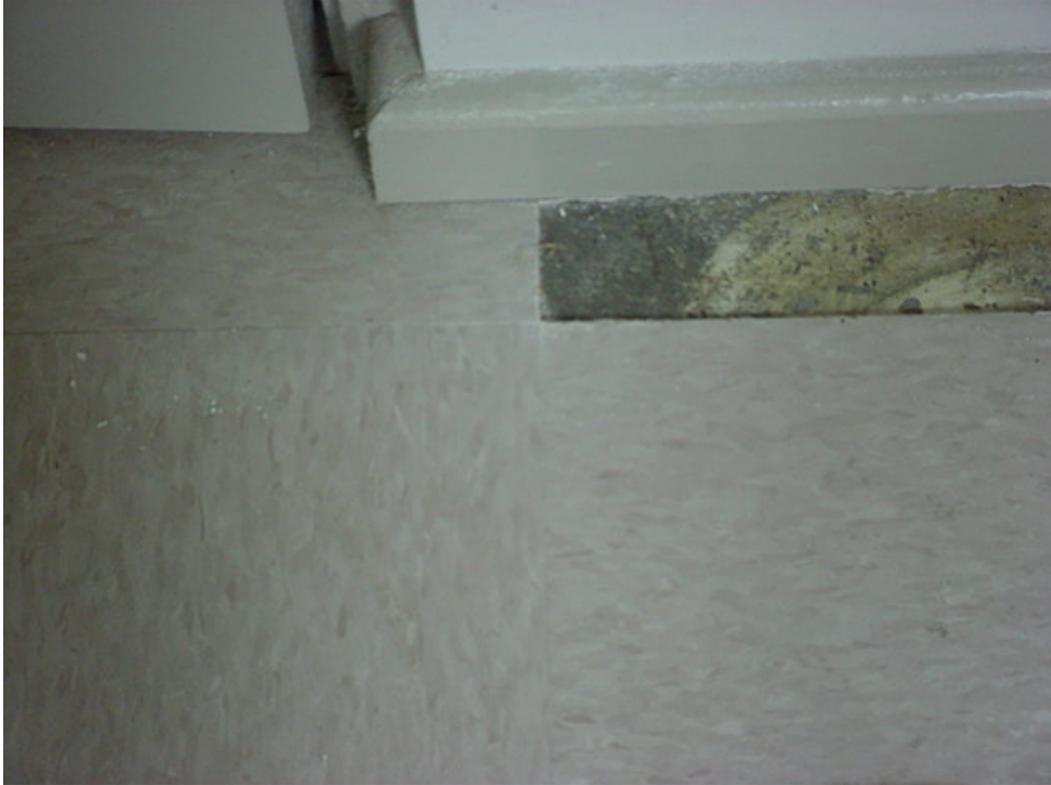
Unit	Material	Material No.	Comment	Condition
11 FDR Drive	Floor Adhesive (Yellow With Black Residual, Under Tan 1' X 1' Mottled Vinyl Floor Tile)	003	This Is The Adhesive For Material #002.	Undamaged
12 Cabot Lake	See Initial Entry for Material #003	003		Undamaged
13 Cowrens Drive	See Initial Entry for Material #003	003		Undamaged
13 Monterey Road	See Initial Entry for Material #003	003		Undamaged
14 Cabot Lake	See Initial Entry for Material #003	003		Undamaged
14 Monterey Road	See Initial Entry for Material #003	003		Undamaged
14 San Jacinto Road	See Initial Entry for Material #003	003		Undamaged
16 FDR Drive	See Initial Entry for Material #003	003		Undamaged
19 Monterey Road	See Initial Entry for Material #003	003		Undamaged
2 Cabot Lake	See Initial Entry for Material #003	003		Undamaged
21 FDR Drive	See Initial Entry for Material #003	003		Undamaged
26 Monterey Road	See Initial Entry for Material #003	003		Undamaged

MATERIAL NUMBER	MATERIAL TYPE (MATERIAL DESCRIPTION)	ASBESTOS CONTENT	MATERIAL LOCATION(S)	FRIABLE	CONDITION	QUANTITY	COMMENTS
003	FLOOR ADHESIVE (YELLOW WITH BLACK RESIDUAL, UNDER TAN 1' X 1' MOTTLED VINYL FLOOR TILE)	2% CH	11 FDR DRIVE 12 CABOT LAKE 13 COWRENS DRIVE 13 MONTEREY ROAD 14 CABOT LAKE 14 MONTEREY ROAD 14 SAN JACINTO ROAD 16 FDR DRIVE 19 MONTEREY ROAD 2 CABOT LAKE 21 FDR DRIVE 26 MONTEREY ROAD 29 MONTEREY ROAD 30 FDR DRIVE 30 MONTEREY ROAD 31 FDR DRIVE 4 COWRENS DRIVE 4 MONTEREY ROAD 43 MONTEREY ROAD 5 CABOT LAKE 5 MONTEREY ROAD 5 SAN JACINTO ROAD 6 BATAAN DRIVE 6 FDR DRIVE 7 COWRENS DRIVE	No	UNDAMAGED	31,905 SF	THIS IS THE ADHESIVE FOR MATERIAL #002.

Material Number 003  
Floor Adhesive (003) under 1' x 1' Vinyl Floor Tile

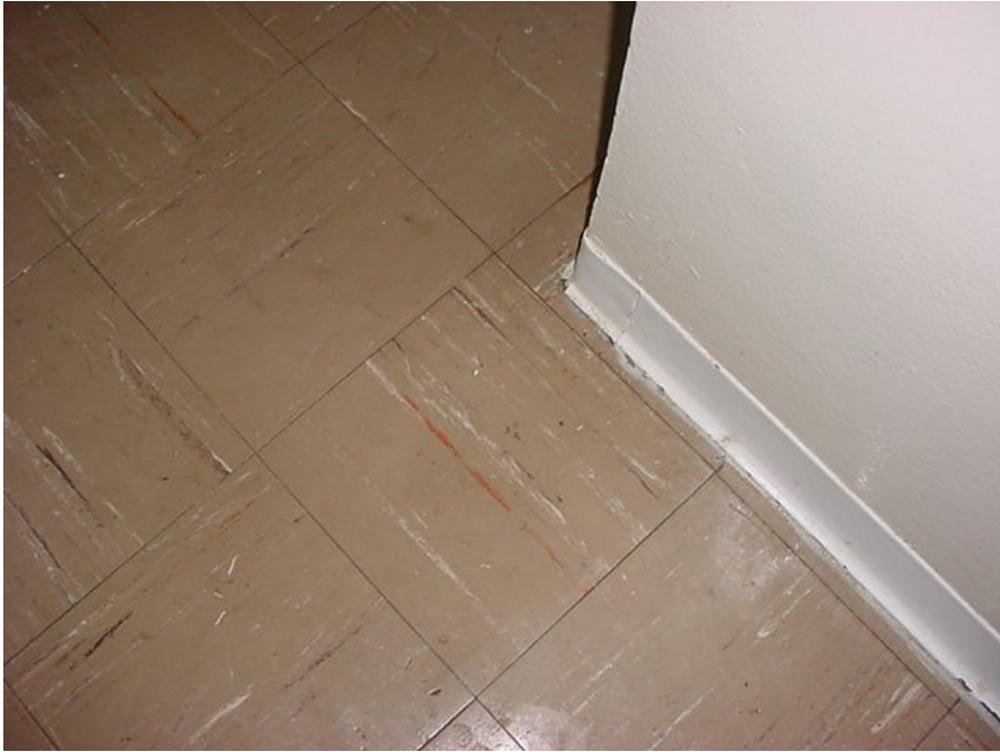
<b>Unit</b>	<b>Material</b>	<b>Material No.</b>	<b>Comment</b>	<b>Condition</b>
1675 Intrepid Street	Floor Adhesive (Black, Under 1' X 1' Brown With White And Red Streaks Vinyl Floor Tile)	007	This Is The Adhesive For Material #006.	Undamaged
1677 Intrepid Street	See Initial Entry for Material #007	007		Undamaged
1678 Intrepid Street	See Initial Entry for Material #007	007		Undamaged
1679 Intrepid Street	See Initial Entry for Material #007	007		Undamaged

MATERIAL NUMBER	MATERIAL TYPE (MATERIAL DESCRIPTION)	ASBESTOS CONTENT	MATERIAL LOCATION(S)	FRIABLE	CONDITION	QUANTITY	COMMENTS
007	FLOOR ADHESIVE (BLACK, UNDER 1' X 1' BROWN WITH WHITE AND RED STREAKS VINYL FLOOR TILE)	3% CH	1675 INTREPID STREET 1677 INTREPID STREET 1678 INTREPID STREET 1679 INTREPID STREET	No	UNDAMAGED	3,942 SF	THIS IS THE ADHESIVE FOR MATERIAL #006.

Material Number 007  
Floor Adhesive (007) under 1' x 1' Vinyl Floor Tile

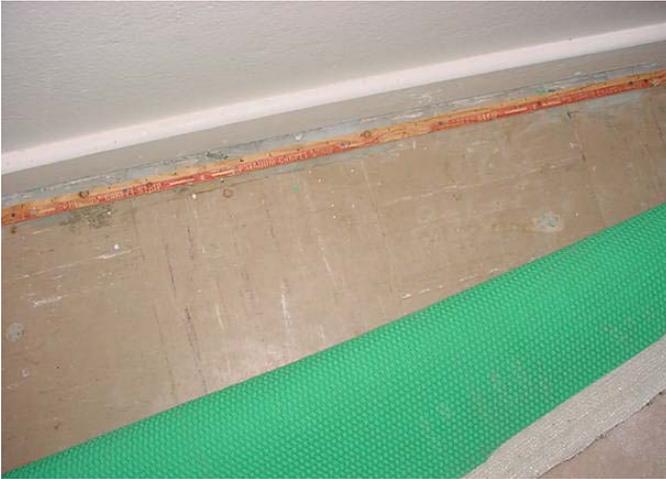
MATERIAL NUMBER	MATERIAL TYPE (MATERIAL DESCRIPTION)	ASBESTOS CONTENT	MATERIAL LOCATION(S)	FRIABLE	CONDITION	QUANTITY	COMMENTS
005	FLOOR ADHESIVE (BLACK, UNDER 1' X 1' BROWN WITH RED STREAKS VINYL FLOOR TILE)	8% CH	5 FDR	No	UNDAMAGED	600 SF	THIS IS THE ADHESIVE FOR MATERIAL #004.
006	VINYL FLOOR TILE (9" X 9" GRAY WITH WHITE STREAKS)	4% CH	1 FDR 5 FDR	No	UNDAMAGED	1,868 SF	THE ADHESIVE FOR THIS MATERIAL IS MATERIAL #007. THIS MATERIAL IS LOCATED BELOW THE EXISTING CARPET.
007	FLOOR ADHESIVE (BLACK, UNDER 9" X 9" GRAY WITH WHITE STREAKS VINYL FLOOR TILE)	6% CH	1 FDR 5 FDR	No	UNDAMAGED	1,834 SF	THIS IS THE ADHESIVE FOR MATERIAL #006.
009	FLOOR ADHESIVE (BLACK, UNDER 1' X 1' TAM MOTTLED VINYL FLOOR TILE)	5% CH	3 FDR	No	UNDAMAGED	634 SF	THIS IS THE ADHESIVE FOR MATERIAL #007.
011	VINYL FLOOR TILE (1' X 1' BROWN WITH TAN STREAKS)	3% CH	3 FDR	No	UNDAMAGED	600 SF	THE ADHESIVE FOR THIS MATERIAL IS MATERIAL #012. THIS MATERIAL IS LOCATED BELOW THE EXISTING CARPET.

Material Number 005  
Floor Adhesive under 1' x 1' Vinyl Floor Tile

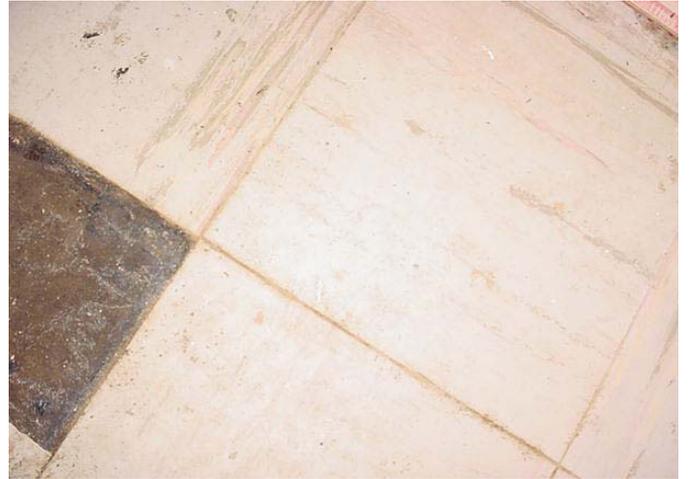
Unit	Material	Material No.	Comment	Condition
1 FDR Drive	Vinyl Floor Tile (9" X 9" Gray With White Streaks)	006	The Adhesive For This Material Is Material #007. This Material Is Located Below The Existing Carpet.	Undamaged
	Floor Adhesive (Black, Under 9" X 9" Gray With White Streaks Vinyl Floor Tile)	007	This Is The Adhesive For Material #006.	Undamaged
3 FDR Drive	Floor Adhesive (Black, Under 1' X 1' Tan Mottled Vinyl Floor Tile)	009	This Is The Adhesive For Material #007.	Undamaged
	Vinyl Floor Tile (1' X 1' Brown With Tan Streaks)	011	The Adhesive For This Material Is Material #012. This Material Is Located Below The Existing Carpet.	Undamaged
5 FDR Drive	Floor Adhesive (Black, Under 1' X 1' Brown With Red Streaks Vinyl Floor Tile)	005	This Is The Adhesive For Material #004.	Undamaged
	Vinyl Floor Tile (9" X 9" Gray With White Streaks)	006	The Adhesive For This Material Is Material #007. This Material Is Located Below The Existing Carpet.	Undamaged

Material Numbers 006 and 007  
9' x 9' Vinyl Floor Tile and Adhesive

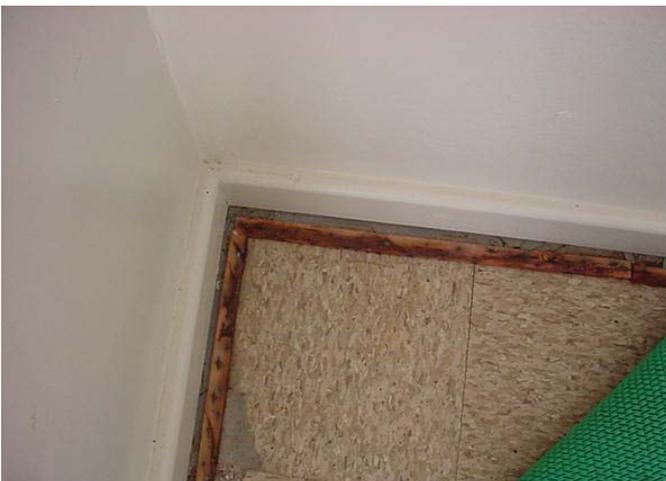
Material Number 009  
Floor Adhesive under 1' x 1' Vinyl Floor Tile

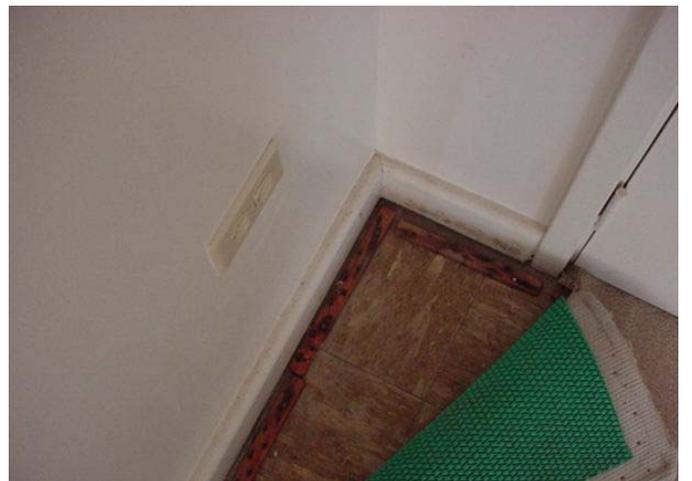
Material Number 011  
1' x 1' Vinyl Floor Tile

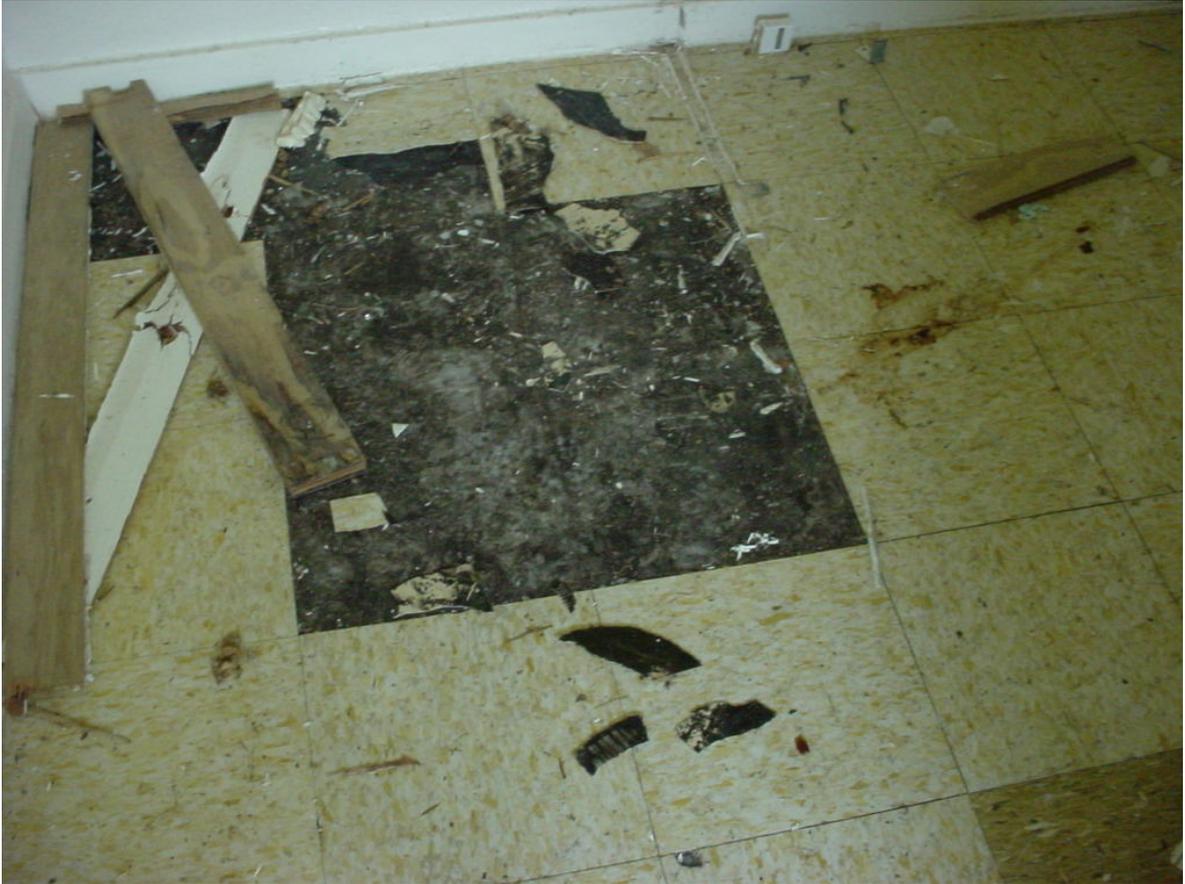
Unit	Material	Material No.	Comment	Condition
6 Intrepid Street	Vinyl Floor Tile (1' X 1' Yellow Mottled)	001	The Adhesive For This Material Is Material #002.	Damaged
	Floor Adhesive (Black, Under 1' X 1' Yellow Mottled And 1' X 1' Brown With White And Orange Stripes Vinyl Floor Tile)	002	This Is The Adhesive For Materials #001 And #005.	Damaged
7 Intrepid Street	Floor Adhesive (Black, Under 1' X 1' Yellow Mottled And 1' X 1' Brown With White And Orange Stripes Vinyl Floor Tile)	002	This Is The Adhesive For Materials #001 And #005.	Damaged

MATERIAL NUMBER	MATERIAL TYPE (MATERIAL DESCRIPTION)	ASBESTOS CONTENT	MATERIAL LOCATION(S)	FRIABLE	CONDITION	QUANTITY	COMMENTS
001	VINYL FLOOR TILE (1' X 1' YELLOW MOTTLED)	2% CH	6 INTREPID STREET	No	DAMAGED	970 SF	THE ADHESIVE FOR THIS MATERIAL IS MATERIAL #002.
002	FLOOR ADHESIVE (BLACK, UNDER 1' X 1' YELLOW MOTTLED AND 1' X 1' BROWN WITH WHITE AND ORANGE STRIPES VINYL FLOOR TILE)	4% CH	6 INTREPID STREET 7 INTREPID STREET	No	DAMAGED	1,940 SF	THIS IS THE ADHESIVE FOR MATERIALS #001 AND #005.

Material Numbers 001 and 002  
1' x 1' Vinyl Floor Tile and Adhesive
