FINAL LEAD-BASED PAINT RISK ASSESSMENT REPORT MILITARY FAMILY HOUSING

***For* NAVAL ACTIVITY PUERTO RICO
CEIBA, PUERTO RICO**

Michael Baker Jr., Inc.
Moon Township, PA

December 21, 2011

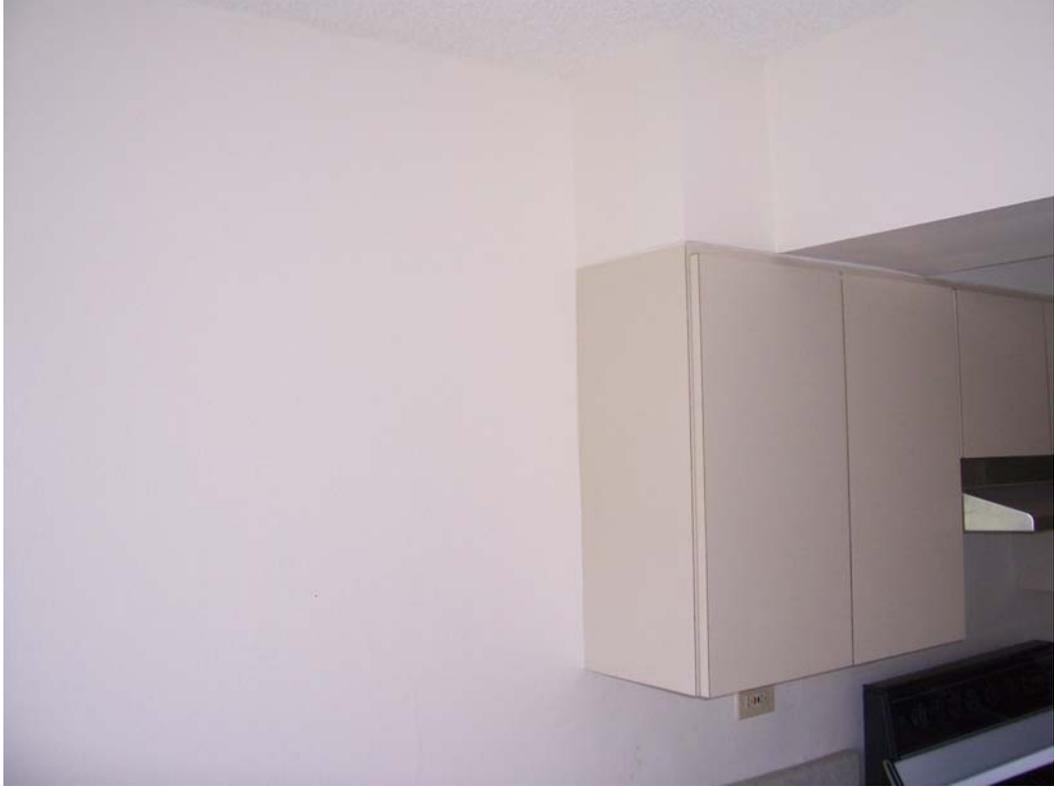
Wall - Concrete
11A American Circle - Kitchen

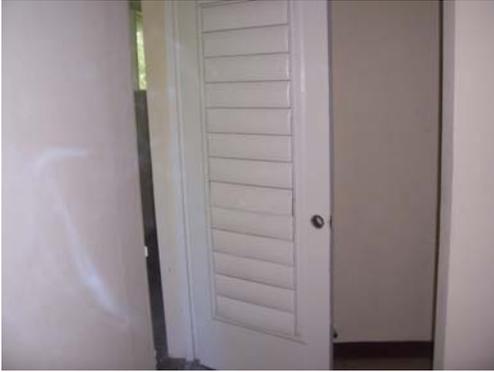
**Door Casing/ Jamb/ Stop
1677 Intrepid -Kitchen**

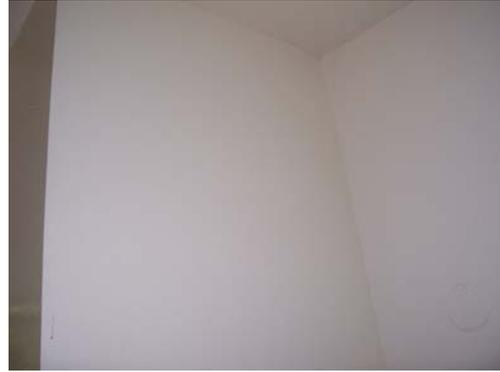
**Wall (Concrete)
1676 Intrepid – Bath 2**

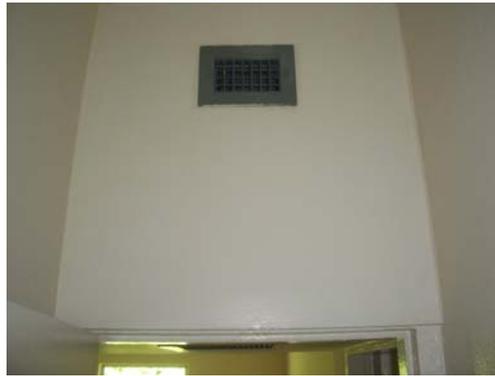
**Wall (Drywall)
1676 Intrepid – Bath 2**

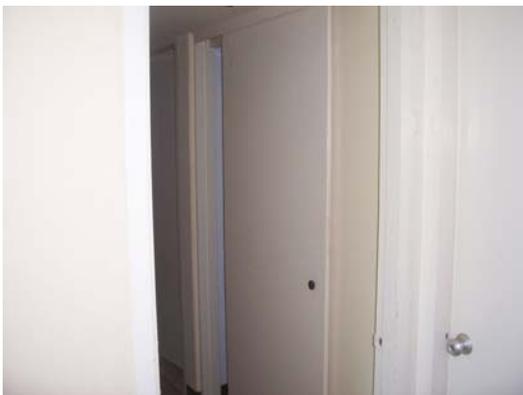
**Sliding Door
1677 Intrepid - Hall**

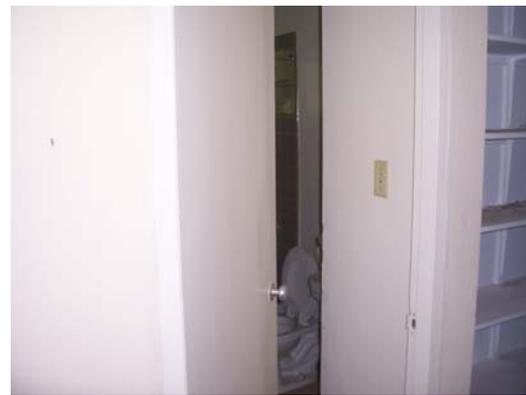
**Wood Door
1677 Intrepid – Bath 1**

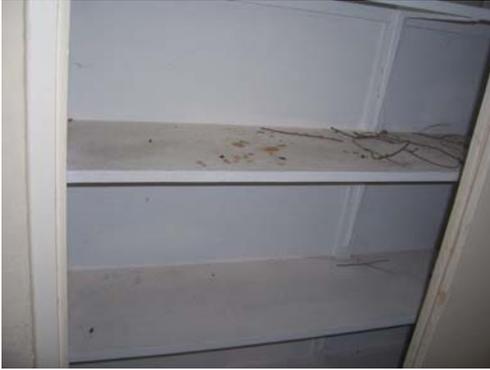
**Shelf / Shelf Support
1678 Intrepid - Hall**

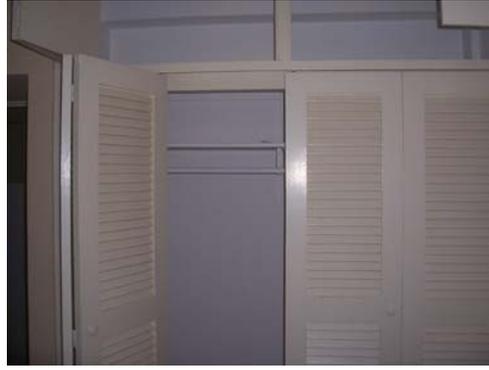
**Folding Door and Folding Door Casing
1678 Intrepid – BR 2**

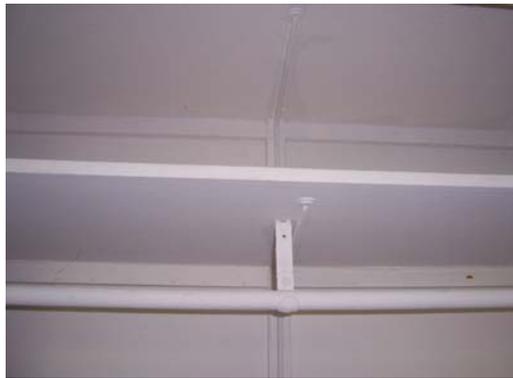
**Shelf / Shelf Support and Wood Ceiling
1678 Intrepid – BR 1**

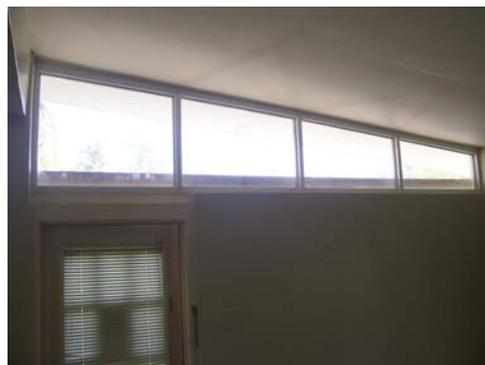
Window Sash (Wood)
9 Lexington Drive - LR

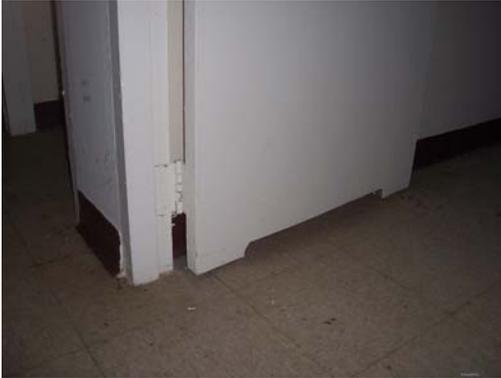
Door – 1675 Intrepid – Bedroom 3

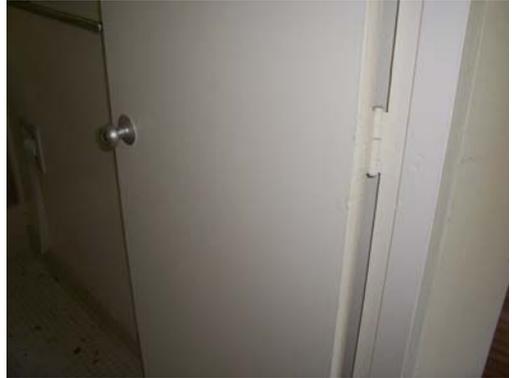
Door – 1675 Intrepid – Bath 2

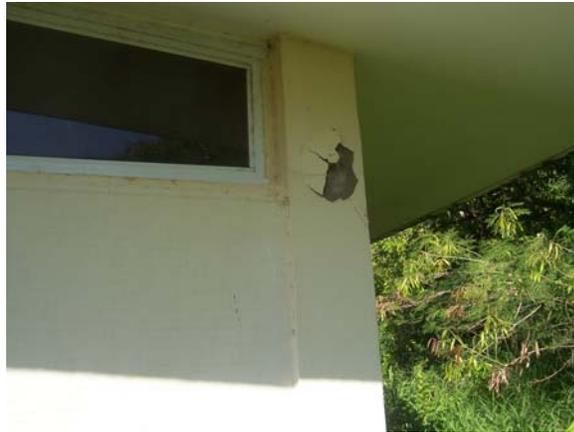
Wall (Concrete) – 1675 Intrepid – Exterior

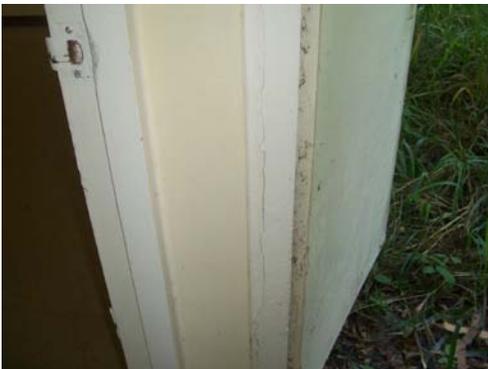
Door Casing -- 1678 Intrepid – Laundry

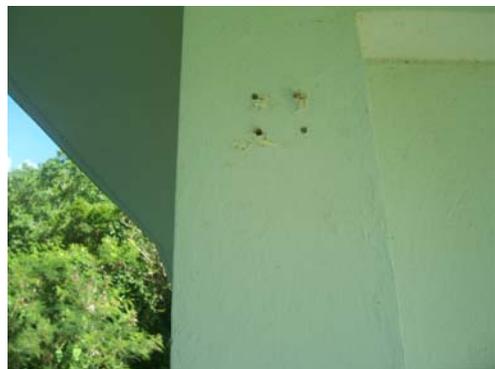
Wall (Concrete) – 1679 Intrepid -- Exterior

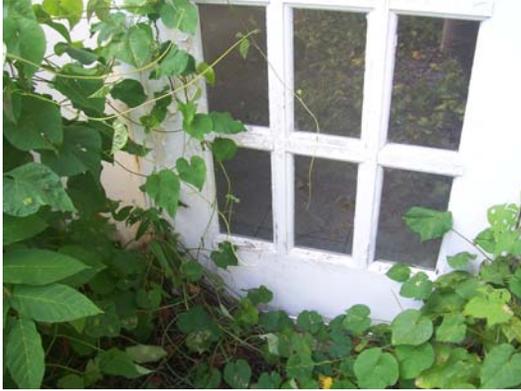
Door -- 36 Saratoga – Exterior

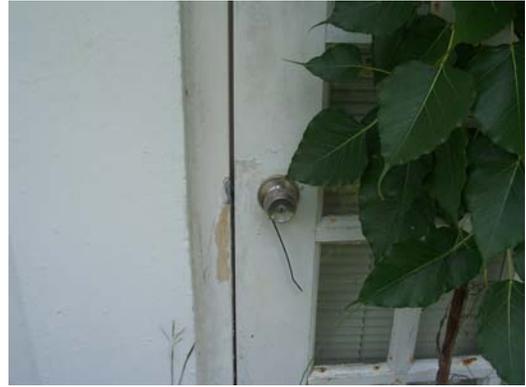
Door / Casing/ Jamb / Stop - 16 Saratoga -- Exterior

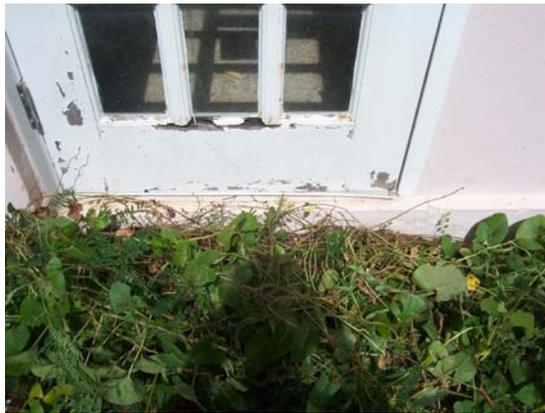
Door – 25 Enterprise – Exterior

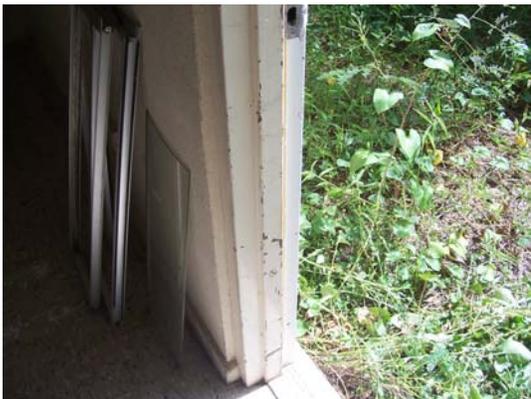
Door Casing/Jamb/Stop - 25 Enterprise – Exterior

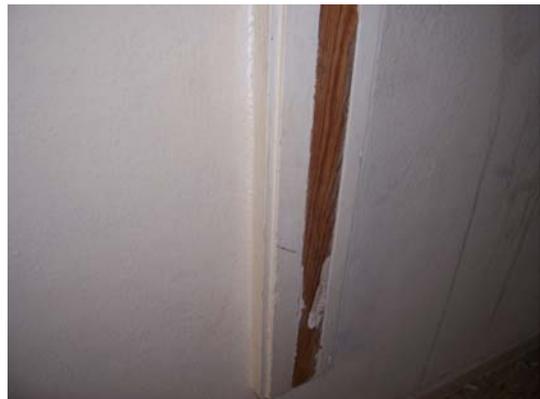
Door Casing/Jamb/Stop - 25 Enterprise - Hall
