DRAFT FINAL RESOURCE CONSERVATION AND RECOVERY ACT FACILITY
INVESTIGATION REPORT FOR SOLID WASTE MANAGEMENT UNIT 11 NAVAL ACTIVITY
PUERTO RICO (DRAFT ACTING AS FINAL)
5/18/2004
CH2M HILL

RCRA Facility Investigation Report

SWMU 11

Naval Activity Puerto Rico
RCRA/HSWA Permit No. PR2170027203
Ceiba, Puerto Rico

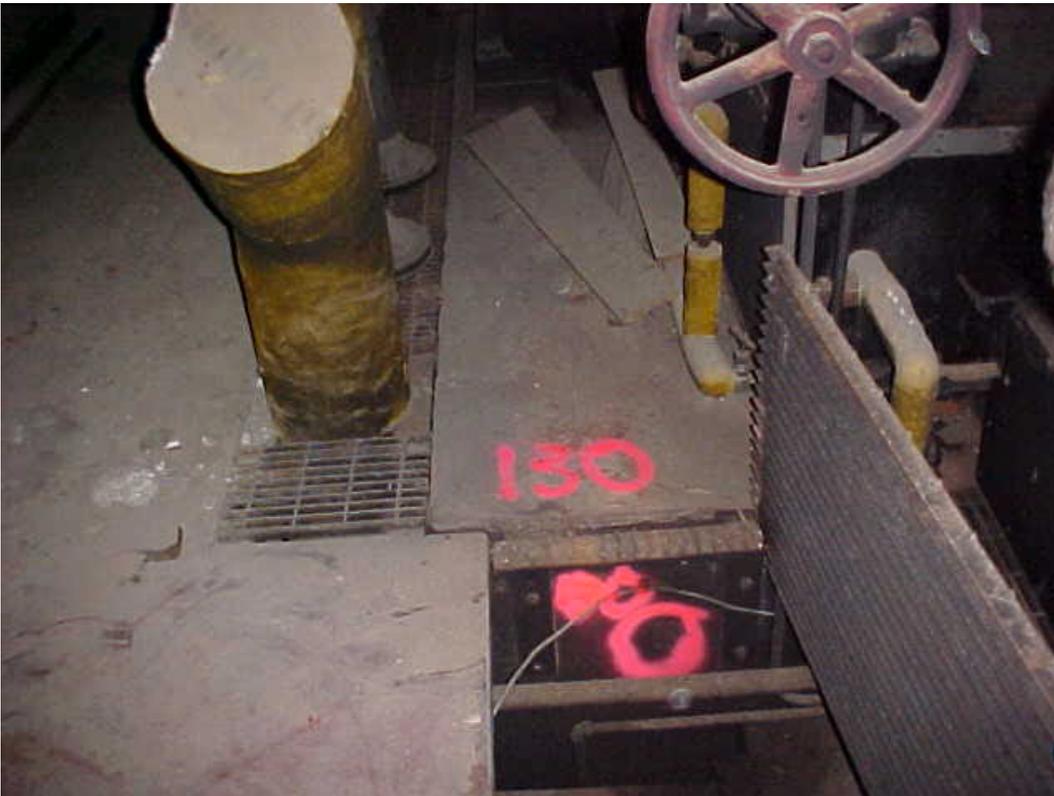
Photo 4: Wipe sample location 11WS130. This photo was taken looking downward to the northwest. This sample was taken from the side of the concrete walkway of the second level in an area of smoke damage.

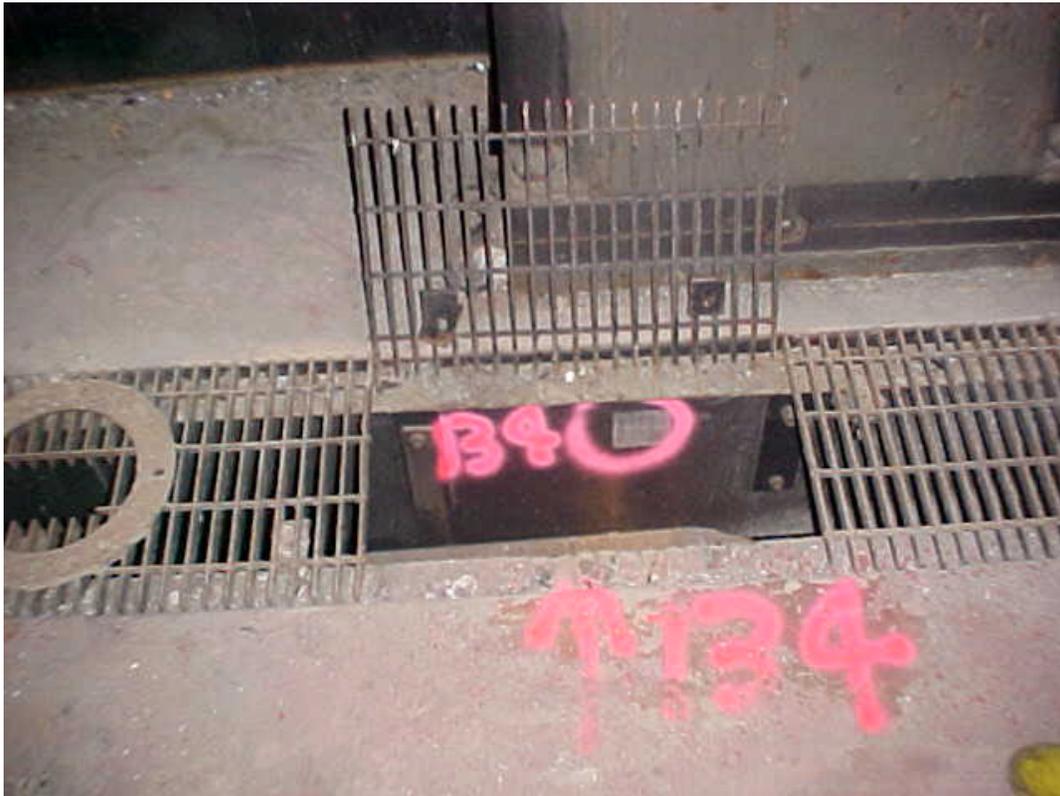
Photo 8: Wipe sample location 11WS134. This photo was taken looking downward to the northwest. This sample was taken from the side of the concrete walkway of the second level in an area of smoke damage.

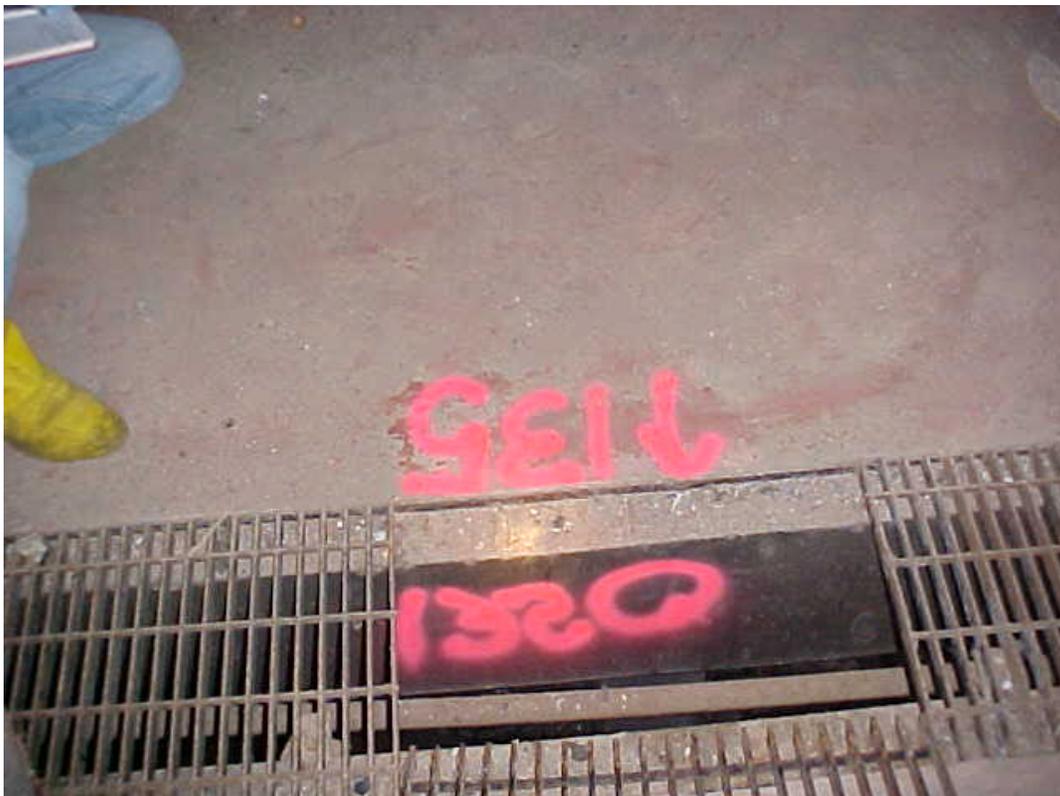
Photo 9: Wipe sample location 11WS135. This photo was taken looking downward to the northwest. This sample was taken from the side of the concrete walkway of the second level in an area of smoke damage.

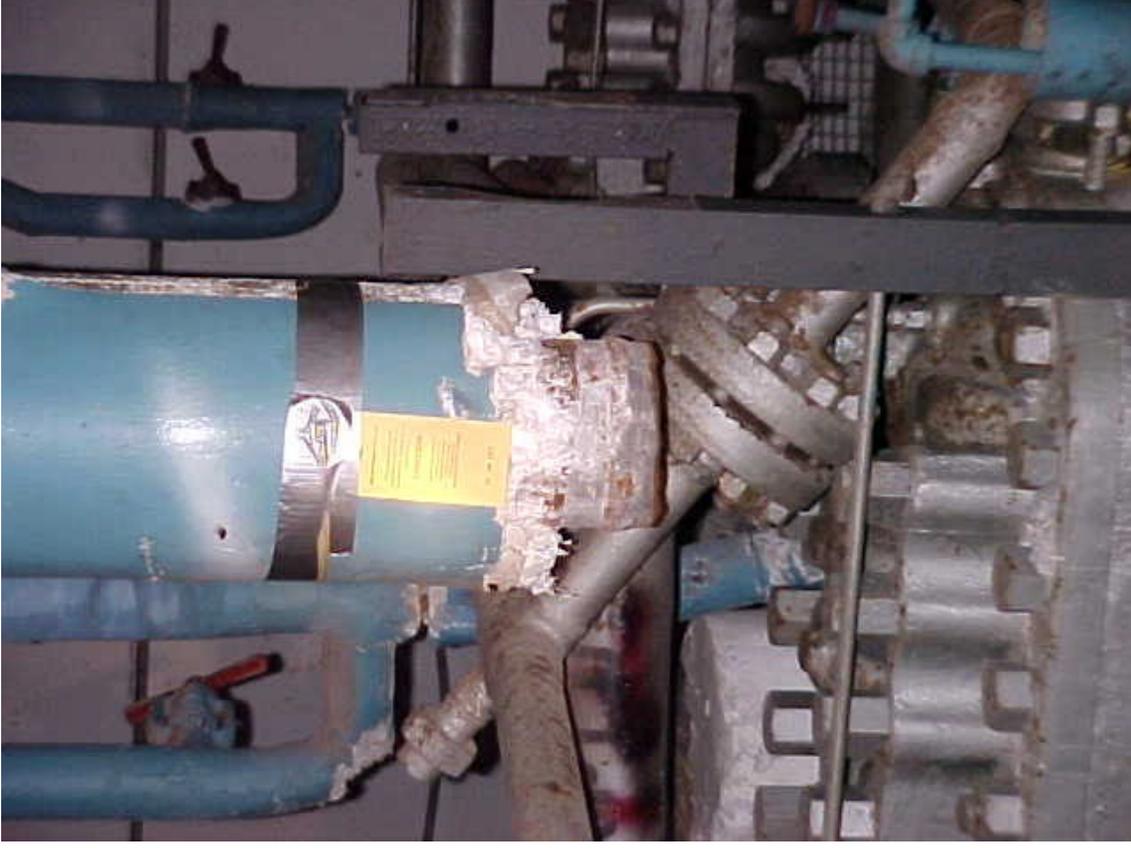
- **Asbestos Assessment Location 4** is located in the southern portion of the building in the southwest section (see Appendix A.2). The pipe TSI at this area is approximately eight inches in diameter. The actual TSI around the piping is approximately two inches thick, and is comprised of a white fibrous material that appears to be friable. This insulation is significantly damaged at the end of the pipe. Repair of the TSI is warranted at this location if the building is to be inhabited in the future. The current condition of the TSI at this location has the potential to pose a risk to human health. Section 6.0 of this document provides a recommendation for dealing with this issue.

Photo 13: Asbestos Assessment Location 4. This photo was taken looking to the northwest. The assessment was performed on the TSI pipe insulation located in the southwest section of Building 38 in the compressor area.

COMMENTS: The pipe insulation is approximately 8" in diameter (outside to outside edge). This Section of the building contained significantly damaged pipe insulation all over.

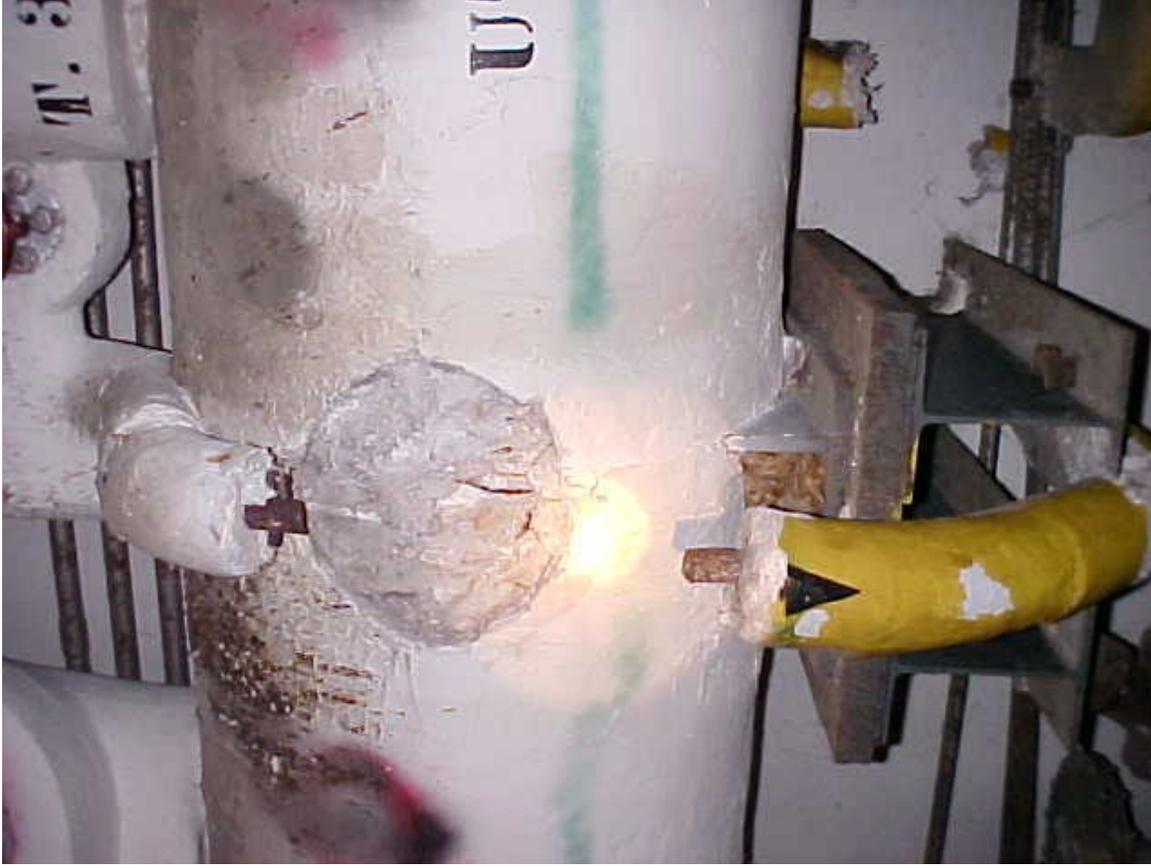
- **Asbestos Assessment Location 5** is located in the southern portion of the building along the northern wall separating the northern and southern sections of Building 38 (see Appendix A.2). This is a location where two small valves that once lead into a tank, were cut and exposed the interior portion of the TSI. The actual TSI around both pipes leading to the tank is approximately two inches thick, and is comprised of a white fibrous material that appeared to be friable. This insulation is significantly damaged in a distributed area. Repair of the TSI is warranted at this location if the building is to be inhabited in the future. The current condition of the TSI at this location has the potential to pose a risk to human health. Section 6.0 of this document provides a recommendation for dealing with this issue.

Photo 14: Asbestos Assessment Location 5. This photo was taken looking to the northeast. The assessment was performed on the TSI pipe insulation located in the southern section of Building 38 along the northern wall by the two boilers.

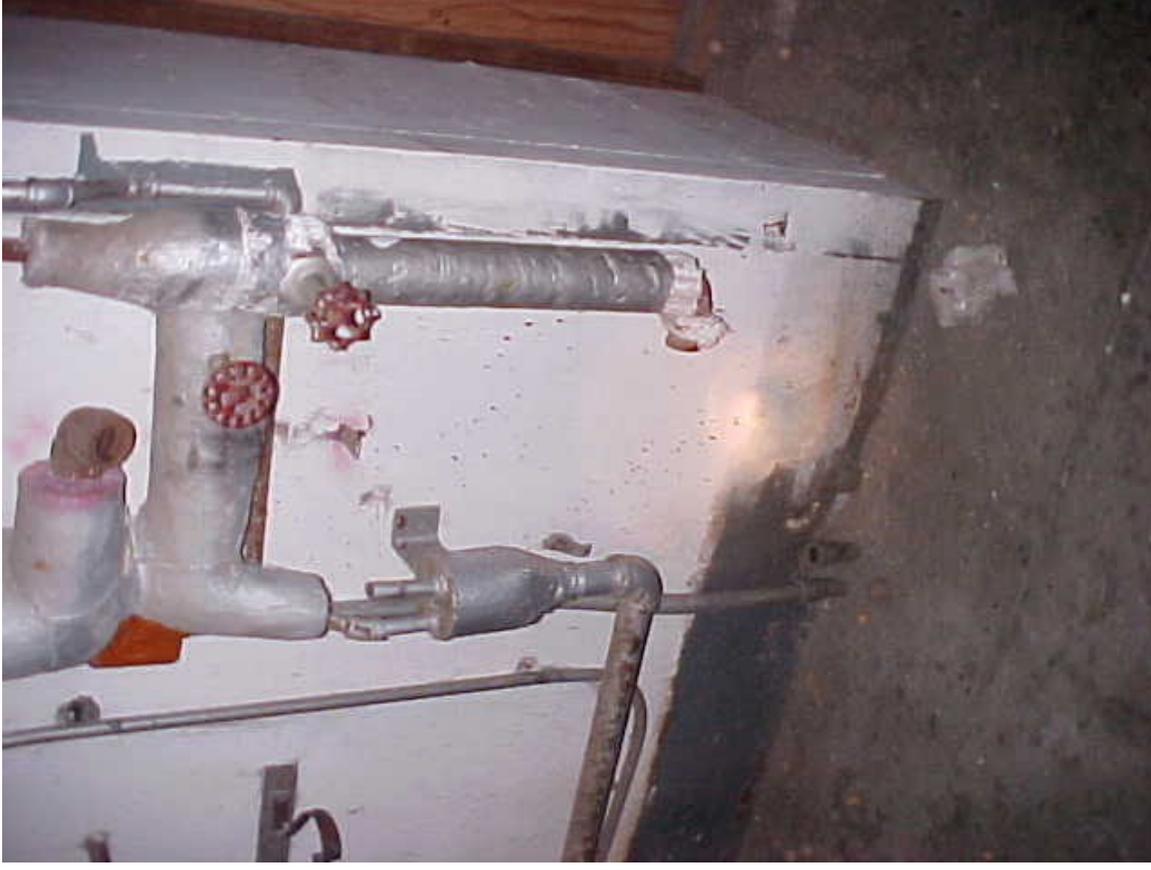
- **Asbestos Assessment Location 6** is located in the southern portion of the building along the northern wall separating the northern and southern sections of Building 38 (see Appendix A.2). This is a location along the eastern side of the northern wall where a pipe and its TSI were cut, with the interior portion of the TSI exposed. The pipe and TSI at this area is approximately four inches in diameter. The actual TSI around both pipes leading to the tank is approximately one inch thick, and is comprised of a white fibrous material that appeared to be friable. This TSI is damaged in a distributed area. The coating of the insulation in this area appeared to be of a burlap-type of texture. Repair of the TSI is warranted at this location if the building is to be inhabited in the future. The current condition of the TSI at this location has the potential to pose a risk to human health. Section 6.0 of this document provides a recommendation for dealing with this issue.

Photo 15: Asbestos Assessment Location 6. This photo was taken looking to the northeast. The assessment was performed on the TSI pipe insulation located in the southern section of Building 38 along the northern wall on the eastern side.
