DRAAFT FINAL RESOURCE CONSERVATION AND RECOVERY ACT FACILITY
INVESTIGATION REPORT FOR SOLID WASTE MANAGEMENT UNIT 11 NAVAL ACTIVITY
PUERTO RICO (DRAFT ACTING AS FINAL)
5/18/2004
CH2M HILL

RCRA Facility Investigation Report

SWMU 11

Naval Activity Puerto Rico
RCRA/HSWA Permit No. PR2170027203
Ceiba, Puerto Rico

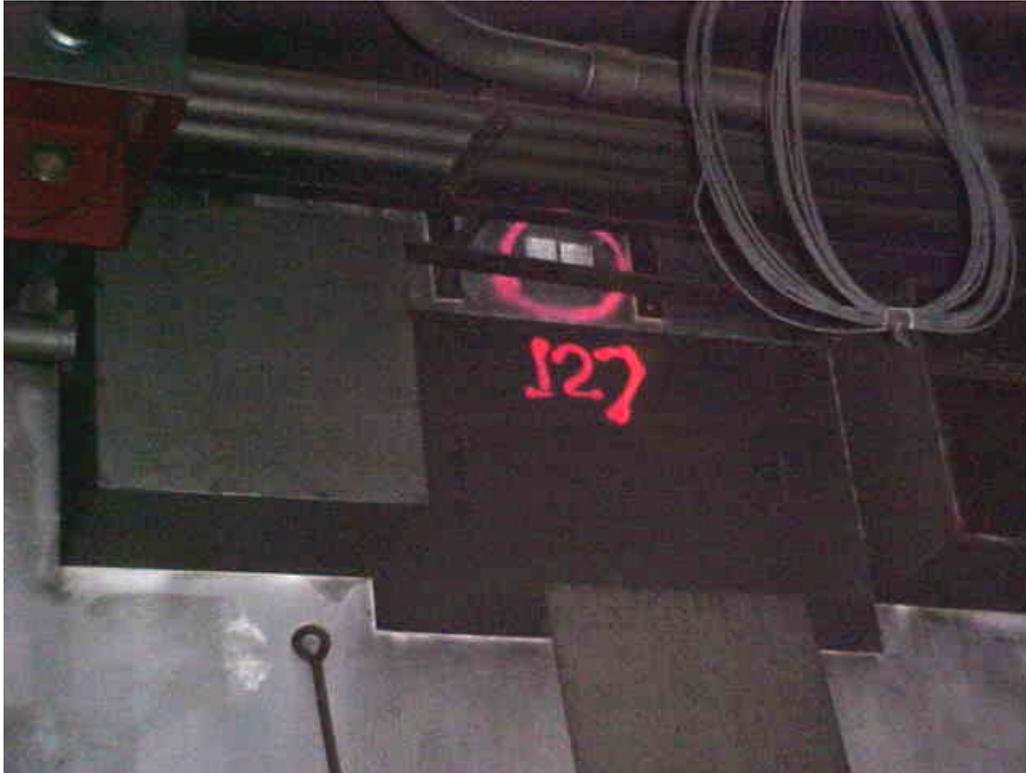
Photo 1: Wipe sample location 11WS127. This photo was taken looking overhead to the southeast. This sample was taken from the concrete wall in an area of smoke damage located under the walkway of the second level.

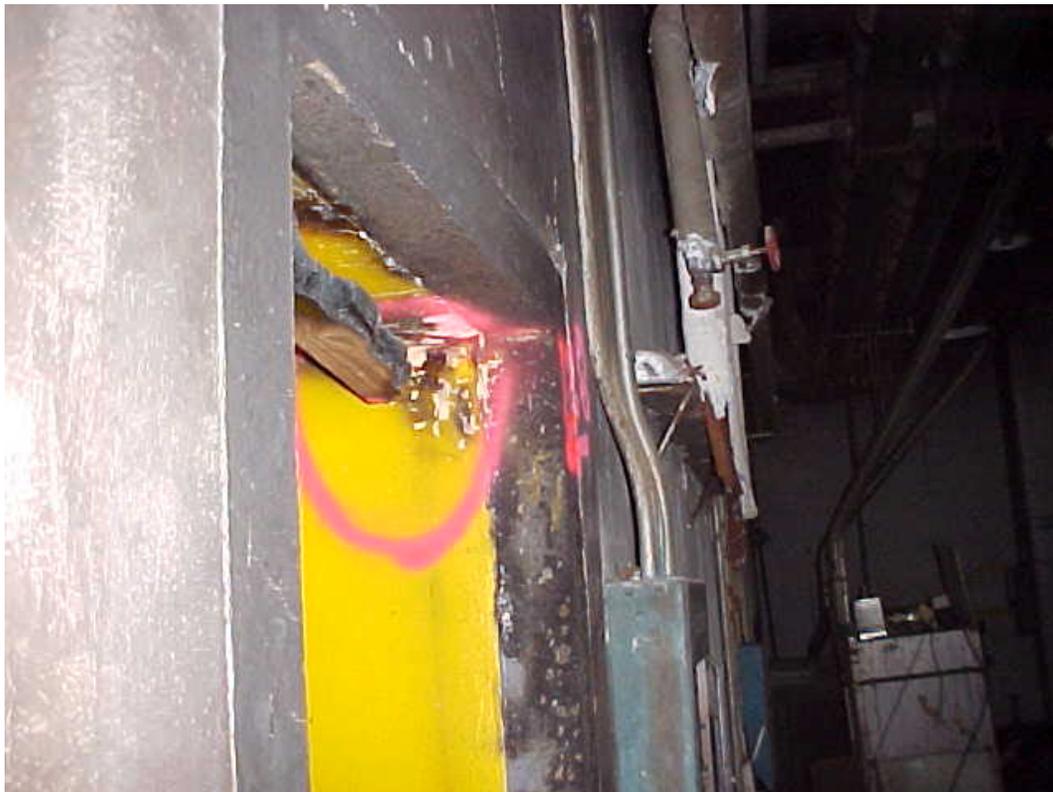
Photo 2: Wipe sample location 11WS128. This photo was taken looking west. This sample was taken from the concrete wall inside the doorway between the northern and southern portions of Building 38.

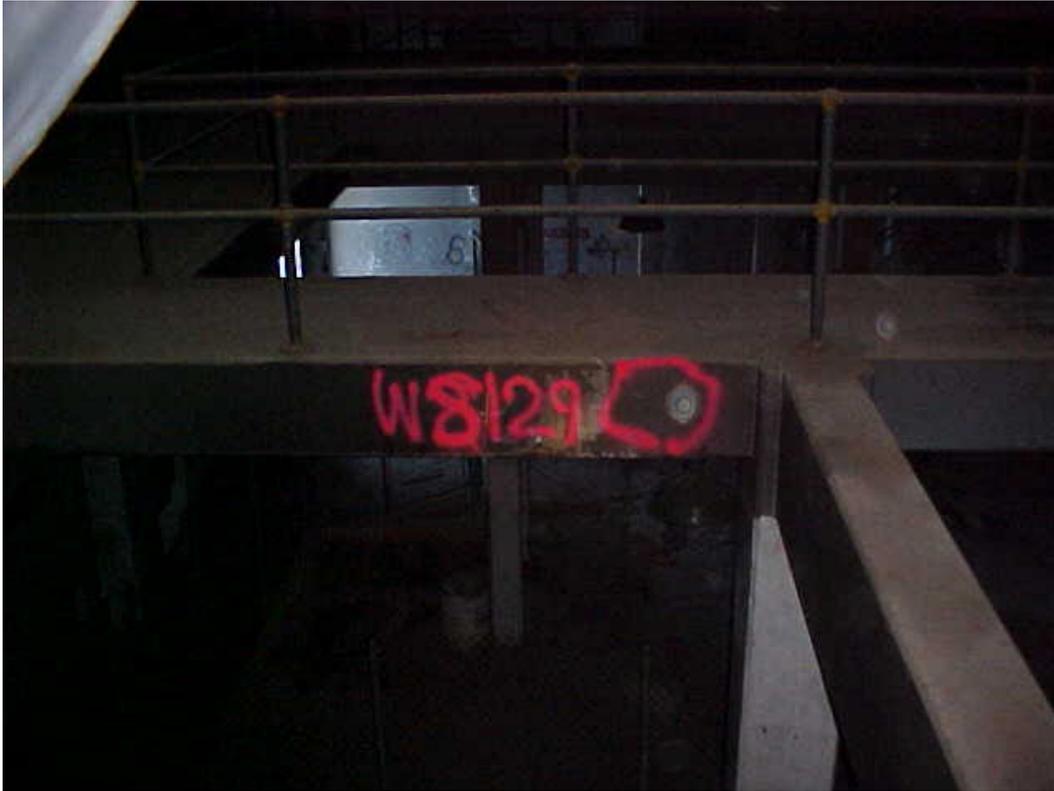
Photo 3: Wipe sample location 11WS129. This photo was taken looking to the southeast. This sample was taken from the side of the concrete walkway of the second level in an area of smoke damage.

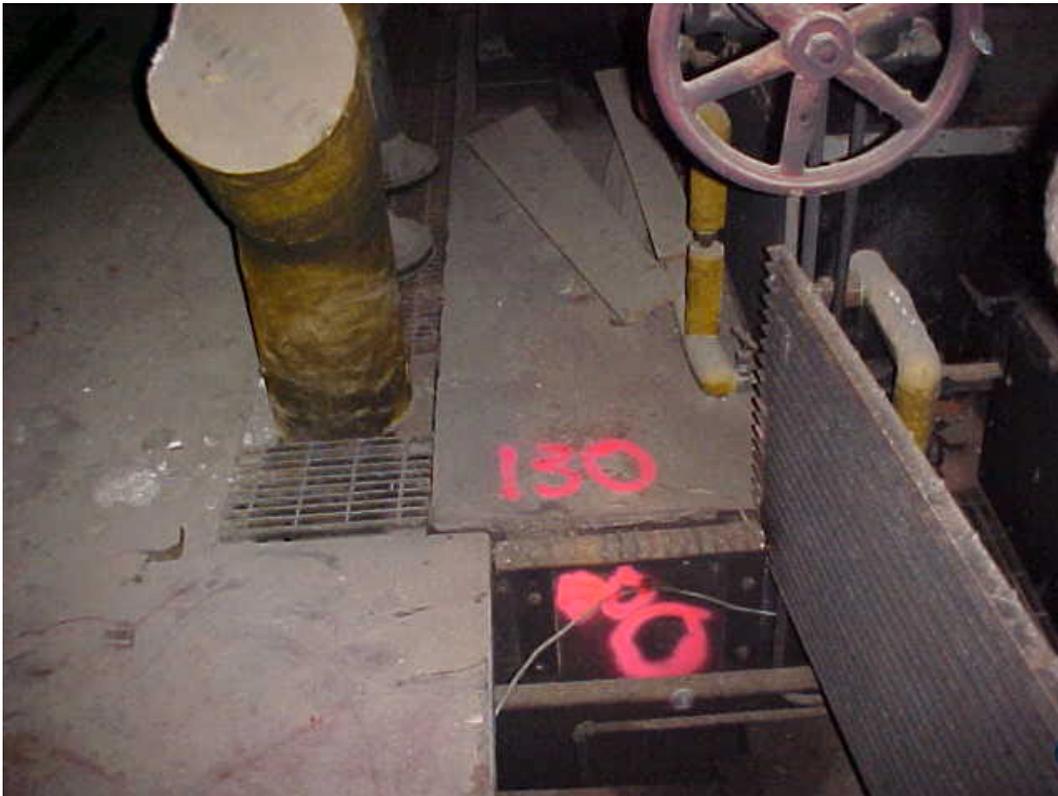
Photo 4: Wipe sample location 11WS130. This photo was taken looking downward to the northwest. This sample was taken from the side of the concrete walkway of the second level in an area of smoke damage.

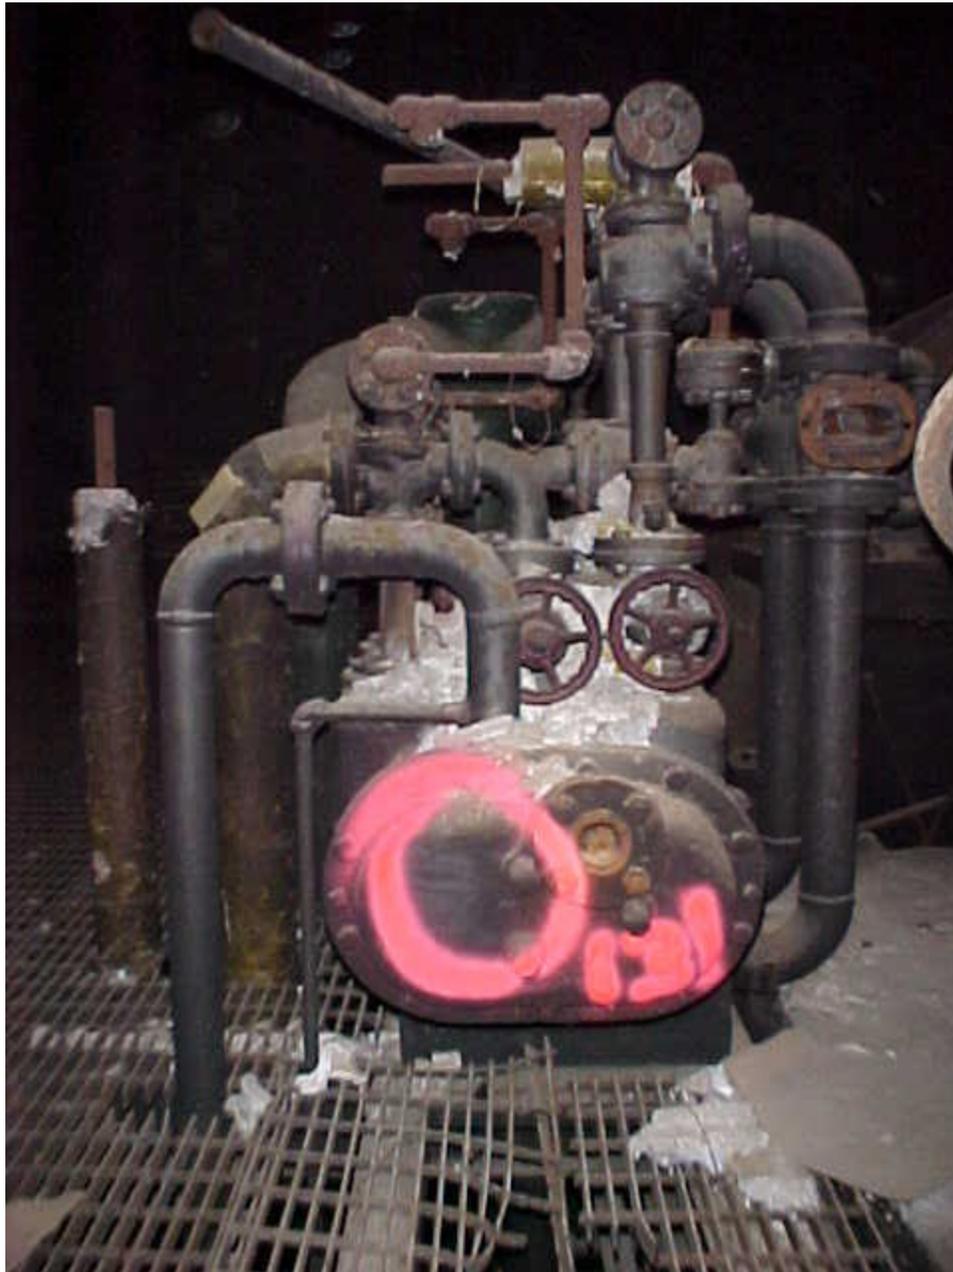
Photo 5: Wipe sample location 11WS131. This photo was taken looking to the northeast on the second level. This sample was taken from the steel end cap.

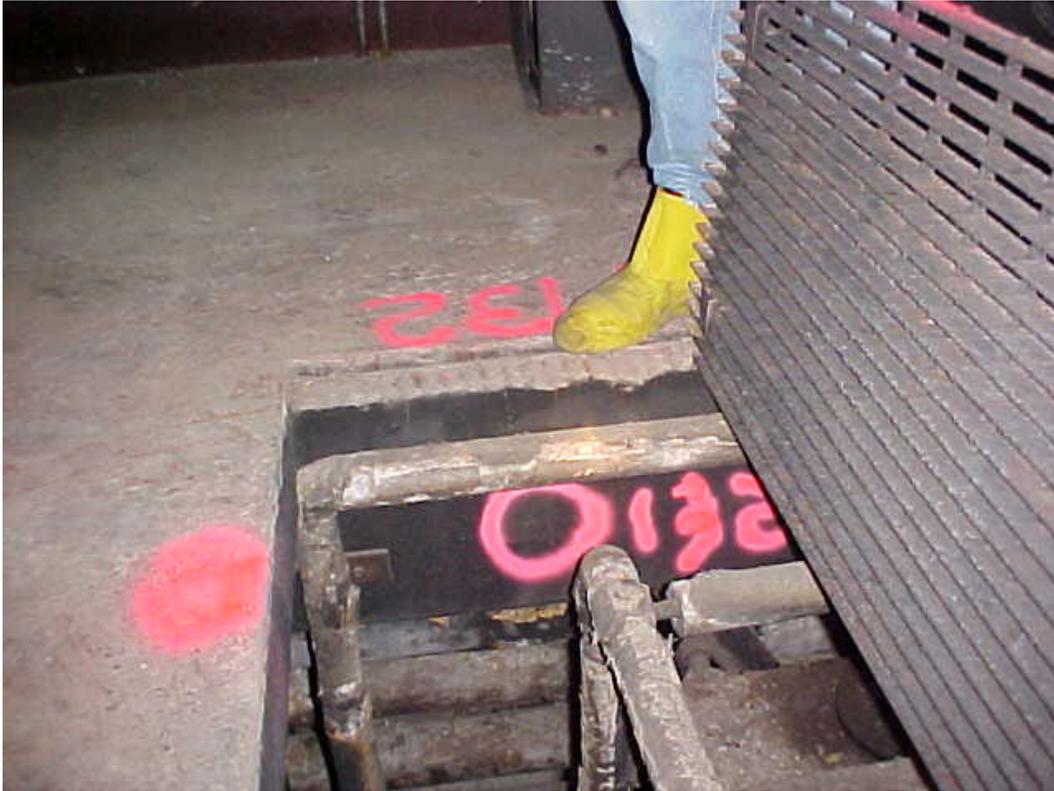
Photo 6: Wipe sample location 11WS132. This photo was taken looking downward to the southwest. This sample was taken from the side of the concrete walkway of the second level in an area of smoke damage.

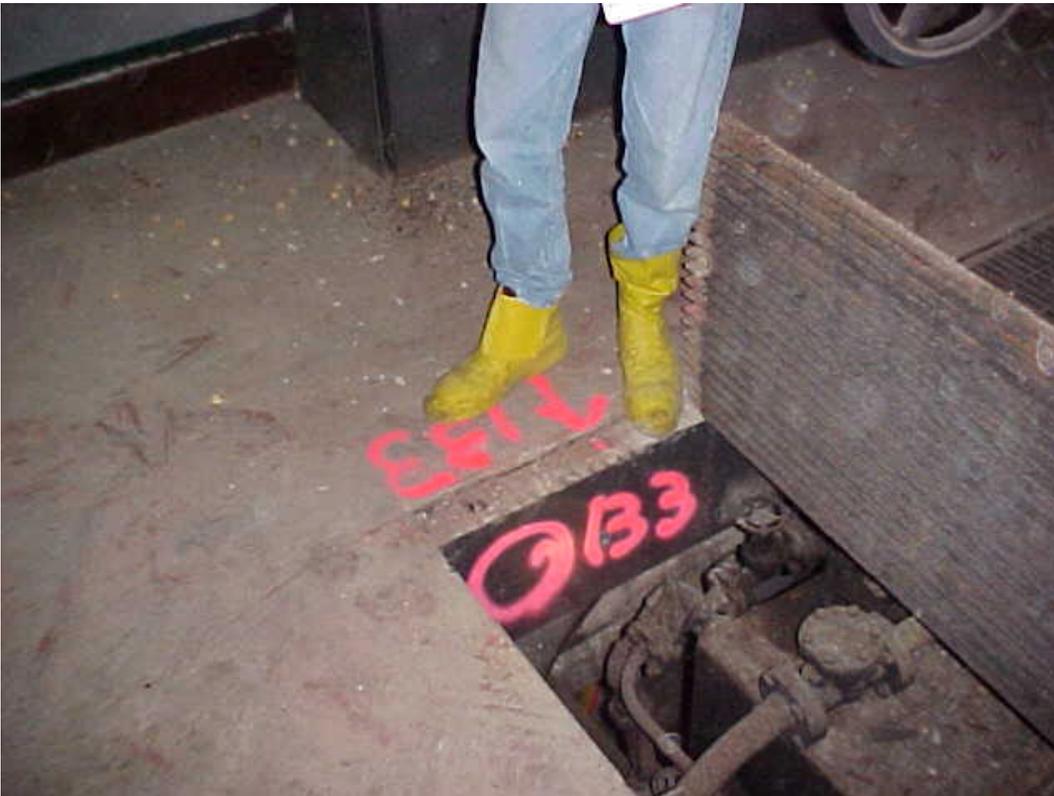
Photo 7: Wipe sample location 11WS133. This photo was taken looking downward to the west. This sample was taken from the side of the concrete walkway of the second level in an area of smoke damage.

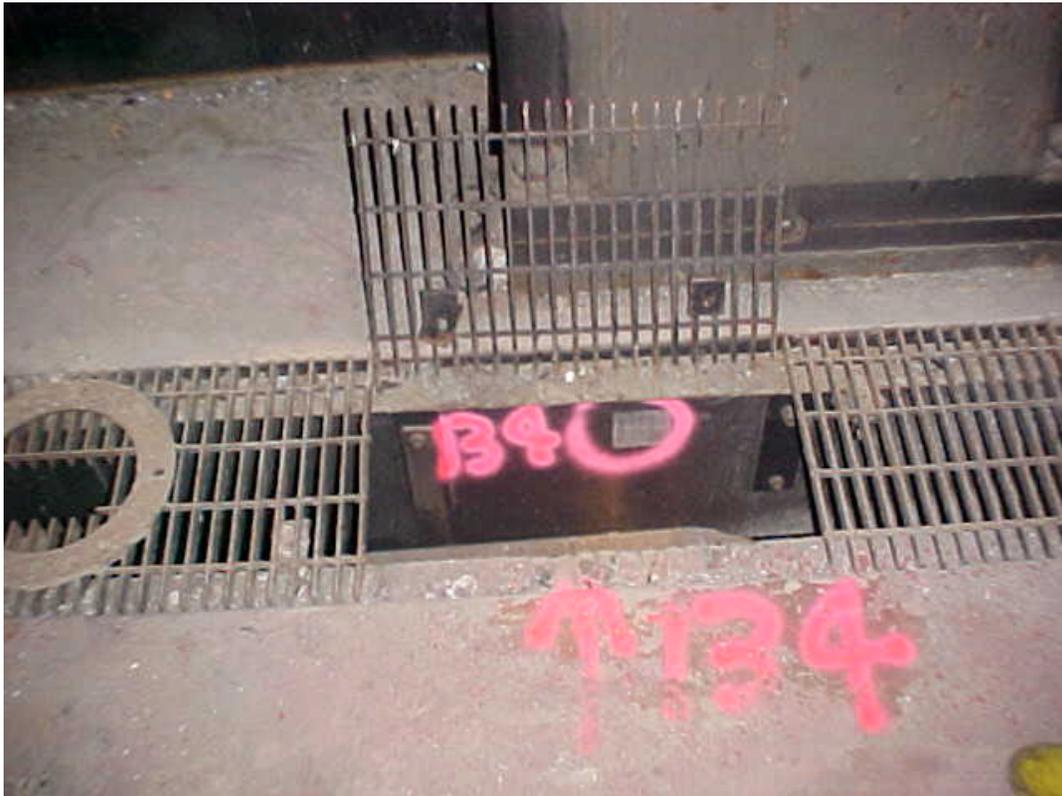
Photo 8: Wipe sample location 11WS134. This photo was taken looking downward to the northwest. This sample was taken from the side of the concrete walkway of the second level in an area of smoke damage.

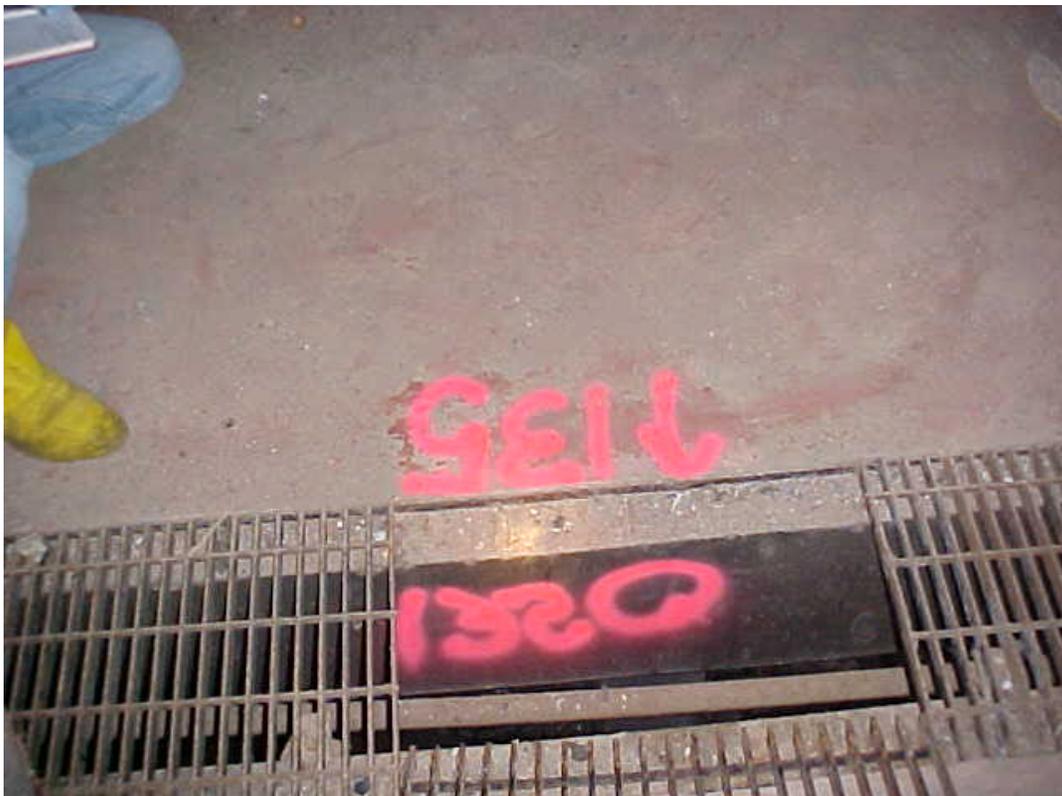
Photo 9: Wipe sample location 11WS135. This photo was taken looking downward to the northwest. This sample was taken from the side of the concrete walkway of the second level in an area of smoke damage.

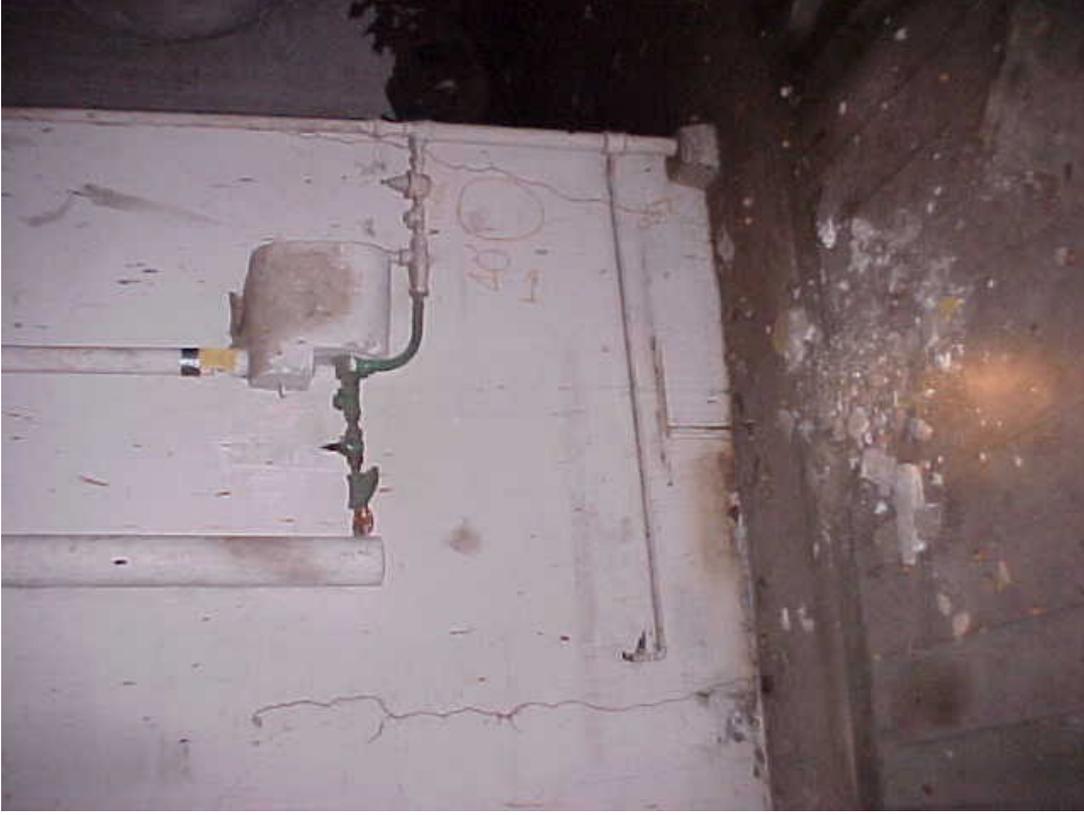
- **Asbestos Assessment Location (AAL) 1** is located in the southern section of the building in the southeast corner by the lavatory (see Appendix A.2). The pipe TSI at this area is approximately five inches in diameter. The actual insulation around the piping is approximately one inch thick, and is comprised of a white fibrous material that appeared to be friable. This insulation appeared to be undamaged at this location. No repair of the pipe insulation is required at this time.

Photo 10: Asbestos Assessment Location 1. This photo was taken looking to the southeast. The assessment was performed on the TSI pipe insulation located in the southeast corner of Building 38 by the lavatory.

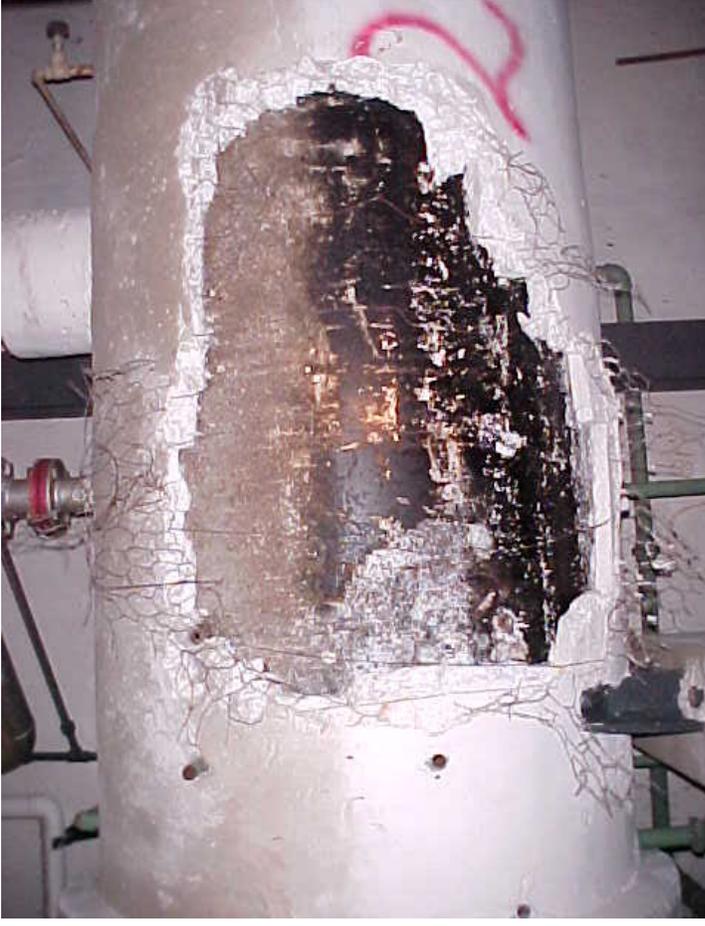
- **Asbestos Assessment Location 2** is located in the southern section of the building in the southeast corner by the lavatory (see Appendix A.2). The TSI at this area is encapsulating a tank that is believed to be Evaporator Tank Number 2. The actual TSI around this tank is approximately two inches thick, and is comprised of a white fibrous material that appeared to be friable. This insulation is significantly damaged and appears to have been stripped from the side of the tank and left on the floor. Repair of the TSI and clean up of the removed TSI is warranted at this location if the building is to be inhabited in the future. The current condition of the TSI at this location has the potential to pose a risk to human health. Section 6.0 of this document provides a recommendation for dealing with this issue.

Photo 11: Asbestos Assessment Location 2. This photo was taken looking to the southwest. The assessment was performed of the TSI covering the AST located in the southeast corner of Building 38 by the lavatory.

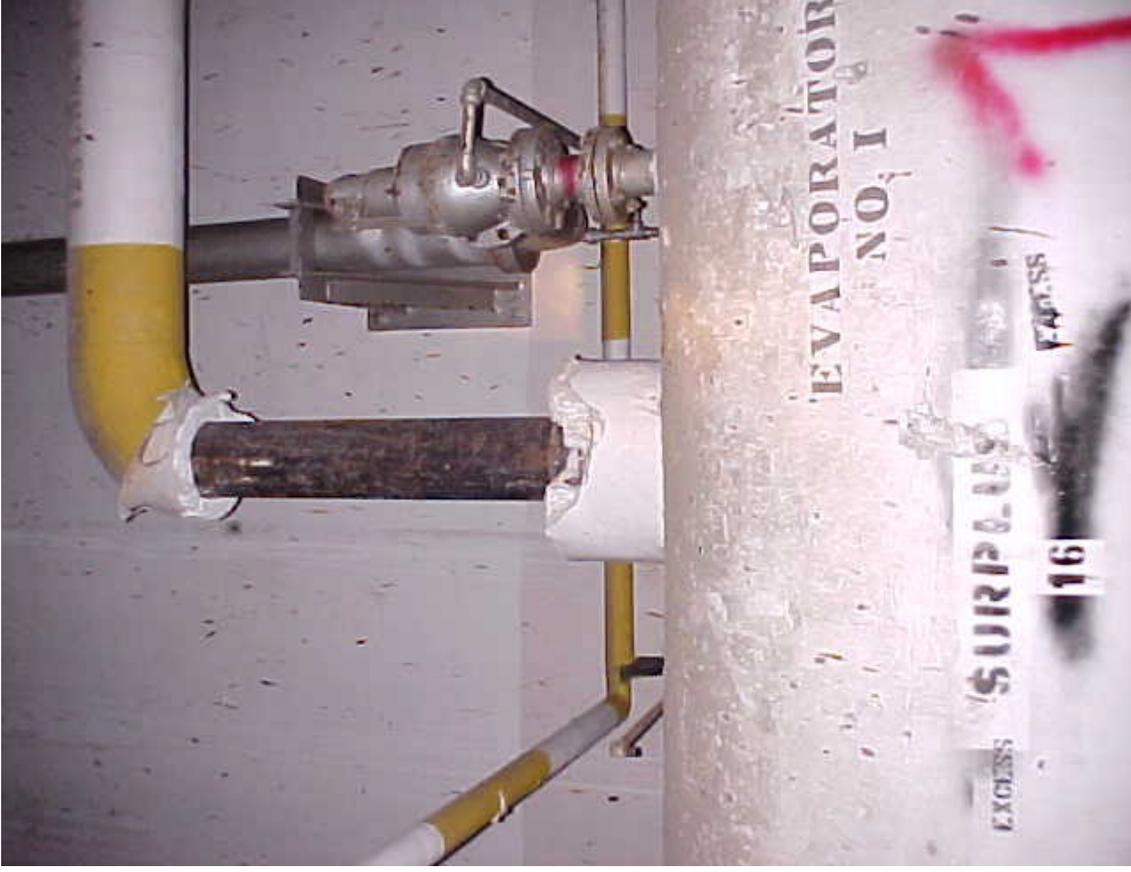
- **Asbestos Assessment Location 3** is located in the southern section of the building in the southeast corner by the lavatory (see Appendix A.2). The pipe TSI at this area is approximately 12 inches in diameter. The actual insulation around the piping is approximately two inches thick, and is comprised of a white fibrous material that appeared to be friable. This insulation is damaged in a localized area. Repair of the TSI is warranted at this location if the building is to be inhabited in the future. The current condition of the TSI at this location has the potential to pose a risk to human health. Section 6.0 of this document provides a recommendation for dealing with this issue.

Photo 12: Asbestos Assessment Location 3. This photo was taken looking to the southwest. The assessment was performed on the TSI pipe insulation located in the southeast corner of Building 38 by the lavatory.

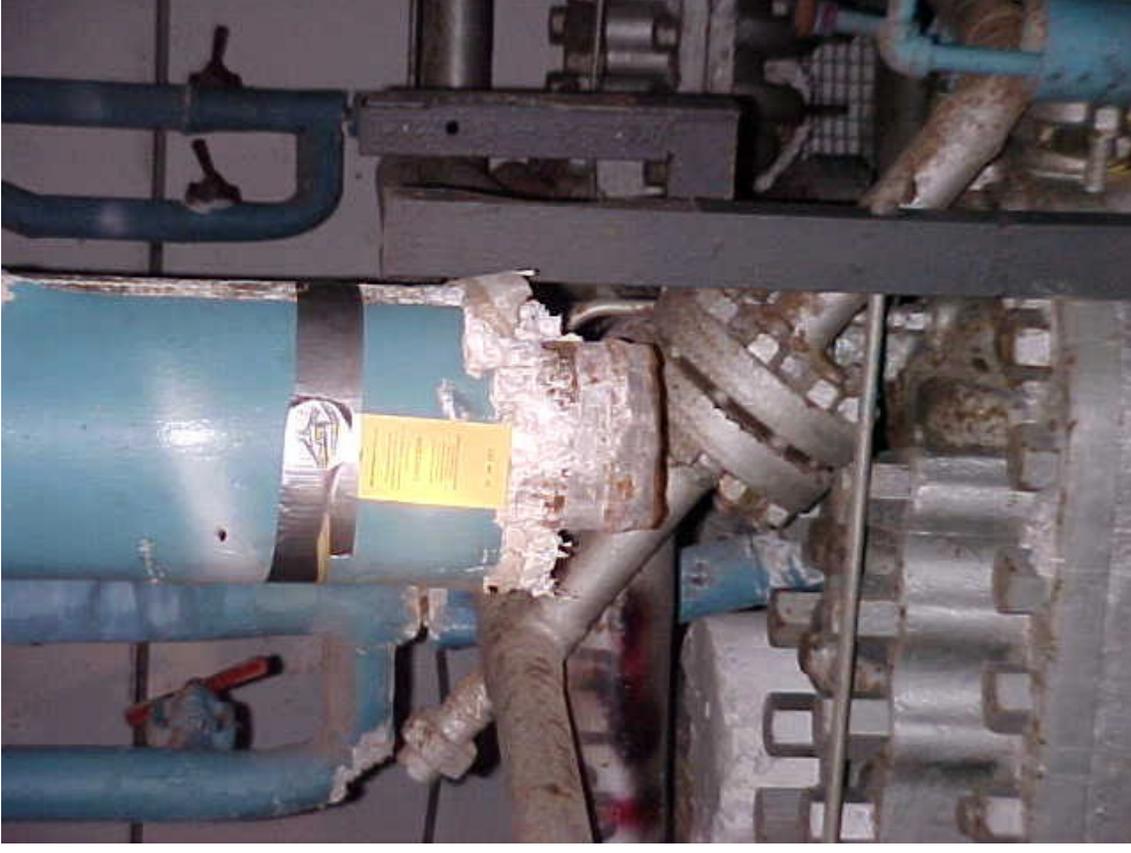
- **Asbestos Assessment Location 4** is located in the southern portion of the building in the southwest section (see Appendix A.2). The pipe TSI at this area is approximately eight inches in diameter. The actual TSI around the piping is approximately two inches thick, and is comprised of a white fibrous material that appears to be friable. This insulation is significantly damaged at the end of the pipe. Repair of the TSI is warranted at this location if the building is to be inhabited in the future. The current condition of the TSI at this location has the potential to pose a risk to human health. Section 6.0 of this document provides a recommendation for dealing with this issue.

Photo 13: Asbestos Assessment Location 4. This photo was taken looking to the northwest. The assessment was performed on the TSI pipe insulation located in the southwest section of Building 38 in the compressor area.

COMMENTS: The pipe insulation is approximately 8" in diameter (outside to outside edge). This Section of the building contained significantly damaged pipe insulation all over.

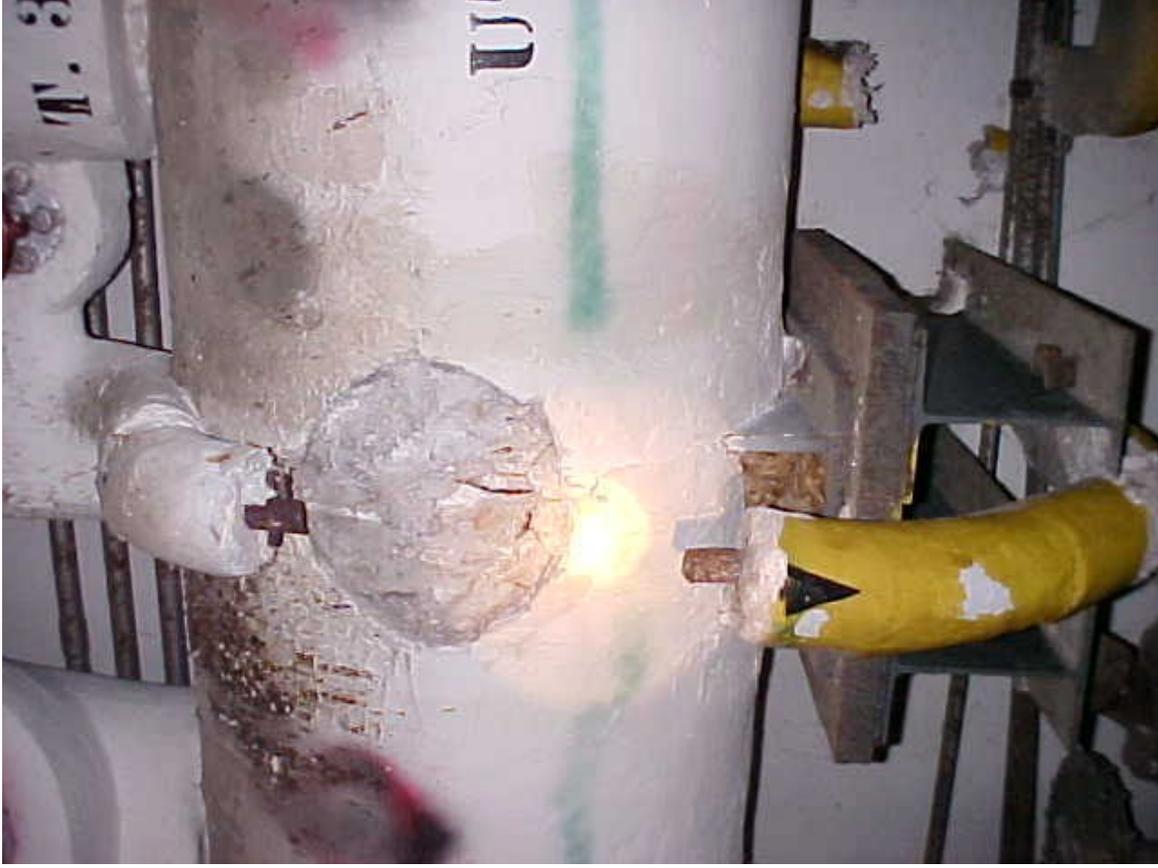
- **Asbestos Assessment Location 5** is located in the southern portion of the building along the northern wall separating the northern and southern sections of Building 38 (see Appendix A.2). This is a location where two small valves that once lead into a tank, were cut and exposed the interior portion of the TSI. The actual TSI around both pipes leading to the tank is approximately two inches thick, and is comprised of a white fibrous material that appeared to be friable. This insulation is significantly damaged in a distributed area. Repair of the TSI is warranted at this location if the building is to be inhabited in the future. The current condition of the TSI at this location has the potential to pose a risk to human health. Section 6.0 of this document provides a recommendation for dealing with this issue.

Photo 14: Asbestos Assessment Location 5. This photo was taken looking to the northeast. The assessment was performed on the TSI pipe insulation located in the southern section of Building 38 along the northern wall by the two boilers.

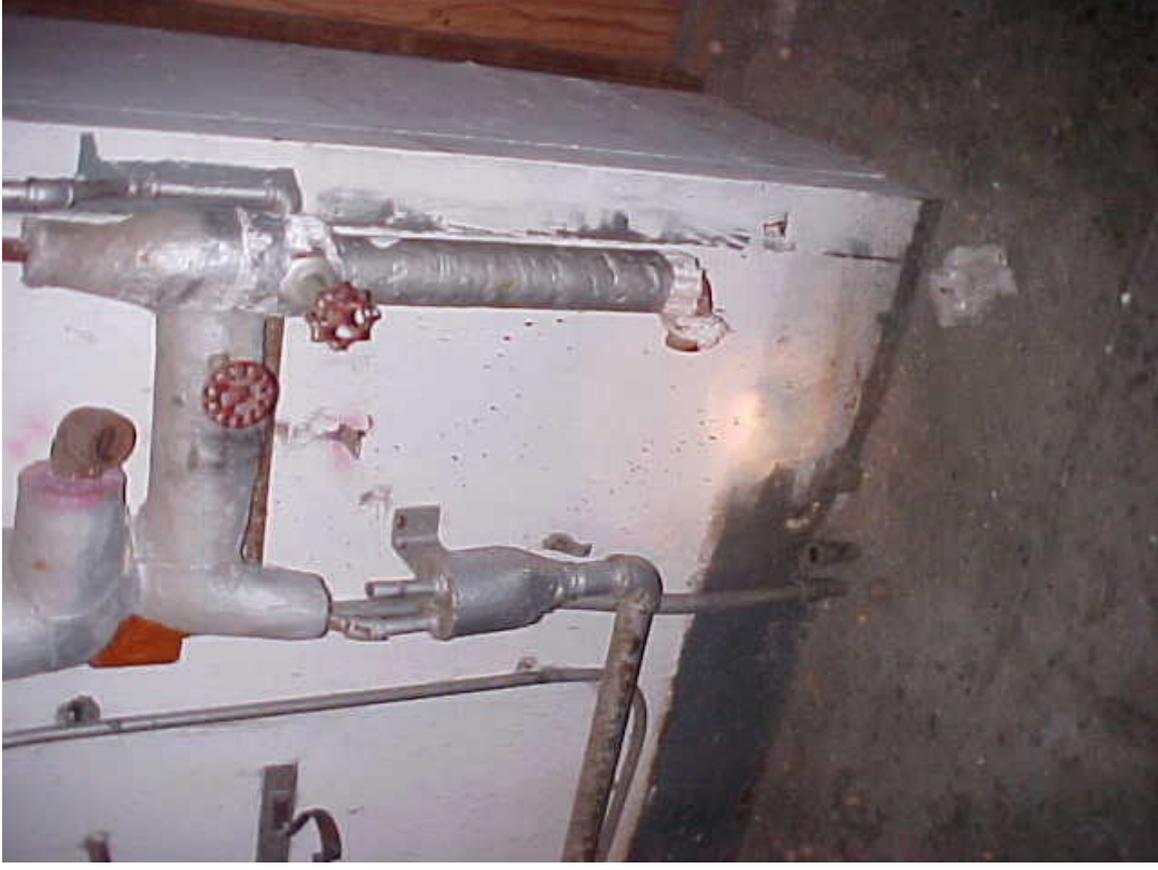
- **Asbestos Assessment Location 6** is located in the southern portion of the building along the northern wall separating the northern and southern sections of Building 38 (see Appendix A.2). This is a location along the eastern side of the northern wall where a pipe and its TSI were cut, with the interior portion of the TSI exposed. The pipe and TSI at this area is approximately four inches in diameter. The actual TSI around both pipes leading to the tank is approximately one inch thick, and is comprised of a white fibrous material that appeared to be friable. This TSI is damaged in a distributed area. The coating of the insulation in this area appeared to be of a burlap-type of texture. Repair of the TSI is warranted at this location if the building is to be inhabited in the future. The current condition of the TSI at this location has the potential to pose a risk to human health. Section 6.0 of this document provides a recommendation for dealing with this issue.

Photo 15: Asbestos Assessment Location 6. This photo was taken looking to the northeast. The assessment was performed on the TSI pipe insulation located in the southern section of Building 38 along the northern wall on the eastern side.

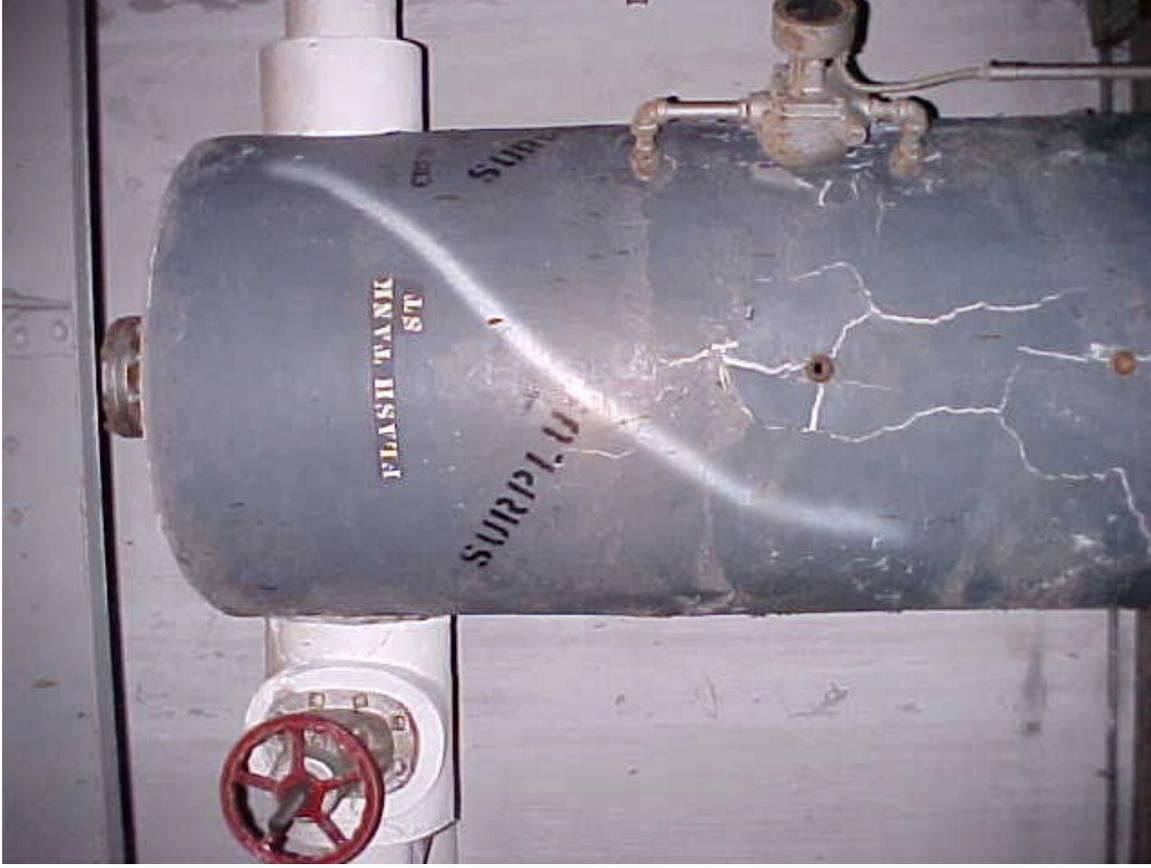
- **Asbestos Assessment Location 7** is located in the southern portion of the building along the southern wall on the second level of Building 38 (see Appendix A.2). The TSI in question covers a flash tank that contained a crack that ran vertically down the center of the tank. The actual TSI was comprised of a white fibrous material that appears to be friable. The TSI is damaged in a distributed area. Repair of the TSI is warranted at this location if the building is to be inhabited in the future. The current condition of the TSI at this location has the potential to pose a risk to human health. Section 6.0 of this document provides a recommendation for dealing with this issue.

Photo 16: Asbestos Assessment Location 7. This photo was taken looking to the southwest. The assessment was performed on the TSI on the flash tank located in the southern section of Building 38 along the southern wall on level 2.

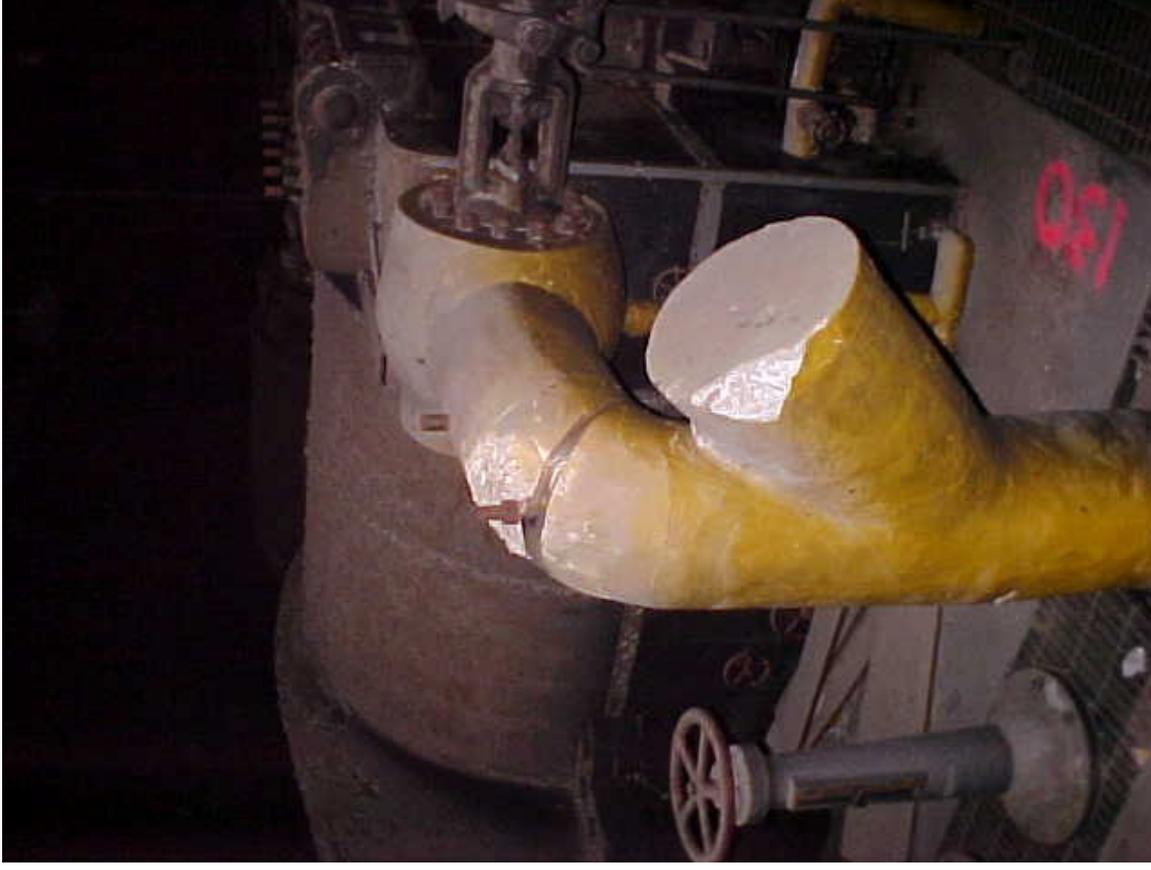
- **Asbestos Assessment Location 8** is located in the northern portion of the building on the second level of Building 38 (see Appendix A.2). The pipe and TSI at this area is approximately 12 inches in diameter. The actual TSI around the piping leading to one of the turbines is approximately two inches thick, and is comprised of a white fibrous material that appeared to be friable. This TSI is significantly damaged in a distributed area. There was also TSI around piping in the same general area that contained the same type of TSI. The TSI and piping is approximately two inches in diameter. Repair of the TSI is warranted at this location if the building is to be inhabited in the future. The current condition of the TSI at this location has the potential to pose a risk to human health. Section 6.0 of this document provides a recommendation for dealing with this issue.

Photo 17: Asbestos Assessment Location 8. This photo was taken looking to the northeast. The assessment was performed on the TSI pipe insulation located in the northern section of Building 38 in the center portion of second level. This is insulation around a steam line running to a turbine.
