ENGINEERING INVESTIGATION

TELEVISION INSPECTION
AND
ENGINEERING STUDY OF STORM SEWERS

AT
ALAMEDA NAVAL AIR STATION
ALAMEDA, CALIFORNIA

DECEMBER 1990

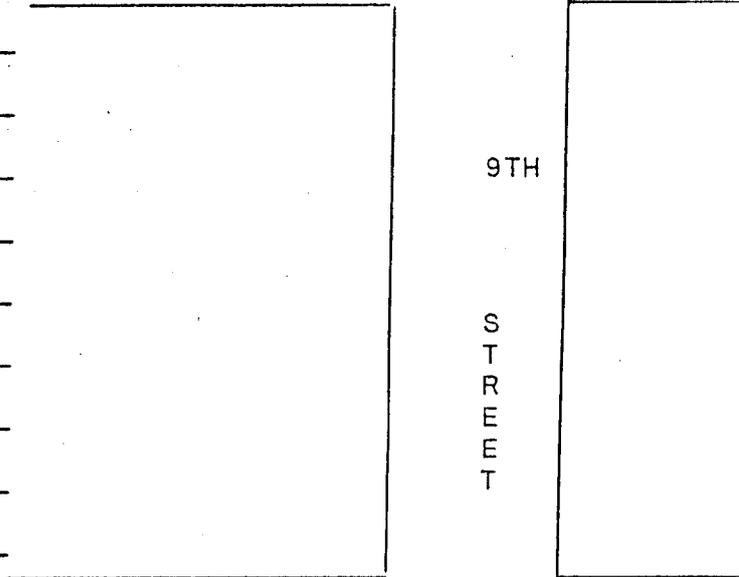
MANHOLE
() #6-H
ATLANTIC AVENUE

The reach from manhole 6H to 7H contains radial cracks. No other structural deficiencies were found in System "H."

Remove and repair 186' of 12" RCP from Manhole 2E1 to Catchbasin 2E1B	\$ 10,230
Remove and repair 130' of 27" RCP from Manhole 12G to 14G	9,660
Sliplining 411' of 36" RCP from Manhole 6H to Manhole 7H	95,000
Sliplining 50' of 12" RCP from Manhole 6G16 to Catchbasin 6G18A	4,500
Sliplining 207' of 21" RCP from Manhole 4G to Manhole 4G1	13,500
Sliplining 108' of 12" RCP from Manhole 3G1 to Catchbasin 3G1A	<u>3,300</u>
Subtotal	\$136,190
Overhead and profit of Prime Contractor (20%)	<u>27,238</u>
TOTAL	\$163,428

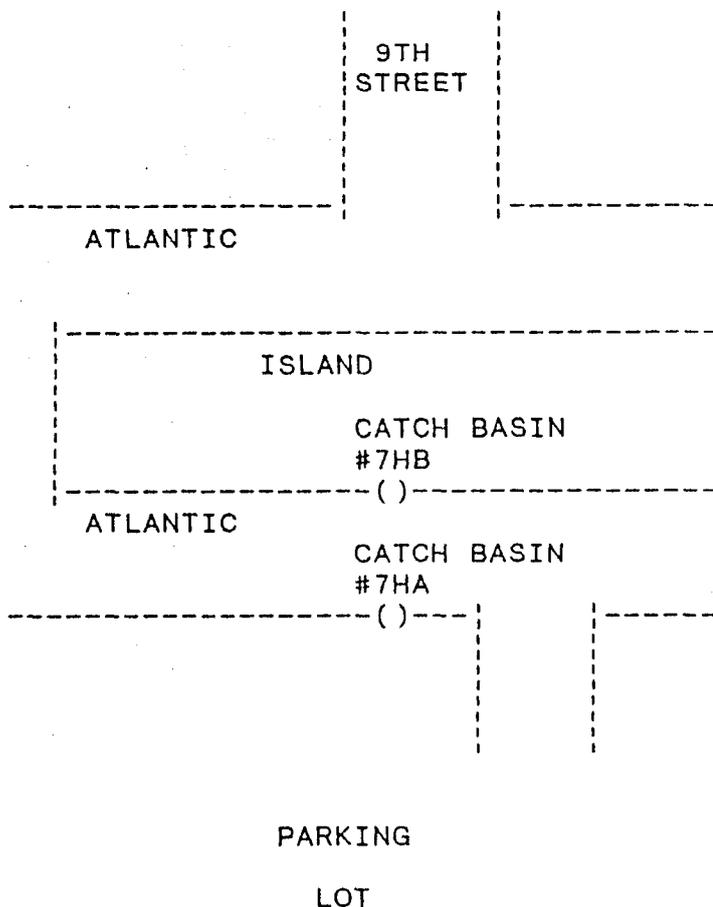
PIPE CONDITION: FAIR

REMARKS: DEBRIS THROUGHOUT

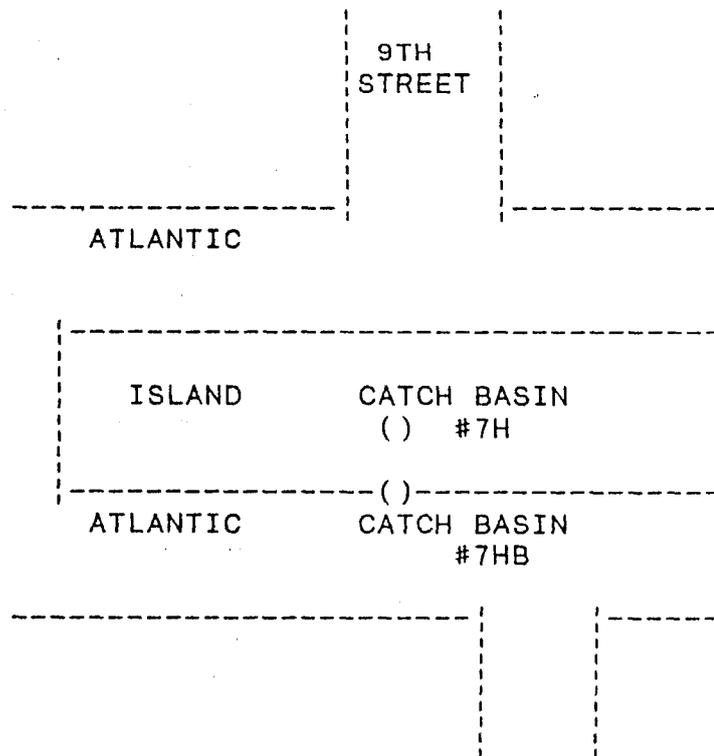
PIPE CONDITION: FAIR

REMARKS: DEBRIS THROUGHOUT

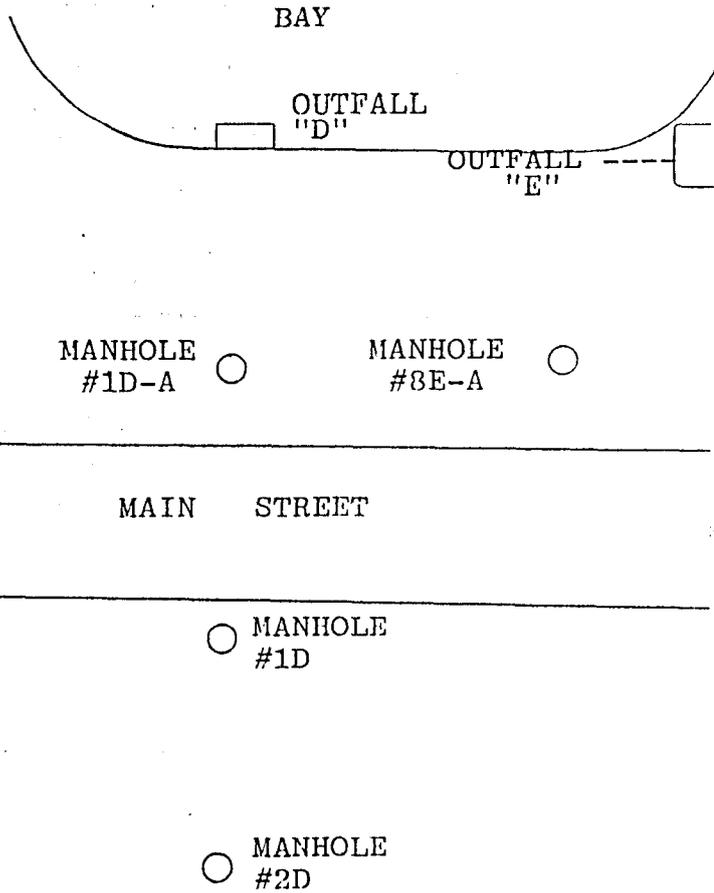
DESCRIPTION: TV INSIDE MANHOLE S TO SHOW
EXCESSIVE MATERIAL ALSO LEAK AT OUTFALL

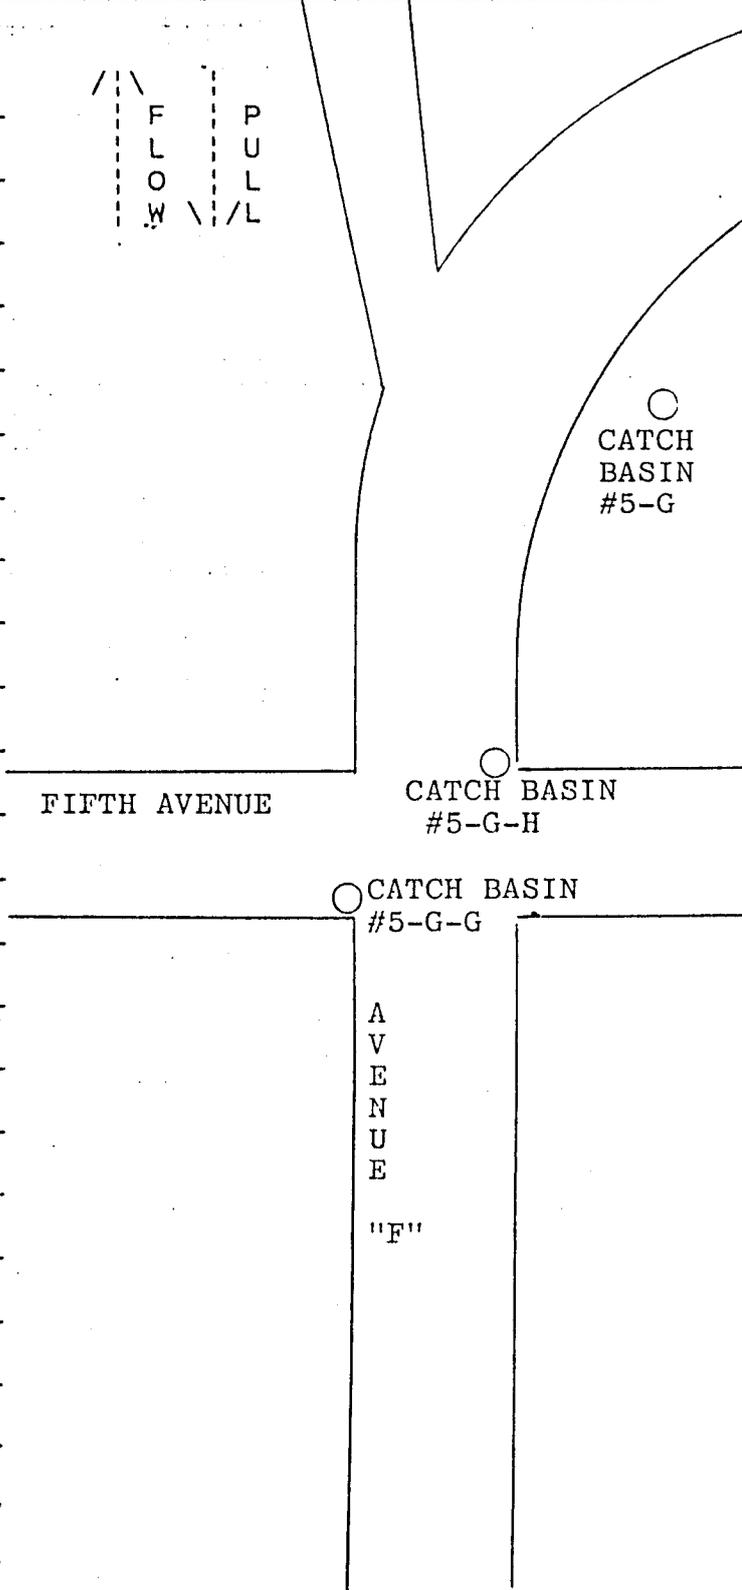
PIPE CONDITION: FAIR

REMARKS: PIPE SIZE ON TAPE READS 8"
SHOULD BE 12"

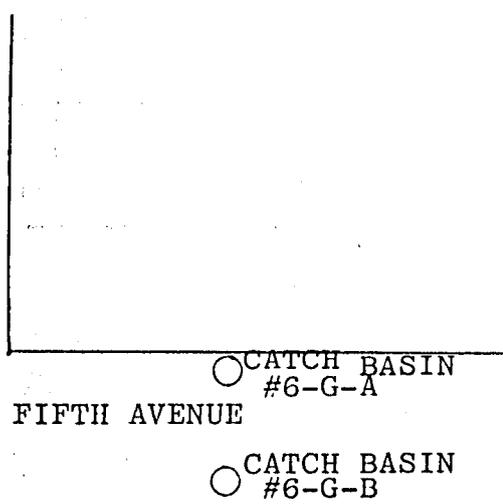
PIPE CONDITION: POOR - PIPE IS TOO DIRTY

GRADE: UNKNOWN - DUE TO PIPE CONDITION

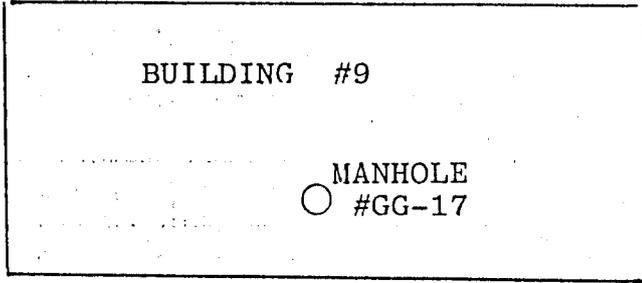
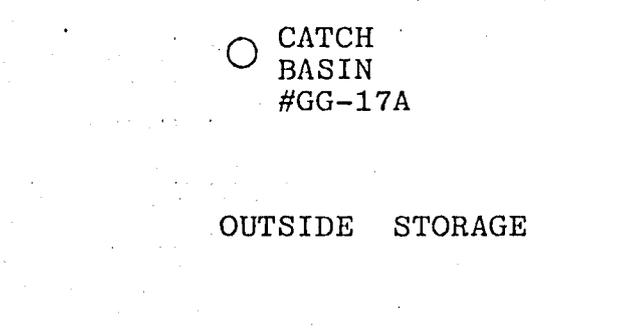
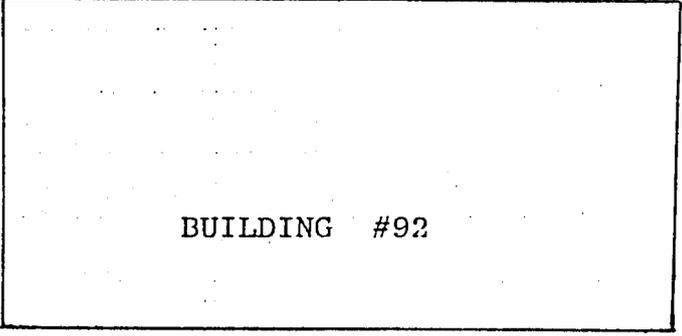
PIPE CONDITION: FAIR

REMARKS: LINE HAS MOTOR OIL AND

GREASE BUILTUP.
