THE NAVY'S UNDERESTIMATION OF
SOLVENT CONTAMINATION
AT THE MCAS EL TORO, CALIFORNIA

January 2000

**PES Environmental, Inc.
2030 East 4th Street, Suite 213
Santa Ana, California 92705**

The City of Irvine

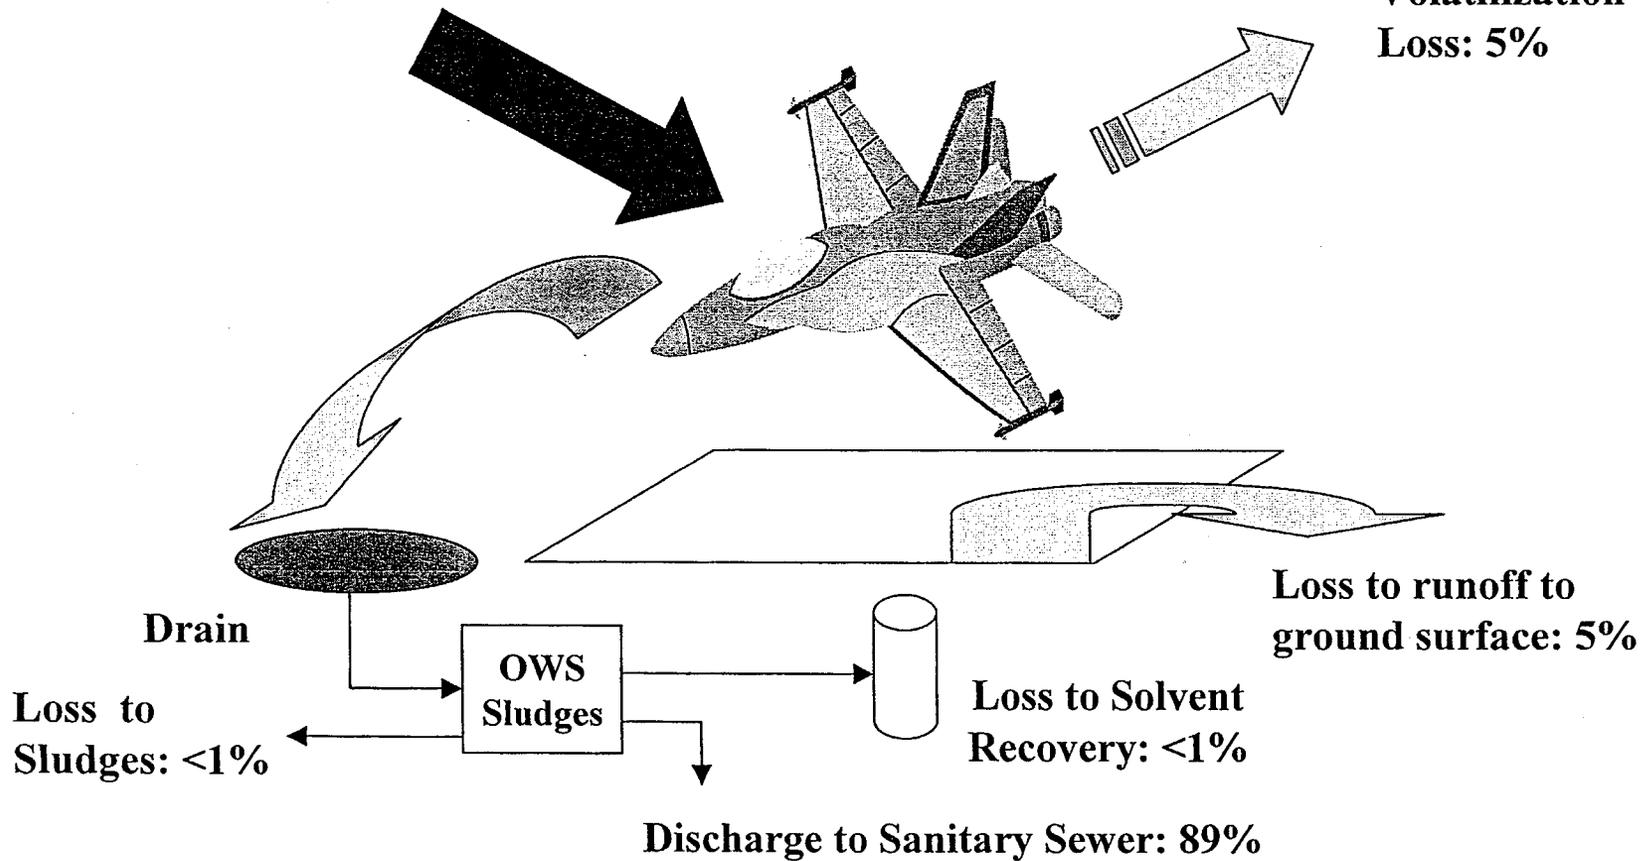
Aircraft Wash Process and Estimated Solvent Loss
MCAS, El Toro, California

- A 5 percent loss to the ground surface was assumed for aircraft wash processes. According to station records (Navy, 1991; Jacobs Engineering, 1995), the aircraft washing was typically conducted on engineered concrete aprons that were sloped to direct process rinsate to a drain (Navy, 1991; Jacobs Engineering, 1995). Station records indicate that run-off to the ground surface would have been incidental and relatively small resulting from inadvertent or misdirected flow, cracks in the concrete, or washings in unauthorized areas.

Volatilization
Loss: 5%

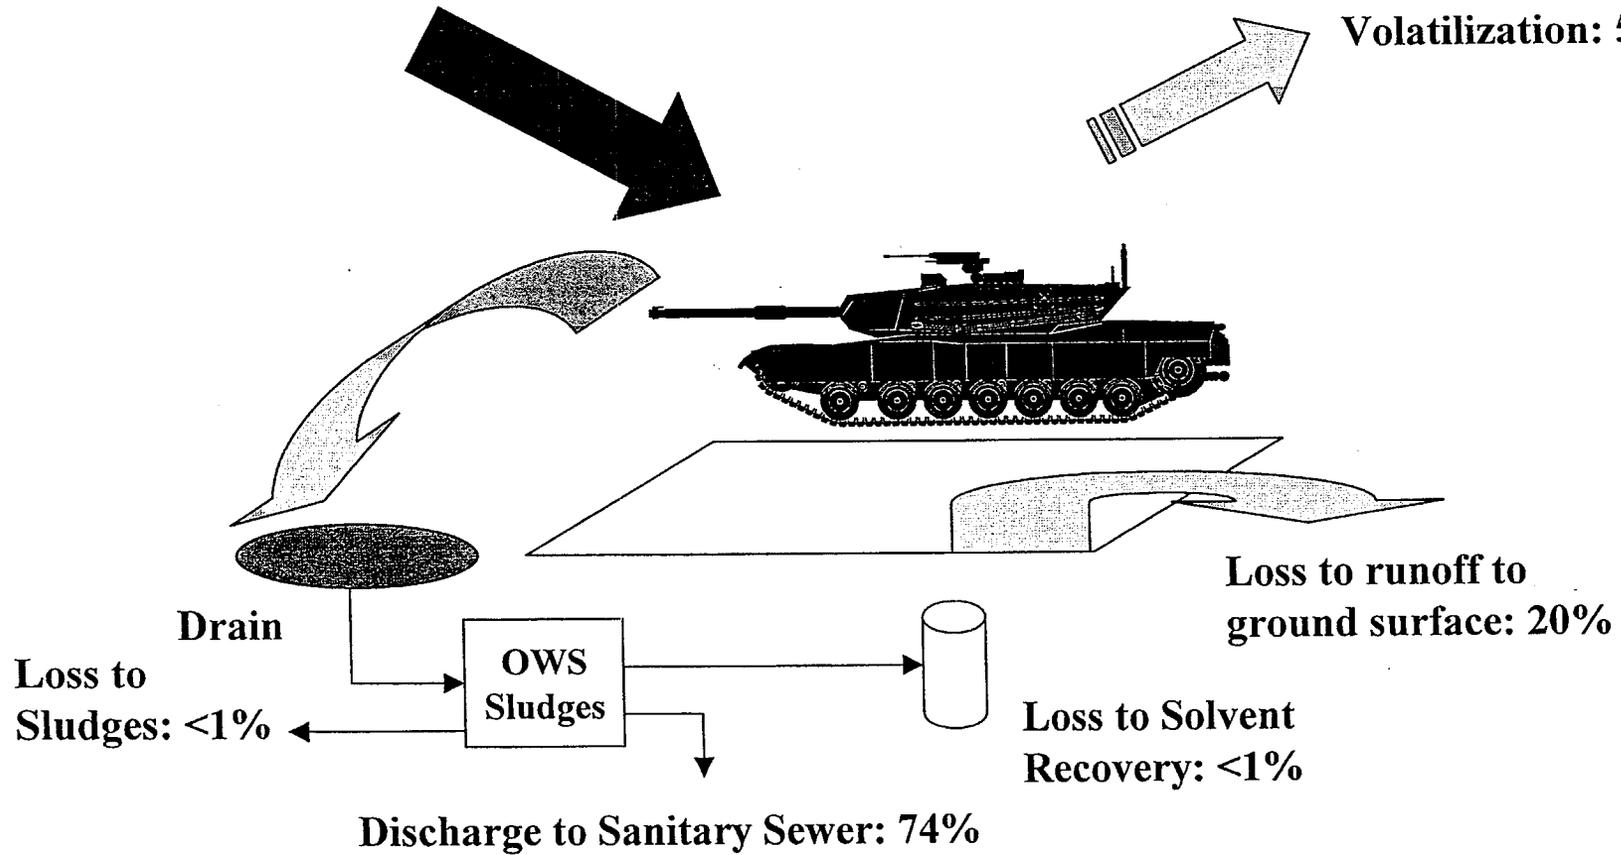
Vehicle Wash Process and Estimated Solvent Loss
MCAS, El Toro, California

Loss to
Volatilization: 5%

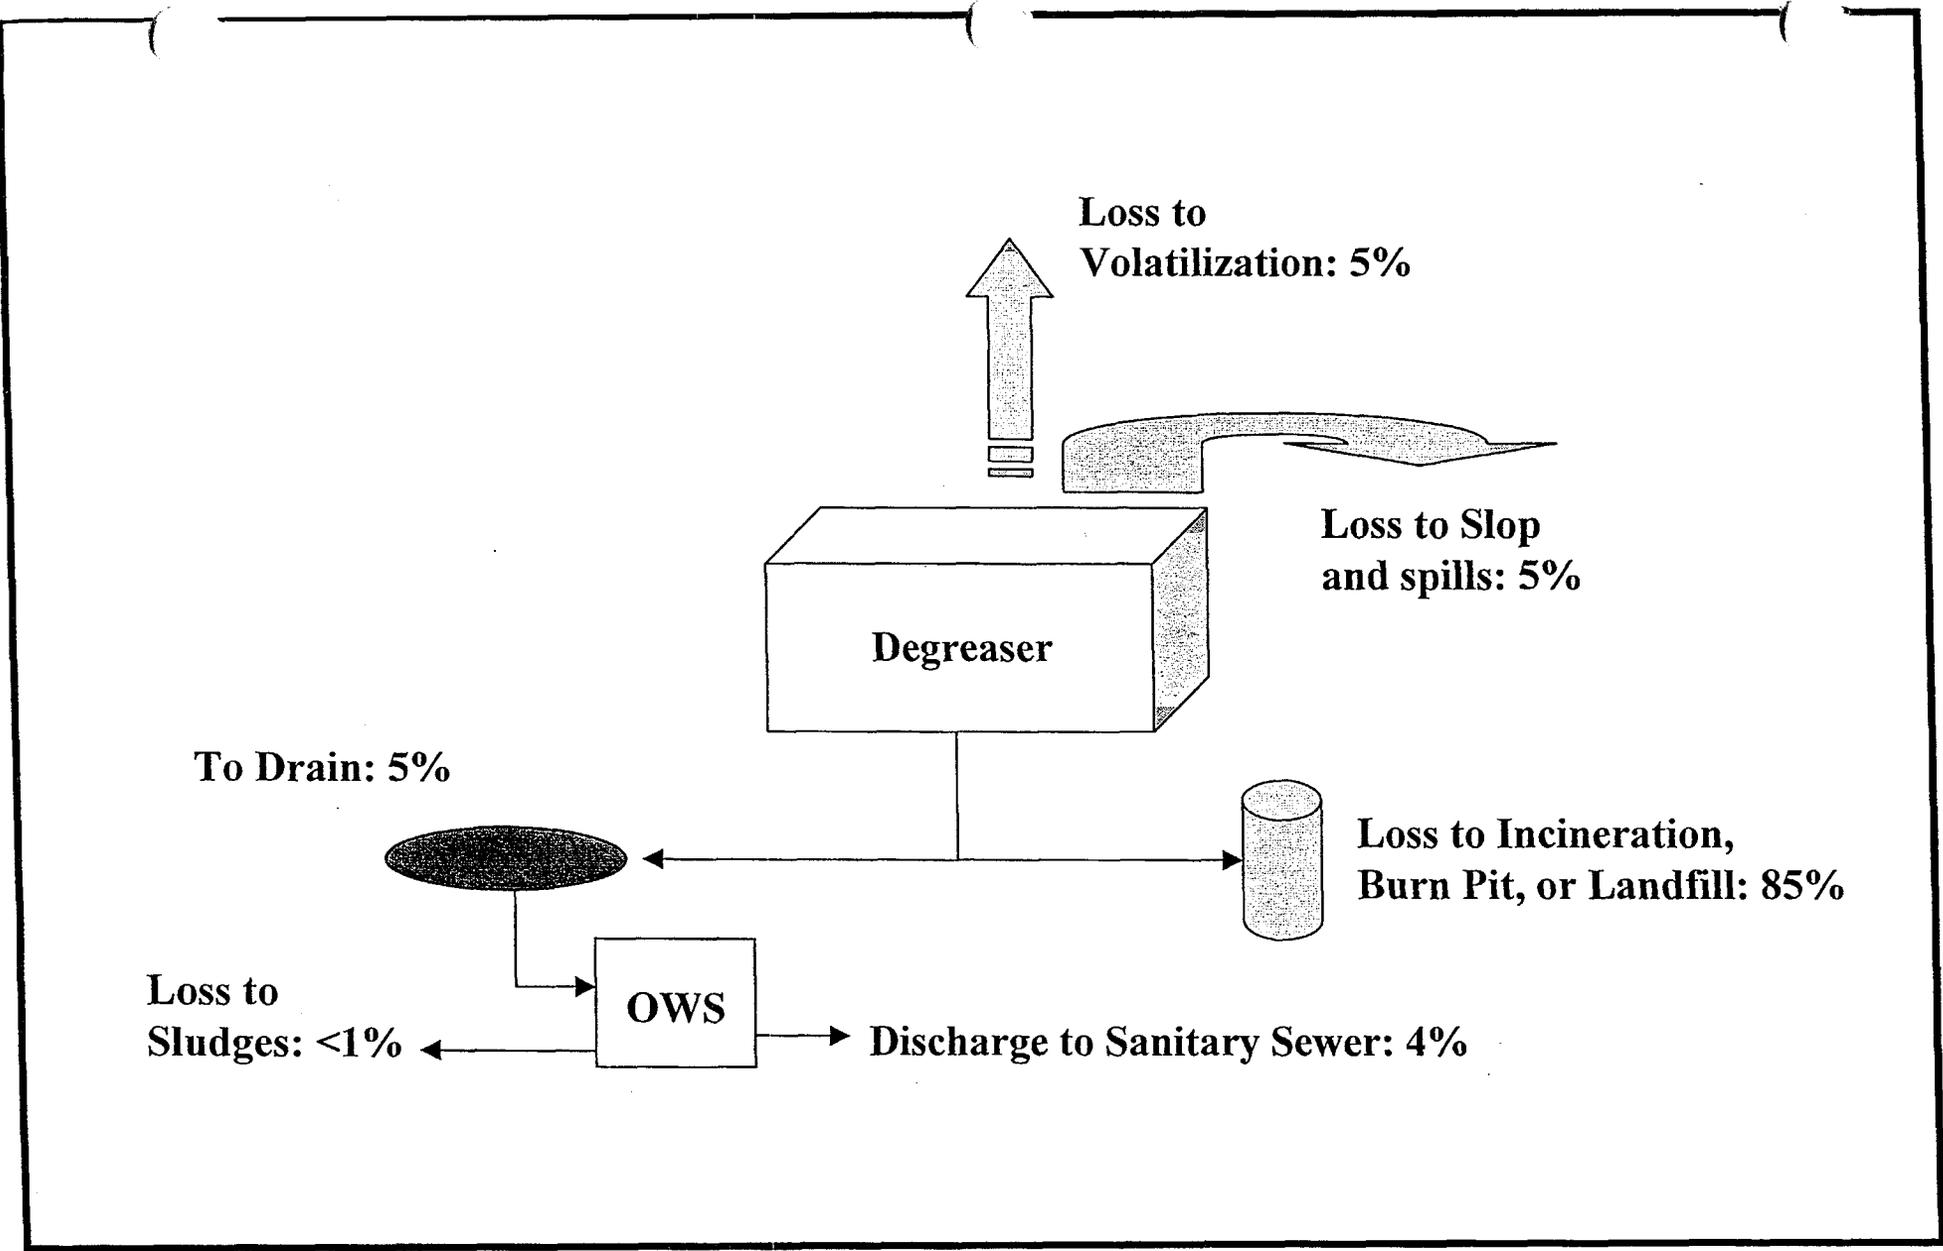
Degreasers and OWS and Estimated Solvent Loss
MCAS, El Toro, California

- A 5 percent loss was assumed for degreasing aircraft and vehicle repair parts. Considering the design and operation of large and bench-top degreasers, the low partial pressures of the VOCs in solvent solution, solution temperature and the degree of turbulence, PES believes the volatilization of the VOCs would have been minimal and is generally consistent with SCAQMD Rule 1122 (Solvent Degreasers).

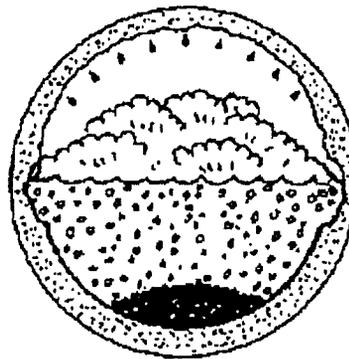
D. If pipe is of corrodible material, sulfuric acid attacks it causing ultimate failure. Vitriified clay pipe is chemically inert and not vulnerable to acid attack.
