Final Report
Aerial Photograph Assessment
MCAS El Toro
Contract No. N68711-91-D-4658
Delivery Order 0002
SAIC Project No. 01-0817-02-0817

August 2, 1993

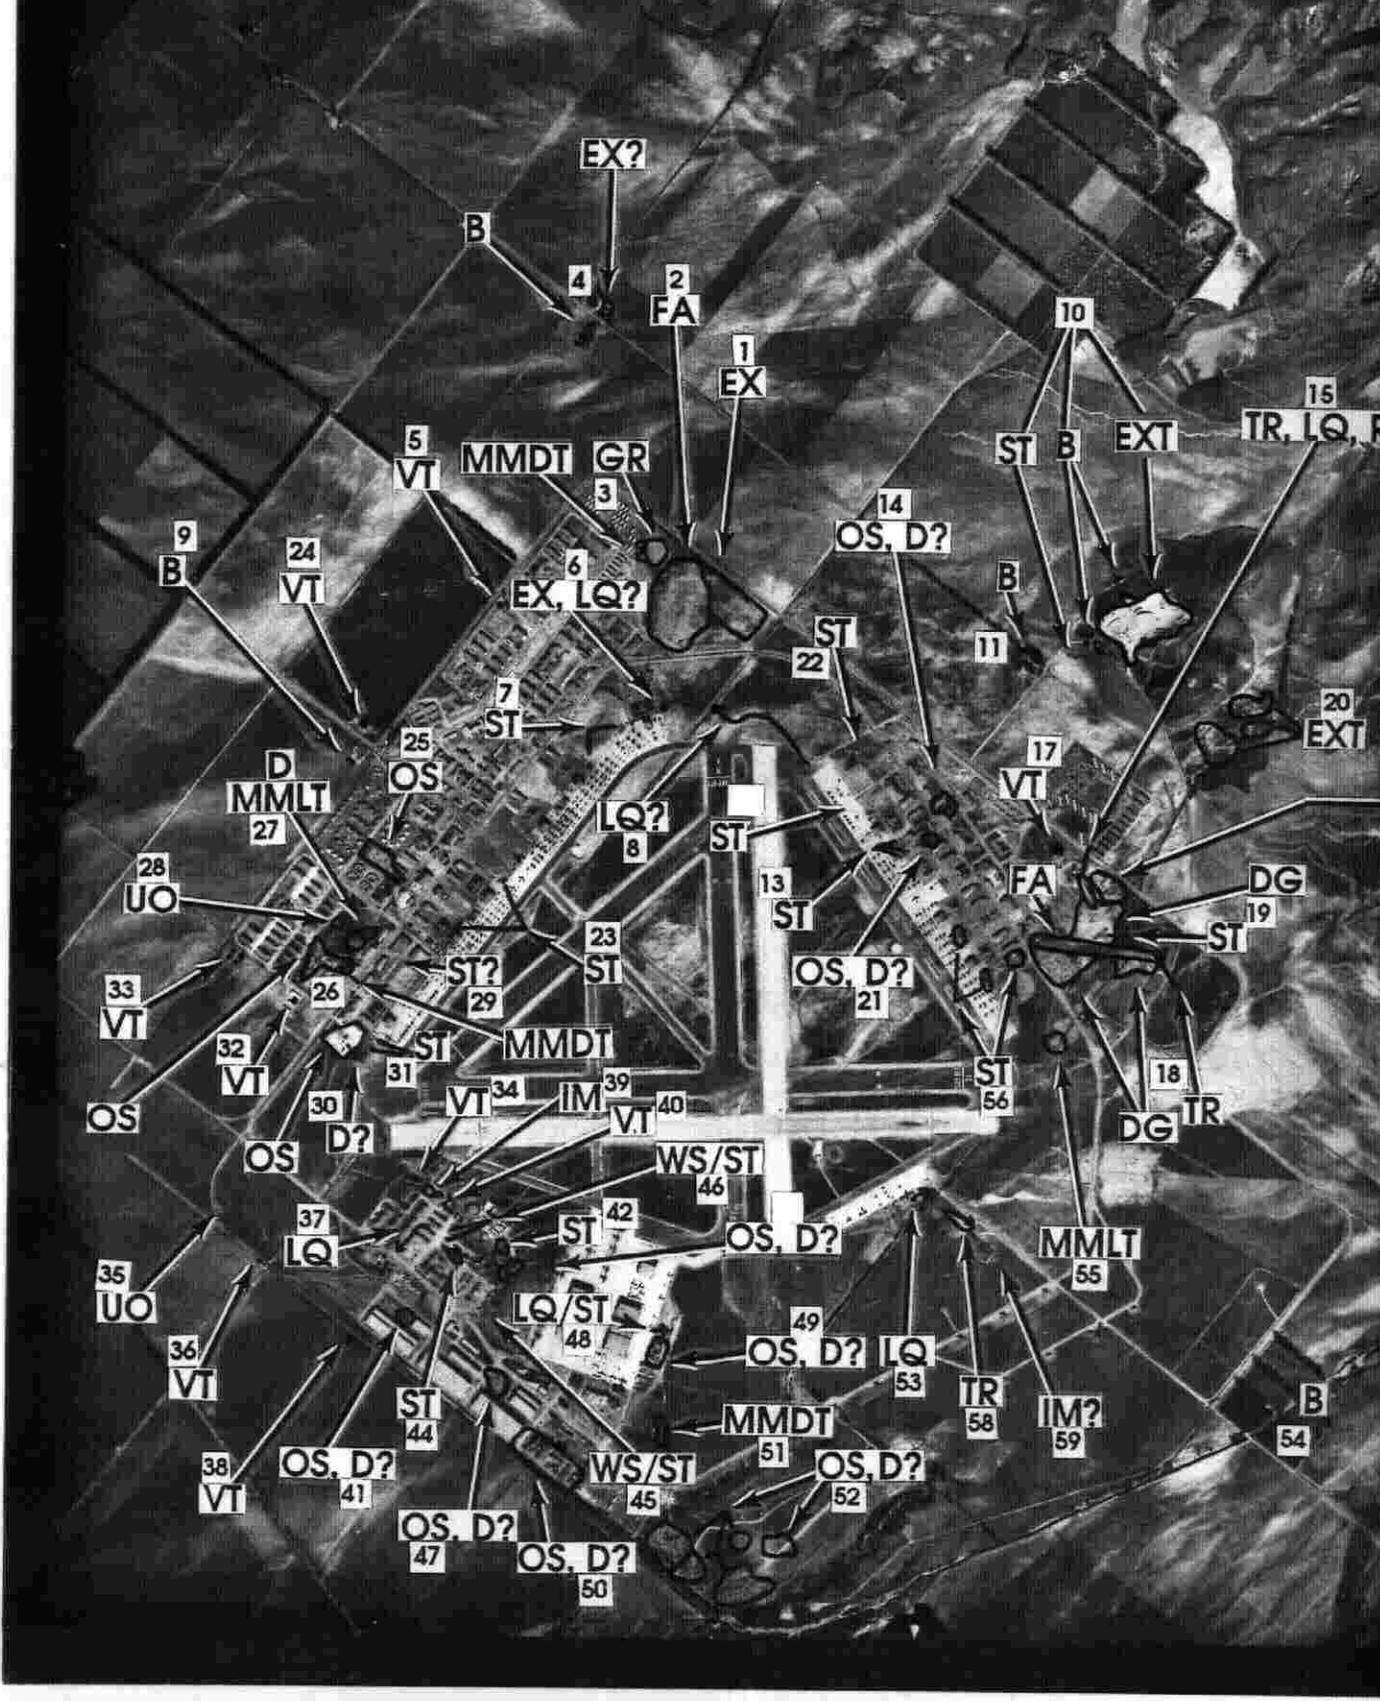
1946

c 1. An excavation (EX) about 400 feet wide by 500 feet long is noted beneath the present threshold area of Runway 16L. The purpose of the excavation is unknown, but may be an early, undocumented disposal area. The site history, or the site itself, should be investigated to determine if potential contaminants were disposed of in the excavation.

c 2. A fill area (FA) is located immediately west of the excavation (EX) discussed in the previous comment. The area appears to contain spoil material from the excavation. No additional investigation of the fill material is recommended at this time.

c 3. A circular graded (GR) area about 300 feet in diameter is located near the present Auto Hobby Shop (Building 625). Along the western border of the area is a dark-toned mound (MMDT) of unknown composition, but may be soil and vegetation debris from the grading. No additional investigation is recommended at this time.

c 4. Farm buildings (B) and a possible excavation (EX) are located on Irvine Boulevard, north of the activity. The buildings may contain fuel, solvents, pesticides, fertilizers, and other potential contaminants; the excavation may have been used to dispose of these materials. No additional investigation is recommended at this time, unless contamination is detected near, or downgradient of the site, in areas of interest to the IR program.

c 5. A vertical tank (VT) is noted at N 6th Street and D Street. This is probably Building 222 (Elevated Water Tank). No additional investigation is recommended at this time.

c 7. There are stains (ST) adjacent to the aircraft parking apron at N 6th Place and K Street, and at N 4th Place and K Street. Additional investigation of these sites is recommended.

c 8. A drainage channel (EX) with probable liquid (LQ) extends from the aircraft parking apron near the approach end of Runway 21 and into a drainage ditch near the approach end of Runway 16R. The channel probably controls runoff from the apron area, and may convey contaminated water. Additional investigation is recommended.

- c 9. Farm buildings (B) are noted adjacent to Trabuco Road, near Gate No.1. The buildings may contain fuel, solvents, pesticides, fertilizers, and other potential contaminants; the excavation may have been used to dispose of these materials. No additional investigation is recommended at this time, unless contamination is detected near, or downgradient of the site, in areas of interest to the IR program.

- c 10. A large quarry (EXT) with apparent support buildings (B) and stains (ST) are located northwesterly of the present residential area of the activity. The buildings may be the site of fuel, oil and solvent use and storage. No additional investigation is recommended at this time, unless contamination is detected near, or downgradient of the site, in areas of interest to the IR program.

- c 11. Farm buildings (B) are located adjacent to Irvine Boulevard, southwest of the quarry. The buildings may contain fuel, solvents, pesticides, fertilizers, and other potential contaminants; the excavation may have been used to dispose of these materials. No additional investigation is recommended at this time, unless contamination is detected near, or downgradient of the site, in areas of interest to the IR program.

- c 12. There are stains (ST) adjacent to the aircraft parking apron in the vicinity of the present site of Building 605, near N 8th Street and M Street. Additional investigation of the site is recommended.

- c 13. There are soil stains (ST) in the area southwest of Building 292, near N 8th Street, between N Street and M Street. The stains appear to result from flowing liquids. Additional investigation is recommended.

- c 14. An open storage (OS) area on the northerly side of Building 136, between N 9th Street and North Marine Way, and between N Street and O Street, may contain drums (D). Additional investigation of the site is recommended.

- b 16. Light-and dark-toned mounded material (MMLT and MMDT) occur on the easterly side of the trench (TR) noted in the previous comment. The materials are unidentified, but may be construction debris. The areas appears to extend beyond the limits of the present IR program field investigation. Expansion of the investigation area is advised.

- a 17. Vertical tank (VT) is Tank 293, Water Reservoir. No additional investigation is recommended.

b 19. There is a large area of stained (ST) soil in the vicinity of the Original Landfill (DG). The Site 3 investigation appears to encompass the area; no additional investigation is recommended at this time.

c 20. There are three areas of apparent extraction (EXT) at the mouth of Agua Chinon Wash. These areas may have been used for waste disposal. Additional investigation is recommended if contamination is detected near, or downgradient of the site, in areas of interest to the IR program.

c 21. An open storage (OS) area on the northwest side of Building 120, near N 8th Street and O Street, contains possible drums (D). Additional investigation is recommended.

c 22. Probable soil stains (ST) occur in the southwestern portion of Tank Farm No. 4, near N 8th Street and O Street. Additional investigation is recommended.

a 23. There are stains (ST): adjacent to the aircraft parking apron about 200 feet northeast of Building 12; at S 1st Street and K Street; and between Buildings 10 and 11, on S 4th Place.

c 24. Seven (7) possible vertical tanks (VT) are noted on the north side of Trabuco Road, west of Gate No. 1. These may be silos, however, the existence and use of the suspected tanks should be verified, and if necessary, the area investigated.

c 26, a 27, and c 28. These sites are located on the northwesterly sides of Buildings 25, 27, 29, and 31 between S 5th and S 8th Streets and G Street and West Marine Avenue. The area contains open storage (OS) areas with possible drums (D), light- and dark-toned mounded material (MMLT and MMDT), unidentified materials, and unidentified objects (UO) that may be mounds or drums. Additional investigation of these areas is recommended.

a 29. There appears to be stained (ST) soil on the southwest side of Building 241, near S 5th Street and West Marine Way. Additional investigation is recommended.

- c 30. An open storage (OS) area with possible drums (D) is located on the southwest side of Building 246, near S 8th Street and West Marine Way. Additional investigation is recommended.

- b 31. There is stained (ST) soil on the southeast side of Building 246, near S 8th Street and West Marine Way. Additional investigation is recommended.

- c 32. A probable vertical tank (VT) is located about 400 feet southwest of Building 31, near S 8th Street and West Marine Way. There also appears to be soil staining (ST) or wet soil (WS) at the base of the tank. Verification of the tank and possible contents is recommended.

- c 33. There is a probable vertical tank (VT) on the southwest side of Building 249, near S 8th Street and D Street. Verification of the tank and its possible contents is recommended.

- c 34. A probable vertical tank (VT), possibly Tank 155, is located near S 11th Street and L Street. Verification of the tank and its contents is recommended.

- c 35. An unidentified object (UO), possibly a vertical tank (VT) or mound (M) is noted on the north side of Perimeter Road, about 800 feet northwest of Bee Canyon Wash. Additional investigation is recommended.

- c 36. There appears to be a vertical tank (VT) near the railroad tracks at the Bee Canyon Wash crossing. Verification of the tank and its contents is recommended.

- a 37. There is liquid (LQ) flowing southwesterly from the southwest side of Building 132, near S 14th Street, between M and N Streets. Additional investigation is recommended.

- c 38. There appears to be a vertical tank (VT) adjacent to the railroad tracks about 250 feet southwest of Building 317. Verification of the tank and its contents is recommended.

- c 39. Two impoundments (IM) can be observed on the southwest side of Building 306, near S 11th Street and L Street. Investigation of the impoundments' uses is recommended.

- a 40. There are two vertical tanks (VT) on the northeast side of Building 306, near S 11th Street and L Street. Investigation of the tanks' contents is recommended.

- b 41. There is an open storage (OS) area, possibly with drums (D), on the westerly side of Building 320, near S 15th Street and O Street. Additional investigation is recommended.

- b 42. There are soil stains (ST) beneath the present aircraft parking apron about 500 feet southeast of Tank 174. Additional investigation may be advisable.

- b 43. Open storage (OS) areas with possible drums (D) are noted about 700 and 1000 feet southeast of Tank 174, beneath the present aircraft parking apron. Additional investigation may be advised.

- c 44. There are soil stains (ST) in an open storage (OS) area now occupied by Buildings 386 and 1389, about 350 feet northeast of Building 368 (Public Works). Additional investigation is advisable.

- b 45. There is wet soil (WS) or stains (ST) in the open storage (OS) area about 500 feet northwest of Building 322 (Mess Hall). Additional investigation is advisable.

- c 46. There is wet soil (WS) or stains (ST) in the area now occupied by the southwest corner of Building 1389, and in the open storage (OS) area about 200 feet northwest of Building 1389. Additional investigation is be advisable.

- c 47. There is an open storage (OS) area with possible drums (D) near the approximate location of Building 359, near South Marine Way and P Street. Additional investigation is recommended.

- b 48. There appear to be stains (ST) caused by liquids (LQ) flowing easterly from the aircraft parking apron about 200 feet east of Building 296 (hangar). Additional investigation is recommended.

- b 49. There may be drums (D) in an open storage (OS) area about 200 feet east of Building 296 (hangar). Additional investigation is recommended.
- c 50. There is an open storage (OS) area at the present location of Building 360, near South Marine Way, between Q and R Streets. Additional investigation may be advisable.

- c 51. Dark-toned mounded material (MMDT) can be seen adjacent to the drainage ditch between Perimeter Road and the southeast corner of the aircraft parking apron. The mounds appear to be soil related to maintenance of the ditch. No additional investigation is recommended at this time.

c 53. Liquid (LQ) can be seen flowing from a former hangar (?) near the northeast end of the aircraft parking apron on the northerly side of the present ACER site (Site 19). The liquid (LQ) discharges into a drainage ditch from a small building behind the former hangar. The flow appears to be significant and additional investigation is recommended.

c 54. There are farm buildings (B) near Perimeter Road and Borrego Canyon Wash, near Gate No. 3 on Trabuco Road. The buildings may contain fuel, solvents, pesticides, fertilizers, and other potential contaminants. Additional investigation is recommended if contamination is detected near the site, or downgradient of the site, in areas of interest to the IR program.

c 55. There is light-toned mounded material (MMLT) adjacent to the drainage ditch between North Marine Way and the approach end of Runway 25R. The material appears to be soil associated with construction or maintenance of the ditch. The ditch drains the Original Landfill (Site 3) area, and is intersected by one of the trenches. Investigation of the mounded soil and ditch is recommended.

c 56. Soil stains (ST) can be observed: on the southeast side of Building 125, near S Place and N 9th Street; at the edge of the aircraft parking apron about 200 feet northwest of Tank Farm No. 6; and near the present location of Buildings 697 and 642, near N 8th Street and S Street. Additional investigation is recommended.

b 57. No activity was noted at either the Magazine Road Landfill (Site 2), or the Communication Station Landfill (Site 17).

c 58. A trench (TR), possibly for drainage, can be seen northwest of the former building, located about 800 feet west of East Marine Way and El Toro Boulevard. Additional investigation is recommended.

c 59. There is a probable impoundment (IM) or storage tank of some sort southeast of the building indicated in the previous comment. The object appears to be a square-shaped, bermed area with impounded liquid or a square-shaped object on top of the mound. Additional investigation is recommended.

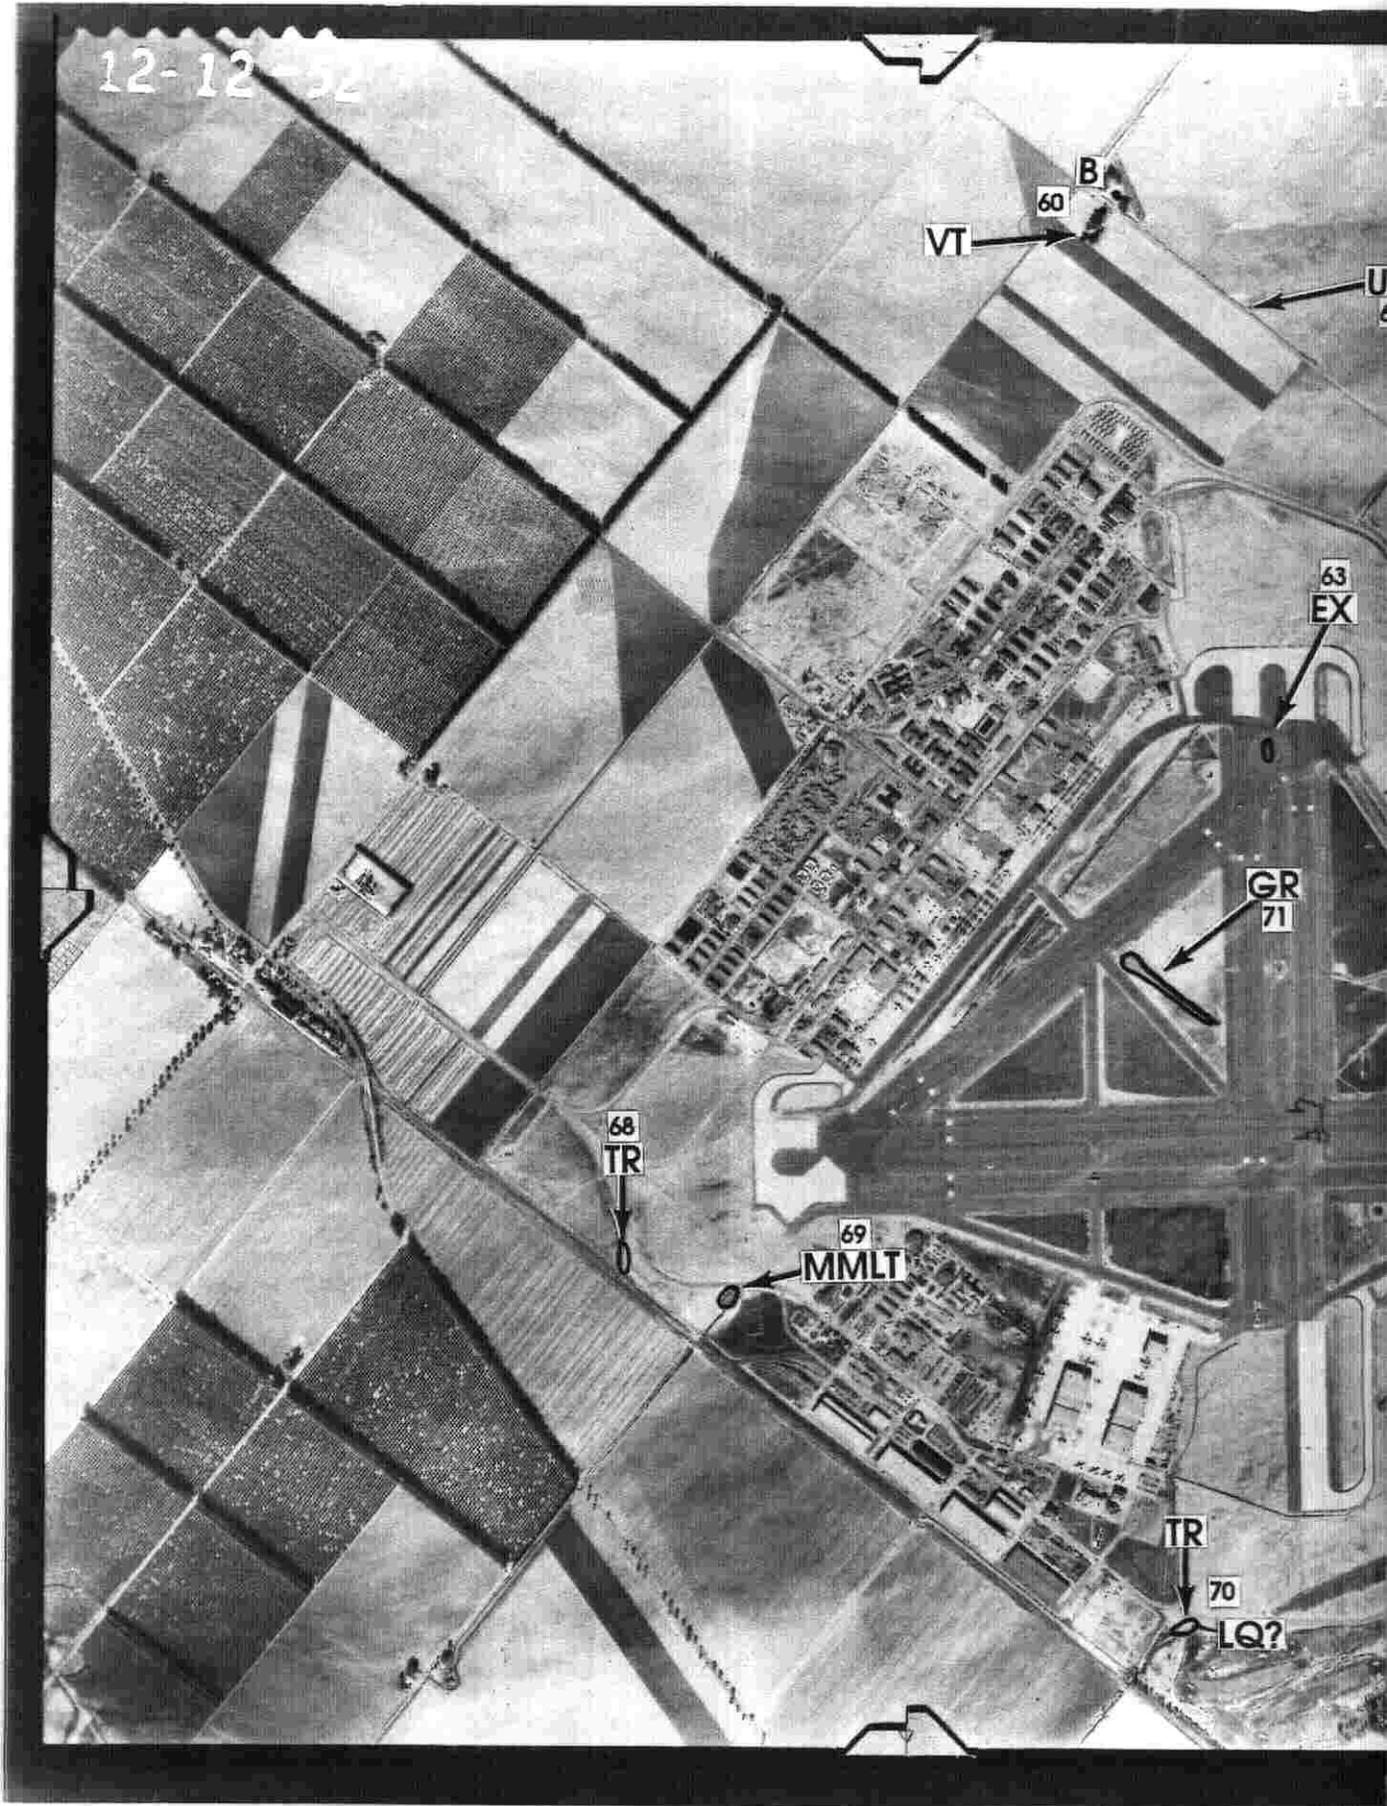
1952

c 60. Farm buildings (B) are noted at Irvine Road and Range Road. There are probable vertical tanks (VT) about 500 feet southerly of intersection. Farm buildings and probable vertical tank may contain fuels, solvents fertilizers, pesticides or other chemicals. Investigation is recommended if contaminants are detected near or downgradient of the site, in areas of interest to the IR program.

c 61. There is an unidentified object (UO) on north side of Irvine Road, about 2000 feet southeast of Range Road that may be a mound. Additional investigation is not recommended at this time.

c 62. There is a large quarry (EXT) with numerous support structures on northwest and southwest sides. Heavy equipment is probably used and maintained at the site, and therefore, fuel, oil and solvent use and storage are likely. Additional investigation is recommended if contaminants are detected near the site, or downgradient of the site, in areas of interest to the IR program.

c 65. The MCAS El Toro residential area is under development with extensive grading (GR) and earthmoving. Additional investigation is not recommended at this time.
