2.4 1958 PHOTOGRAPHS

Aerial Photographic Interpretation
 MCAS El Toro
 Santa Ana, California
 1960

Figure 6

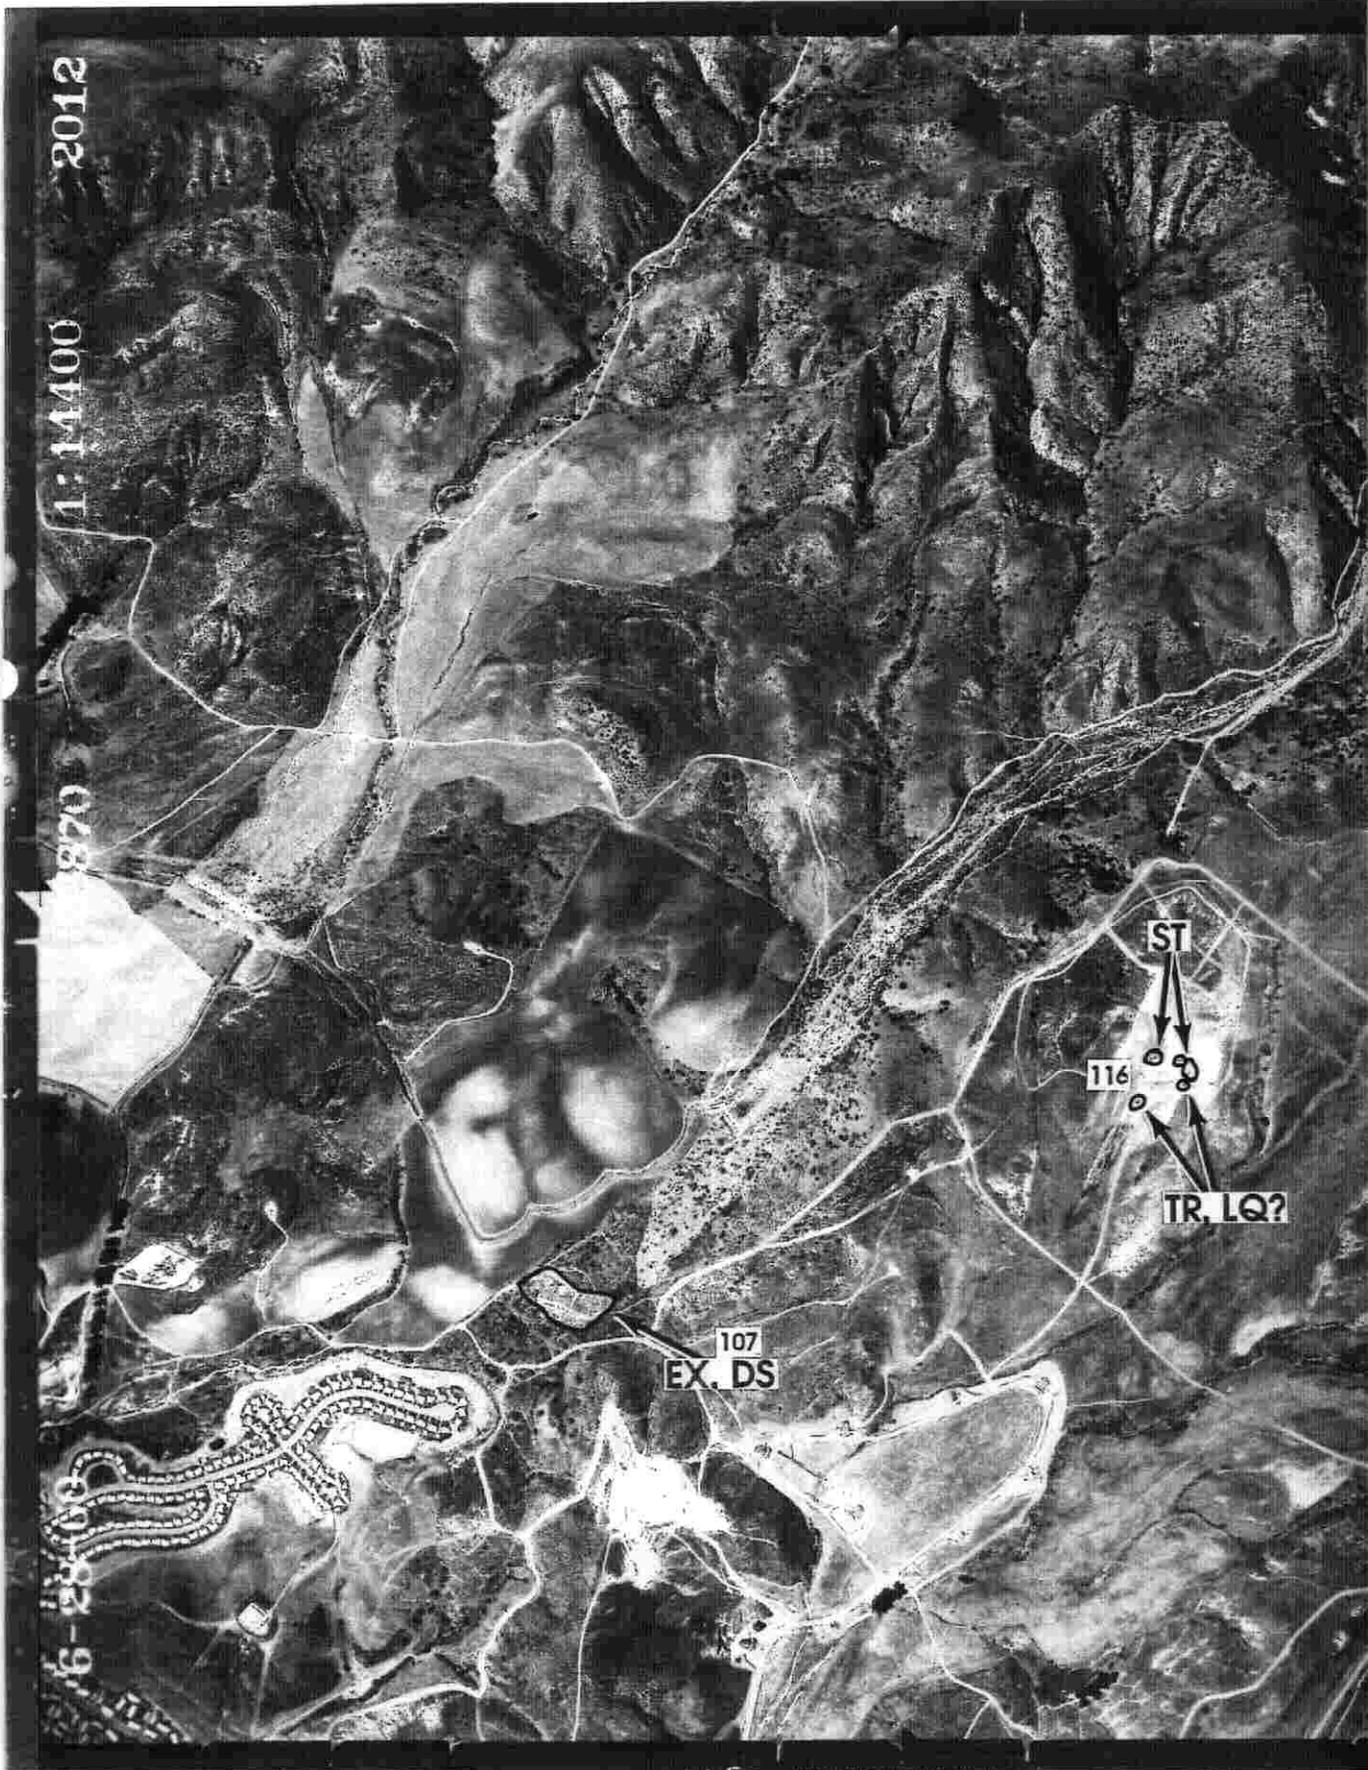
Figure 6

c 99. Several buildings (B) with unknown purposes are noted along westerly border of the Rifle Range area. There is disturbed ground (DG) along westerly side of Range Road, near the center of the range. It appears to be earthwork with the purpose unknown. There is an impoundment (IM) with possible wet soil (WS) at the northeast corner of the range. There is disturbed ground (DG) adjacent to northeast corner of range, that is probably construction related. Disturbed ground (DG) with a probable excavation (EX) can be seen about 200 feet northerly of range; this is a possible disposal site. Additional investigation of the possible disposal site is recommended.

c 100. Disturbed ground (DG) with a possible excavation (EX) or trench (TR) is located about 1800 feet east of the Rifle Range. Additional investigation is recommended.

c 101. Excavation (EX) and stain (ST) or wet soil (WS) are located at the southwest edge of Rodeo Area. They may be related to earthmoving or manure spreading. The dark-toned mounded material (MMDT) may be hay or manure piles. The purpose of excavation is unknown, but may be a disposal site. Additional investigation of the excavation may be advisable.

c 102. Possible drums (D) are located on the northeast side of Building 415, located easterly of the Rodeo Area. Additional investigation is recommended.

c 103. Several features can be observed at the South Coast Agriculture Field Station. There is a vertical tank (VT) in westerly corner of the developed support area. There are several buildings (B) with unknown purposes. There is an impoundment (IM) with liquid (LQ), probably irrigation water at the northeast corner. Due to the type of land use, fuel, solvents, pesticides, fertilizers, and other chemicals were probably used and stored at the site. Additional investigation is recommended if contamination is detected in the site area or downgradient of the site, in areas of interest to the IR program.

c 105. Stains (ST) or wet soil (WS) can be seen in the cleared areas on the northeast and southeast sides of Rodeo Area complex. Additional investigation may be advisable.

been cleared (GR), possibly for cultivation. Additional investigation of the site history for possible use as a disposal or waste storage site is recommended.

c 107. Excavation (EX) and disturbed ground (DG) are noted in Agua Chinon Wash, about 600 feet northeast of the residential area. A berm, possibly for water diversion, is partially constructed across the wash. Additional investigation of the site history as a possible disposal site is recommended.

c 108. Home sites are located at the mouth of Bee Canyon. Several buildings (B), a vertical tank (VT), probably for water supply, and a probable excavation (EX) are noted. Additional investigation is not recommended unless contamination is detected in the area, or downgradient of the site. The agricultural nature of the area suggests that fuels, chemicals, pesticides, fertilizers, and other potential contaminants may have been used or stored at the sites.

c 109. Two (2) vertical tanks (VT) can be seen at the easterly end of the support area for the large quarry that was noted above. Verification of the tanks and their contents is recommended, as is additional investigation if contaminants are detected downgradient of the site, in areas of interest to the IR program.

c 110. Possible stains (ST) or wet soil (WS) can be seen extending northwest - southeast across field located westerly of El Toro Marine School. Additional investigation is not recommended at this time.

c 111. There is an unidentified object (UO) at the corner of Q Street and N 9th Street that may be an incinerator chimney. Investigation of the site history is recommended.

c 112. There is a trench (TR) at the intersections of Runways 16L, 16R and 21. Additional investigation is not recommended at this time.

c 113. Stains (ST) can be seen at the edge of aircraft parking apron, adjacent to Building 99, near N 4th Place and K Street, and near N 1st Place and K Street, and near the southerly end of Building 624, at J Street and N 6th Place. Additional investigation is recommended.

c 115 There is probable wet soil (WS) and liquid (LQ) is flowing from the open storage (OS) area on the northeast side of N 4th Place. The liquid discharges into the ditch noted in the previous comment.

c 116. At the EOD Range (Site 1) there are several stains (ST) and a trench (TR) with probable liquid (LQ). This area is not shown on the photograph. There are no other significant changes. The current IR program field investigation Site 1 is probably

adequate, relative to the features noted here.

c 117. There is a possible stain (ST) around abandoned Compass Rose No. 1, near K Street and N 1st Place. Additional investigation is recommended.

c 118. There are two (2) unidentified objects (UO) about 370 feet southwest of Compass Rose No. 1. Additional investigation is recommended to identify the objects.

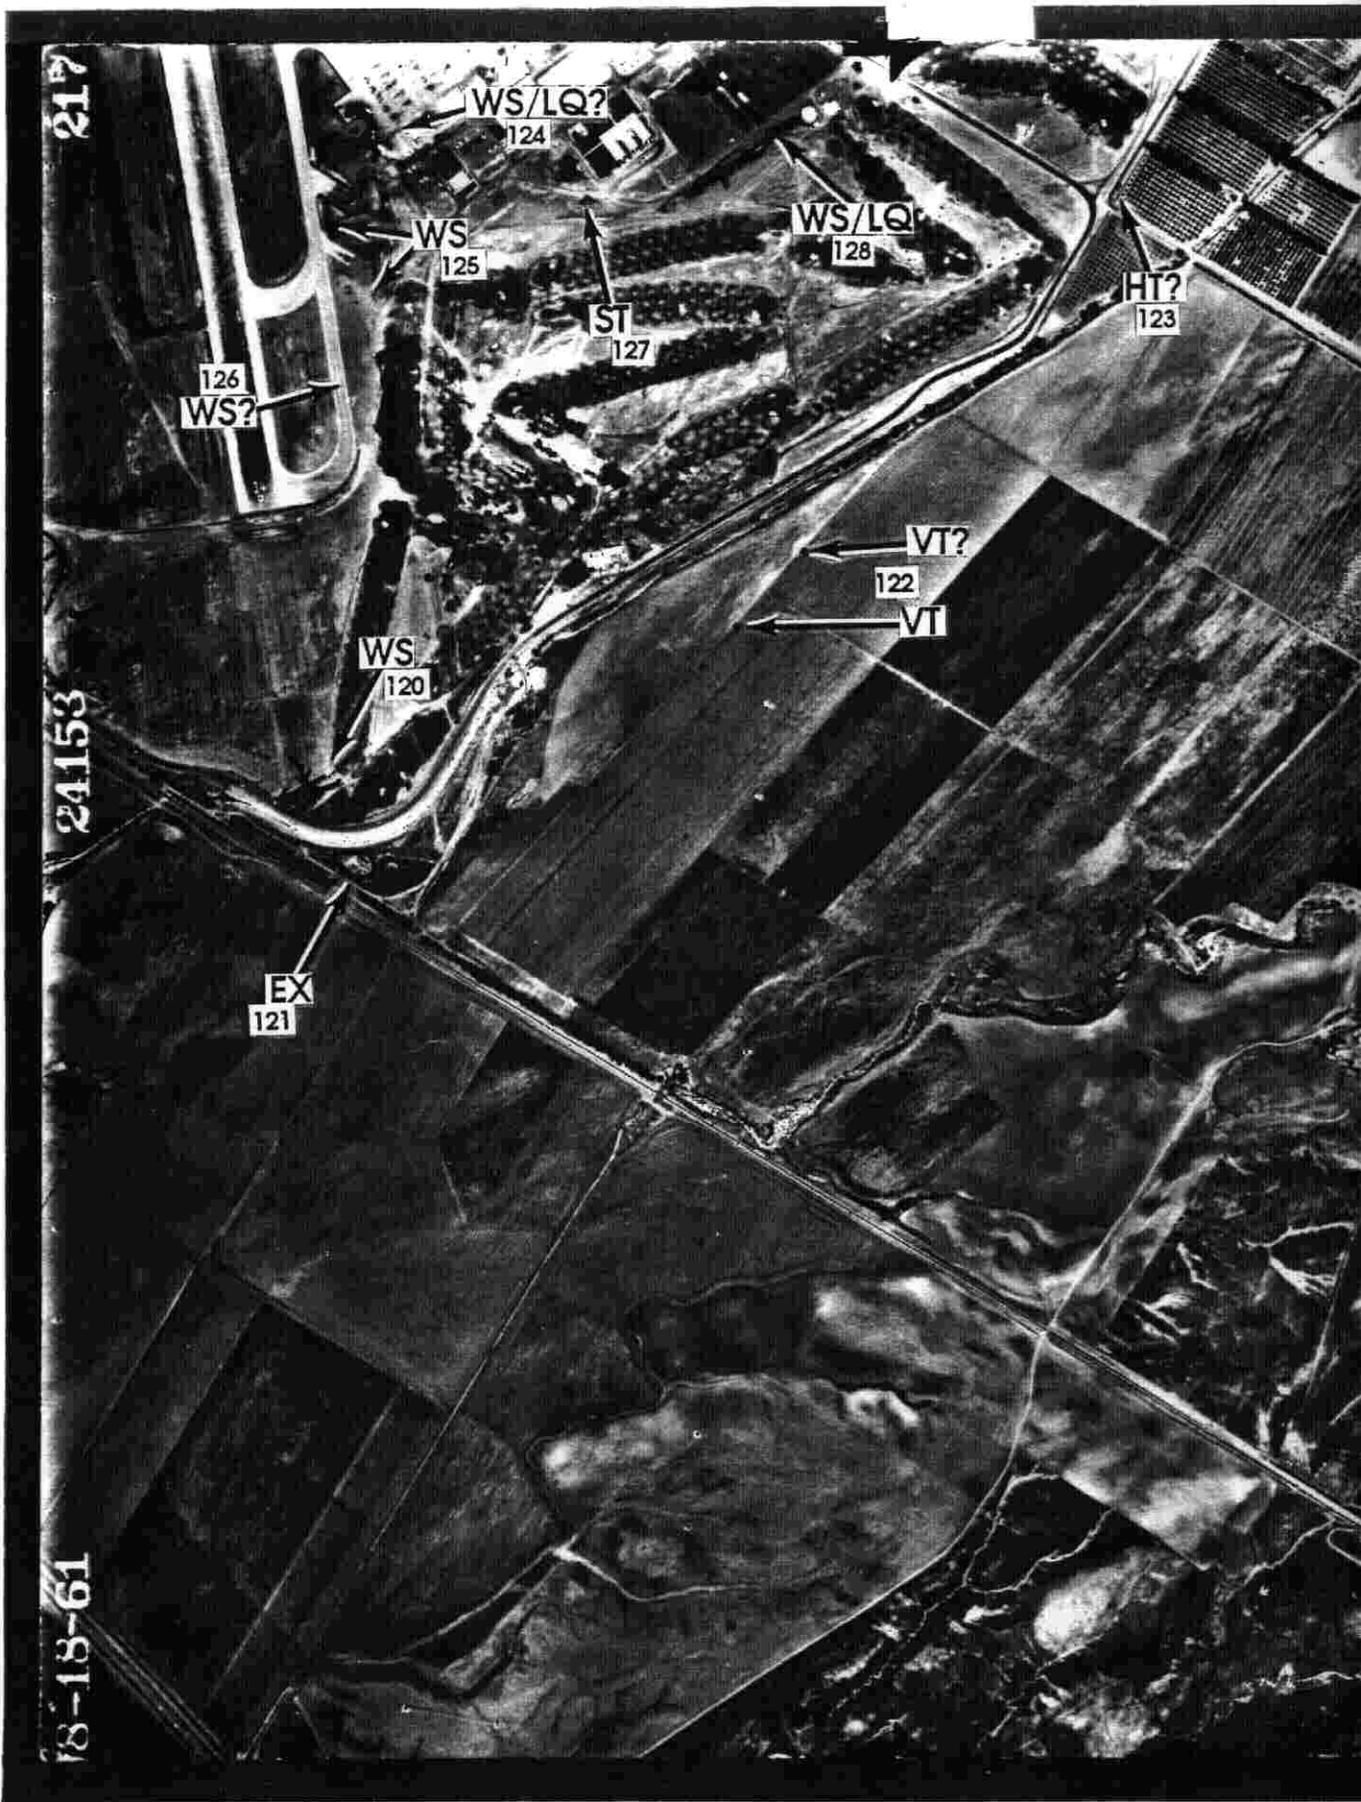
Figure 7
 Sheet 2 of 2
 August 18, 1961
 Photo Number C-24153, 217
 Source: Whittier College,
 Whittier, California

c 120. Possible wet soil (WS) can be seen, and liquid (LQ) is flowing southwestward from Marine Memorial Golf Course, south of threshold of Runway 34R. The apparent wet soil (WS) may be caused by vegetation and irrigation of golf course. No additional investigation is recommended at this time.

c 121. Excavation (EX) with possible extraction (EXT) is noted on the south side of Perimeter Road, at the southern tip of the activity. Investigation of site history as a possible disposal area is recommended.

c 122. There are possible vertical tanks (VT) in the field south of Marine Memorial Golf Course, located about 400 and 600 feet southeast of Perimeter Road. They may be chemical storage tanks or related to irrigation system. Verification of the vertical tanks and determination of their contents are recommended.

c 123. There is a probable horizontal tank (HT) about 100 feet north of Trabuco Road, east of Perimeter Road. Verification of the tank and its contents is recommended.

c 125. Wet soil (WS) can be seen on the east side of the taxiway south of Drop Tank Drainage Area No. 1 (Site 6). Expansion of the Drop Tank Drainage Area No.1 (Site 6) field investigation program to include this area is recommended.

c 126. There is wet soil (WS) on the east side of the taxiway south of the Drop Tank Drainage Area No. 1 (Site 6), adjacent to the fairway for the 14th hole of the Marine Memorial Golf Course. The cause of the wetting is probably golf course irrigation water. However, expansion of the Drop Tank Drainage Area No.1 (Site 6) field investigation program to include this area is recommended.

c 127. A stain (ST) or wet soil (WS) can be seen on the south side of S 6th Street and Z Street, about 200 feet southwest of Building 457. Additional investigation of this feature may be advisable.

c 128. There are wet soil (WS) and liquid (LQ) flowing southwesterly from Tank 459, about 400 feet westerly of El Toro Road and Z Street. It is probably drainage from the water storage facility and related to maintenance. No additional investigation is recommended at this time.

c 129. There is an impoundment (IM) and six (6) vertical tank (VT) near South Marine Way, S 15th Street and Plant Road. Verification of the tanks and determination of their contents are recommended. The Sludge Drying Beds (Site 12) investigation area should be expanded to include this area.

c 130. Stains (ST) and disturbed ground (DG) occur near the northerly and easterly sides of Building 1585, located about 200 feet north of the Mess Hall (Building 322). The site appears to be parking area. Review of site the history is recommended.

b 131. Liquid (LQ) appears to be flowing from hangar (Building 296) at the southeast corner of the aircraft parking apron. The flow discharges into the ditch east of the apron. Investigation of the ditch is advisable.

b 132. There are stains (ST) in the proximity of Building 1749, near South Marine Way and R Street. The site may not be wholly contained within the DRMO Storage Yard investigation area. Because the staining persists for several years, additional investigation is recommended.

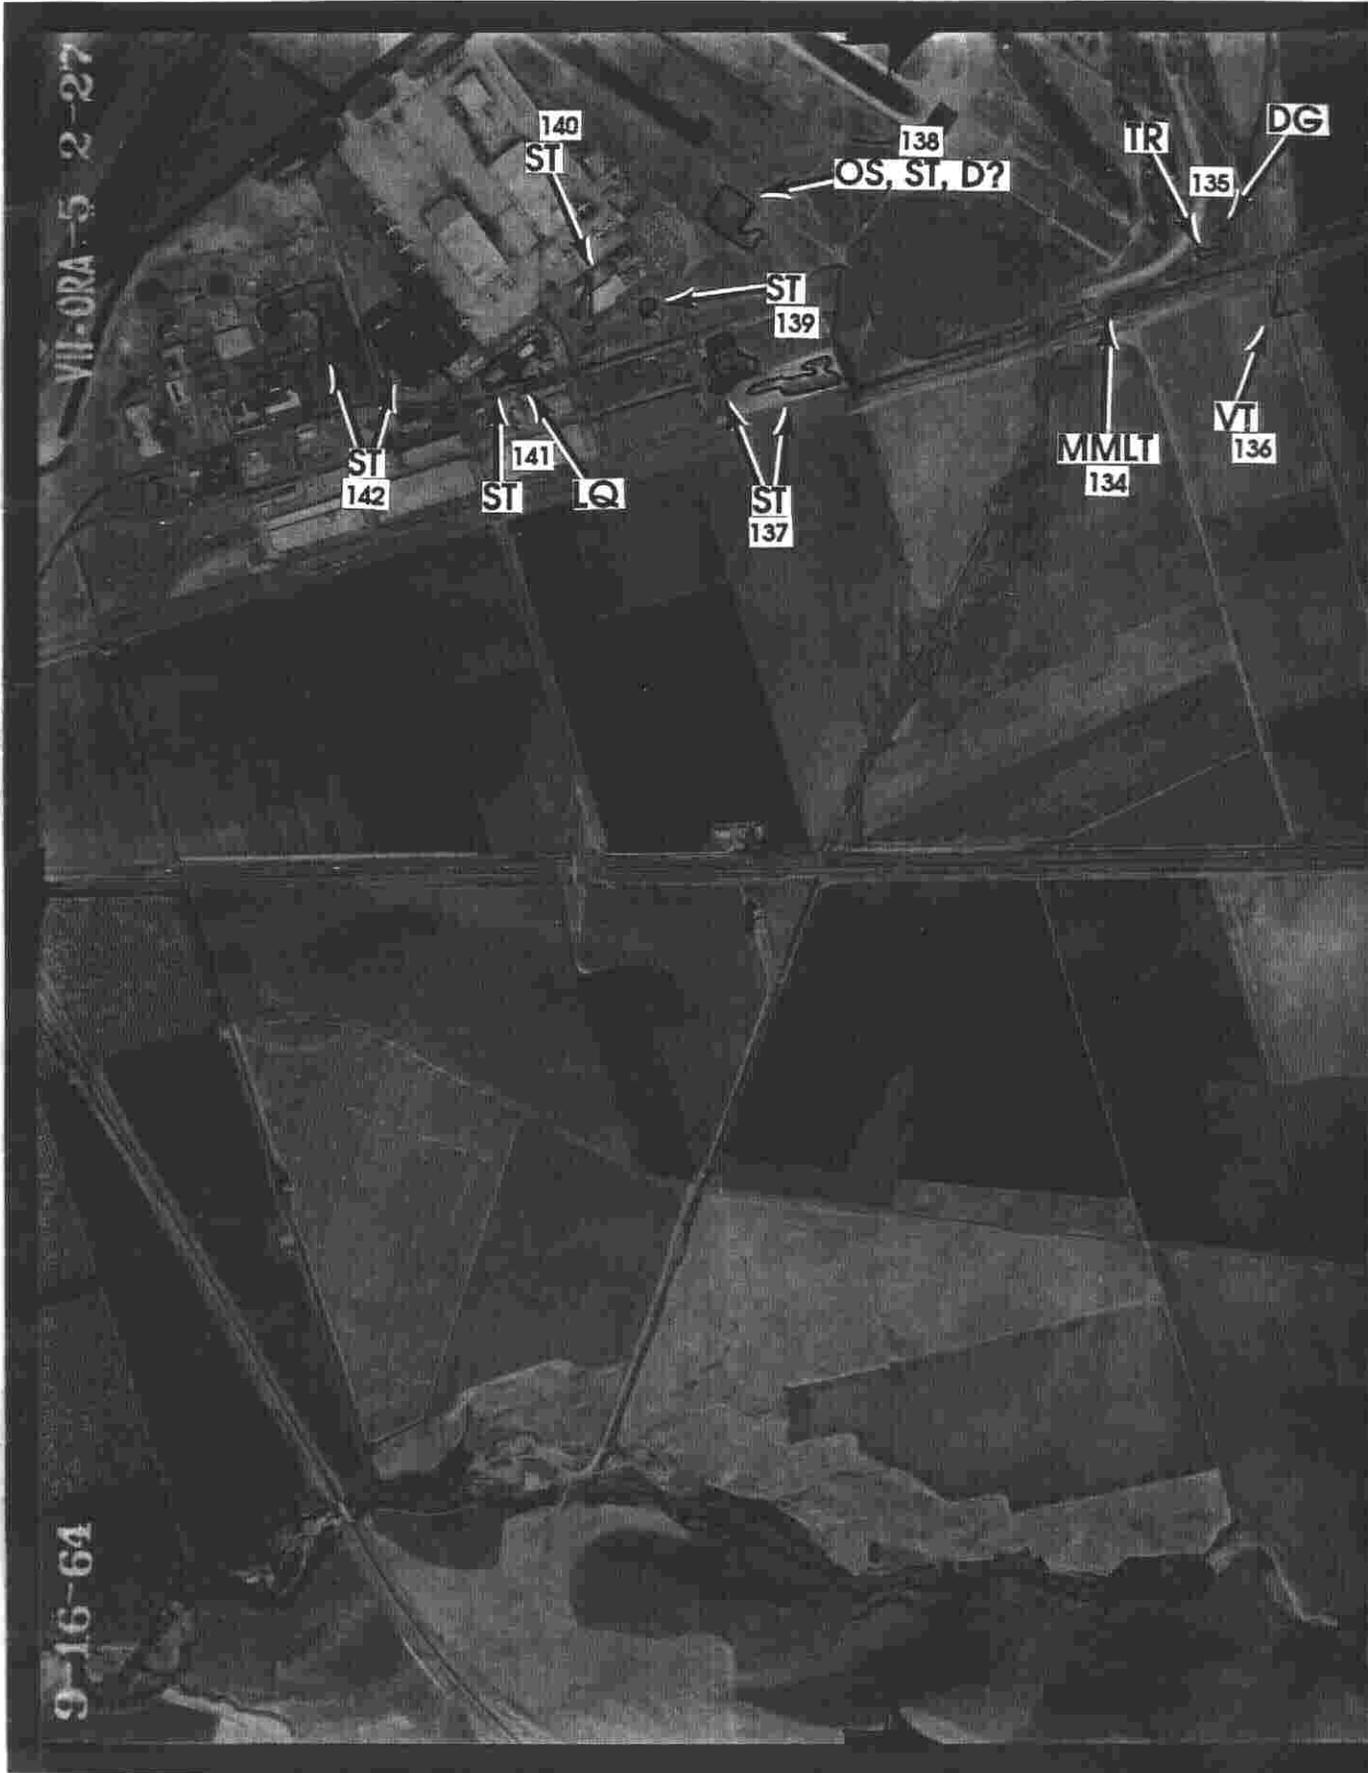
Figure 8

c 133. There is a dark-toned unidentified object (UO), a possible stained (ST) area, and wet soil (WS) or an excavation (EX) south of Perimeter Road near the railroad tracks. Additional investigation is recommended.

c 134. Light-toned mounded material (MMLT) can be seen on the north side of the railroad tracks near the approach end of Runway 34R. The materials appear to be soil and vegetation from earthmoving activities. No additional investigation is recommended at this time.

c 135. There are a trench (TR) and disturbed ground (DG) about 1000 feet northeast of the area noted in the previous comment. The disturbed ground may be a backfilled trench. Purpose of the activity is unknown, but it could be a disposal site. Additional investigation is recommended.

c 136. There are four probable vertical tanks (VT) on the southeast side of the railroad tracks, southeast of the features noted in the previous comment. The tanks may be used for chemical or fuel storage. Verification of the tanks and determination of their contents are recommended.

* 137. Stains (ST) are observed in the cleared or graded area easterly of Building 360 and the DRMO Storage yard (Site 8). Additional investigation of the site is recommended due to the persistence of the features over several years, and the use of the area for open storage.

* 138. There is an open storage (OS) area about 500 feet southeasterly of the southeast corner of the aircraft parking apron. There are also probable stains (ST) and probable drums (D). The Drop Tank Drainage Area No. 2 (Site 7) investigation area should be expanded to include this area.

* 139. Stains (ST) can be seen in the vicinity of Building 325, near S 14th Street and R Street. The cause is unknown and additional investigation is recommended.

* 140. Stains (ST) can be seen on westerly side of Building 324, near S 14th Street and R Street. Additional investigation is recommended.

* 141. There are stains (ST) in the general area of Buildings 309, 311 and 312, between South Marine Way and S 14th Street and O Street. There is probable liquid (LQ) flow toward the northeast from near Building 312. Additional investigation is recommended.

* 142. Stains (ST) are common in the open area within and southerly of the Petroleum Disposal Area (Site 10). Additional investigation in southern portion of area is advisable to supplement the current IR program field investigation.

* 143. A probable excavation (EX) is noted southwest of the Battery Acid Disposal Area (Site 14). Expansion of the Site 14 field investigation to include this site is recommended.

* 144. There are a probable trench (TR) and excavation (EX) southwest of the Battery Acid Disposal Area (Site 14). Photographs from 1961 suggest that the feature may be an access road and turn-around loop. Expansion of the Site 14 field investigation to include this site is recommended.
