Technical Memorandum

Verification of Perchlorate at IRP Site 1, Explosive Ordnance Disposal Range

Marine Corps Air Station, El Toro, California

July 2001

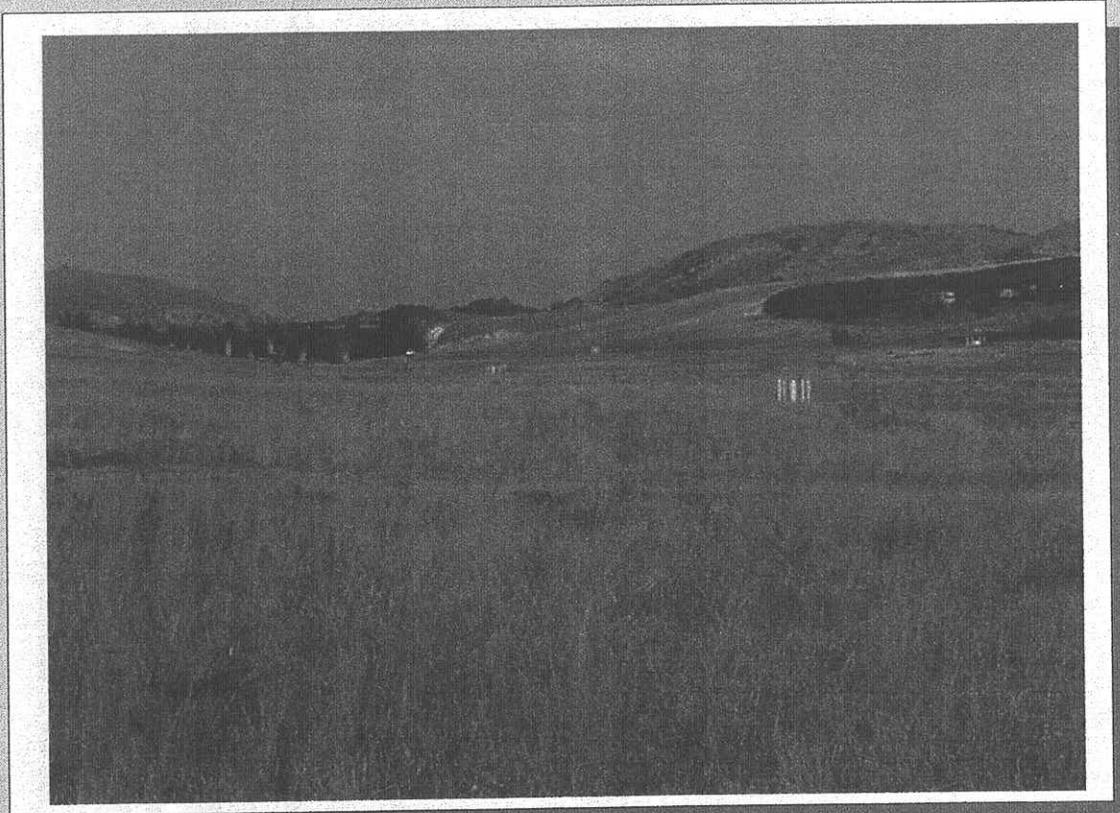
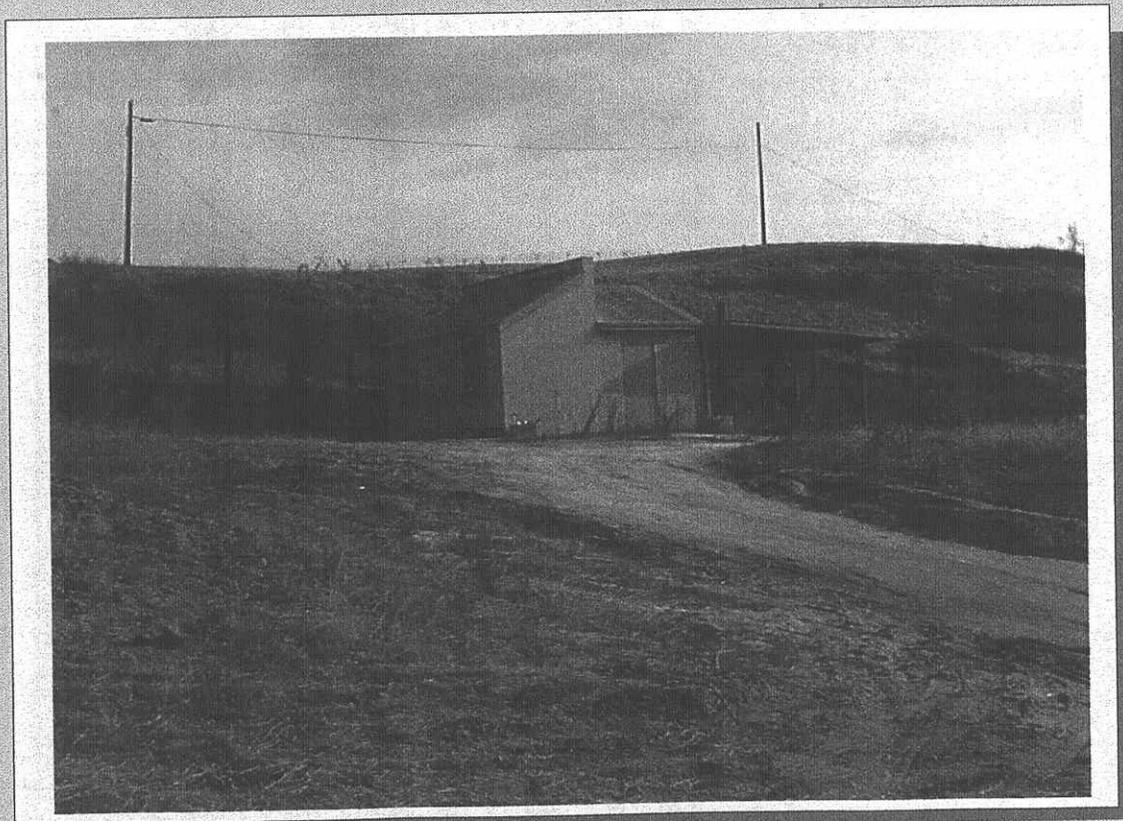
FIGURE 4

Site conditions over the EOD range are illustrated on Figure 4 (upper photo). Subsurface Surveys established a formal rectilinear grid with survey lines extending along the long axis of the site (y-axis). The grid was tied to an existing concrete block building shown on Figure 5 (lower photo). Production over the site varied mostly due to terrain and ground surface condition (low grass, hard soil, and disked soil) (Figure 5). In addition to the main survey area, brush clearing was undertaken for a retention basin at the north end of the site in preparation for geophysical surveying (Figure 6).
