## **Summary Report**

**Repairs to Vehicle Washrack at Building 386  
Solid Waste Management Unit (SWMU) Number 110  
Petroleum Corrective Action Program  
Marine Corps Air Station, El Toro, California**

**4 February 1999**

*Prepared by*  
**Southwest Division, Naval Facilities Engineering Command  
BRAC Operations Office  
1420 Kettner Boulevard, San Diego, CA 92101**

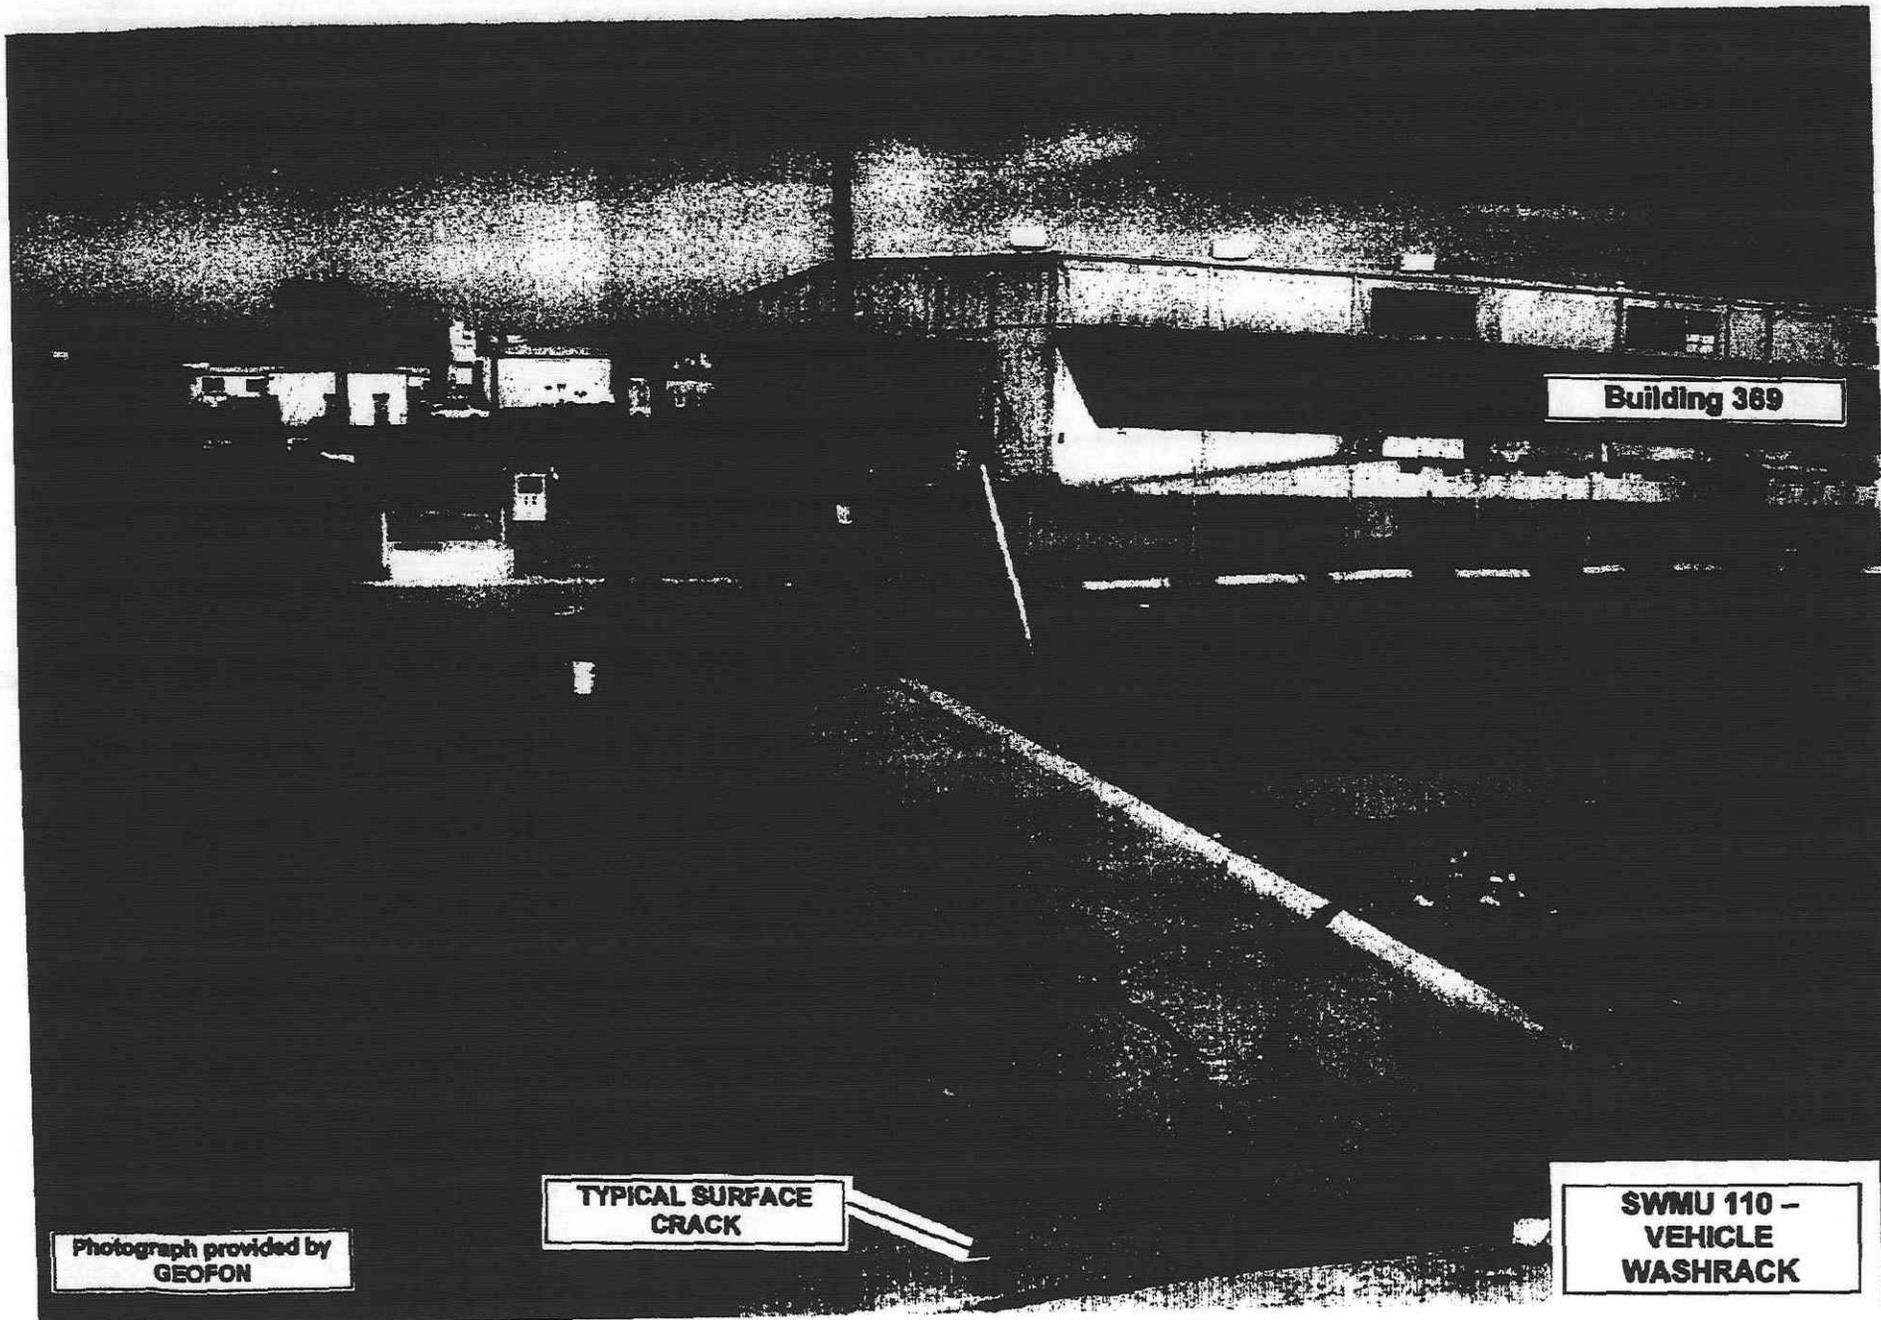
Repairs to the cracks in the surface of SWMU 110 were implemented in December 1998 by GEOFON, Incorporated under Navy Contract N68711-97-D-8702, Delivery Order 19. Photographs of the washrack and field notes are provided in Appendix A. Most of the surface cracks were one-half inch to one inch deep.

**Building 386**

**TYPICAL SURFACE  
CRACK**

**SWMU 110 –  
VEHICLE  
WASHRACK**

GEOFON prepared the washrack slab surface by removing dust and vegetation. Surface cracks were filled with a joint sealant. Information pertaining to the sealant is presented in Appendix A.

The sealed cracks will reduce the infiltration of surface waters through the washrack slab and will reduce the potential migration of subsurface residual petroleum hydrocarbons beneath the slab.
