Summary Report

*Former Temporary Accumulation Area (TAA) 761
Solid Waste Management Unit (SWMU) 236
Former Marine Corps Air Station, El Toro, California*

20 September 2002

Prepared by:
Southwest Division, Naval Facilities Engineering Command
BRAC Programs Office
San Diego, CA 92101-2404

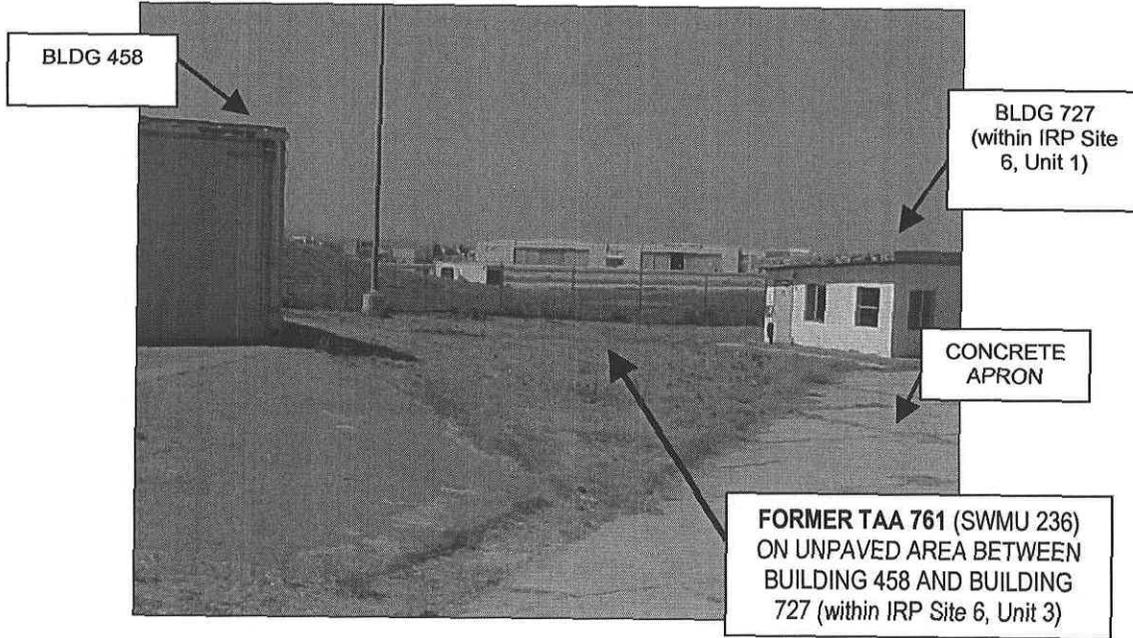
Photograph 1. Former Temporary Accumulation Area (TAA) 761.
Solid Waste Management Unit (SWMU) 236) with Building 458 at the left side of the photograph and Building 727 at the right side of the photograph. The concrete apron is in the foreground. Former Marine Corps Air Station, El Toro Date of Photograph: 17 September 2002

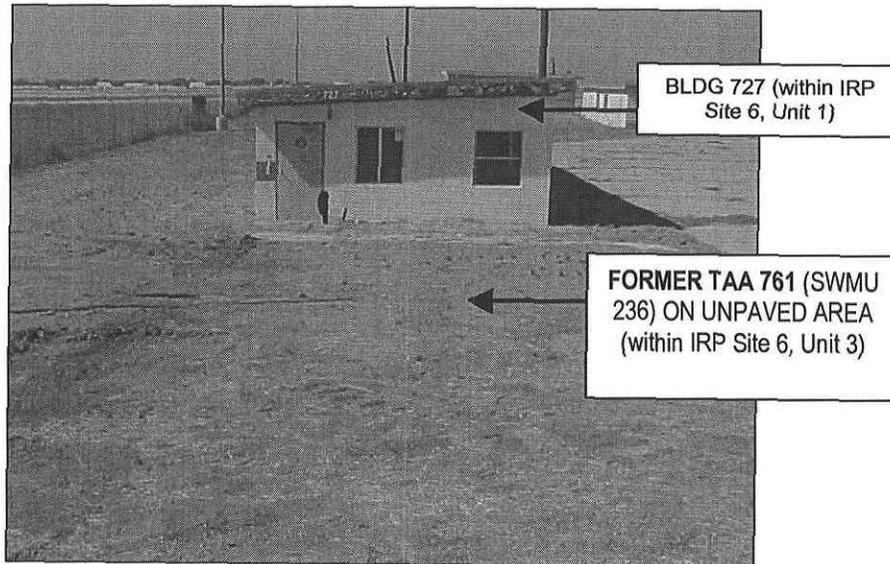
Photograph 2. Former TAA 761 (SWMU 236).

Looking approximately north-northwest toward Building 727.
Former Marine Corps Air Station, El Toro Date of Photograph: 17 September 2002

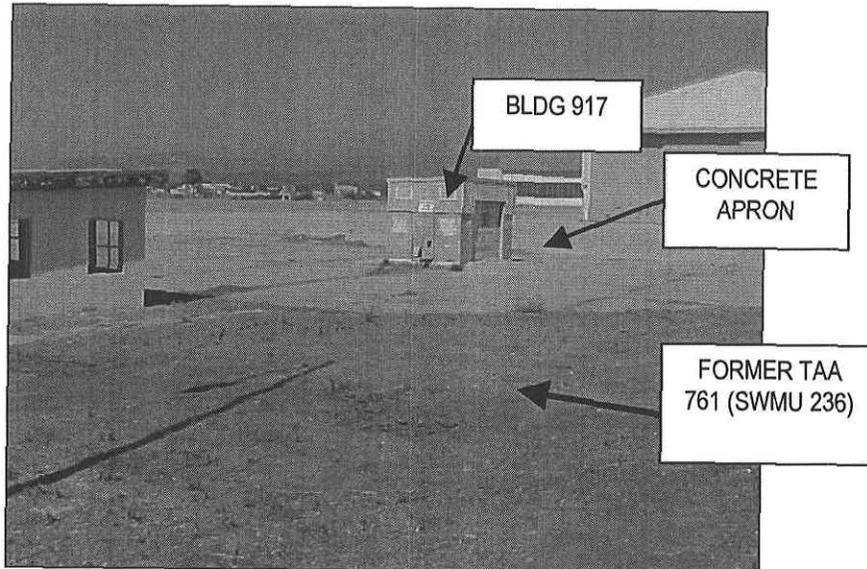
Photograph 3. Former TAA Site 761 (SWMU 236).

Looking approximately northeast toward Building 917 (Former Hazardous Materials Storage Locker) on Concrete Apron.

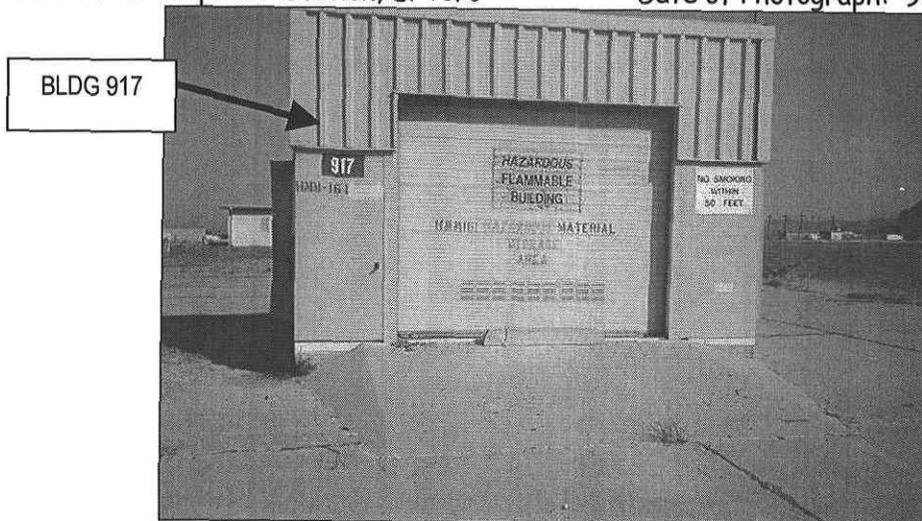
Photograph 4. Former TAA Site 761 (SWMU 236).

Former Hazardous Materials Storage Locker, Building 917, Located northeast of Former TAA Site 761.

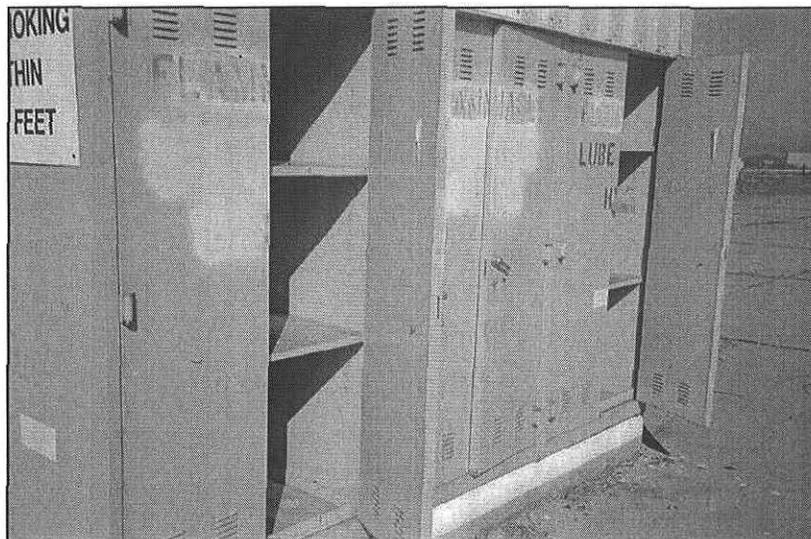
Photograph 5. Former TAA Site 761 (SWMU 236).

Former Hazardous Materials Storage Locker, Building 917, located northeast of Former TAA Site 761.
Former Marine Corps Air Station, El Toro
