Summary Report

Temporary Accumulation Area (TAA) 769
Solid Waste Management Unit (SWMU) 222
Marine Corps Air Station, El Toro, California

18 March 2002

Prepared by:
Southwest Division, Naval Facilities Engineering Command
BRAC Programs Office
San Diego, CA 92101-2404

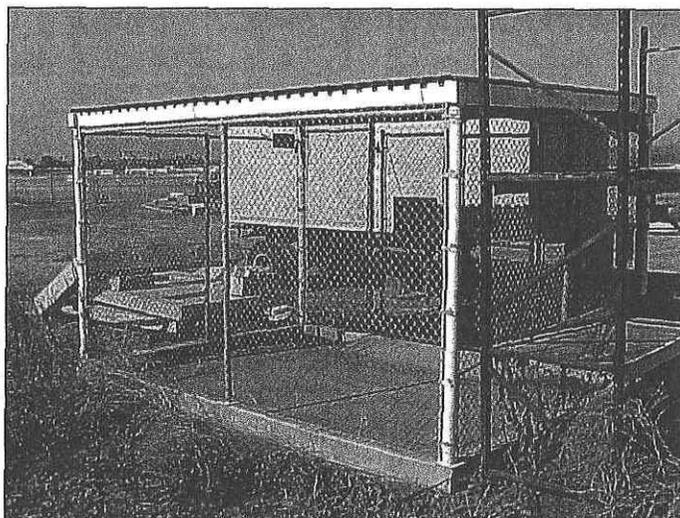
**Photograph 2. Former Temporary Accumulation Area (TAA) 769
Solid Waste Management Unit (SWMU) 222**

Representatives from the Navy conducted visual inspections of the former TAA 769 on 1 and 8 March 2002. On 8 March 2002, the surface of the concrete floor was inspected closely and no stains or significant cracks were observed on the concrete floor or on the curb. The concrete floor and curb appeared to be in excellent condition. Additionally, no stains were observed on the unpaved areas adjacent to former TAA 769. Photographs from the visual inspections of March 2002 are included in the Appendix.

- The Navy inspected TAA 769 on 1 and 8 March 2002. No stains were observed on the concrete surfaces of the floor or on the curb of the TAA. No significant cracks were observed in the concrete surfaces of the floor or on the curb. No stains were observed on the unpaved areas surrounding the TAA.

Based upon the absence of visual evidence of a significant release at or near former TAA 769, the results of the screening risk calculations, and the excellent condition of the concrete floor and curb, it is recommended that no further action status be designated for TAA 769 in the next BRAC Business Plan Update

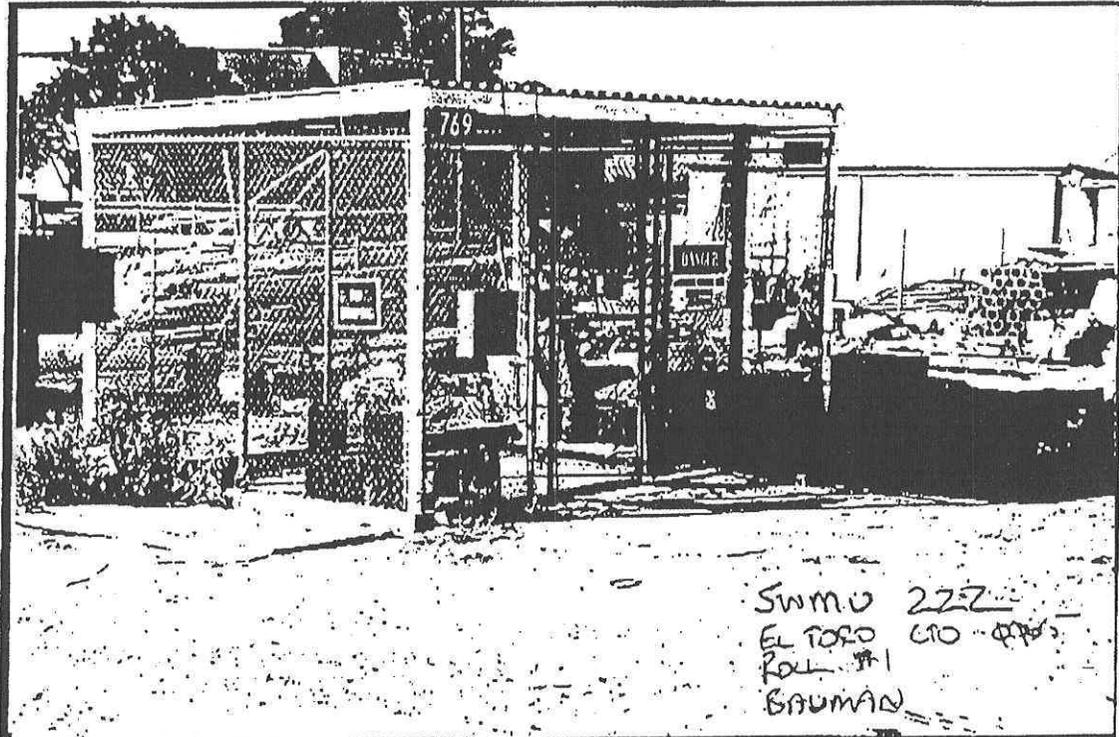
SWMU #: 222

~~Stain(s)~~ ~~Odor(s)~~ ~~Crack(s)~~
Placards/Labels: Y N If Yes, list: .
Observations: Clean concrete pad. Roof over pad. The SWMU is bldg 769.
Status: No change, apparently inactive as of 11-10-95.
