Information Package

Solid Waste Management Unit (SWMU) 110
Former Wash Rack
Former Marine Corps Air Station, El Toro

Prepared by:
Southwest Division
Naval Facilities Engineering Command

27 June 2003

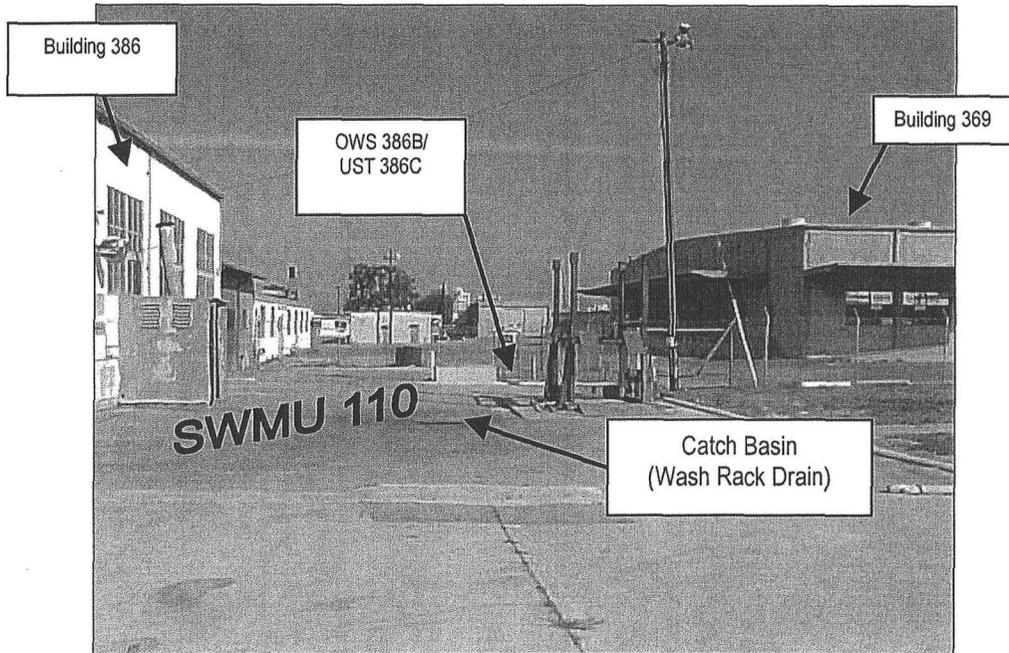
Photograph 1. Solid Waste Management Unit (SWMU) 110 at Center with Building 386 at Left.
Looking Northwest from Southeastern Side of SWMU 110.
Former Marine Corps Air Station, El Toro
Date of Photograph: July 1999

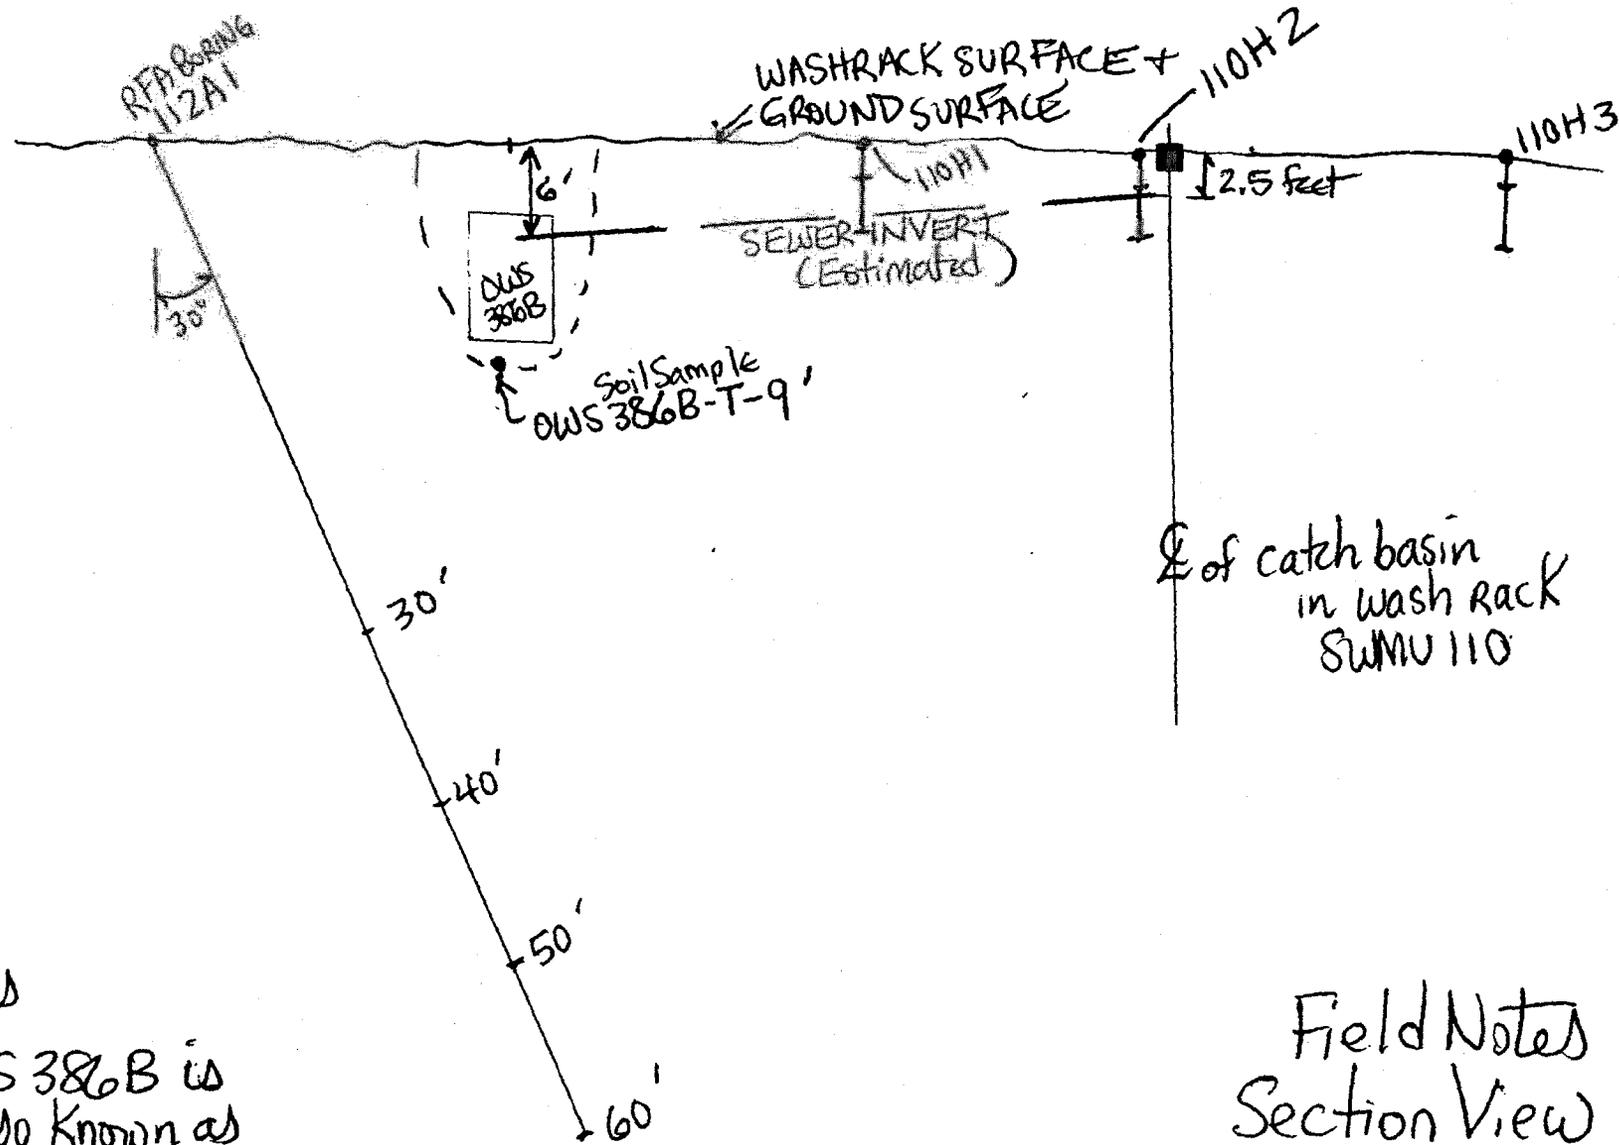
Field Sketch of SWMU 110
5-19 June 2003
Compiled by Lynn Hornacker

- 1) OWS 386B is also known as SWMU 112
- 2) Borings 110H1, 110H2, + 110H3 are through the wash rack.

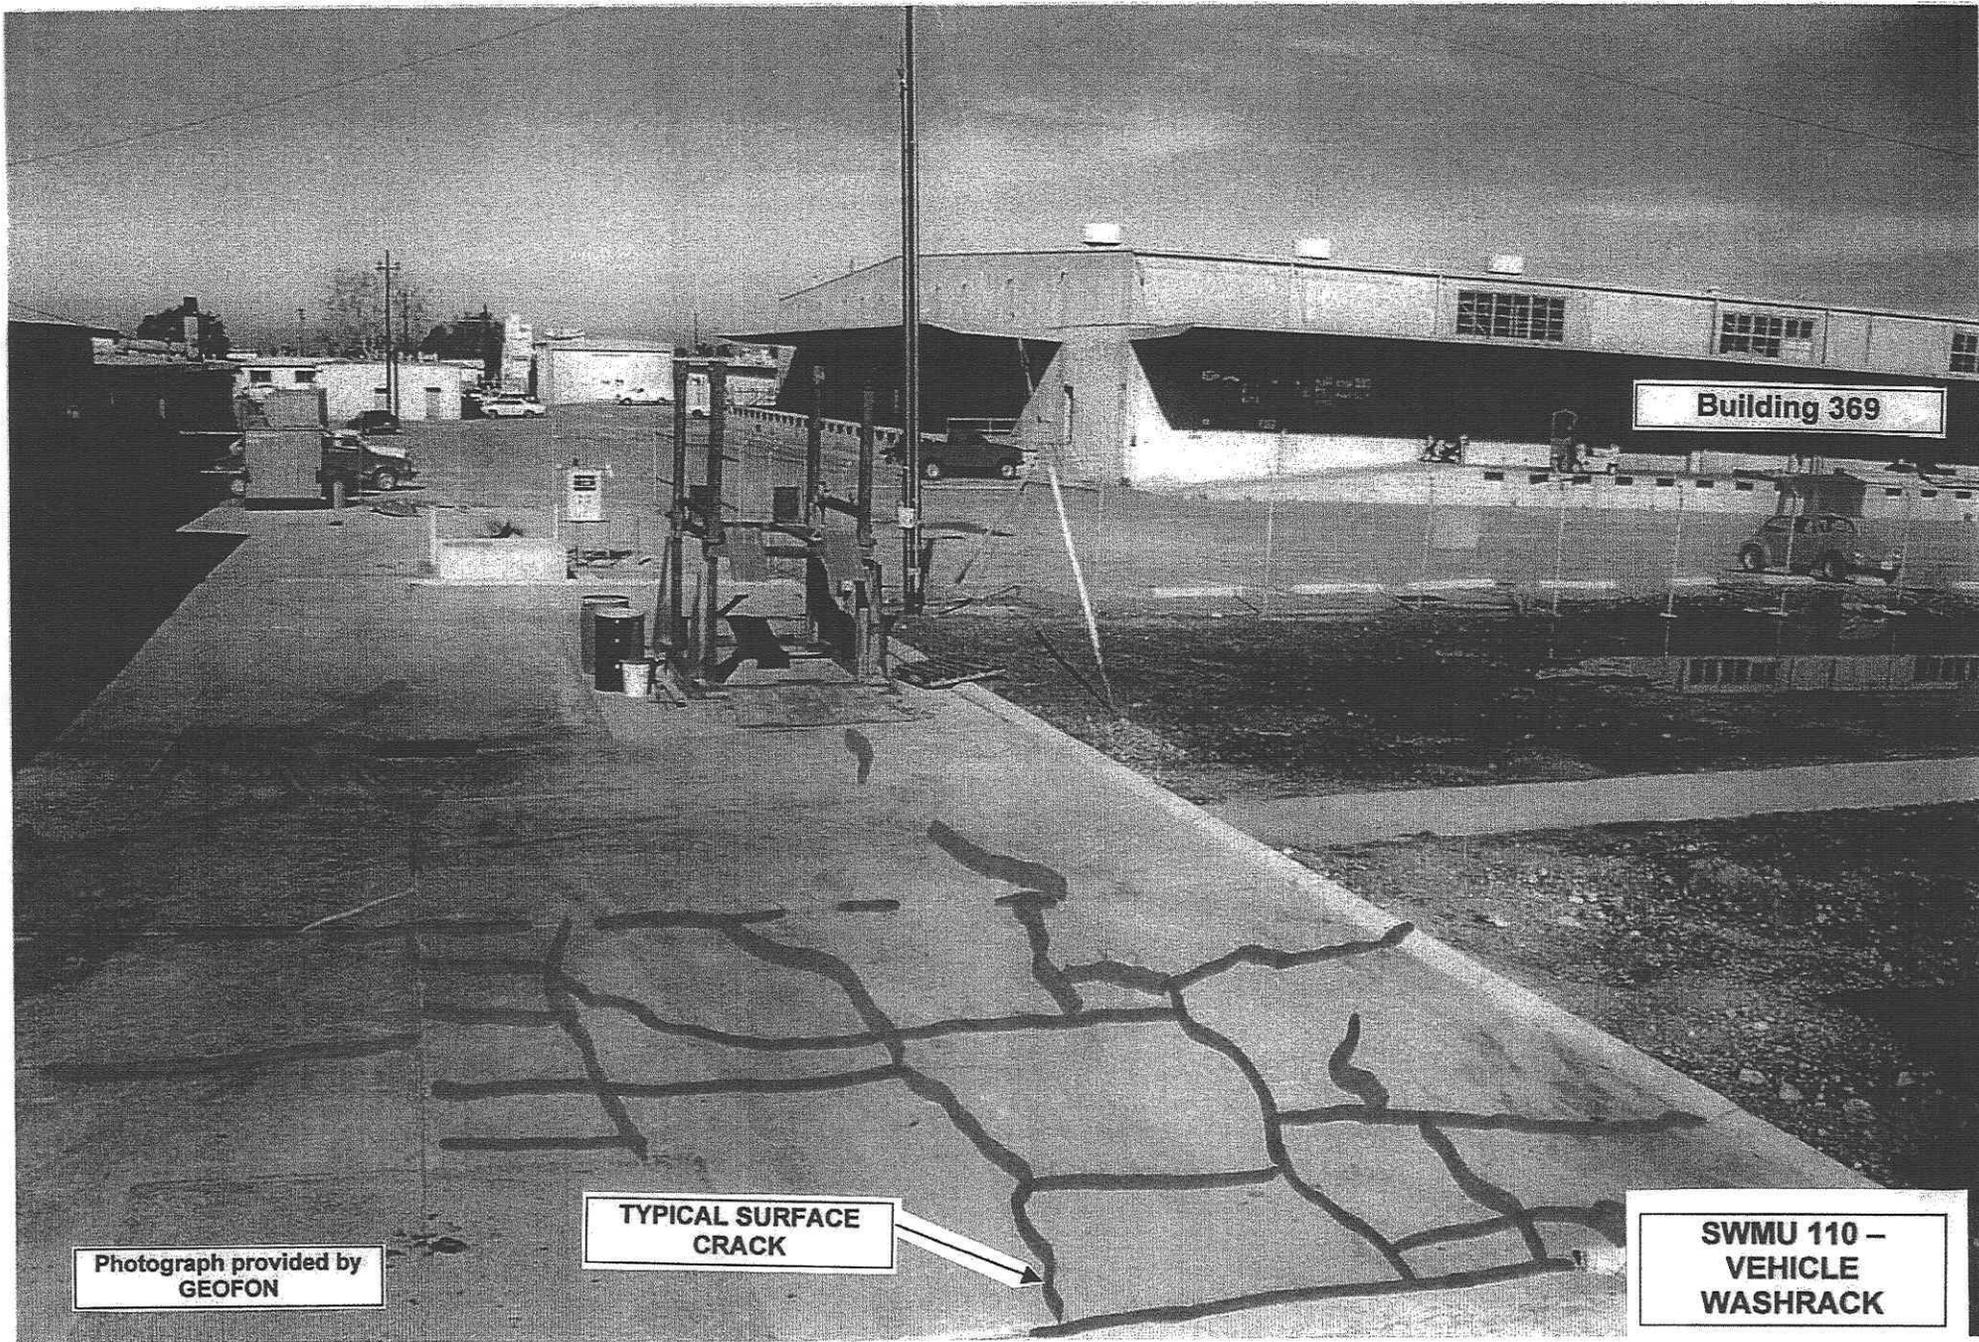
Photograph provided by
GEOFON

Repairs to the cracks in the surface of SWMU 110 were implemented in December 1998 by GEOFON, Incorporated under Navy Contract N68711-97-D-8702, Delivery Order 19. Photographs of the washrack and field notes are provided in Appendix A. Most of the surface cracks were one-half inch to one inch deep.

TYPICAL SURFACE
CRACK

GEOFON prepared the washrack slab surface by removing dust and vegetation. Surface cracks were filled with a joint sealant. Information pertaining to the sealant is presented in Appendix A.
