N00221_003530
MARE ISLAND
SSIC NO. 5090.3.A

**OVERSIGHT REPORT FOR
MEC SOIL SCREENING OPERATION
AT
FORMER MINS CORAL SEA HOUSING AREA**

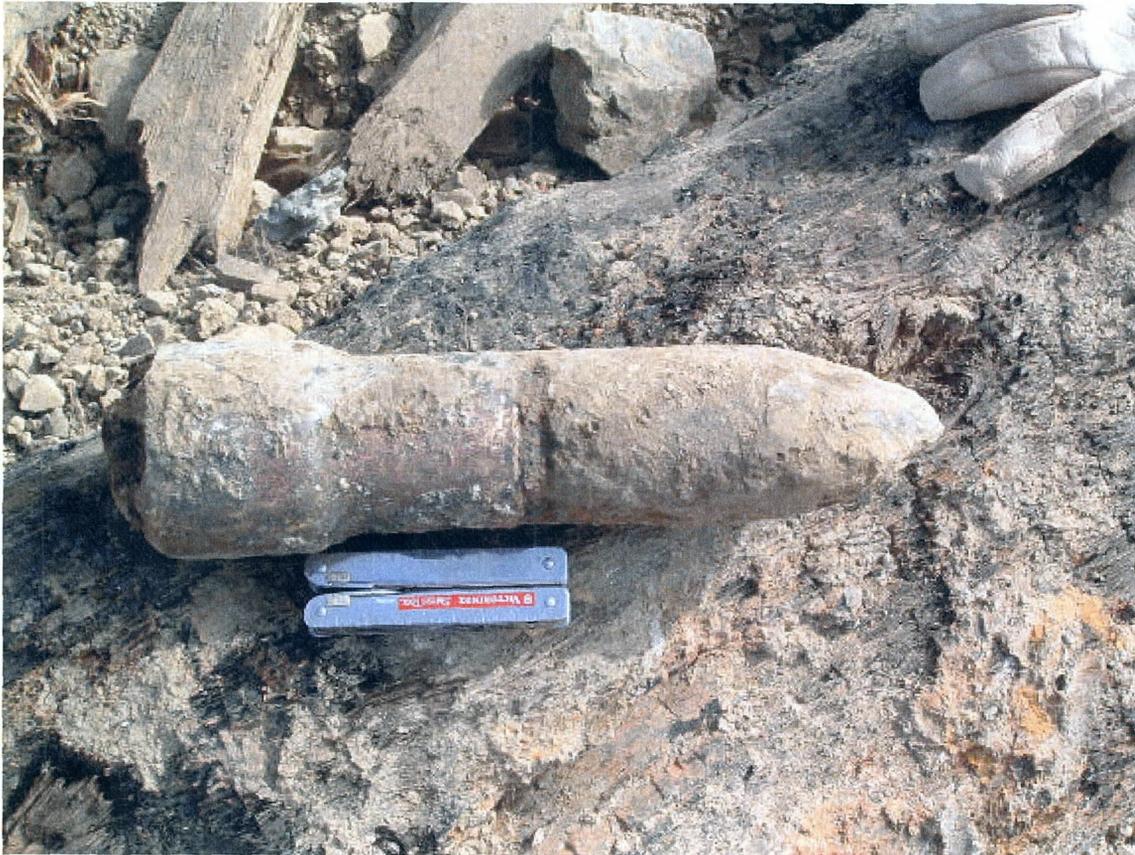
3 inch Dummy Projectile

All three inch projectiles found were solid dummy rounds, both the nose and base were solid metal with no arrangements for fuzing. Some of the rounds still had a partial brass casing attached containing a portion of a wooden dummy cartridge casing

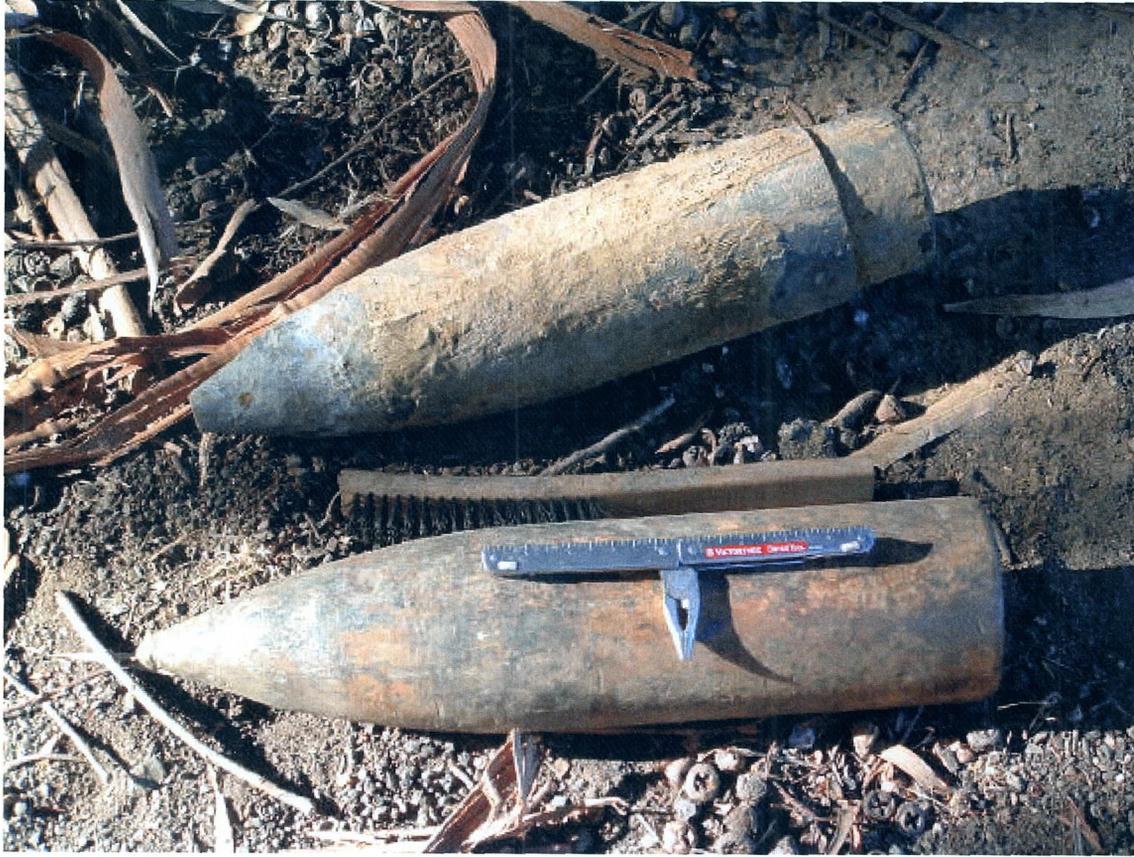
5" MK. MOD. UNKNOWN PROJECTILE BRASS (Bottom)

This projectile was solid dummy round plated in brass; both the nose and base were solid metal with no arrangements for fuzeing.

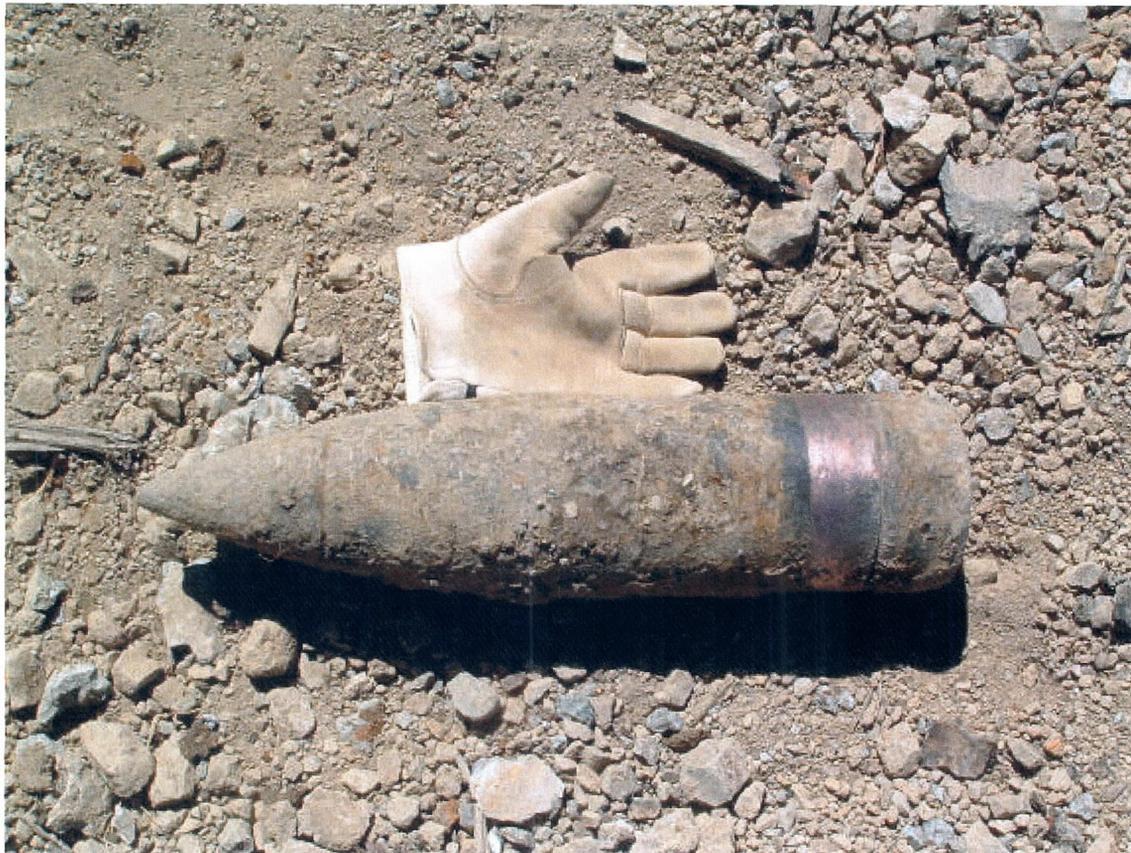
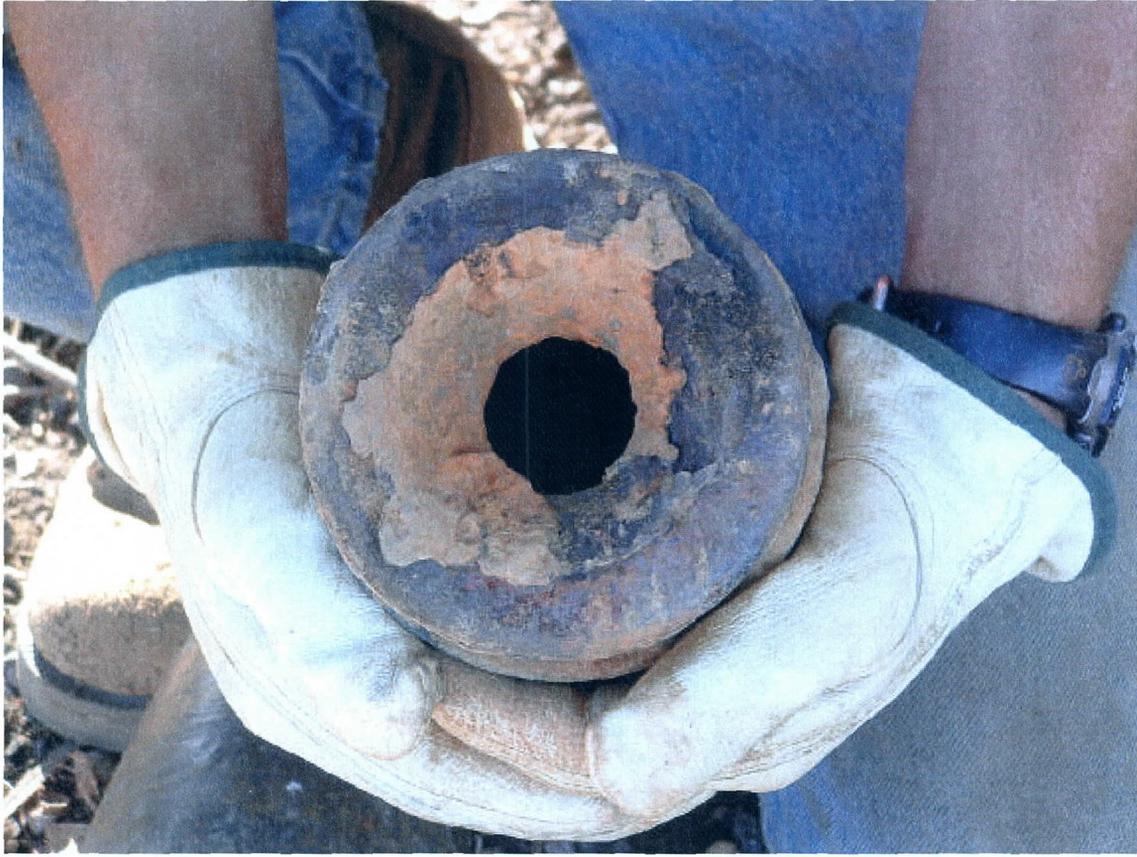
5" MK XXX MOD UNKNOWN PROJECTILE

Upon discovery, a visual inspection of the rotating band was conducted to ensure that these projectiles had not been fired. Also, a visual inspection of the base was conducted to confirm that there was a hole in the center of the base of the projectile exposing the empty projectile cavity. Once these conditions were confirmed, the projectile was considered safe, carried off to a safe area, and cleaned for recording purposes. The first action taken was to insert a non-sparking probe into the hole in the base of the projectile and record the depth of the cavity. The non-sparking probe was then placed on the external body of the projectile revealing a depth of all but the fuze body. On one projectile, the ojive of the fuze was corroded exposing the internal cavity. This cavity was expanded and revealed that the entire fuze body was void of any working components. A non-sparking probe was reinserted into the base of the projectile and manipulated until it eventually entered the fuze body. The tip of the non-sparking probe could now be observed through the external cavity in the fuze body. A further visual search of the interior of each projectile was conducted using a fiber optic light. Upon conclusion of these investigations, on the remaining projectiles and fuzes it was determined that they also were empty and void of any potential energetic materials.

Prior to our departure, all of the 5" MK XXX MOD UNKNOWN projectiles were inspected utilizing a thin non-sparking metal bar thereby confirming our initial findings of these projectiles and again deeming them to be empty and void of any energetic materials.

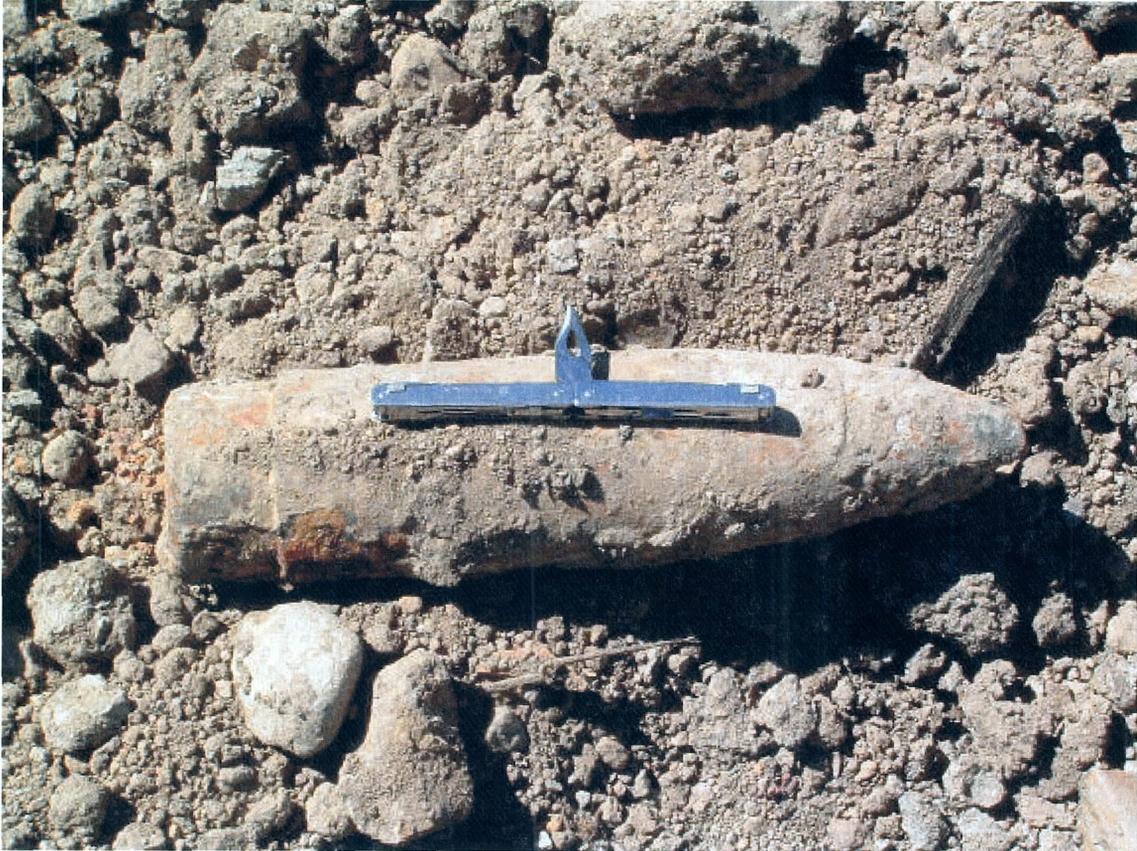
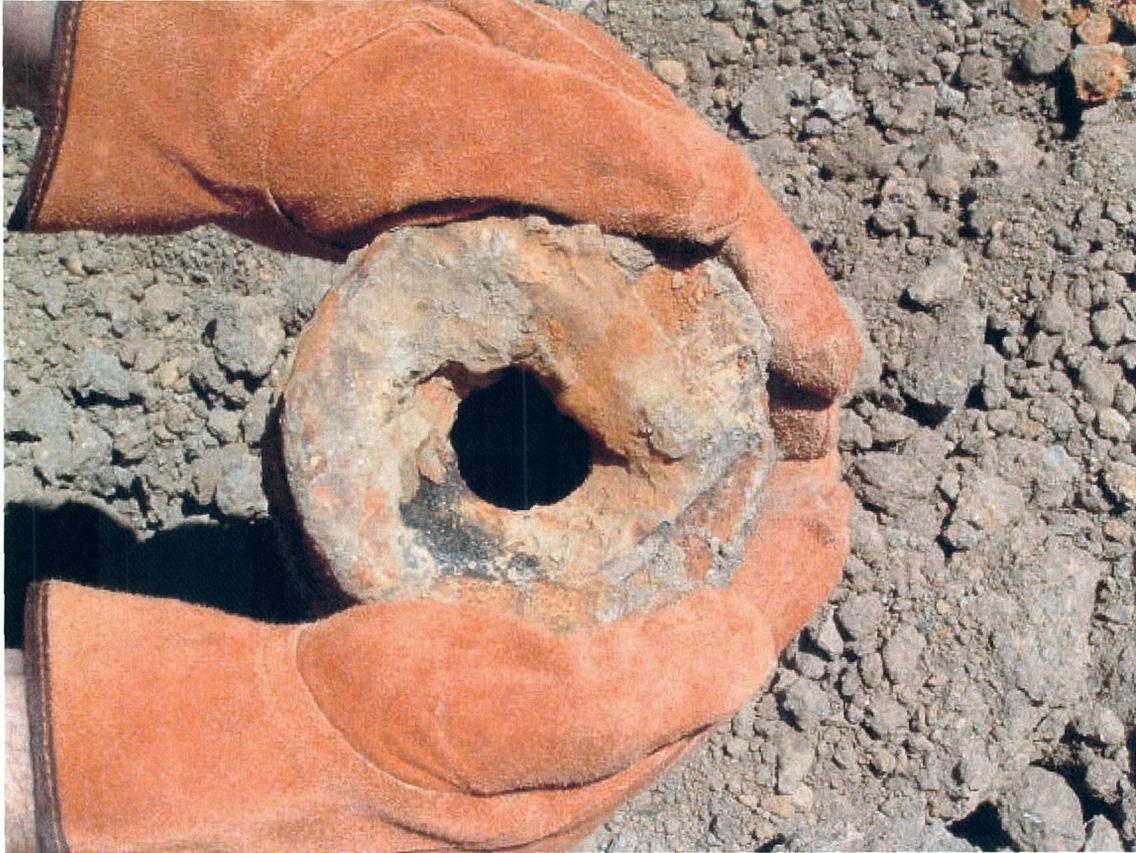
5" MK MOD UNKNOWN PROJECTILE

Upon discovery, a visual inspection was conducted to confirm that there was a hole in the center of the base of the projectile exposing the empty projectile cavity. Due to the lack of a rotating band, no inspection of this item was conducted. Once this condition was confirmed, the projectile was considered safe, carried off to a safe area, and cleaned for recording purposes. The first action taken was to insert a non-sparking probe into the hole in the base of the projectile and record the depth of the cavity. The non-sparking probe was then placed on the external body of the projectile revealing a depth of all but the fuze body. Unlike that of the MK XXX, there was no access into the fuze body from the projectile cavity. Therefore, an extensive inspection of the fuze was conducted. These fuzes revealed no presence of any plunger type devices normally associated with point detonating type fuzes. They did not contain multiple body construction normally associated with powder train time fuzes. The body and booster cups were constructed of solid steel vice a booster cup constructed of aluminum or lighter material therefore allowing for a rapid decomposition and transfer of energy to the main filler. There was no evidence of a safety pin hole, bore riding pin or any other safety related items. The upper fuze body did not rotate separately of the lower fuze body as normally associated with that of a mechanical time fuze. There were no markings stamped into the fuze body with the exception of a self appointed

serial number. All of the fuzes associated with this type of projectile were identical to each other. A further visual search of the interior of each projectile was conducted using a fiber optic light. Upon conclusion of these investigations, on the remaining projectiles and fuzes it was determined that they also were empty and void of any potential energetic materials.

Prior to our departure, all of the 5" MK MOD UNKNOWN projectiles were recertified utilizing a thin non-sparking metal bar and a further visual search of the interior of the projectile was conducted thereby confirming our initial findings of these projectiles and again deeming them to be empty and void of any energetic materials.

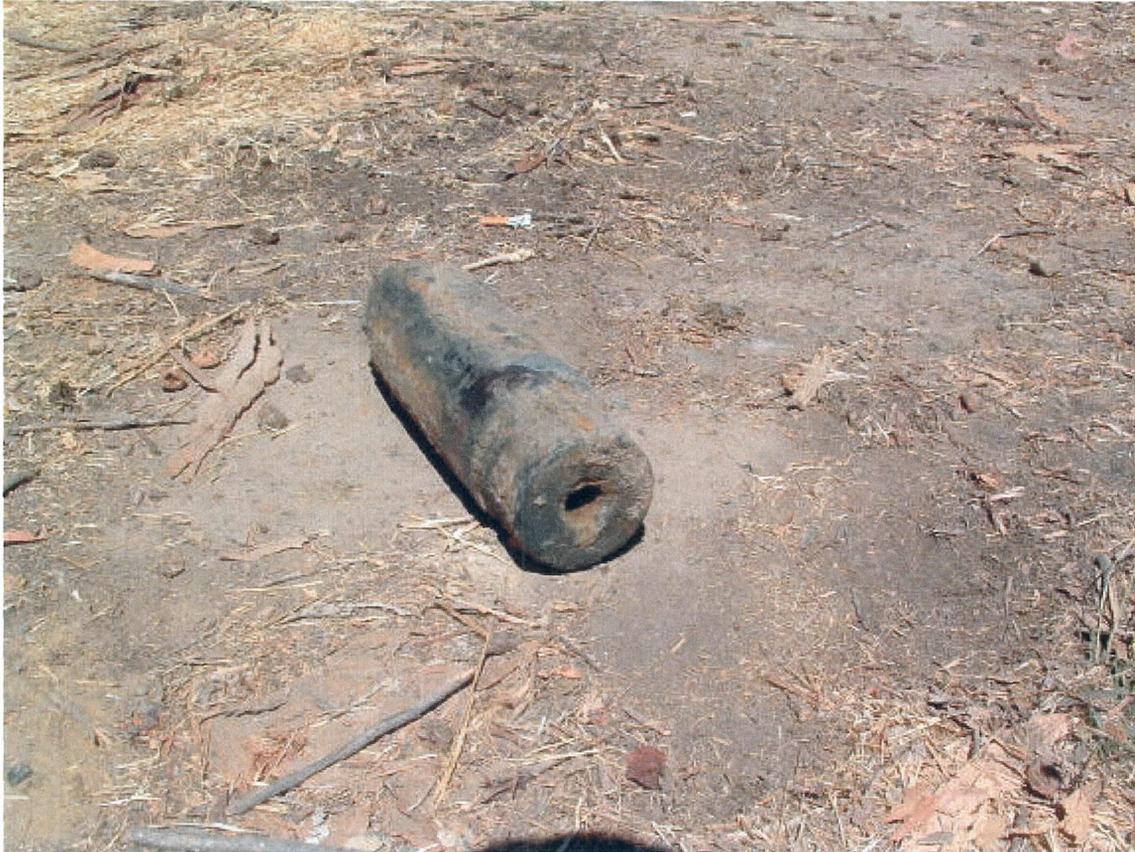
5" AP DUMMY PROJECTILE

Upon discovery, a visual inspection was conducted to confirm that there was no presence of a fuze assembly. Also, an inspection of the rotating band was conducted to verify that this projectile had not been fired. Once these conditions were confirmed, the projectile was considered safe, carried off to a safe area, and cleaned for recording purposes. During the cleaning process, moisture began to exude from the center of the base of the projectile. A screwdriver component of a letherman tool was used to remove debris and a decomposed wooden plug from the base of the projectile revealing an empty cavity. A non-sparking probe was inserted into the fuze hole in the base of the projectile and the depth of the cavity recorded. The non-sparking probe was then placed on the external body of the projectile revealing a depth of all but approximately $\frac{3}{4}$ of an inch which would compensate for the thickness of the nose of the projectile. A further visual search of the interior of the projectile was conducted using a fiber optic light confirming the cavity was empty. Upon conclusion of these investigations, it was determined that the projectile was empty and void of any potential energetic materials.

Prior to our departure, the AP DUMMY projectiles was recertified utilizing a thin non-sparking metal bar and a further visual search of the interior of the projectile was conducted thereby

confirming our initial findings of this projectile and again deeming it to be empty and void of any energetic materials.

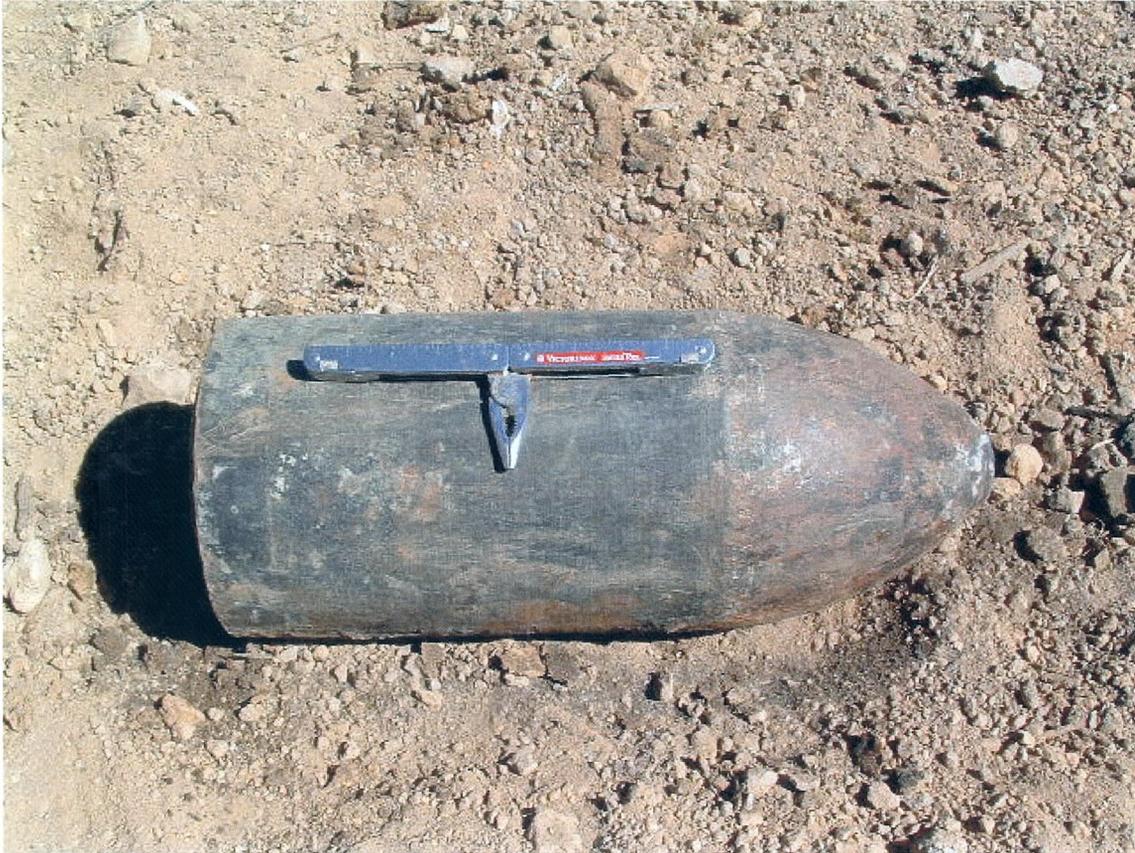
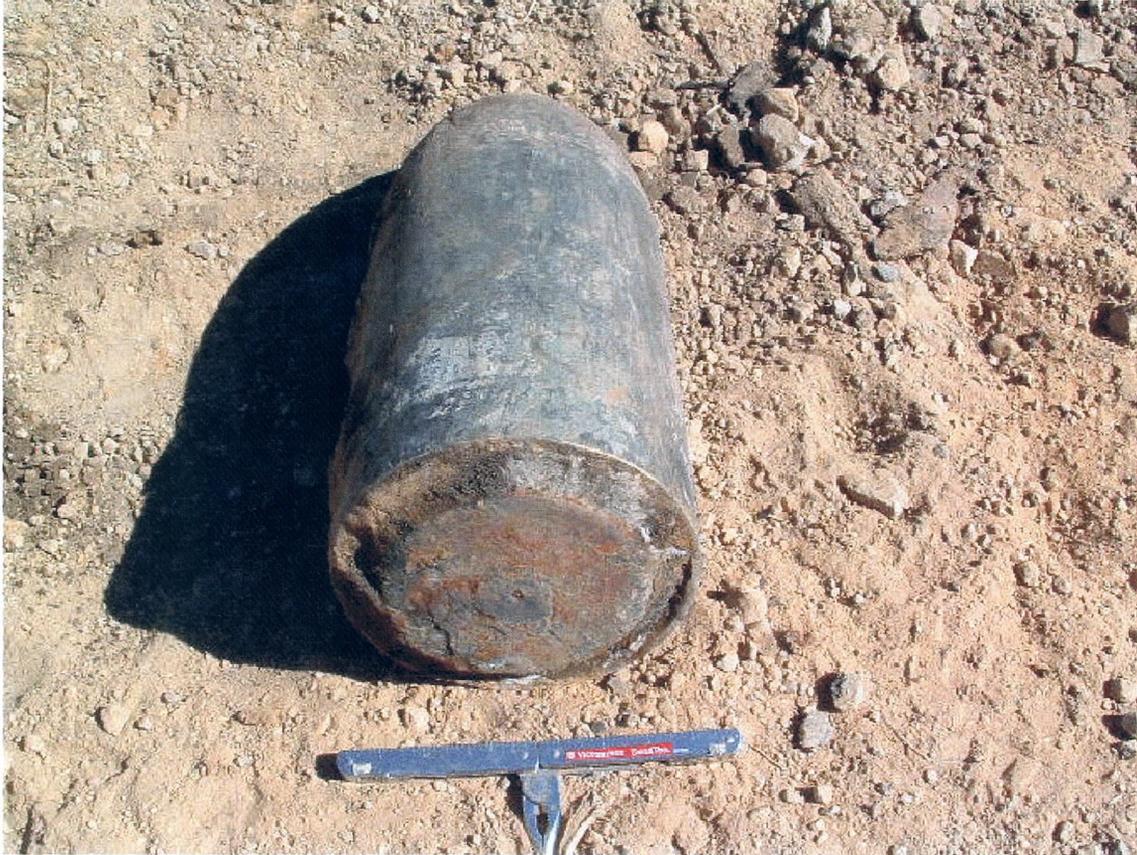
8” PARROT PROJECTILE

Upon discovery, a visual inspection of the rotating band was conducted to ensure that these projectiles had not been fired. Also, a visual inspection of the fuze well was conducted to determine the presence or absence of a functional fuze assembly. Once the conditions were confirmed, the projectile was considered safe, carried off to a safe area, and cleaned for recording purposes. During the cleaning phase, the nose plug on the projectile was seen exuding a liquid substance. An aroma test was conducted, and it was determined that black powder was not contained within the center of the plug.

Based on previous documentation, it was confirmed that these rounds came standard with a wooden shipping plug inserted into the fuze well. A leatherman tool, was used to cautiously remove debris and a decomposed wooden plug and the substances being removed were carefully scrutinized for the potential presence of any type of energetic material. The only substance identified throughout this process was that of bay mud and moistened decomposing wood. The wooden plug and mud was eventually removed revealing an empty cavity. A non-sparking probe was used to record the depth of the cavity and placed on the external body of the projectile revealing a depth of all but approximately $\frac{3}{4}$ of an inch which would compensate for the thickness of the projectile base. A further visual search of the interior of the projectile was conducted using a fiber optic light confirming the cavity was empty. The non-sparking probe was

reinserted and shifted from side to side to ensure that the cavity was entirely void of any potential energetic materials. A metal to metal signature could be heard during this entire procedure. Upon conclusion of this investigation, it was determined that the projectile was empty and void of any potential energetic materials.

Prior to our departure, all of the 8” projectiles were recertified utilizing a non-sparking thin metal bar and a further visual search of the interior of the projectile was conducted thereby confirming our initial findings of these rounds and again deeming them to be empty and void of any energetic materials.

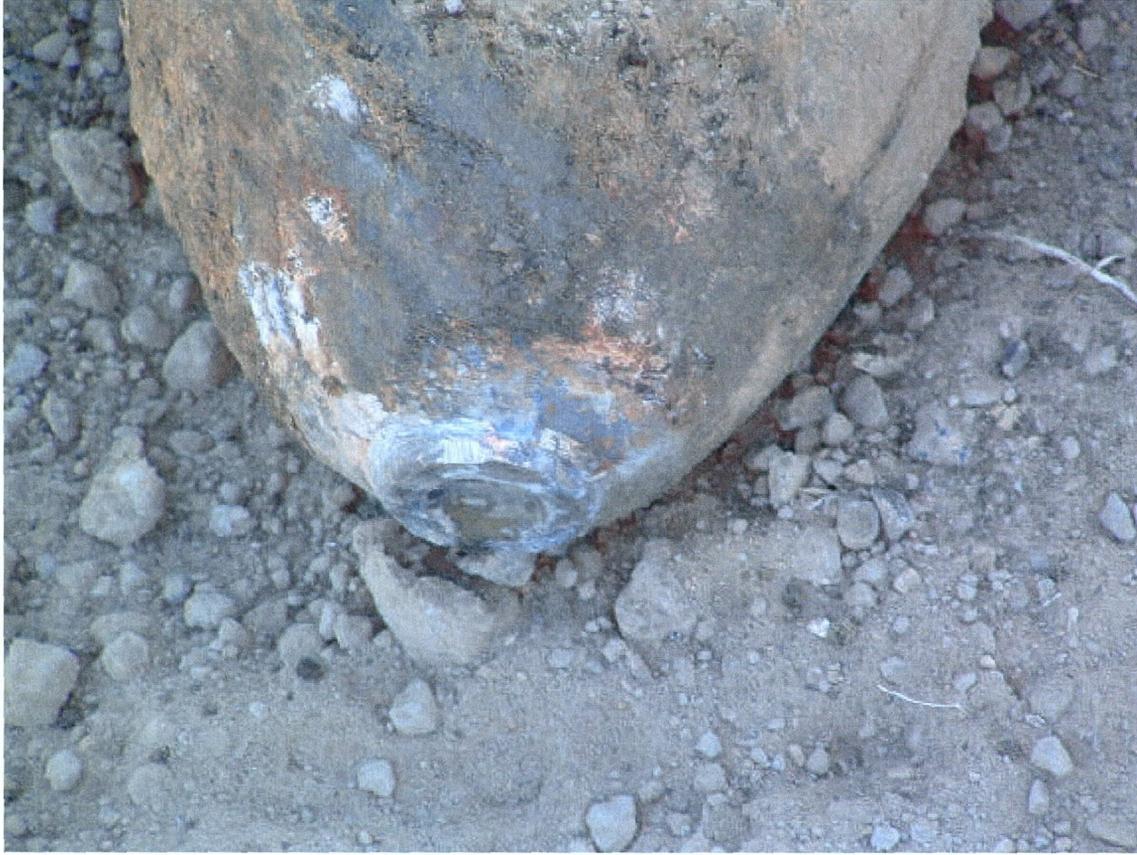
8" PARROT PROJECTILE W/NOSE PLUG AND MUD

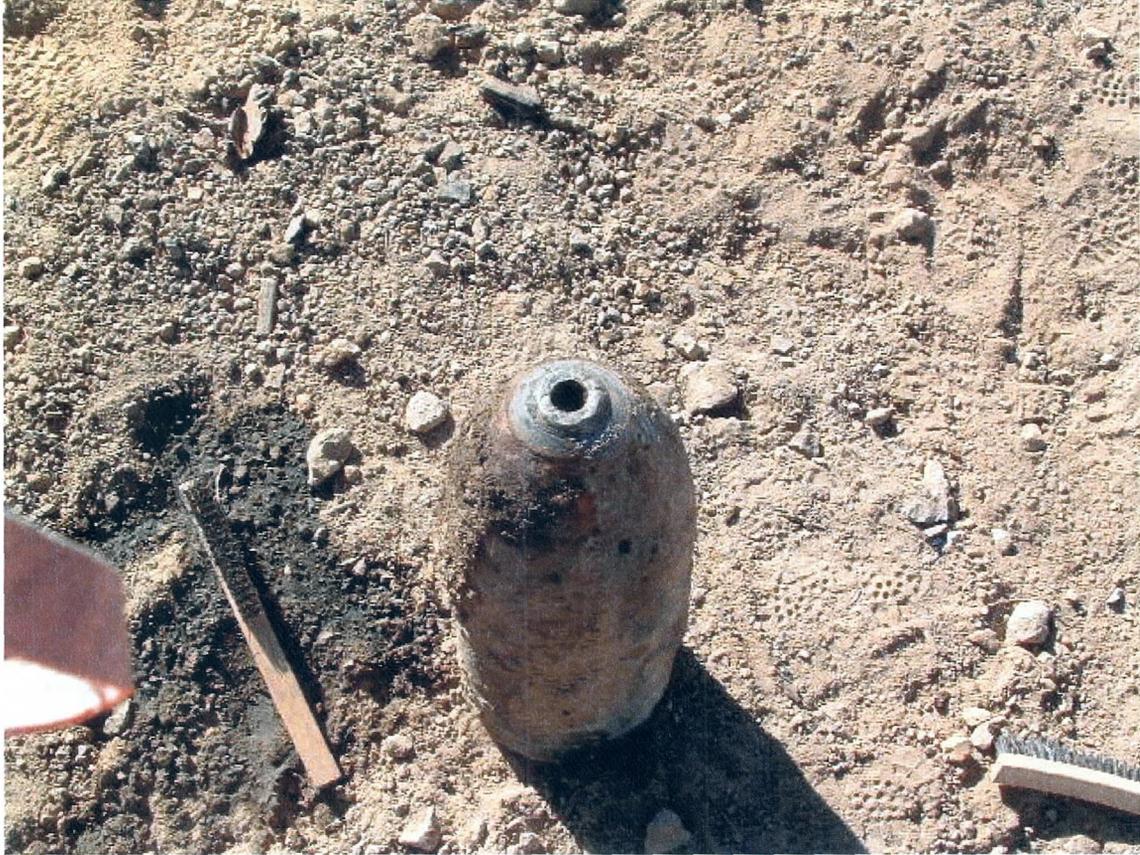
8" PARROT PROJECTILE W/NOSE PLUG AND MUD REMOVED
